**An Historic Building Assessment and Record  
of the Standing fabric forming the Grade II\*  
Listed Building known as Bradgate Stables  
(Bradgate House) Groby,  
Leicestershire (SK 092 517)**

University of Leicester Archaeological Services

Report No. 2006/055 ©2006

**AN HISTORIC BUILDING ASSESSMENT  
AND RECORD OF THE STANDING FABRIC FORMING THE  
GRADE II\* LISTED BUILDING (NOW RUINOUS)**

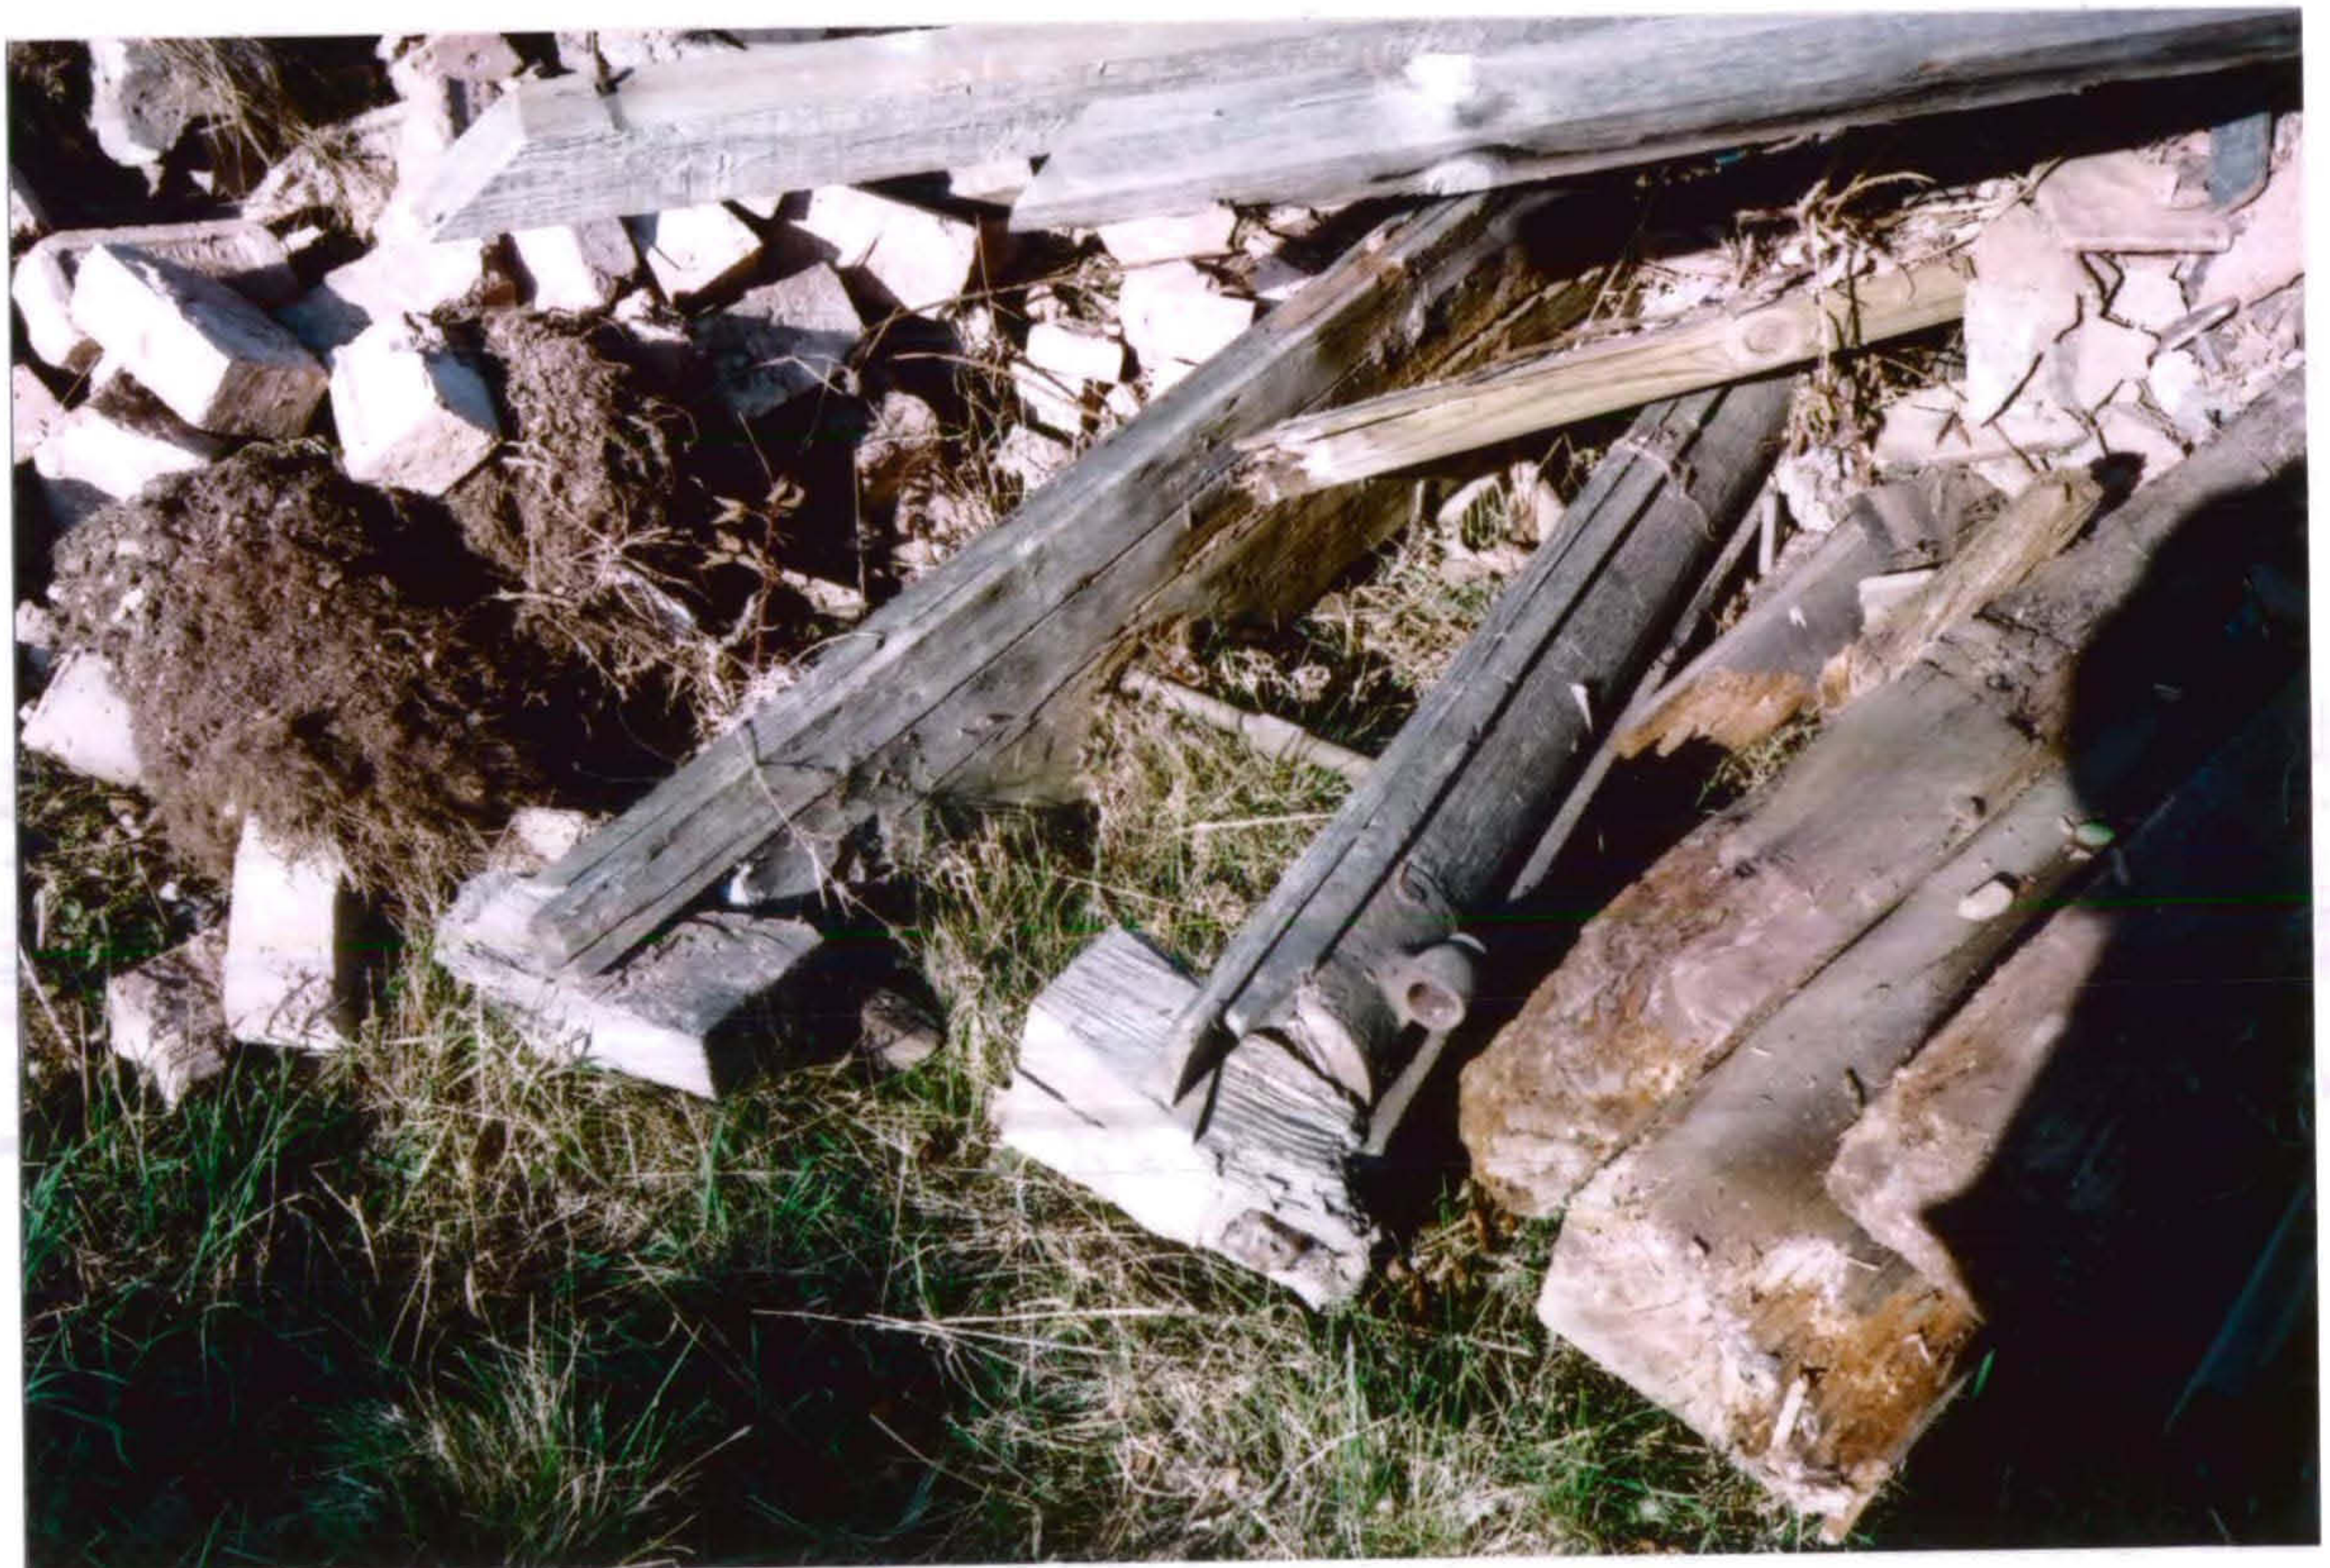
*Plate 12 Hardwood sections of door framing, (see Drawing 9).  
Location: salvaged materials area.*

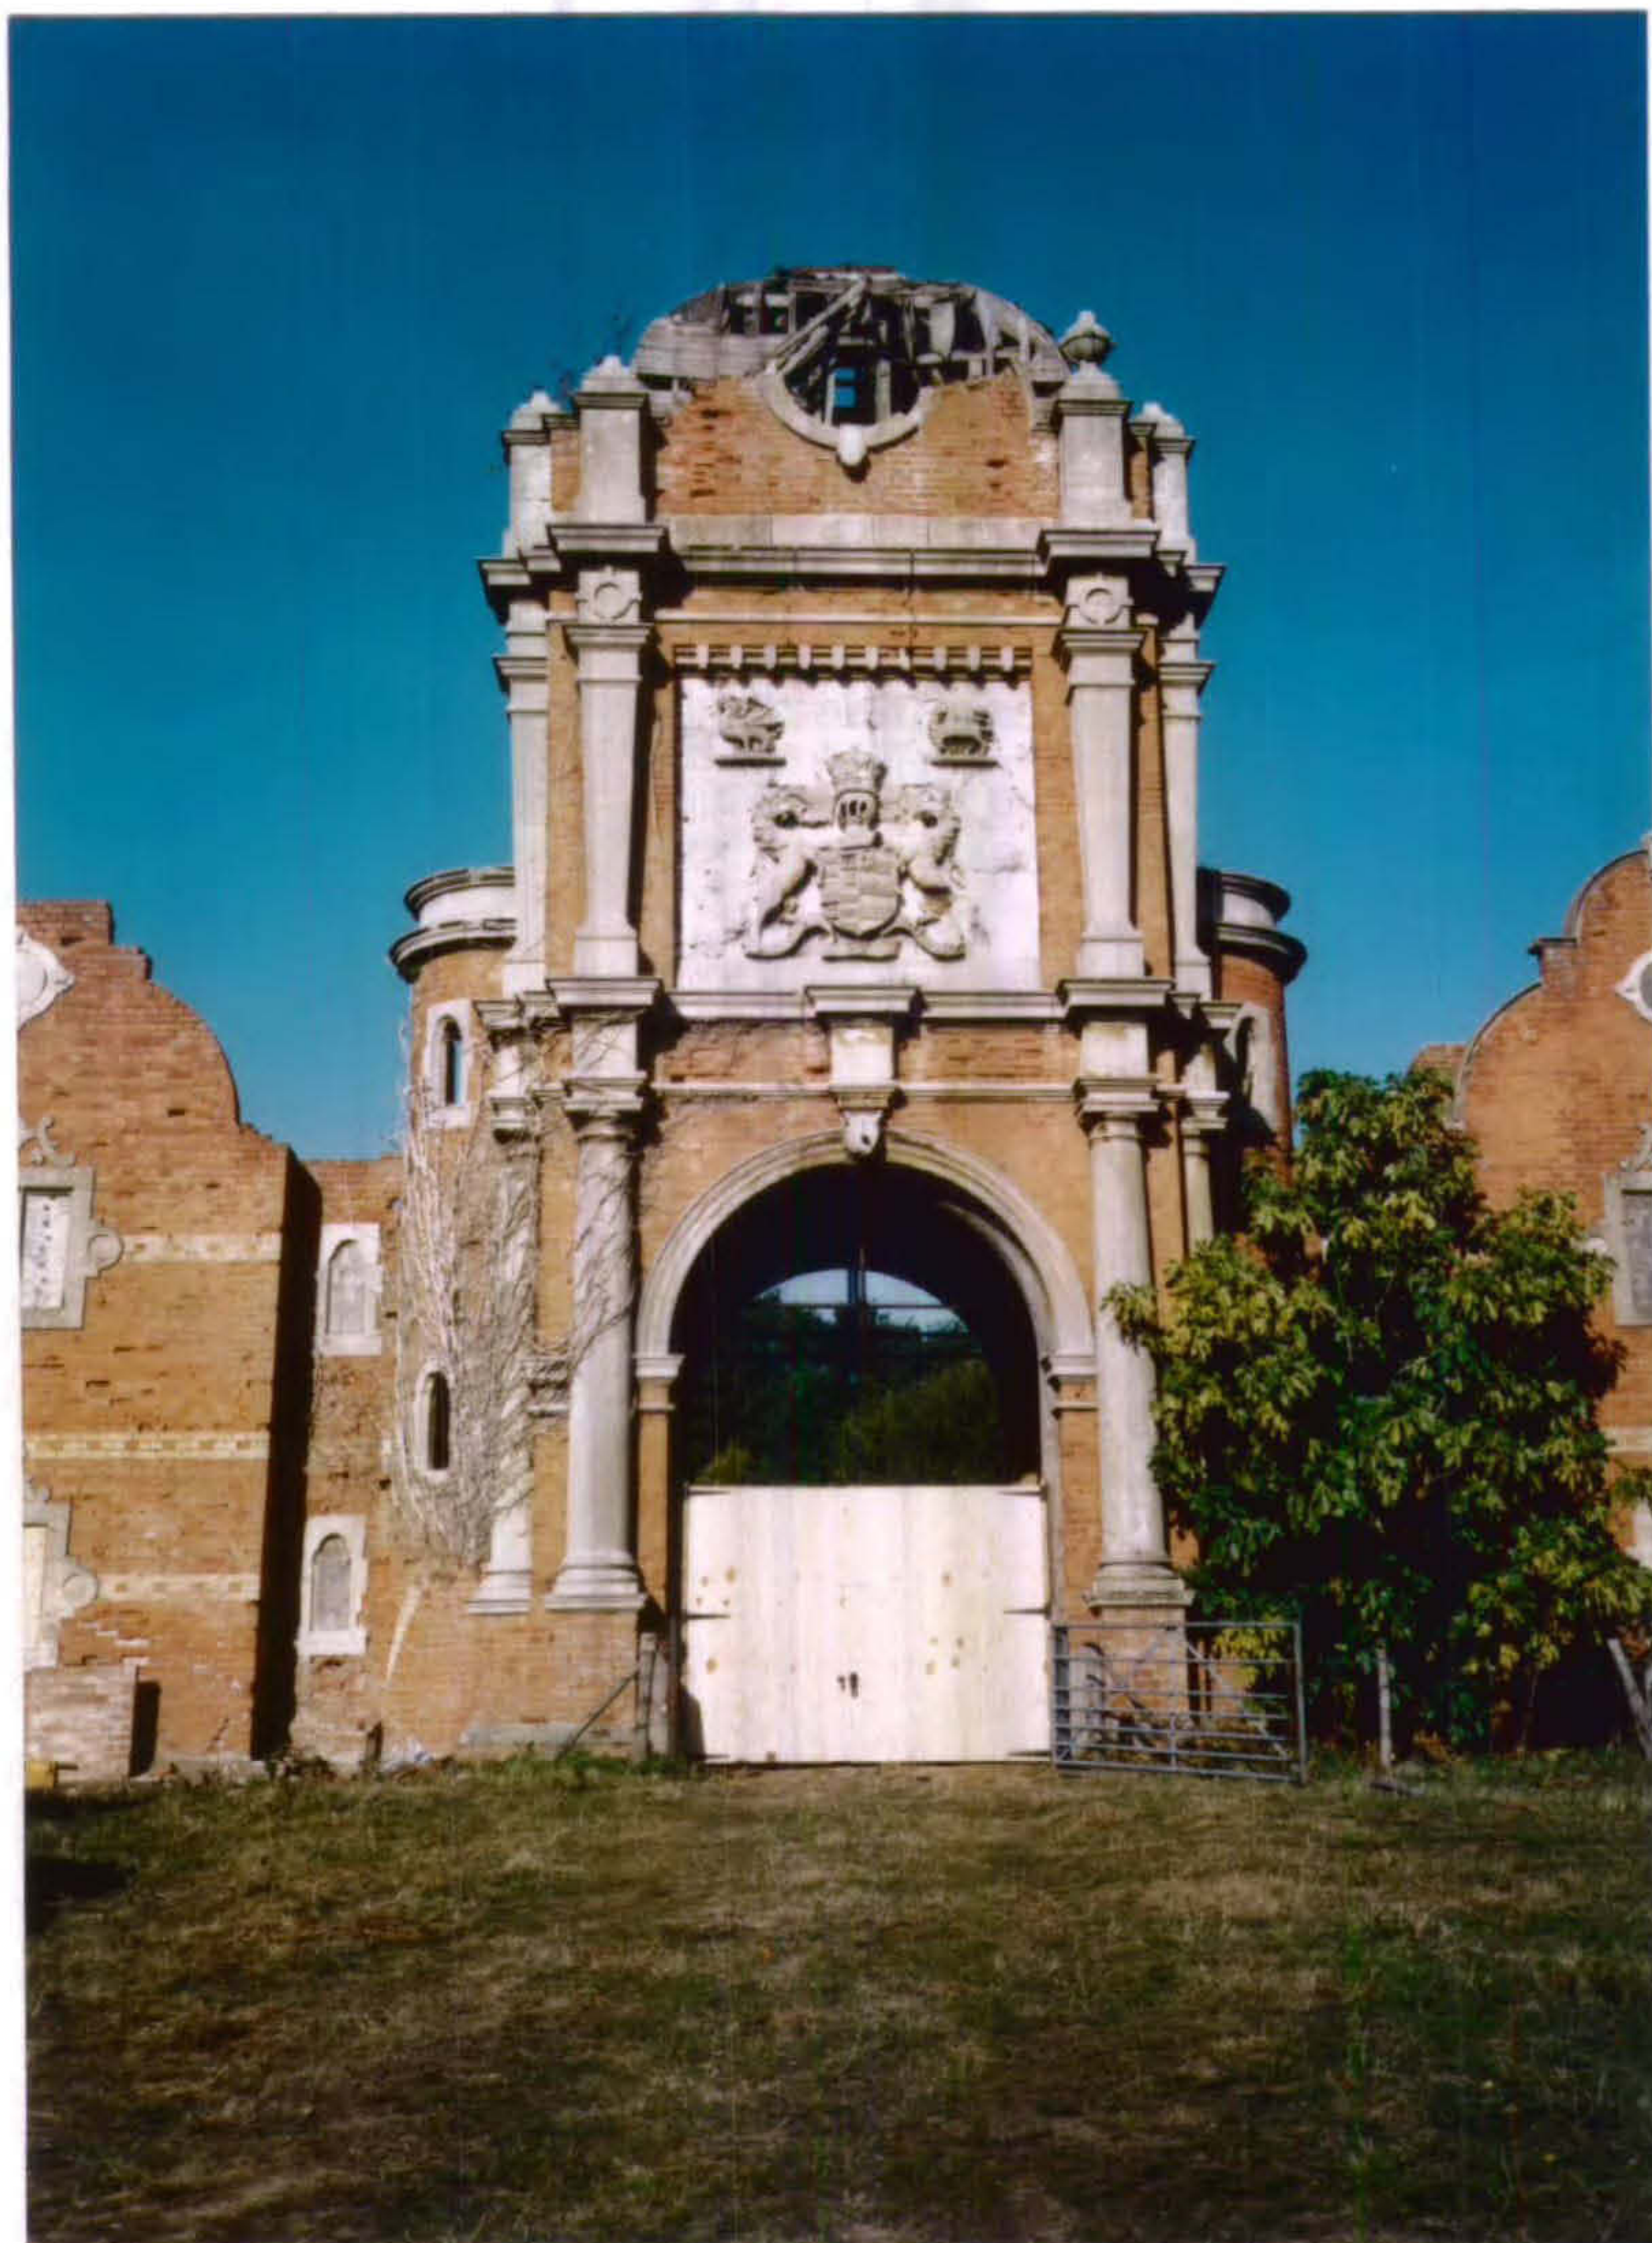
*Plate 15 Bradgate Stables : General View Clock Tower entrance with flanking stair towers.*

By 2003 only the wooden framework of the cupola and the lower part of the Dutch gable survived *in situ* and only one of the four stone orbs set on pedestals now survives, *(see Drawings 1 and 12, and Plate 15)*. A centrally located marble panel of massive proportions flanked by 'Jacobean' pilaster forms, carries the 7<sup>th</sup> Earl of Stamford and Warrington's coat of arms with supporters and Earls coronet. What appear to be two Beasts of Heraldry - a wyvern and a unicorn, the latter superimposed on a sun in splendour, are set in the top left and right corners respectively of the panel, *(see Plate 16)*. The wyvern's forked tongue and the unicorn's horn are made from thin, sheet copper. The narrow frieze forming the topmost section of this inset panel is probably intended to represent the bottom of a raised portcullis. A fox's mask, now broken, forms the central feature of the keystone of the entrance archway. The broken fragment of the fox's mask was recovered by workmen from debris in front of the Stables during the course of the stabilisation programme, its current whereabouts are unknown.

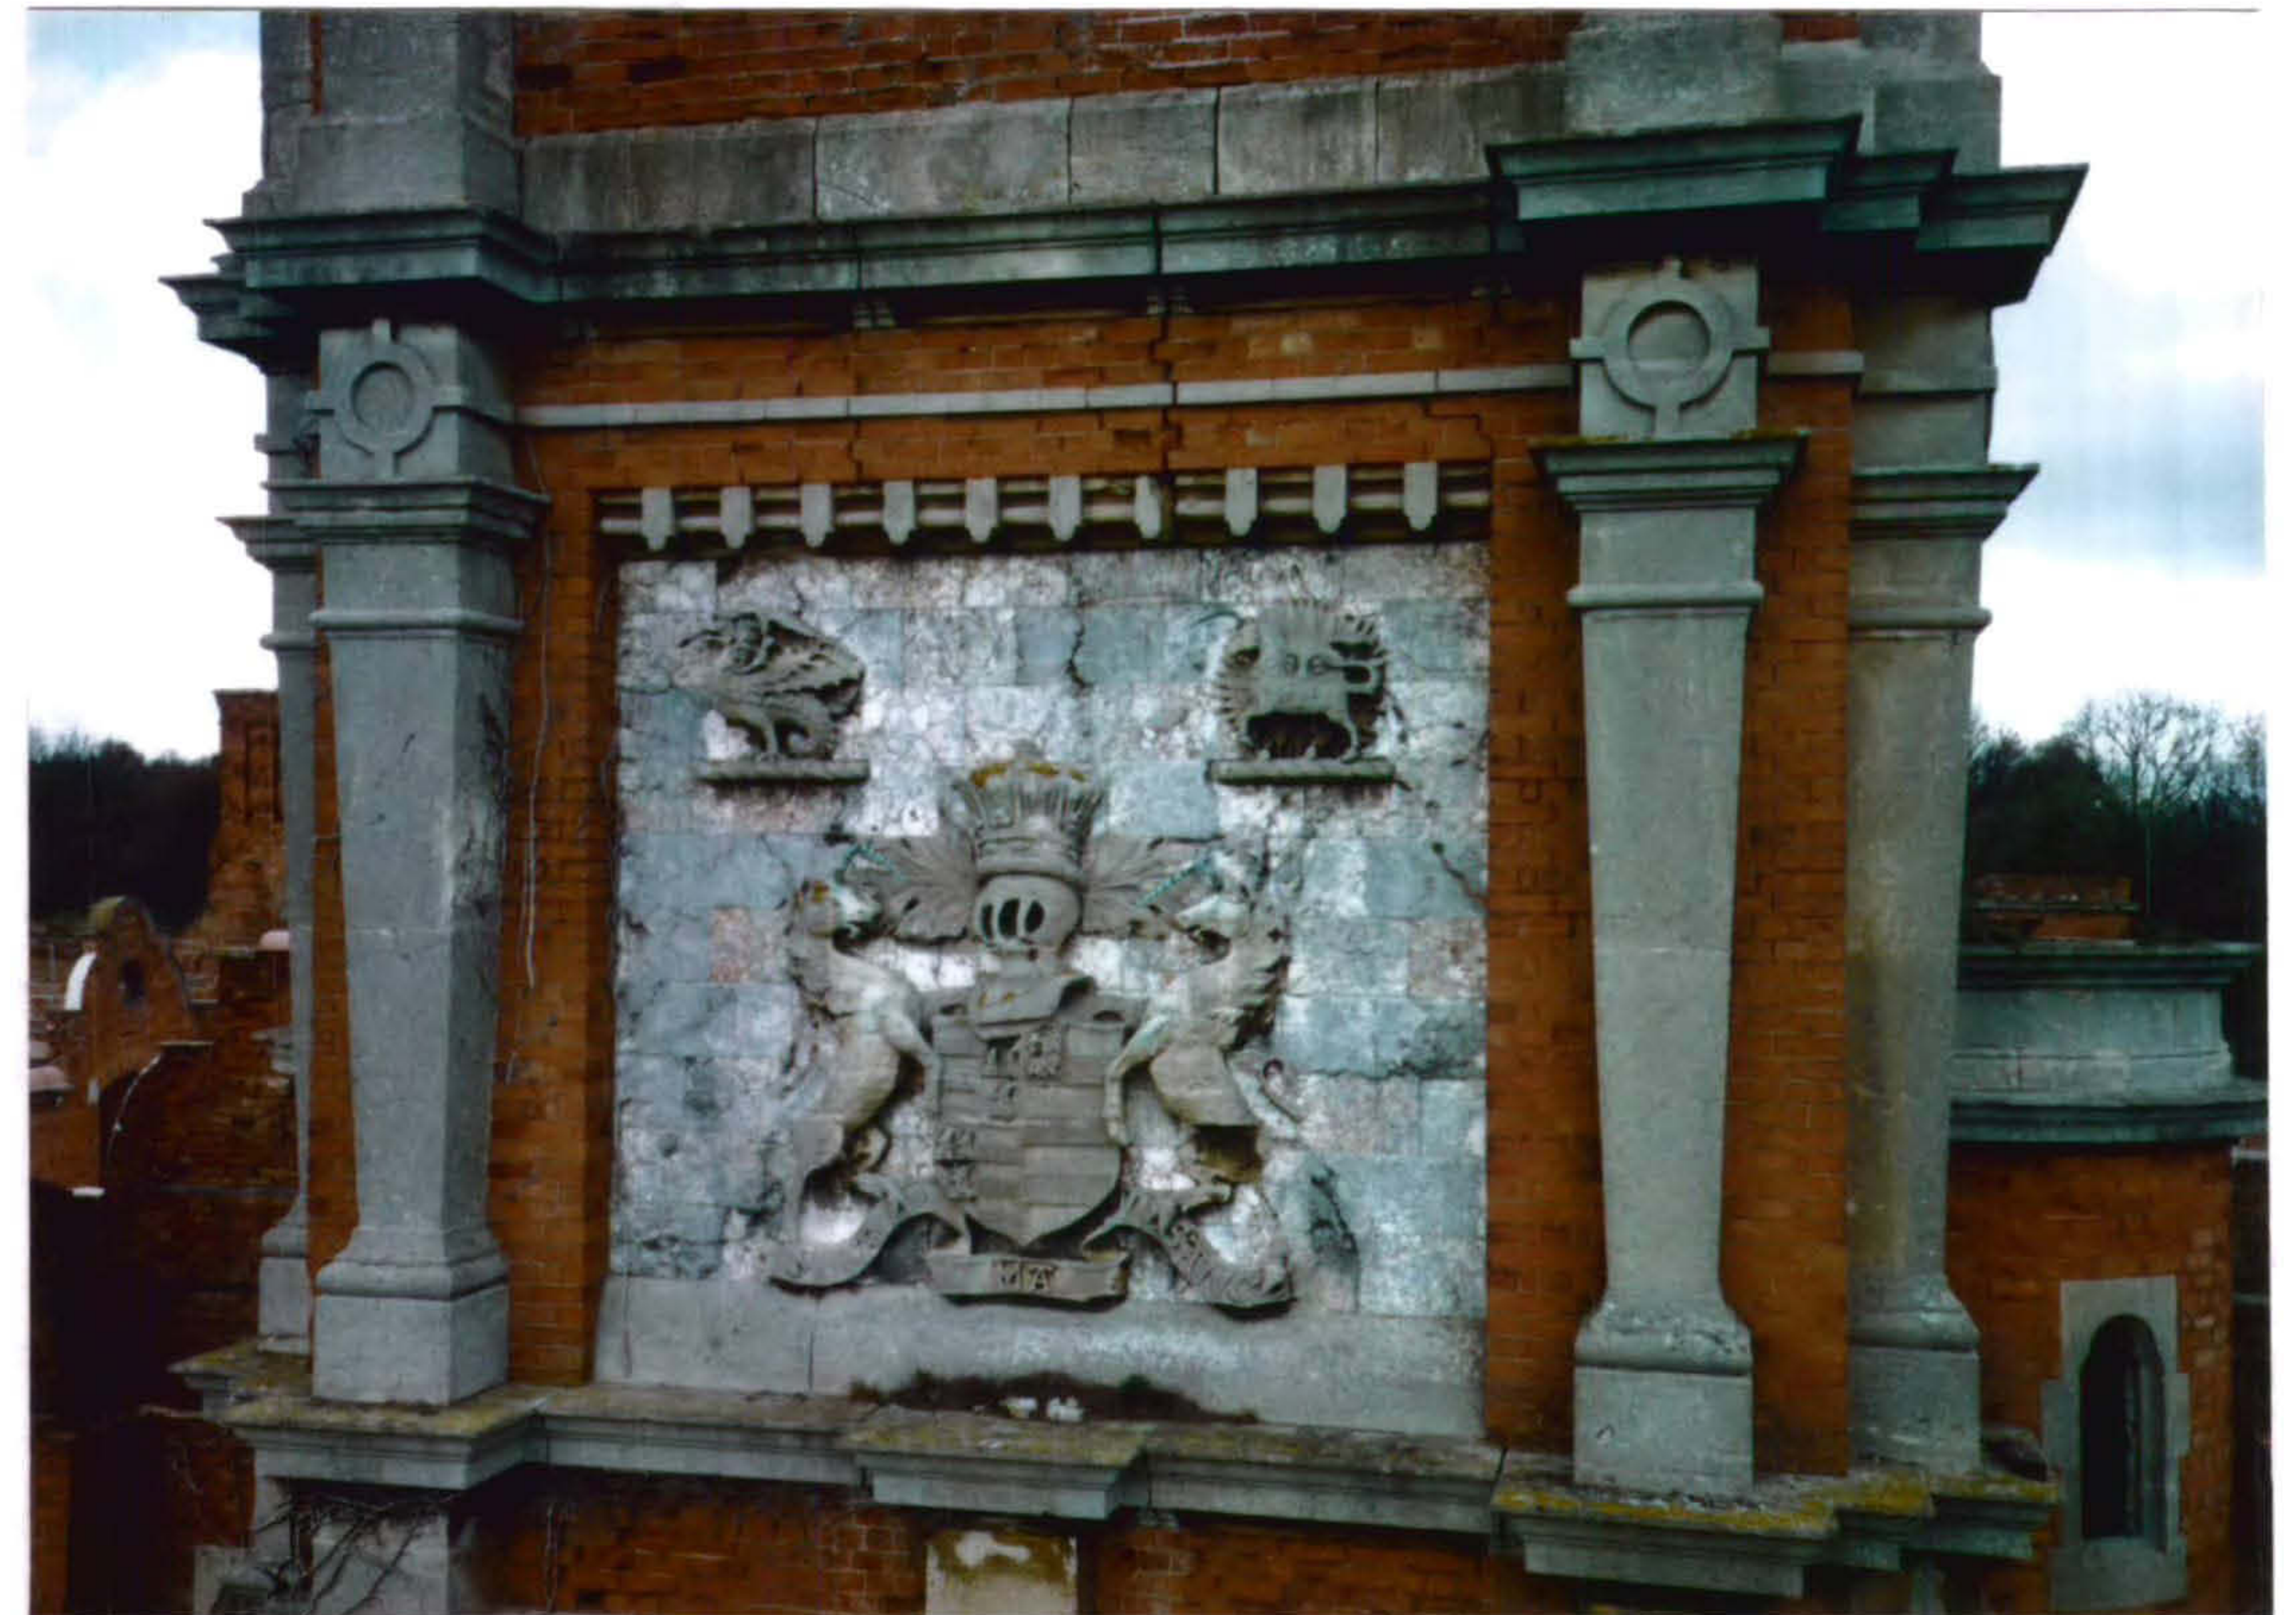
*Plate 16 Detail of the 7<sup>th</sup> Earl of Stamford's coat of arms mounted onto marble and flanked by tapering columns supporting an entablature*

The large coat of arms mounted above the Entrance Gateway to the Stables has a series of marble slabs forming its base, *(see Plate 16)*.

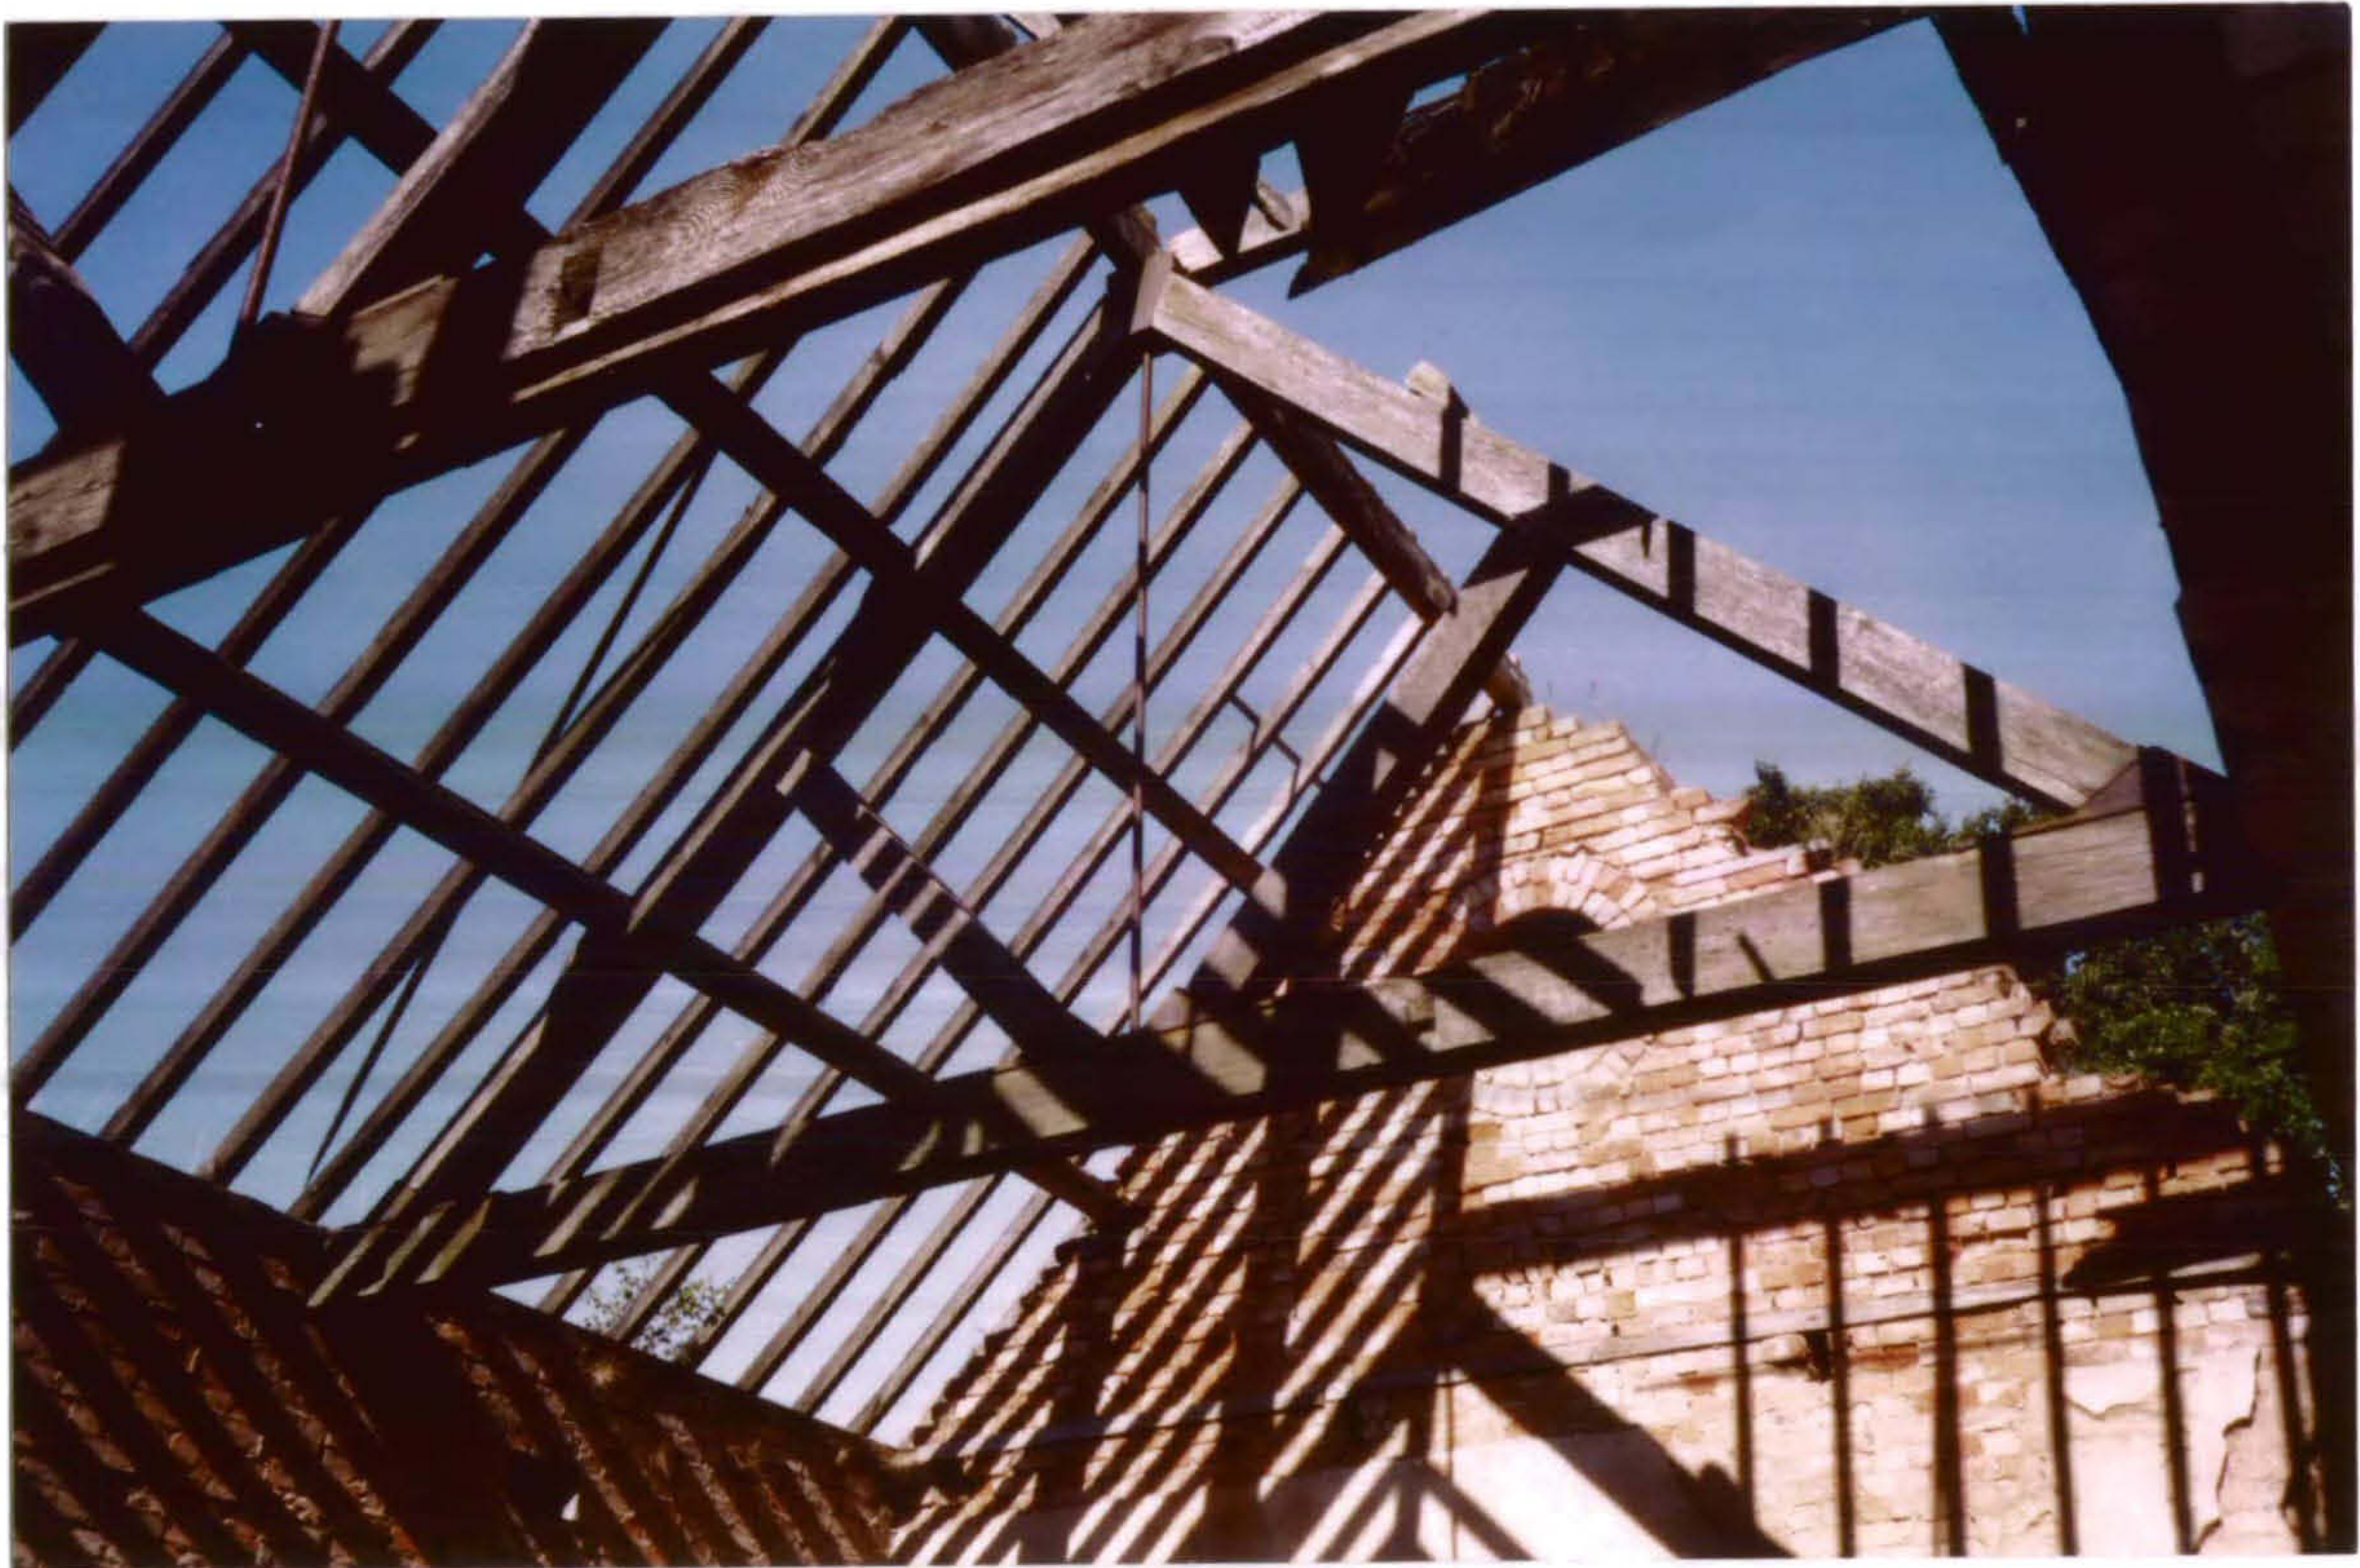
*Plate 32 West Range Internal – north-west corner of range. Bolted principal rafter truss with cast-iron shoe for the base of the raked struts and cast-iron apex junction, October 2003, now removed. A wooden bonding course can be spanning the full width of the bay at the base of the gable brickwork. (see Drawing 8)*
