**A Photographic Survey at Gorse Farm,  
9 Main Street, Stonesby, Sproxton,  
Leicestershire SK 823 246**

**For: Mr and Mrs Pepper**

**ULAS Report Number 2008-069  
©2008  
Accession Number X.A.69.2008**

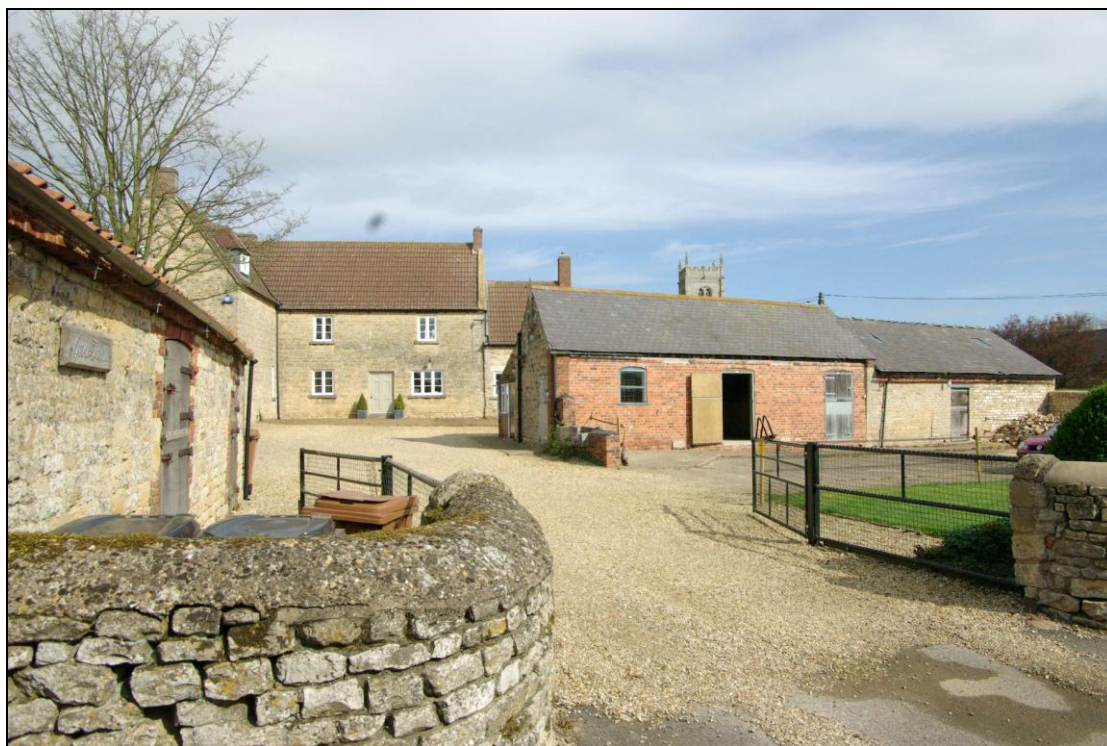
Figure 4. Gorse Farm viewed from Main Street.  
Barn A on right, Barn B on left.

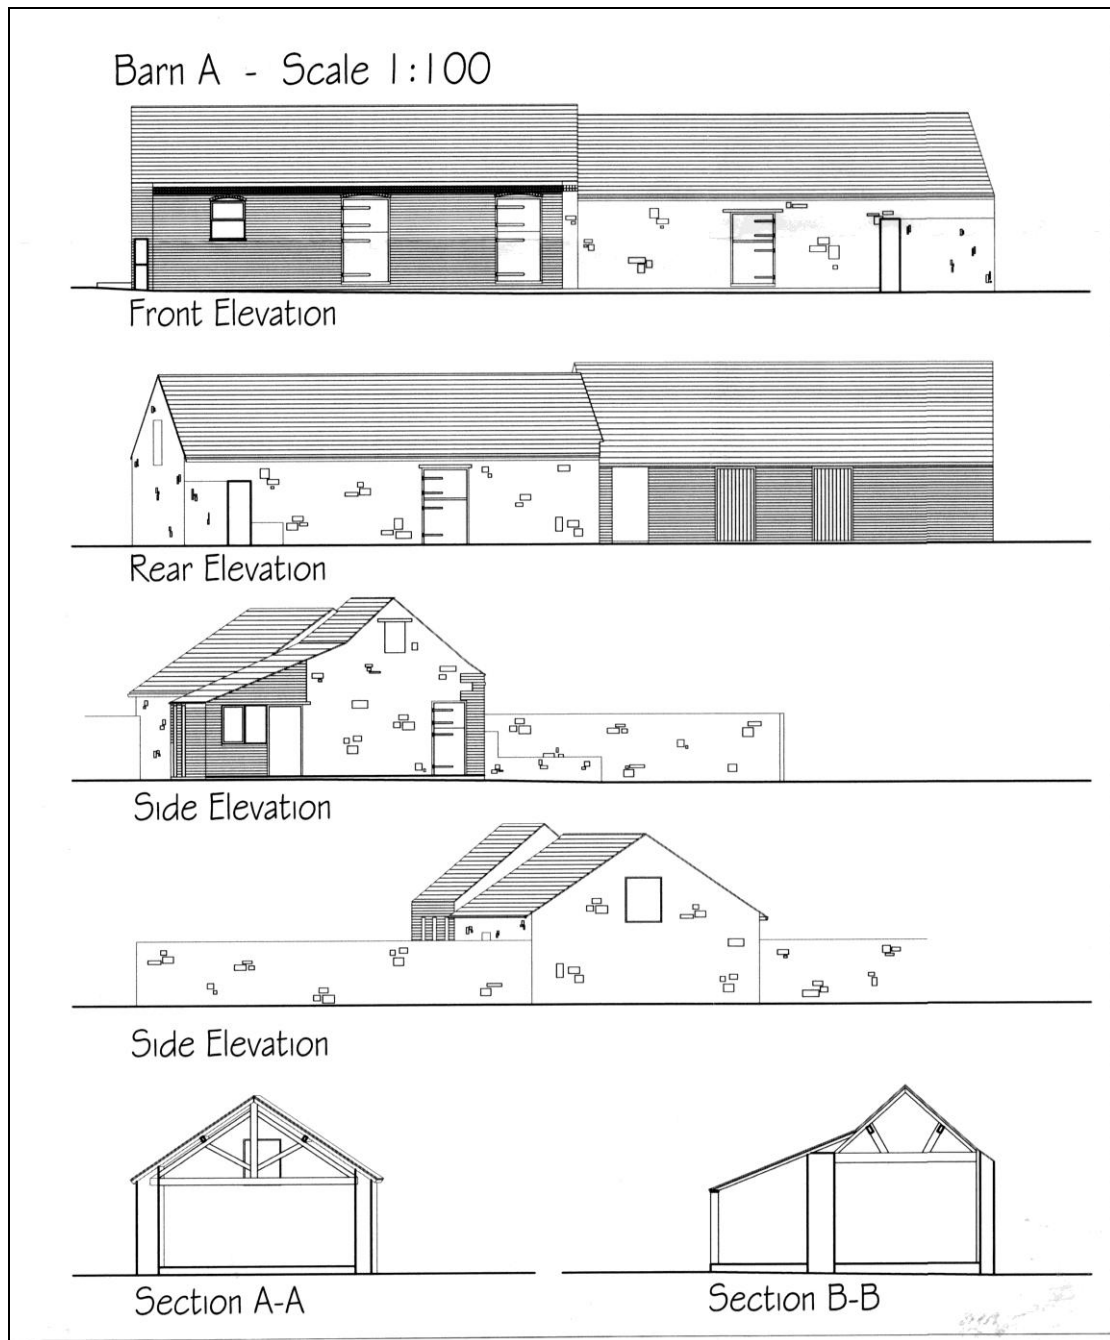
Figure 5. Barn A drawing.  
Source:HSSP Architects. Original scale 1:100

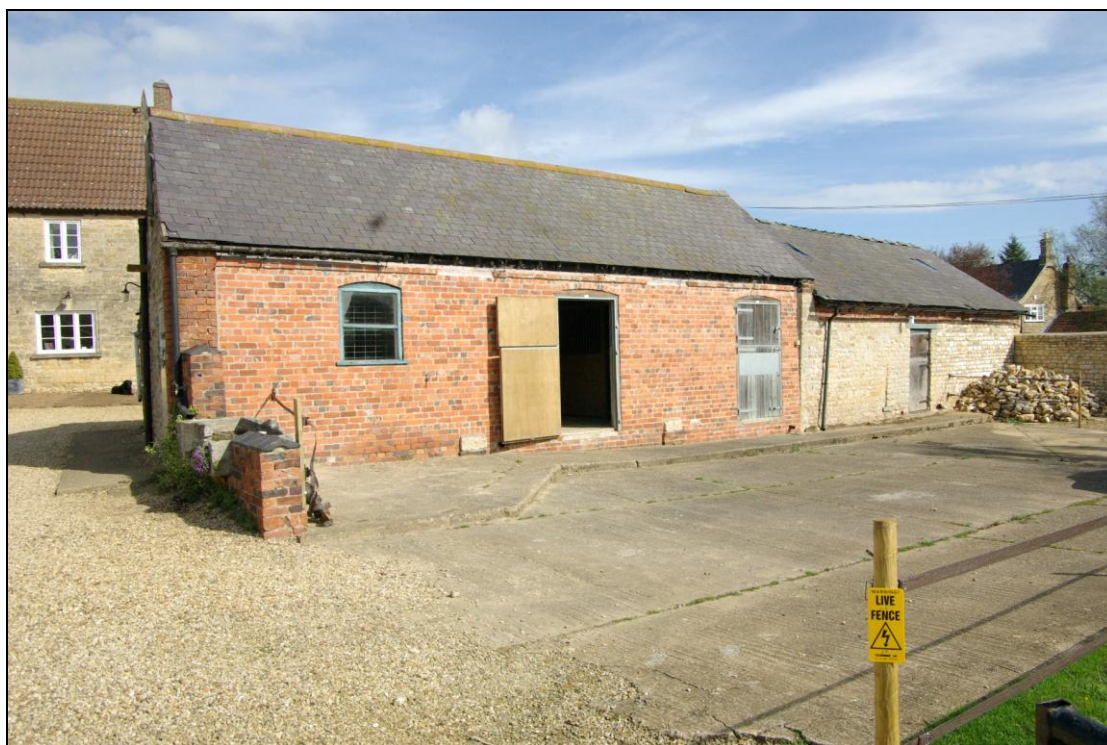
Although labelled as a single barn in the developer's plans Barn A actually consists of two gable-ended barns built side by side along a curving east to west alignment (figs. 3 and 7). The eastern half of the barns, which are built at ninety degrees to The Green, is built of coursed limestone rubble with a Welsh slate roof. Two sheets of plain glass on both sides of the roof help to let light in. Larger, roughly shaped, limestone blocks act as quoins to support each corner of the barn. Six courses of red brick laid in an English bond form the upper courses of the south facing wall. The bricks measure 220mm long x 70mm high x 110mm wide and have a variety of lime and Portland cement pointing, as does the limestone portion of the wall.

Figure 7. Barn A looking north.

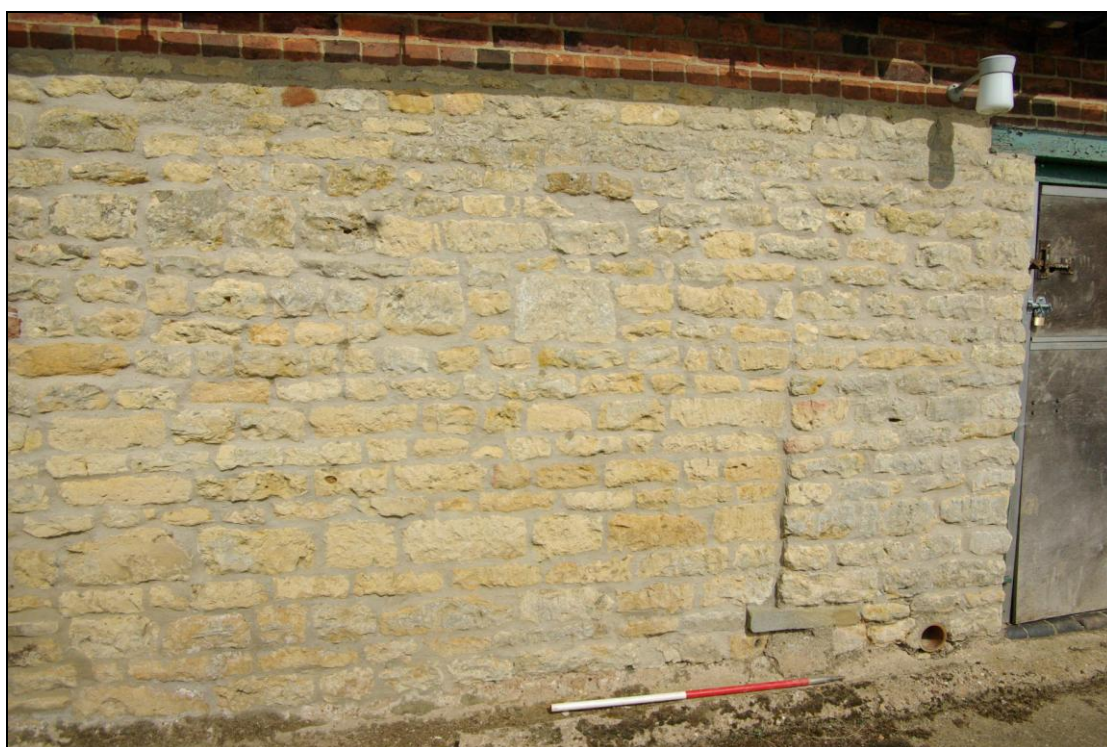
The south face of the barn contains a single stable door near to the centre with a timber lintel. There is faint evidence of a wall scar approximately 3.2m from the eastern corner although this area has recently been heavily repointed which has obscured most traces of any scaring. At this point are the remains of a concrete and brick surface heading southwards running parallel to the 2m high boundary wall which joins the eastern corner of the barn with a straight line joint. The developer's plans show this area as a demolished barn although it is still shown on the latest OS map. On the western side of the doorway is a slight step in the lower part of the wall but it is not clear what purpose this served (fig. 8).

Figure 8. Step or repair in south wall of Barn A (eastern section).

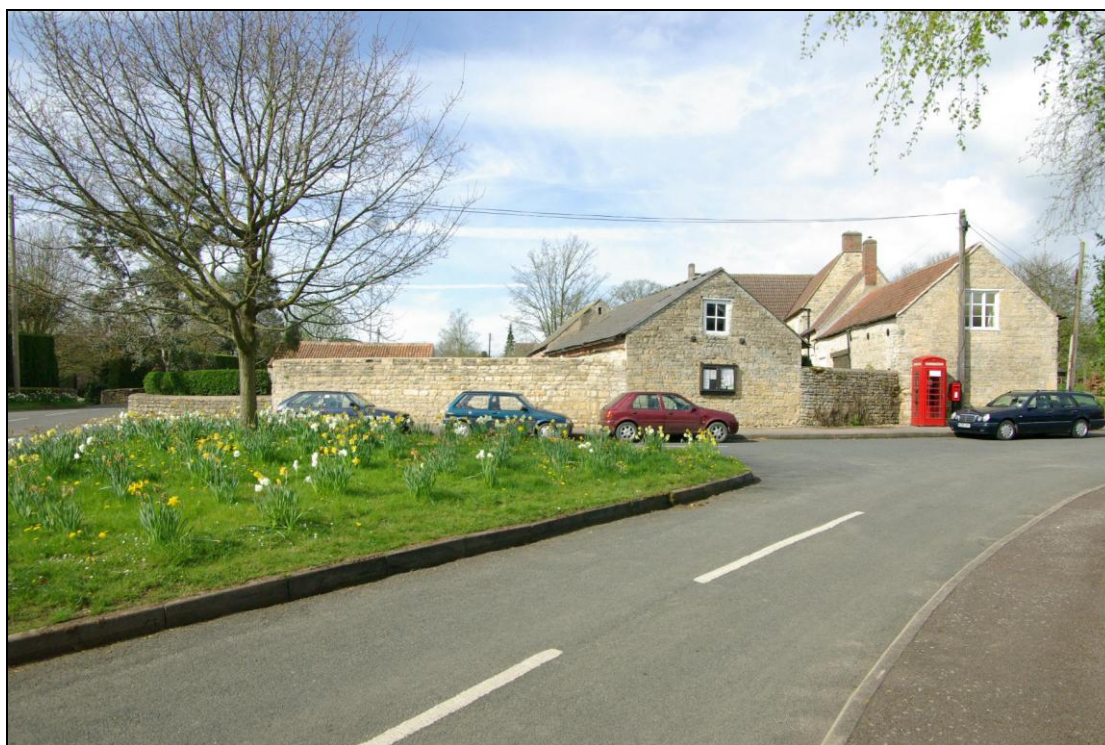
The eastern gable end of the barn forms part of the boundary of the farmyard and The Green. A square wooden-framed window is located in the centre of the gable but otherwise the wall is plain with no evidence of any other openings (fig. 9). Most of the western gable end is obscured by the western half of Barn A but it appears that the gable has been rebuilt in order to accommodate the higher ridge-line and the slightly different alignment of the western building. The lower half of the wall, which is probably original, has no openings set within it.

Figure 9. Eastern gable end of Barn A  
with converted threshing barn attached to farmhouse to the north (right).

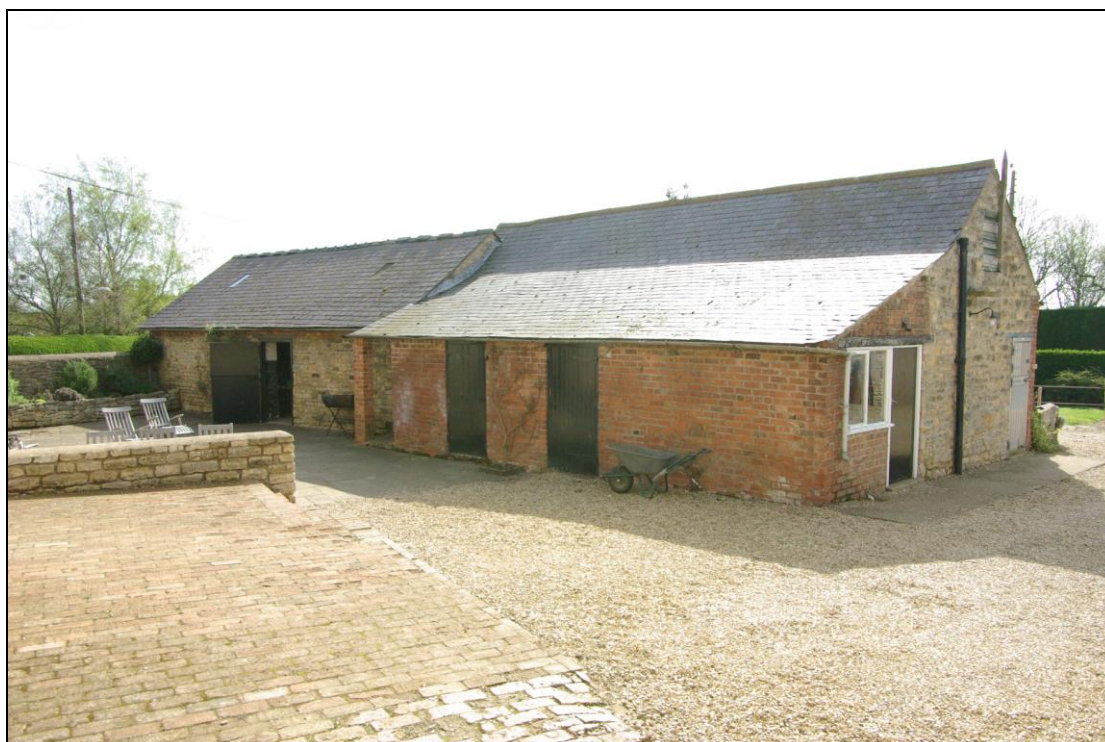
The northern face of the barn has a single stable door entrance towards the western corner (fig. 10). The western corner of the barn projects out approximately 1m beyond the wall line of the adjoining barn to the west. Part of the eastern wall of the brick outhouses has been let into the corner of the projecting corner which has been rounded to improve access into this area (see fig. 14). A small raised garden and a 2m

Figure 10. North face of Barn A looking south-east.

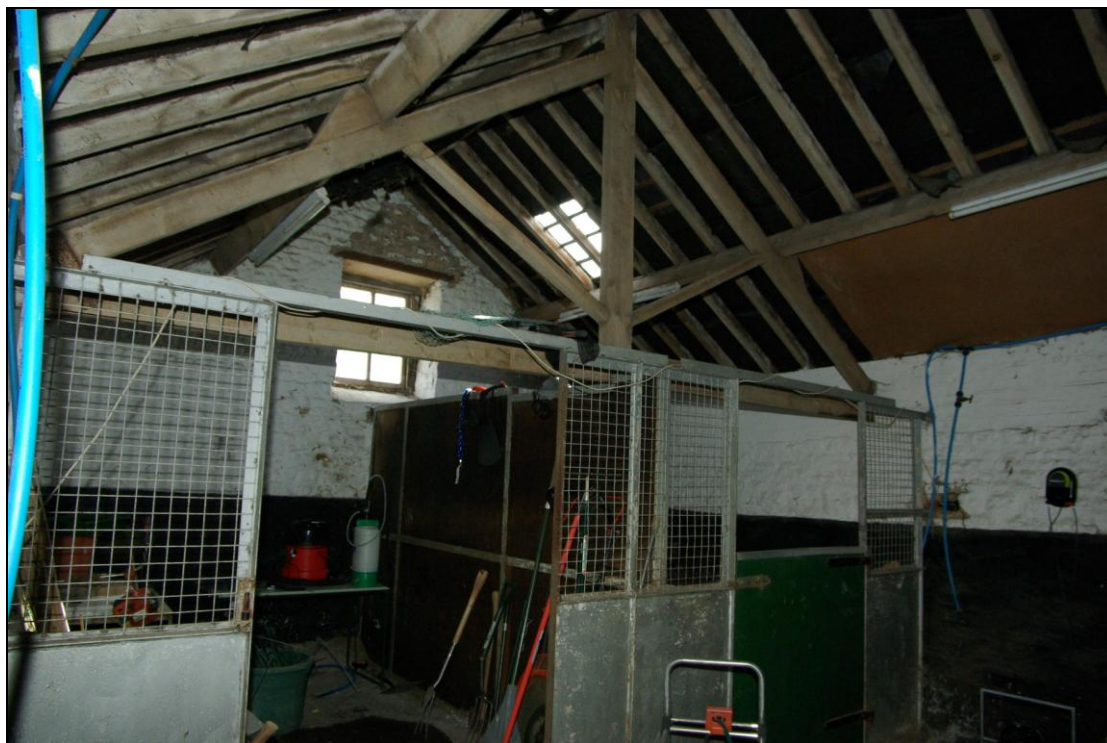
Inside the barn is a concrete floor with a number of small modern partitions dividing the space into a series of pens. No apparent scaring or blocked openings are visible although much of the walls have been painted with limewash or paint which may have obscured any features (fig. 11). The roof consists of a king post structure with raking struts supporting principal rafters onto which the purlins are laid on cleats. The principal rafters do not act as common rafters and appear to be scarf jointed onto the king posts below the ridge line. None of the roof timbers appear to have been re-used elsewhere.

Figure 11. Interior of Barn A (eastern section) looking south-east.

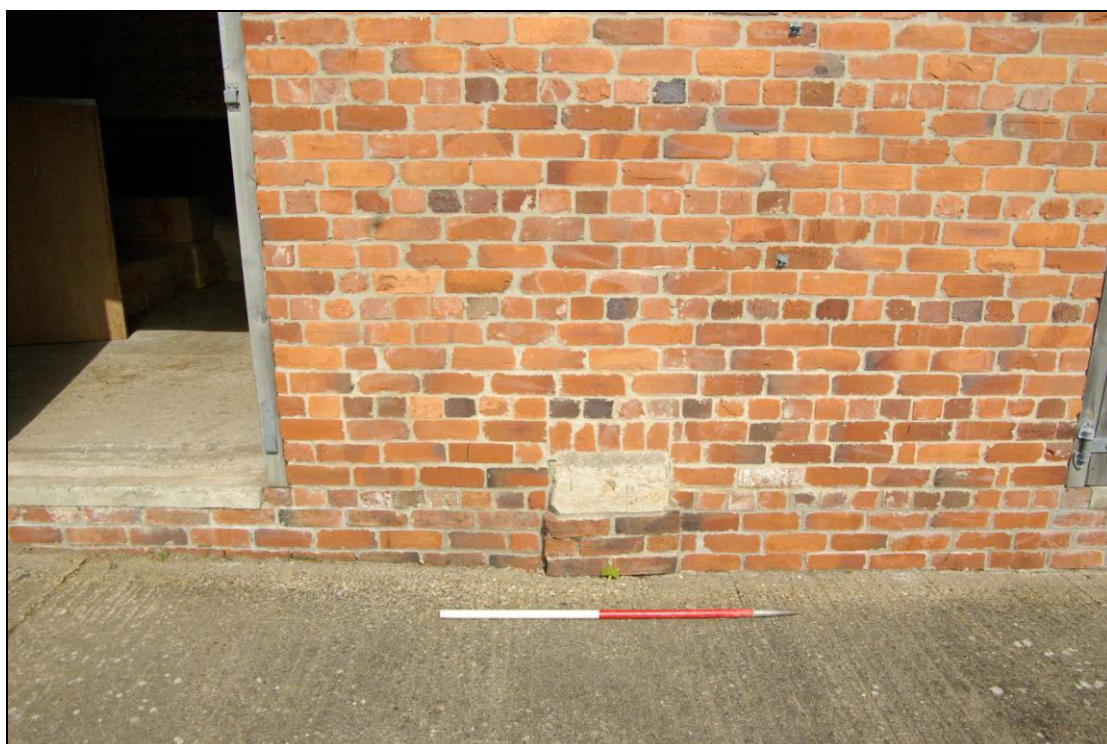
This part of Barn A appears to have been added to the western end of the original stone barn. It is built at a slightly different alignment to the adjacent barn and follows the line of Main Street in order to create a slightly larger yard to the south. The roof is of Welsh slate with plain terracotta ridge tiles. The south facing wall is constructed of a single skin of red bricks measuring 210mm long x 70mm high x 100mm wide laid in an English bond (fig. 7). This has recently been reinforced with an internal skin of modern breezeblocks. A single wooden-framed window and two stable doors are the main openings into the barn. Both doors and windows have shallow arches constructed of a single course of red bricks laid as headers. Two 0.4m wide x 0.2m high chamfered limestone blocks project from the bottom of the wall corresponding with two internal pilasters which support the two main roof beams (fig.12). This suggests that the barn may have been an open-fronted structure when first built. A projecting red brick corner pillar with shaped, rounded bricks supports the western corner of the barn. The bricks measure 230mm long x 70mm high x 110mm long. A low brick wall, made of the same sized bricks, runs southwards into the yard from this pillar.

Figure 12. Plinth projecting from south face of Barn A (western section).

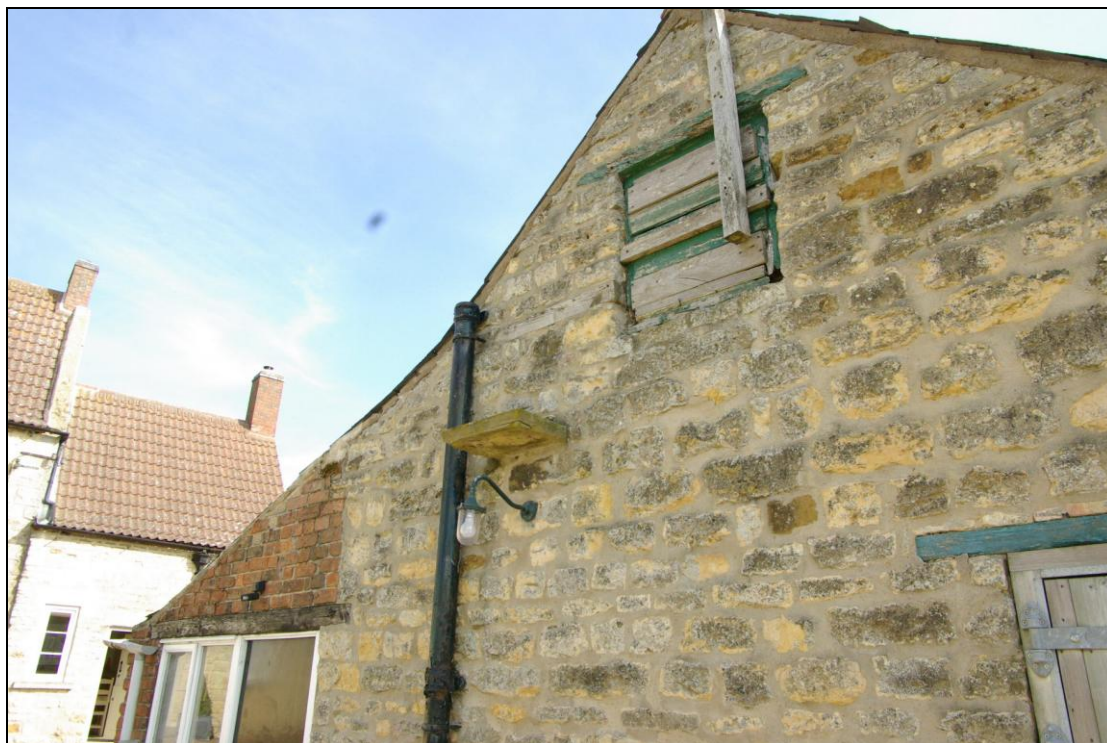
The western gable end is constructed of coursed limestone rubble and has a single width doorway in the southern corner (fig. 13). It has a wooden-framed window in the gable with a straight timber lintel. To the north of this window is a small timber beam above what is apparently a blocked small square opening below which is a projecting limestone ledge measuring 0.4m wide and 0.3m deep. The ledge is approximately 2.68m above current ground level and presently acts as a shelter for an electric light but it is not clear what its original purpose was. The northern half of the roof and part of the gable end have been modified to create a catslide roof over a range of small red brick built outbuildings running along the back of the barn. The bricks for the outbuildings measure 220mm long x 70mm high x 115mm wide.

Figure 13. Western gable end of Barn A showing limestone plinth and rear outbuildings.

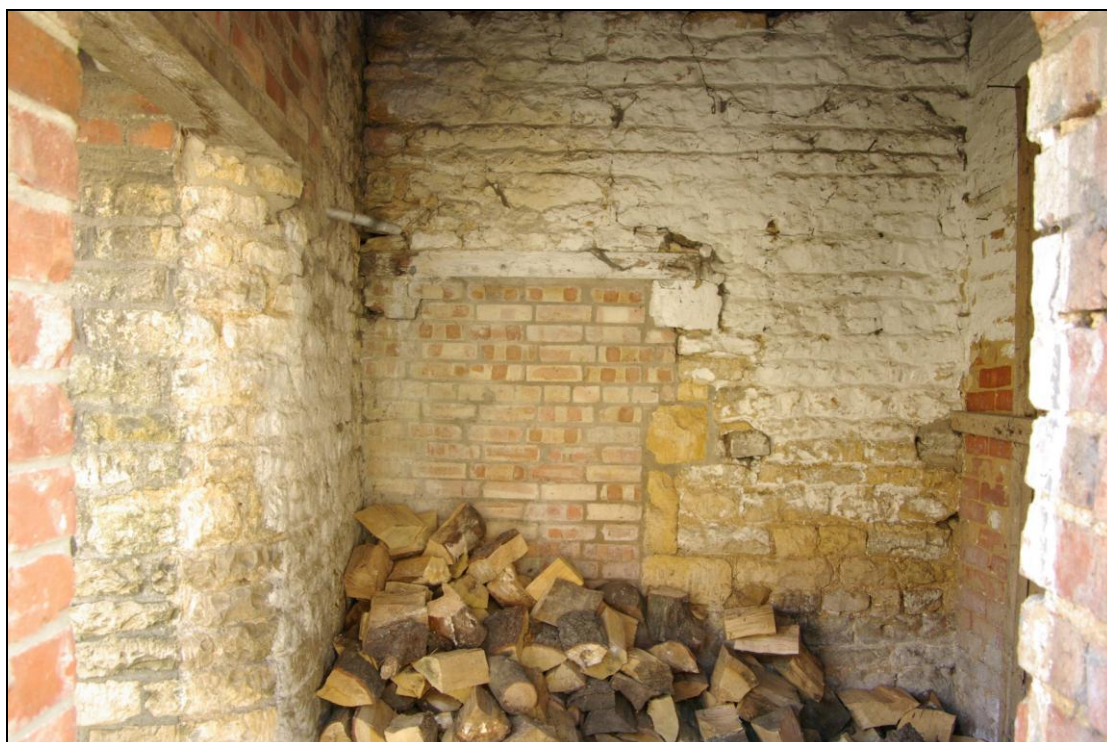
The northern face of the western half of the barn is generally obscured by the later outhouse buildings under the extended catslide roof. Inspection within these outbuildings revealed a coursed limestone rubble rear wall to the barn matching that

seen on the western face. A single bricked-up doorway in the eastern corner of the barn was noted but no other openings were seen (fig. 14).

Figure 14. Blocked doorway on north wall of Barn A (western section) viewed through rear outbuilding doorway.

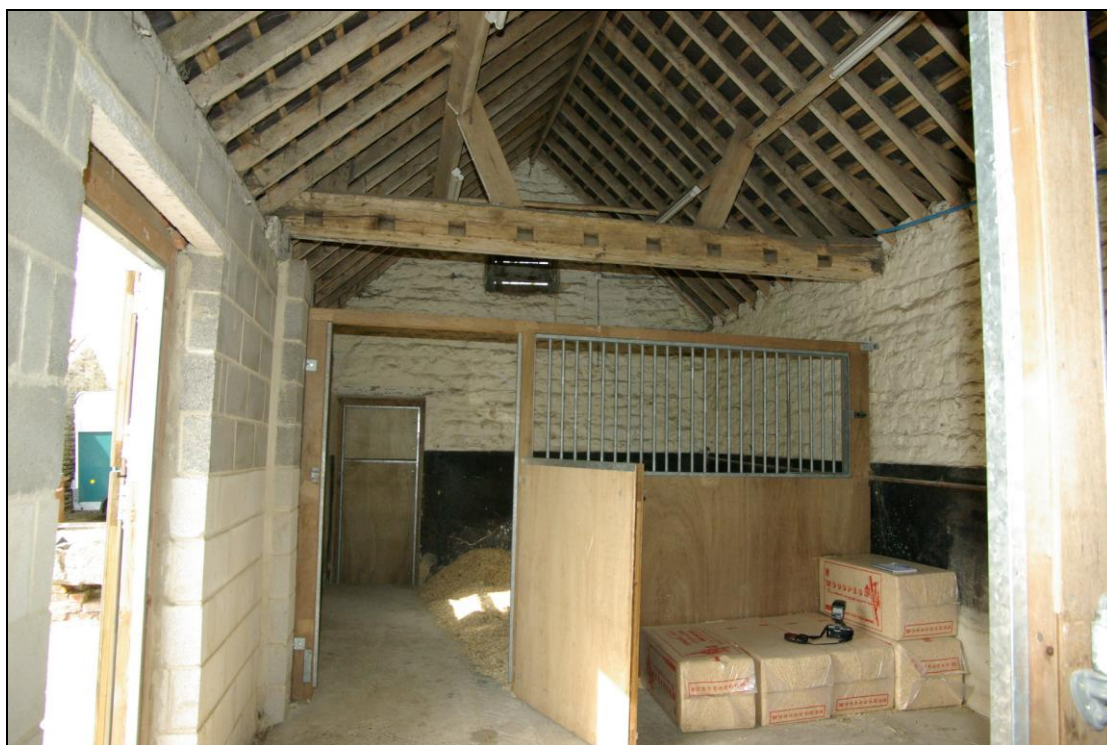
Inside is a large open space partially sectioned into three bays by modern partitions (fig. 15). The floor is of concrete and is higher than the courtyard to the south. The modern breeze block skin on the southern face rises to wall plate height and effectively hides any internal construction details on this wall. The blocked doorway in the north-east corner is visible as is the blocked opening on the west wall over the limestone ledge, but otherwise no internal details or fittings that may aid analysis are visible. The two large roof beams are re-used from elsewhere and have 90mm high x 100mm wide rectangular holes for joists and are clearly marked with Roman numerals (fig. 16). Raking struts directly support the purlins with no use being made of a king post. The purlins and rafters appear to be relatively new timbers and are unmarked.

Figure 15. Interior of Barn A (eastern section) looking west.

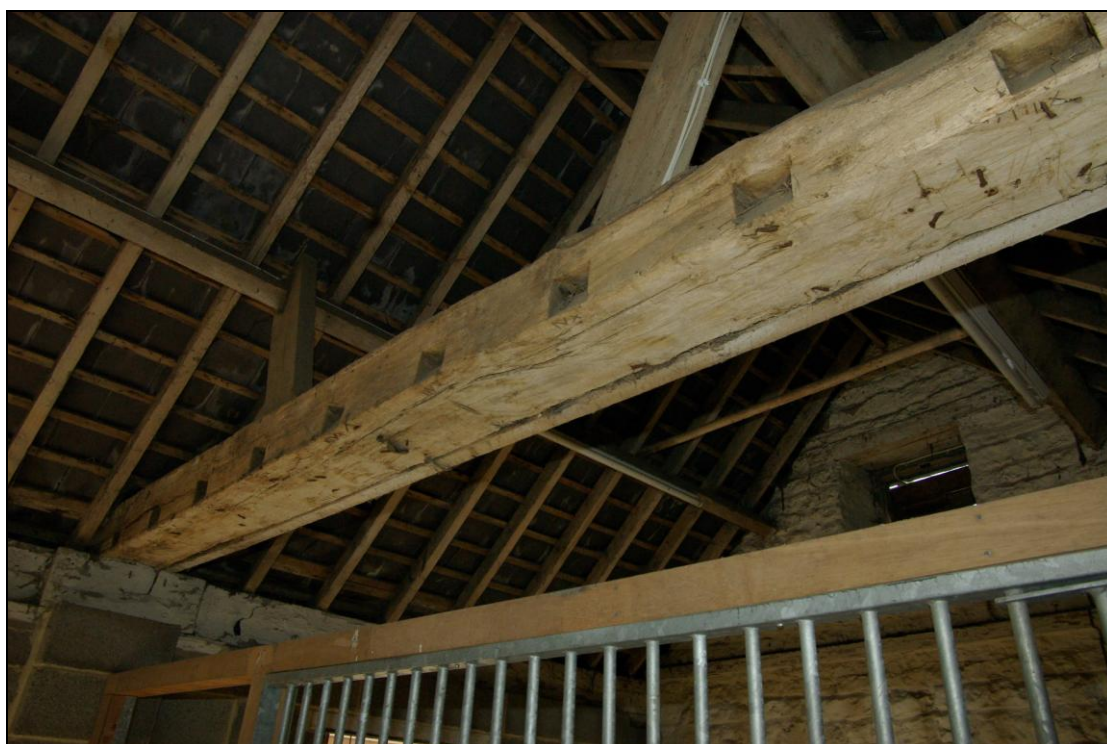
Figure 16. Barn A re-used roof timbers with carpenter's marks.

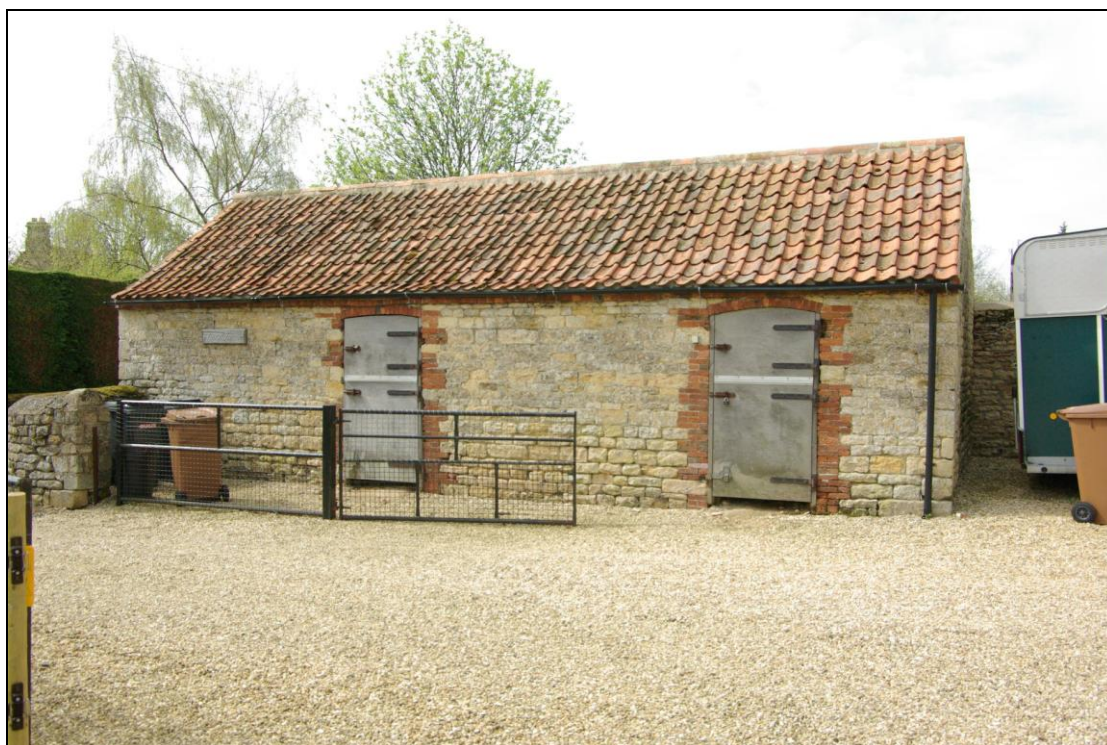
The eastern face, fronting onto the driveway and yard, has two stable door entrances. Narrow bricks, measuring 220mm long x 50mm high x 100mm wide, have been used around each door and for the supporting arches and header course. It is not clear if these form part of the original structure or if they have been added at a later date. The piecemeal way they have been used suggests the latter although some attempt at a pattern survives around parts of the doorways. However, they are quite soft and may have eroded only to be patched by limestone blocks at a later date. Remains of iron hinge pins can be seen on the south side of both doors.

Figure 17. Barn B east face.

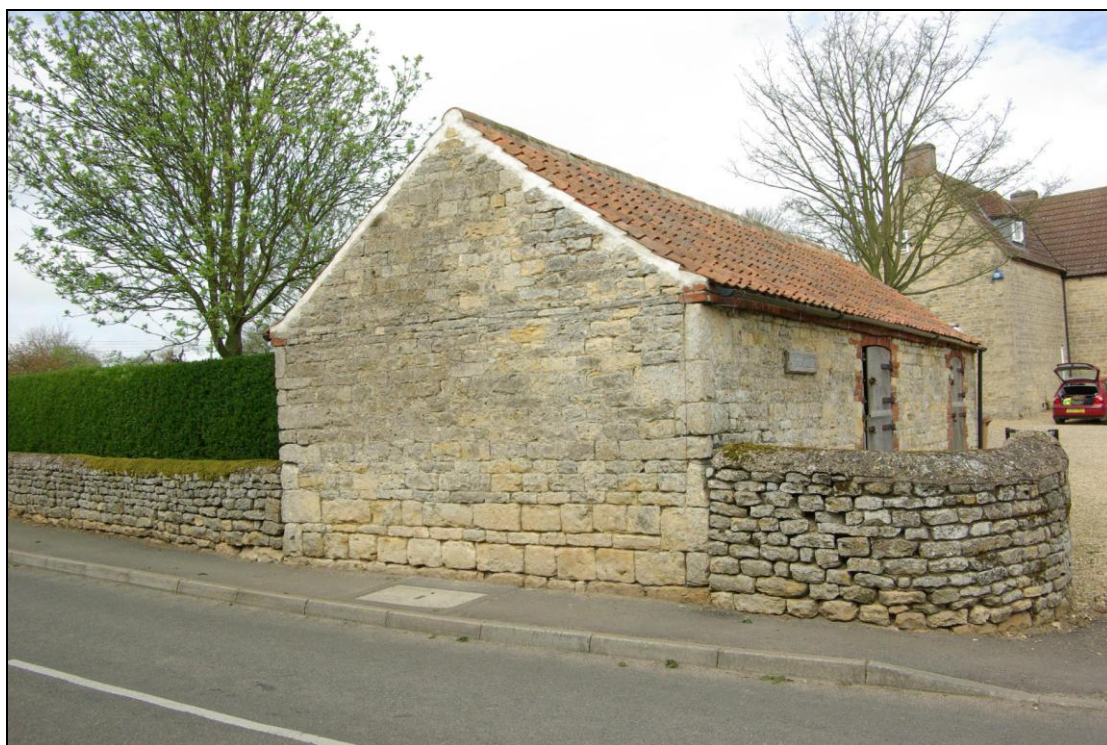
The south face of the barn fronting onto Main Street has a number of lower courses made from some very large limestone blocks (fig. 18). No other features are visible in this face of the barn. Two low limestone walls which act as boundary walls butt against either side of the barn.

Figure 18. South face of Barn B.

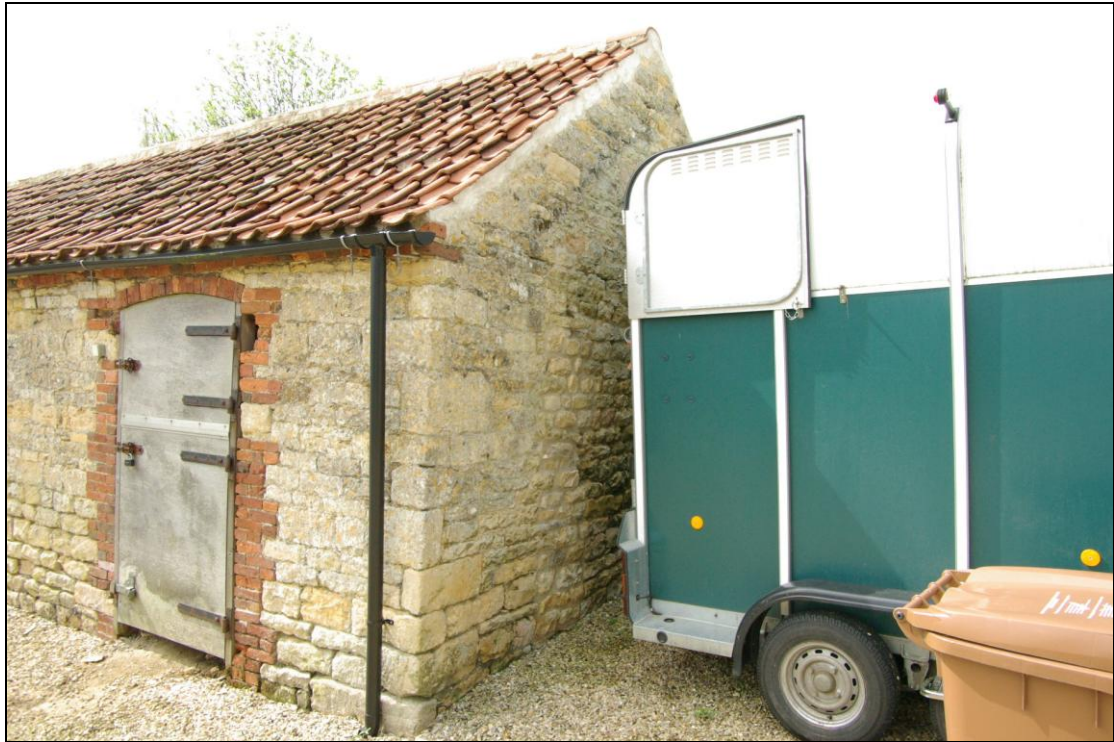
The north face of the barn bears the scar of a lower gable ended building butting up against it (fig. 19). The rear wall of this demolished barn, discussed earlier, remains in place to a height of 2m and is presently used as a garden wall. The wall has two recessed alcoves on the eastern side presumably forming part of an internal feature of the old barn (fig. 20).

Figure 19. Building scar on Barn B north face.

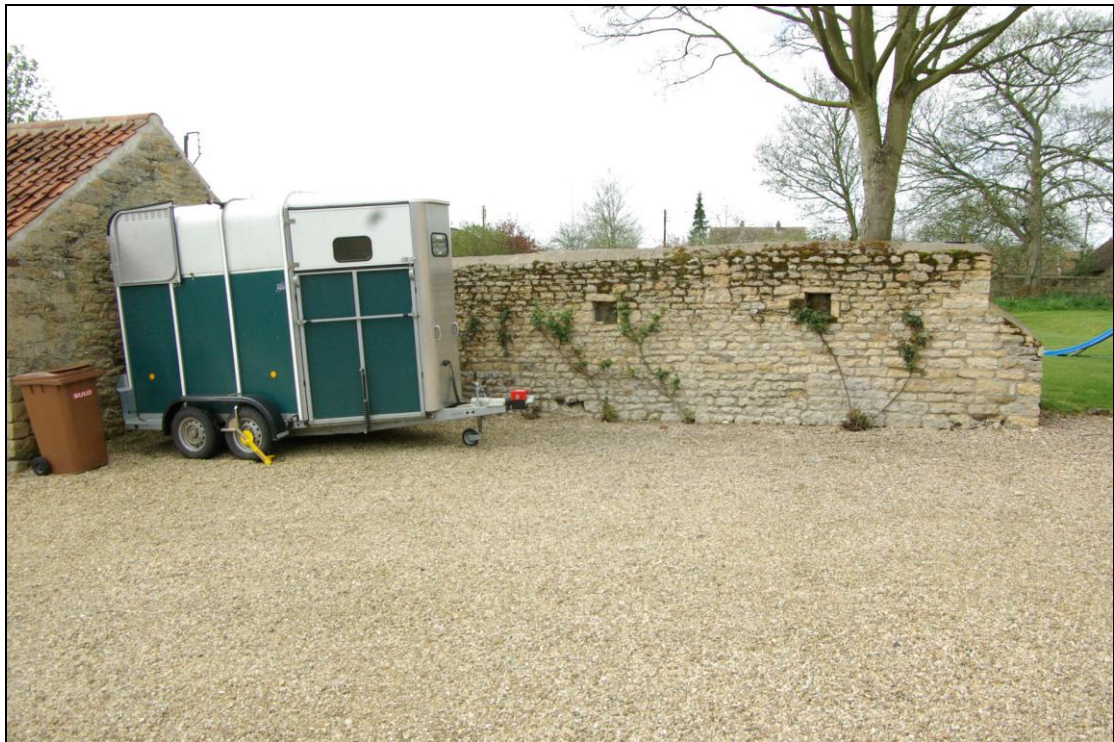
Figure 20. Remaining wall of demolished barn attached to Barn B  
Looking west.

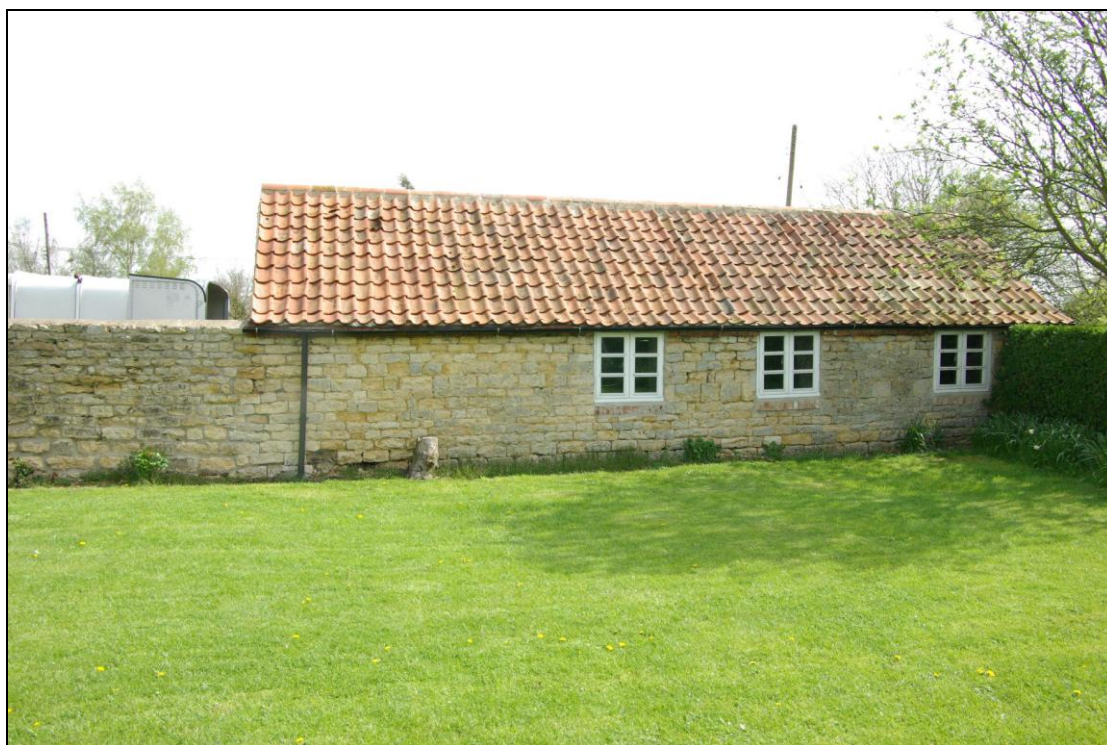
The rear, western face, of Barn B contains three small square windows which are double glazed and are set in new wooden frames (fig. 21). The openings however appear to be of original size. Barn B's wall and the remaining wall belonging to the demolished barn are continuous with no join between the two walls which indicates a contemporary date.

Figure 21. West face of Barn B.

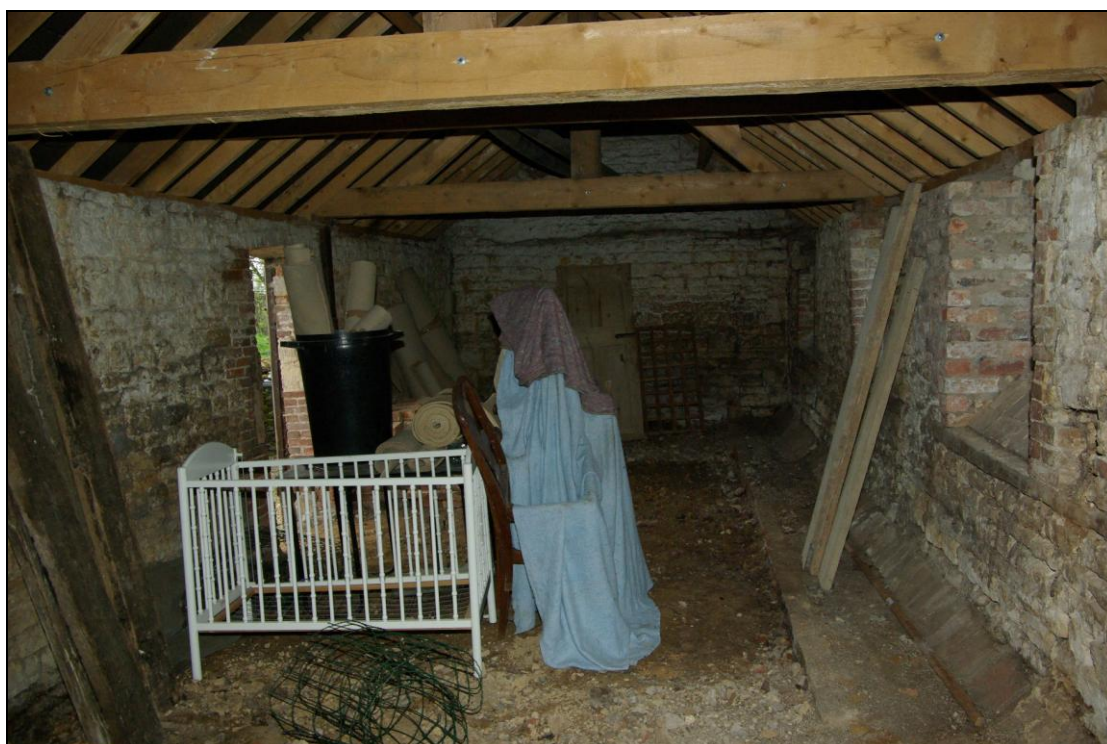
Inside is an uneven earth floor with a small brick plinth and gully running along the western wall (fig. 22). Each window has a narrow plank beneath a sloping brick sill with brick detail around the slightly splayed cheeks (fig. 23). The size and method of laying matches the bricks around the doorways. The roof timbers have been recently erected and are bolted together at key points with modern coach bolts (fig. 24). A simple king post and principal rafter supporting a cleated purlin method of construction has been used.

Figure 22. Interior of Barn B looking south.

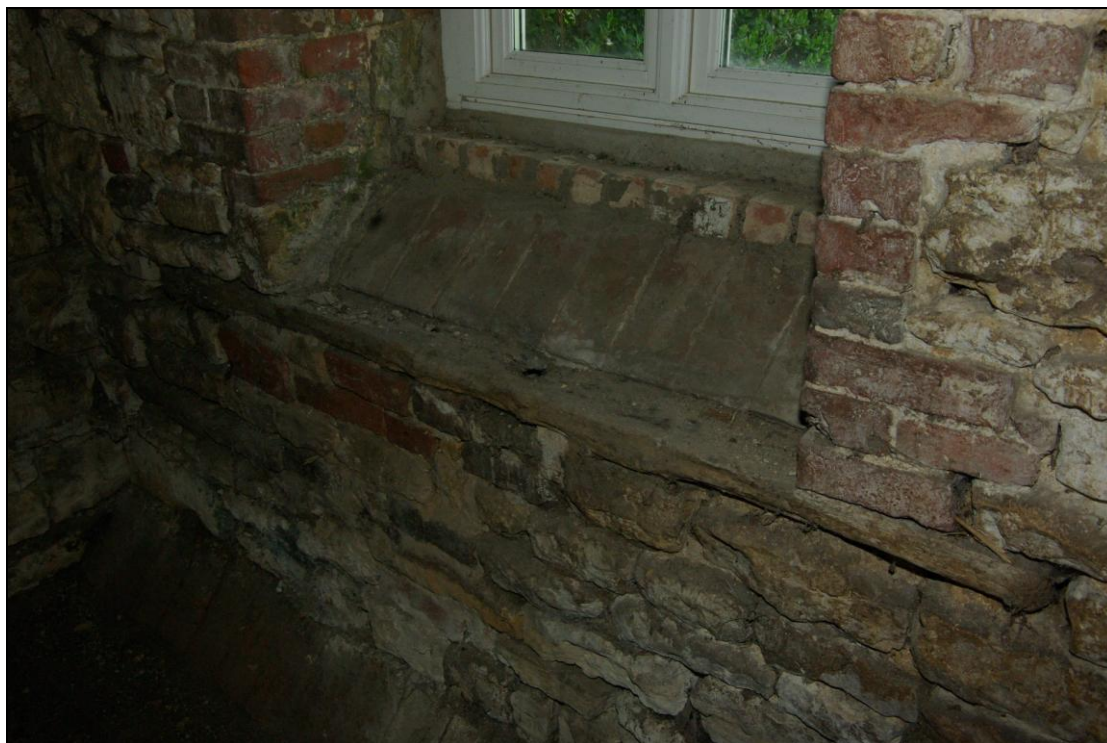
Figure 23. Window detail in Barn B.  
Looking south-west.

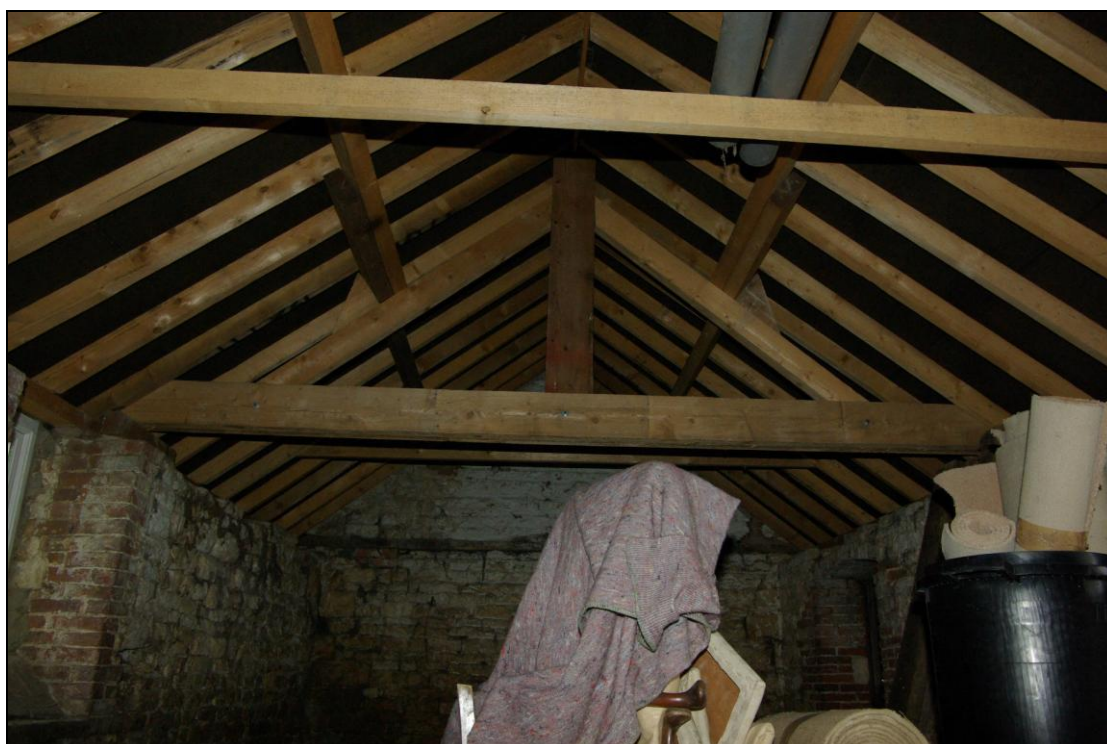
Figure 24. Roof detail Barn B.  
Looking north.
