**An Historic Building Analytical  
Survey (Level 3),  
1 & 2 Setchells Yard,  
Oundle,  
Northamptonshire,  
NGR: TL 038 881**

ULAS Report No. 2009-130  
©2009

**For: Mr and Mrs Pollock**

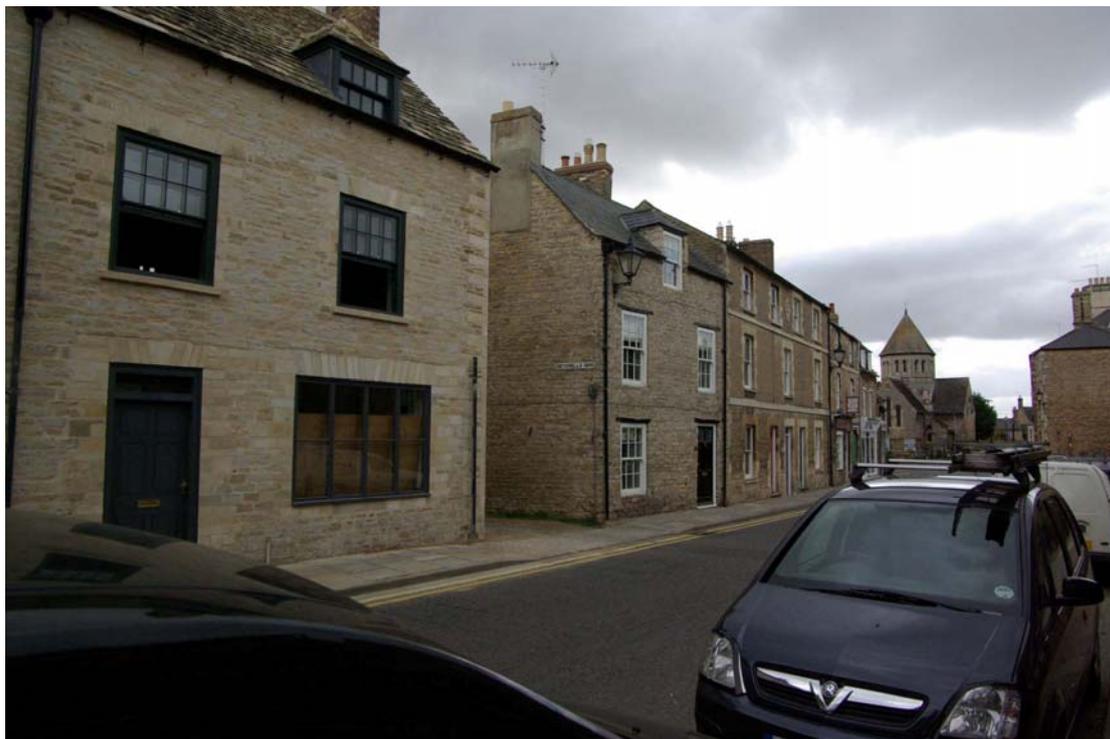
Figure 3 Site location seen from West Street  
Facing south west

The town of Oundle lies in the north eastern corner of Northamptonshire approximately 12km east of Corby and 18km west of Peterborough (fig. 1). The site is situated to the west of the town centre on the south side of West Street within a north to south oriented enclosed yard (figs. 2 and 3). Setchells Yard slopes down to the south with an approximate height of 30m above OD.

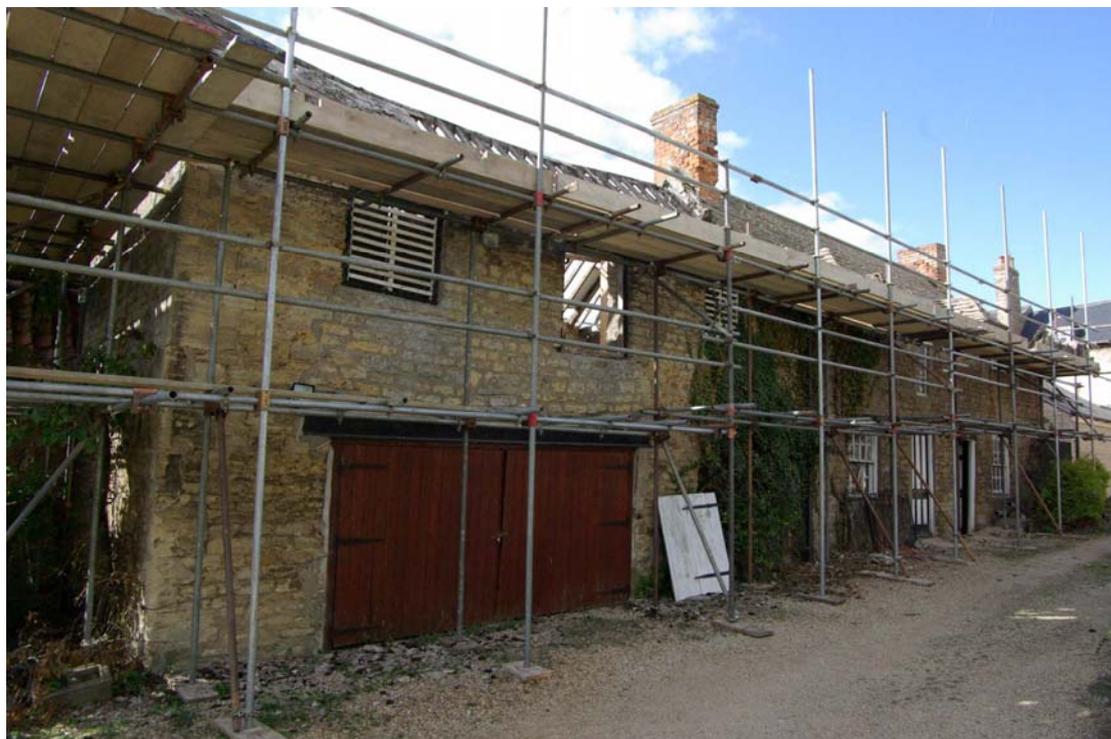
Figure 8 East elevation of range  
Facing north west

In common with rest of the building the eastern elevation, which is the main elevation, is constructed of coursed limestone rubble (fig. 8). Immediately prior to the survey the Collywestern stone tiled roof was removed from all three buildings in order to stabilise the eastern and western walls which were spreading under the weight.

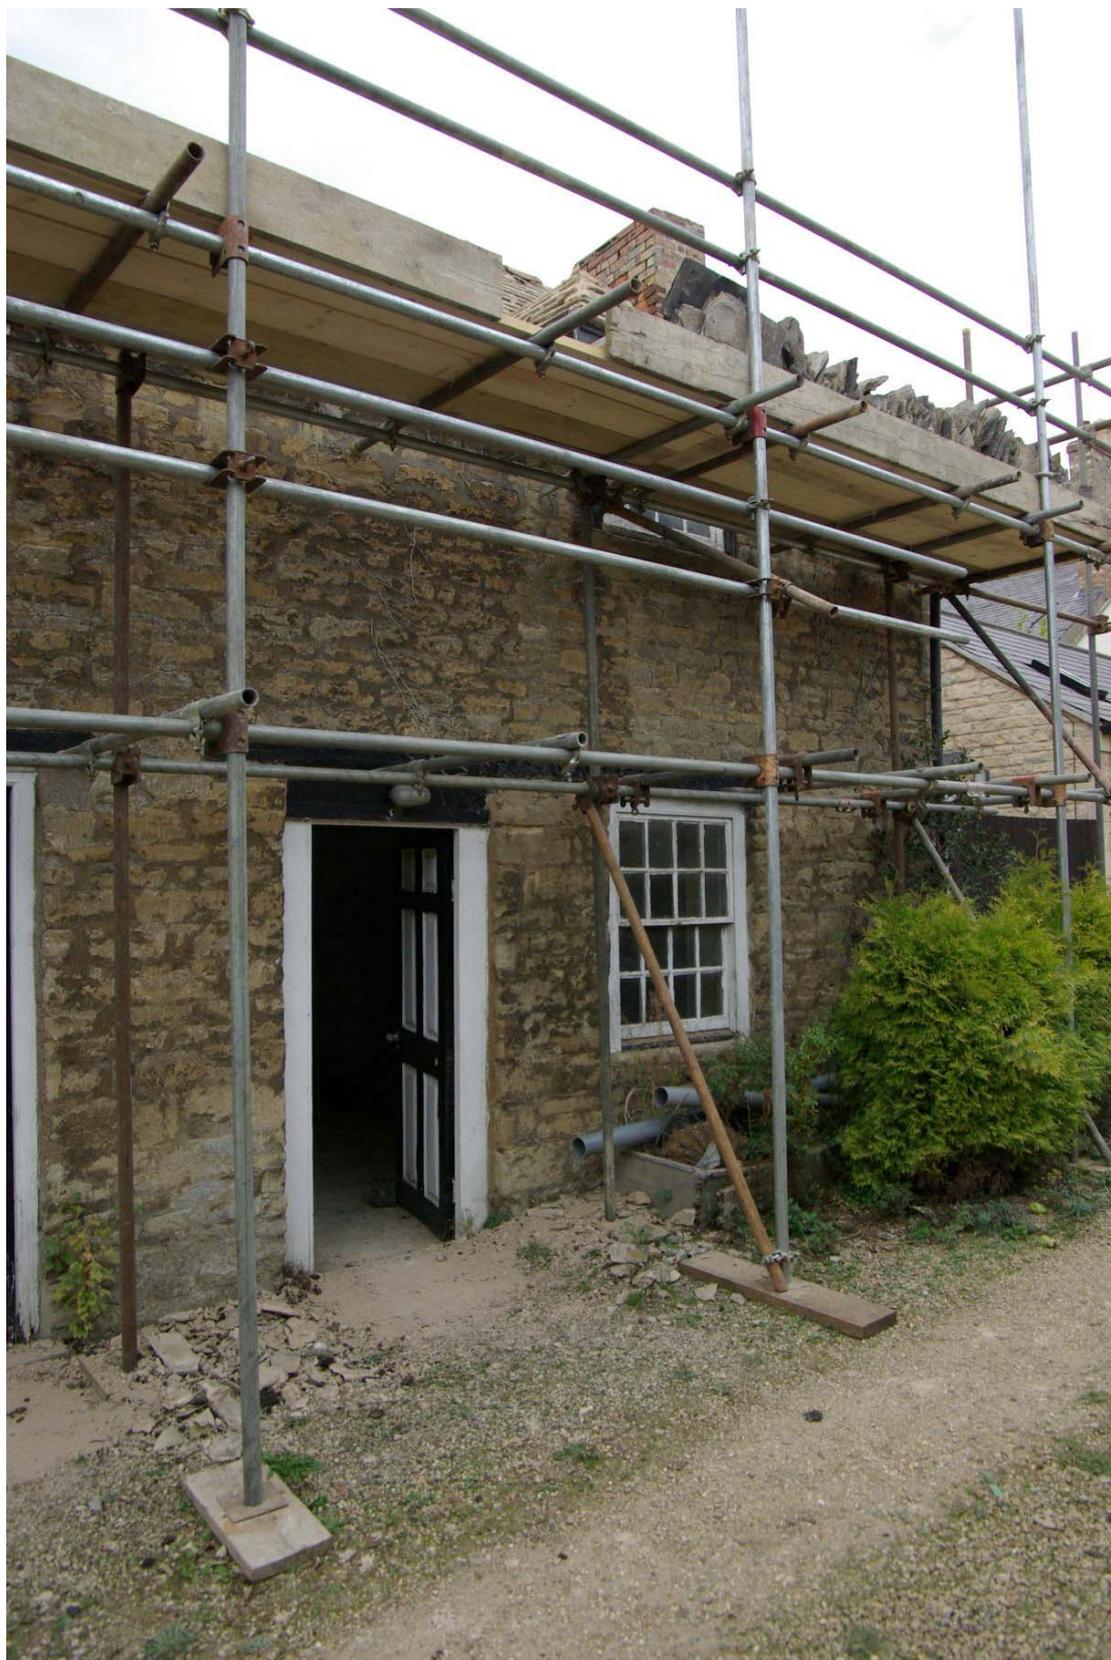
Figure 9 Number 1 Setchells Yard  
Facing north west

A single ground floor sash window with two sashes consisting of 4 by 2 panes is located to the north of the doorway (fig. 9). The lower sash is fixed while the upper, which has no horns, moves vertically. A wooden lintel extends from the window and across the doorway. The present 0.74m wide door is of wood with six panels and is fitted into a 1.05m wide wooden frame suggesting that there was once a wider door when originally constructed. A hipped dormer window that breaks the eaves immediately above the ground floor window has a sliding sash window. There is no evidence of any blocked windows or alteration to the existing door and window openings. At the northern end of the elevation there is an attempt at dressed stone quoins at first floor height but a rather ragged corner from ground level up to approximately 2.1m. This suggests that there was once a continuation of the wall at this height as also suggested by the First edition OS map discussed earlier. The east elevation wall continues to the south without break to cottage number 2.

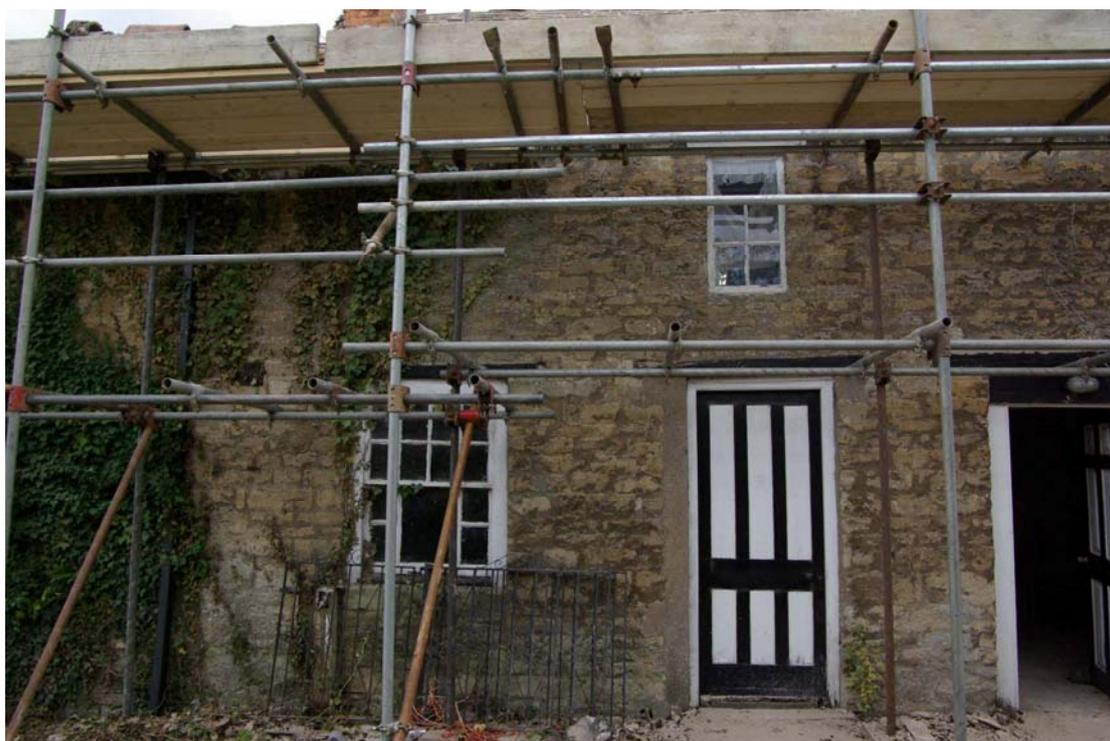
Figure 10 Number 2 Setchells Yard  
Facing west

Number 2 has the same design sash and dormer window as in Number 1 although one of the lower glazing bars on the ground floor sash has been replaced by a larger pane (Fig. 10). A narrow window with fixed glazing bars is located below the eaves just above the doorway. A small iron ventilation grille has been inserted into the wall to the south of the ground floor window at lintel height. As with Number 1 there is no evidence of any modifications to the existing door and windows and no evidence of any alterations to the wall itself. A straight vertical joint running from the ground to the eaves marks the boundary between number 2 and the outbuilding.

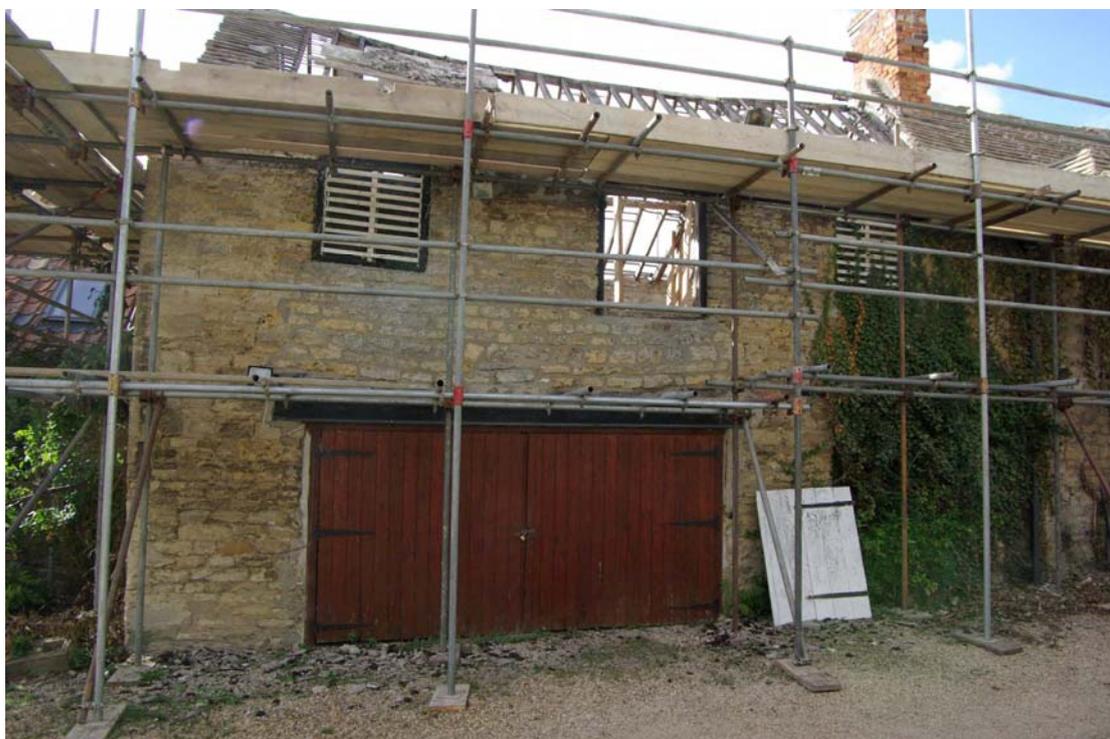
Figure 11 Outbuilding  
Facing west

The coursed limestone rubble of the outbuilding is much less carefully laid than in the two cottages and fewer attempts have been made at selecting stones of similar size for each course (fig. 11). The ground floor has a two paned wooden framed window fitted with modern obscured glass. Large modern wooden double doors beneath a relatively modern RSJ lintel give access into the building. Immediately above the RSJ are two shorter wooden lintels giving the impression that there were once two smaller doorways side by side. This is also suggested in the OS County Series 1:2500 first revision of 1901 where the outbuilding is shown as having two rooms. The stonework above the doorway has settled quite significantly between the two wooden lintels and there is evidence of repair work to the stone in this area which may be contemporary with the insertion of the RSJ. The first floor has two rectangular openings set below the eaves with wooden frames and grilles for ventilation suggesting storage of straw or fodder rather than a window to let in light. The central opening extends from first floor height to the eaves and had a single door made from wooden planks, which appears to have acted as a loading door. Around the central loading door as well as the stonework dropping the wall is bowing outwards quite markedly. This appears to have been caused not only by the doorway below but also due to the weight of the

Collywestern slate roof which is discussed below. The lack of a proper key into the adjacent cottage is also affecting the stability of this wall. Dressed limestone quoins form the south eastern corner of the building.

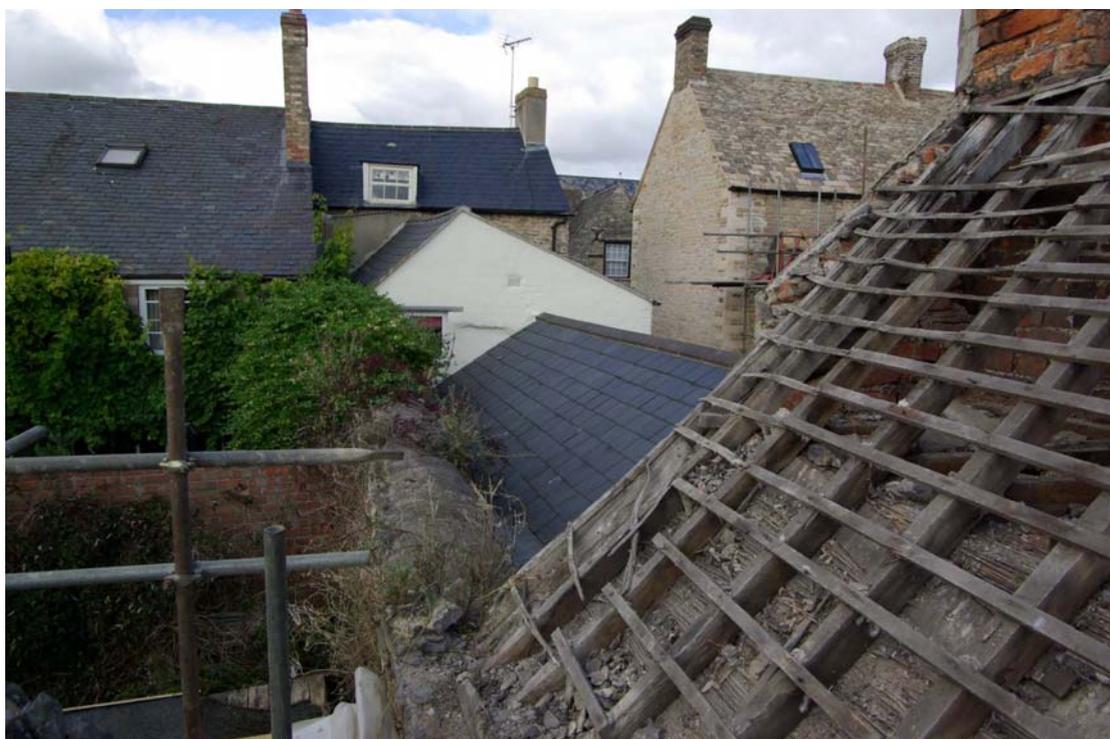
Figure 13 Continuation of western wall from number 1 towards West Street  
Facing north

No access into the adjacent property could be gained to view this elevation properly. However, the presence of scaffolding used to remove the roof meant that some limited inspection and measurements could be made. The western, rear, face of the outbuilding appears to be quite plain with no apparent modifications. The same severe spreading problems seen on the eastern elevation of the outbuilding can also be seen on the west wall. A pronounced step in the wall between the outbuilding and cottage number 2 was observed (fig. 12). The difference in alignment of the outbuilding and numbers 1 and 2 as they follow a pre-existing property boundary can also be seen along the western elevation. Each cottage appears to have a small bricked up window which would have once looked out onto the neighbouring property. The western wall of the cottages continues without break at full height from the north western corner of cottage number 1 along the property boundary towards West Street (fig. 13).

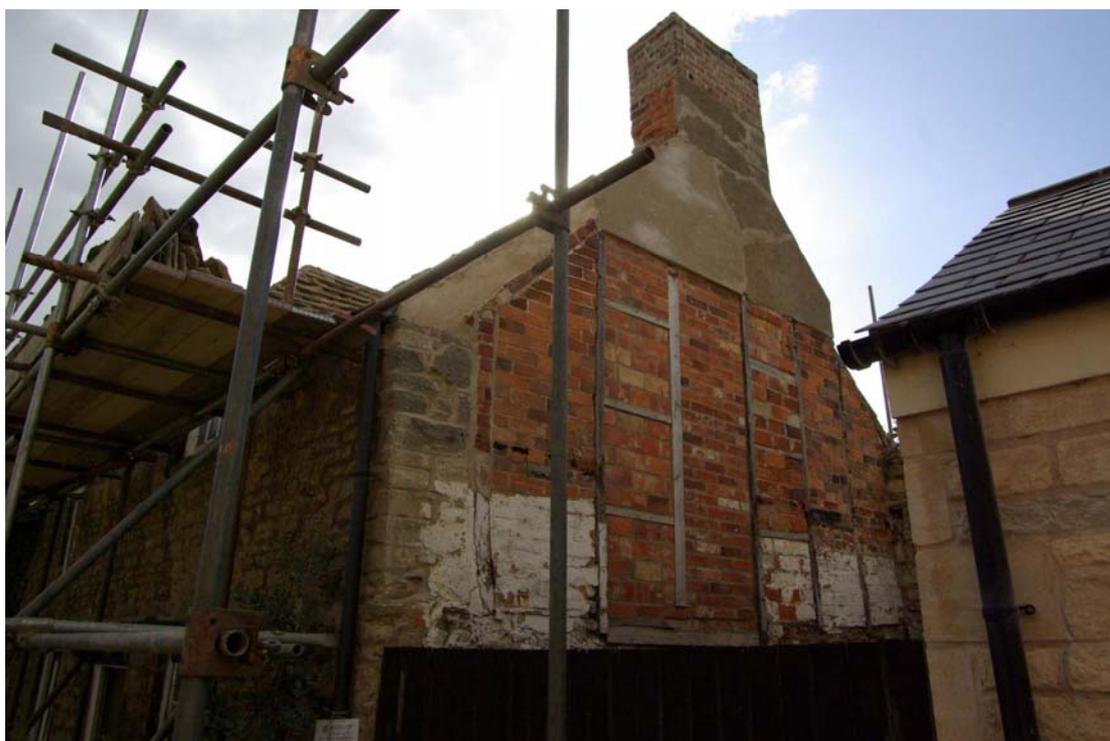
Figure 14 North elevation  
Facing south west

The adjacent new property to the north of cottage number 1 has a private yard set against the northern wall making this elevation inaccessible. However, a visual inspection could be made by looking over the boundary fence (fig. 14). The key feature of this elevation is that it has, as mentioned, limestone walls at either side belonging to the east and west elevations and timber studwork with brick infill between. The bricks forming the back of the chimney appear to be hand-made. Either side of the central chimney are bricks measuring 204mm wide x 100mm high x approximately 80mm deep. The infill between these larger bricks and the outer stone walls is made of 240mm wide x 65mm high x 110mm deep bricks. Traces of paint or whitewash are visible up to the top of ground floor level. The upper half of the gable end has been rendered and part of the western side has a slight step in the brickwork at this point. The whole wall gives the impression of a patched internal wall consistent with the OS evidence that the range once extended further north.

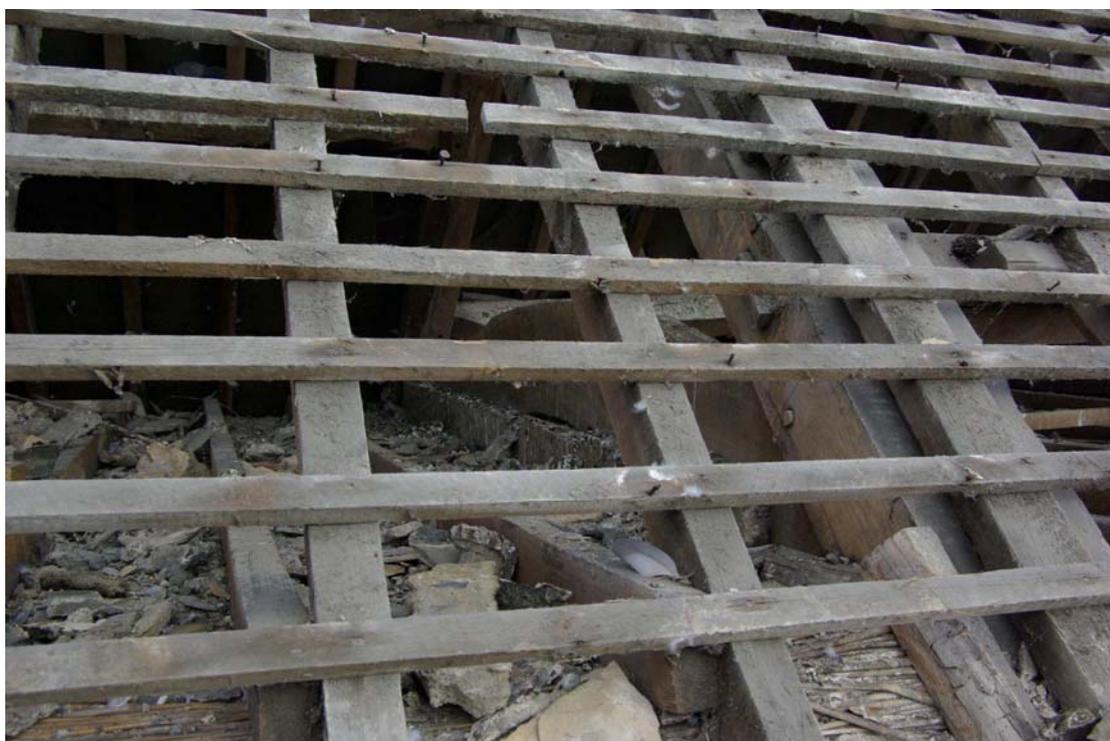
Figure 15 Collar and pegged purlin, number 1  
Facing south east

Inspection of the roof of the two cottages was made through the rafters following the removal of the Collywestern tiles as no other access was possible. The roof structure is of four bays defined by three approximately equally-spaced principal rafter trusses.

The centre truss is on the party line between numbers 1 and 2 with the other trusses over the centre of each cottage. The trusses are of similar form with a cambered collar tenoned and pegged into the principal rafters; there are no tiebeams. Staggered purlins are tenoned into the principal rafters. This roof form is typical of high-quality building of the 17<sup>th</sup> and 18<sup>th</sup> centuries in Northamptonshire (RCHME 1984, xlvi). The principal roofing members are of sawn oak (fig. 15). The northernmost purlin on the western side has two  $\beta$  type symbols inscribed on its outer face (fig. 16). A number of linear scratches on the inner faces of the pine common rafters may be shipping marks and so would indicate a Baltic origin for these timbers which may therefore be later than the main roofing timbers. Less substantial joists supporting the plaster ceiling are nailed to the northern face of each rafter. No tie beams are present as the first floor rooms extend above eaves height hence the spreading effect on the walls that the heavy Collywestern roof covering is having. Terracotta ridge tiles of a simple U shape formed the ridge of both roofs.

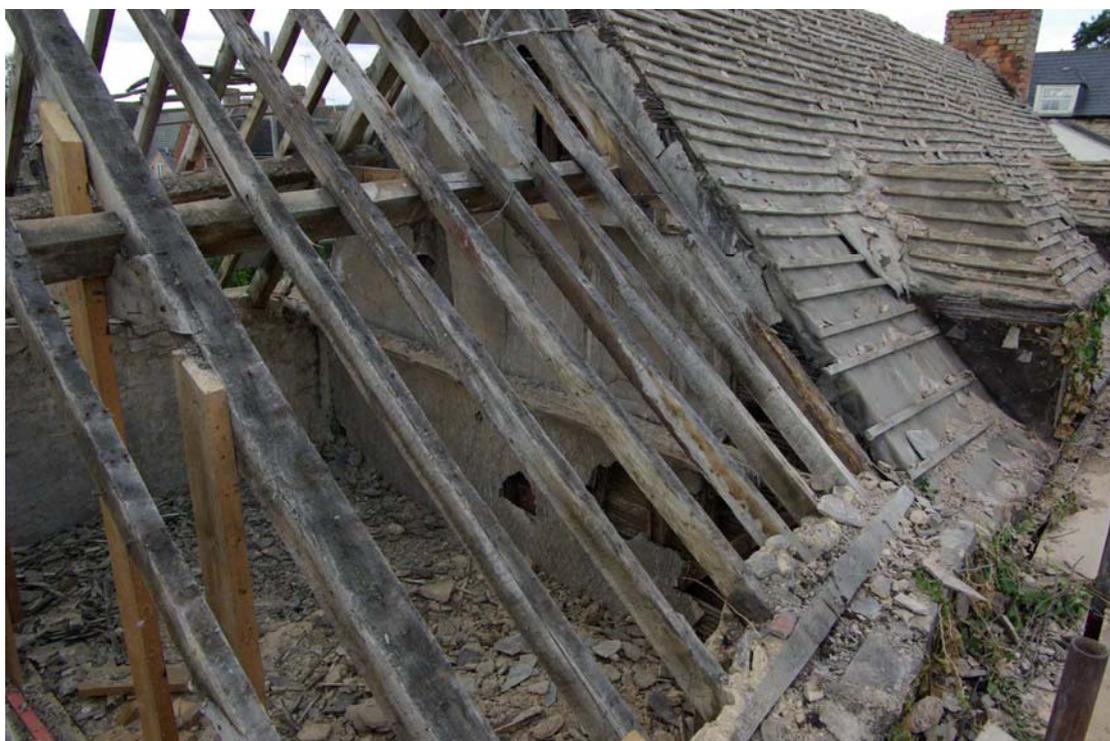
Figure 17 Roof structure of outbuilding  
Facing north west

The outbuilding roof is in a generally poor state of repair and is supported by the recent insertion of props and patches (fig. 17). This is a two bay structure with a principal rafter truss across the centre of the building and a second truss at the north end. The sawn collars are lap jointed and nailed onto the southern face of the principal rafters. The purlins are clasped between the collar and the principal rafters in a style common to this region and which continued well into the 19th century especially in lower status buildings. At the south end the purlins are embedded in the gable wall. There is a single tie beam at the northern end of the building, which is not associated with the roof truss. Otherwise there is no evidence of any other tie beams hence the degree of movement seen in the east and west walls.

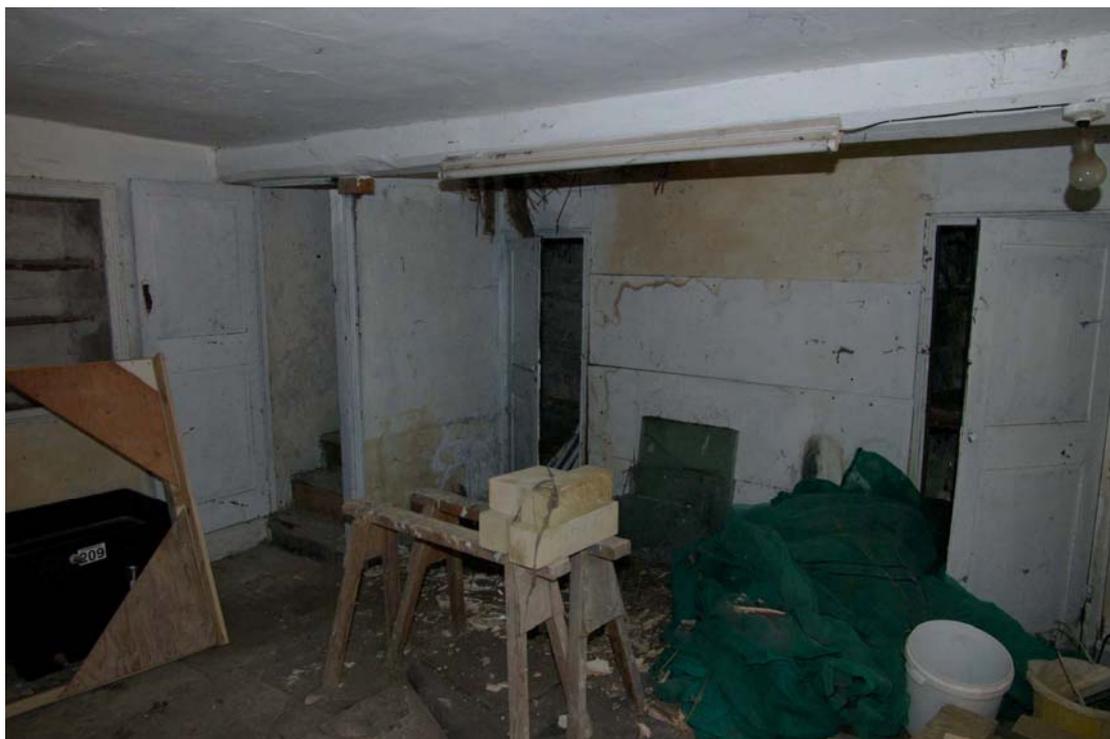
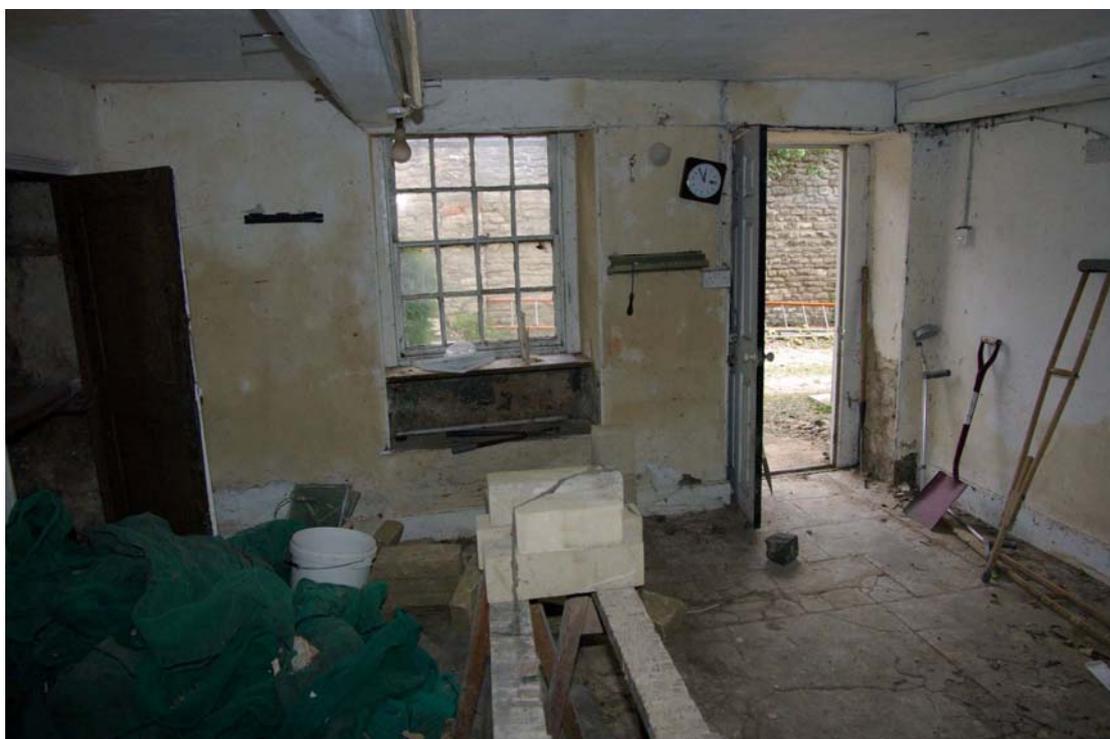
Figure 18 Number 1, ground floor  
Facing north west

The ground floor has a stone flagged floor with plastered walls and a 0.18m high single beaded skirting board (fig. 18 and 19). The fireplace has been boarded over with no indication of what may be behind. Either side of the fireplace two cupboards with wooden doors reaching to the floor reveal the rear face of the brickwork seen on the northern elevation. The brickwork appears to a single skin as daylight can be seen in places between the wooden studding and the brick infill. The blocked window on the western wall has been converted to create a small cupboard with a wooden outer frame. Some attempt at decorative beading has been made around the east window which has a shallow step in the wall thickness below the sash. A similar bead detail is seen on a large east to west beam running across the southern end of the room. Towards the northern side of the room a second, but slightly more substantial beam has a crudely cut chamfer on its lower face. A third beam can be seen running across the top of the stairs. This chamfered beam is partially set into the northern wall and runs from the west wall to the chimney breast. The three beams seem to be rather large for such a small room and the fact that the recessed beam has a chamfer would suggest re-use from elsewhere. The narrow wooden stairs are enclosed by a plastered brick partition and a simple wooden door. The iron door latch design is of an early to mid 19th century date.

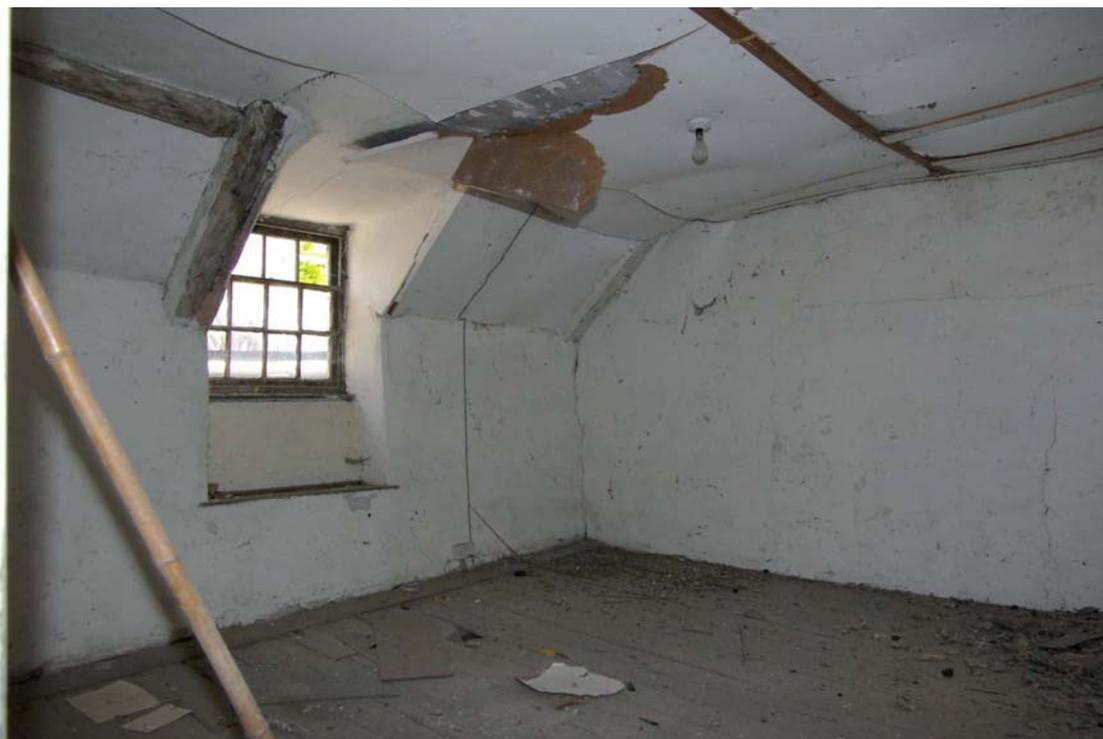
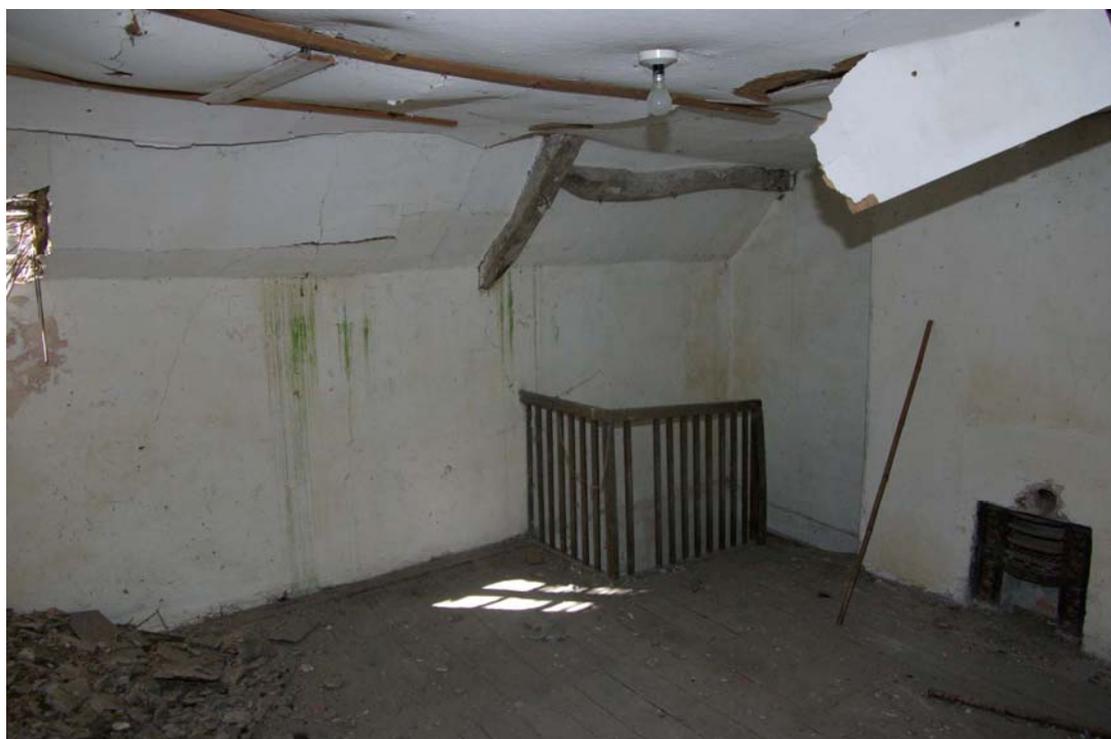
Figure 20 Number 1, first floor  
Facing south east

Upstairs the floor is laid using 165mm wide butted sawn floorboards (fig. 20). The walls are plastered and a modern plasterboard ceiling has been attached to the earlier plaster ceiling at collar height. The wooden banister is undecorated with rectangular balusters (fig. 21). The lower of the tenoned purlins pegged into the principal rafters

can be seen on both sides of the room just above eaves height. The fireplace appears to have originally been approximately 0.7m wide but has been reduced in size to fit a smaller cast iron grate. This replacement grate is a “Pantheon” pattern hob grate of late 18th century design (fig. 22; Eveleigh 1983, 4-6). Above the grate is a small hole which may have accommodated the flue of a later heater or stove that would have stood in front.

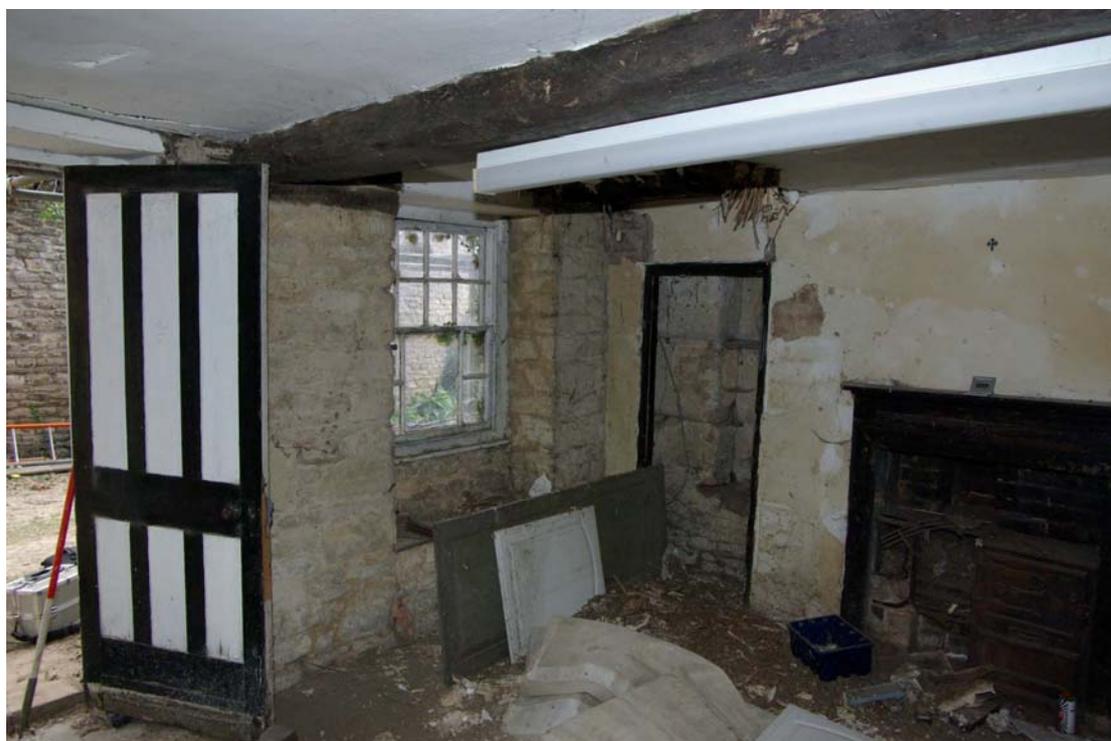
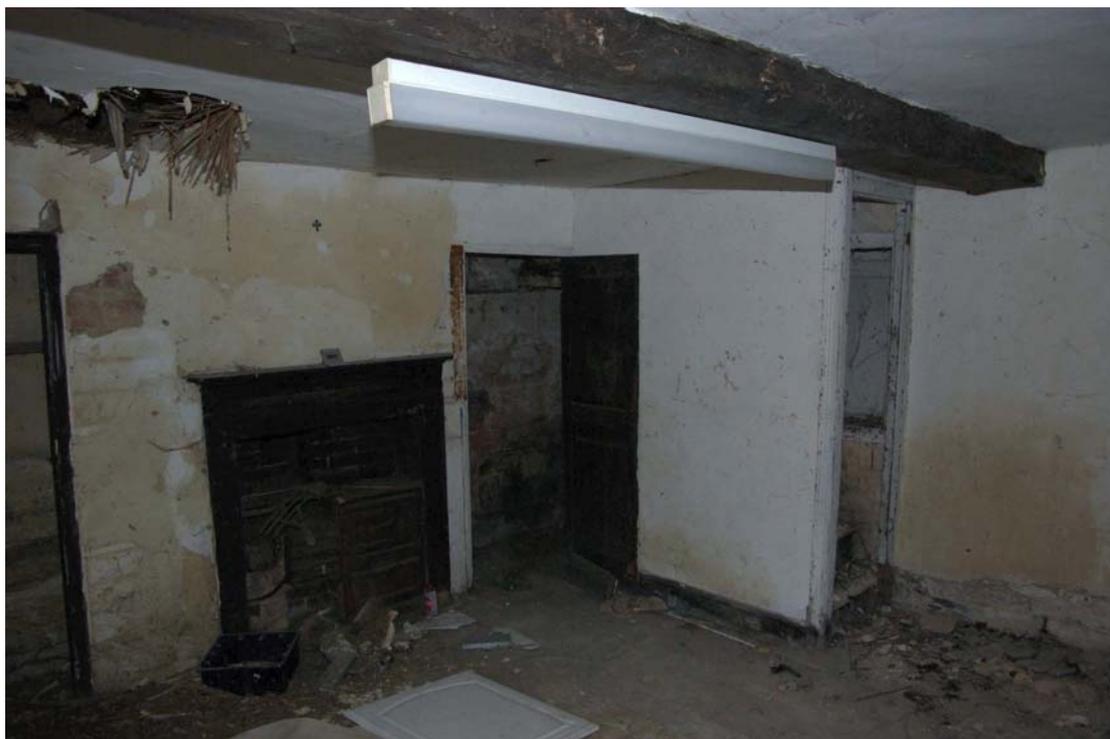
Figure 23 Number 2, ground floor  
Facing south east

As in the first cottage the ground floor of number 2 is made of stone flags with some later tile repairs. Most of the walls are plastered but some has been stripped from the east wall to reveal the limestone coursing (fig. 23). The beaded skirting board is the same design as in number 1. A cupboard with a wooden door is built partially under the enclosed stairs and to the west of the central chimney breast (fig. 24). The rear wall of this cupboard is made of coursed limestone rubble for the first 0.6m with bricks on top up to ceiling height which suggests some remodelling of this wall. The bricks measure 204mm long x 70mm high x 115mm wide. To the east of the chimney is another cupboard built over what appears to be a blocked window. The evidence for this is a limestone built spur that forms a small corner and a return before stopping at a straight line joint with a brick wall that then extends to the chimney breast. The kitchen range is very similar in design to one registered by the Coalbrookdale Company in 1869 and so presumably replaces an earlier range (Eveleigh 1983, 17). Some plaster has become detached from the chimney breast to reveal the higher 204mm wide x 100mm high x 80mm wide bricks as seen in the north external elevation. A crudely chamfered beam runs across the centre of the room from east to west. A small rectangular window at the foot of the enclosed stairs has been converted into a small cupboard. The position of a window inside the stairs would seem to indicate that at one time the stairs were not enclosed. Holes in the plaster show that the wall enclosing the stairs is made from the 100mm high bricks seen elsewhere. A hole in the ceiling indicates that a straw and plaster layer survives beneath the floor boards.

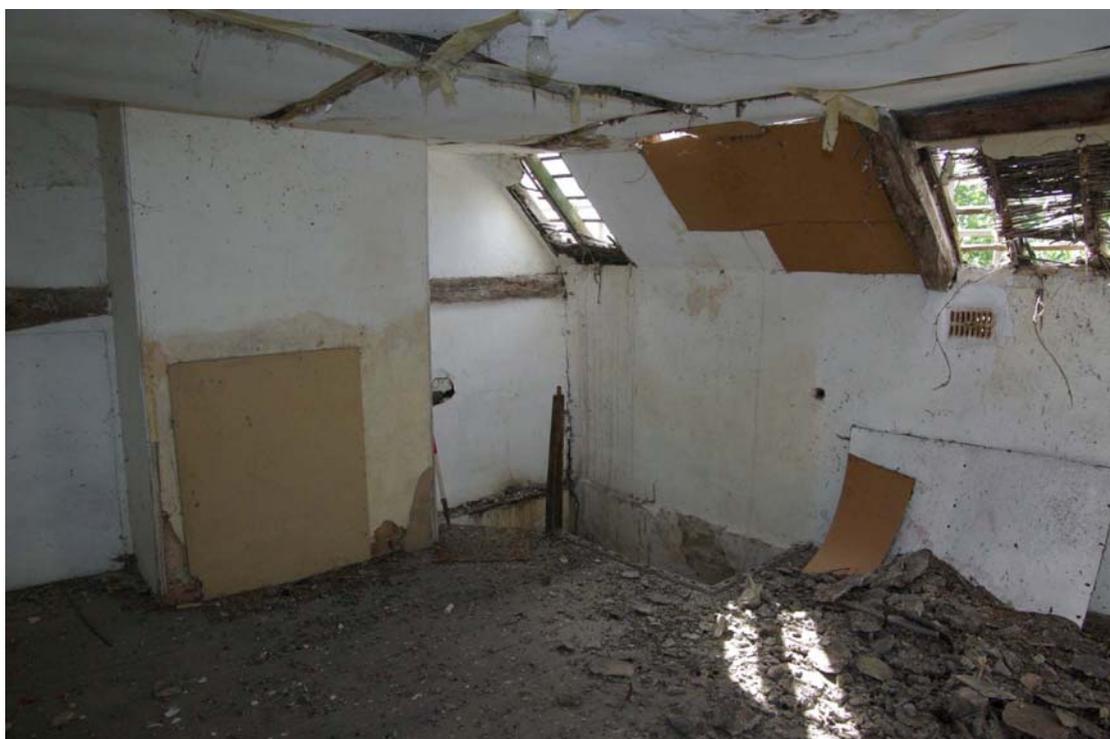
Figure 25 Number 2, first floor  
Facing south west

Upstairs the banister and balustrades are missing but mortice holes indicate that it was of the same pattern as in cottage number 1. Generally the layout and details are similar to number 1 with the same visible purlins and principal rafters and plasterboard ceiling (Fig. 25). The 230mm wide floorboards are plain sawn butted boards. The fireplace is boarded over with no indication of what may lie behind. The northern wall, which divides the two cottages, shows signs of a number of regular cracks around what appears to be timber studding with brick infill. A small hole in the southern wall shows this wall to be constructed of straw and plaster.

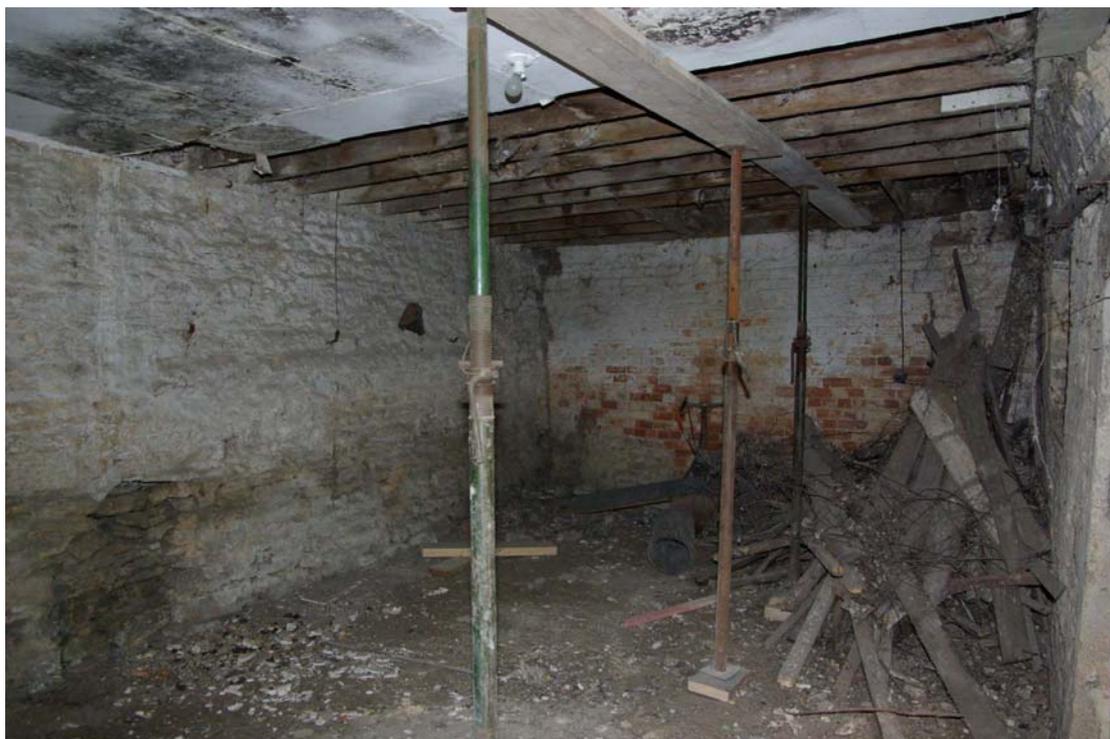
Figure 26 Outbuilding, ground floor  
Facing north west

The single ground floor room is laid with small river washed stones set in a regular linear pattern (fig. 26). Most of the north wall is constructed of brick but with a small area of stone at floor level in the western corner as seen in the fireside cupboard of number 2, mentioned above. At the eastern corner of this wall a limestone spur can be seen extending to the west. The bricks are laid in English Garden Wall bond using 204mm long x 70mm high x 115mm wide bricks. The brickwork butts against the eastern and western limestone walls without being bonded to them. The western wall

is deflecting outwards quite badly and has a patched hole in the centre at the bottom. At this point three joist holes can be seen one above another in a vertical line which may be the remains of a wooden partition wall dividing the ground floor area into two rooms as shown on the 1901 OS map. The single window on the east wall has already been discussed as has the modern double door and RSJ. The wall above the door shows signs of recent repair but is still deflecting outwards. A small trapdoor in the north western corner is the only internal access to the first floor.

Many of the first floor floorboards are rotten as are some floor joists so this floor was inspected through the removed roof from the outside scaffolding. There is no evidence of any blocked windows or openings on the western wall and only the single blocked door at the southern gable end as already discussed. The north wall has been rendered over plaster and straw supported by a timber frame.
