**An Archaeological Investigation by Test
Pits at Shires Plot F (SK 583 046),
and Shires Plot G1 and G3 (SK 585 047),
St. Peter's Lane, Leicester.**

**Planning Application No. ??
Planning Authority: Leicester City Council
For: Shire GP Ltd.**

**University of Leicester
Archaeological Services**

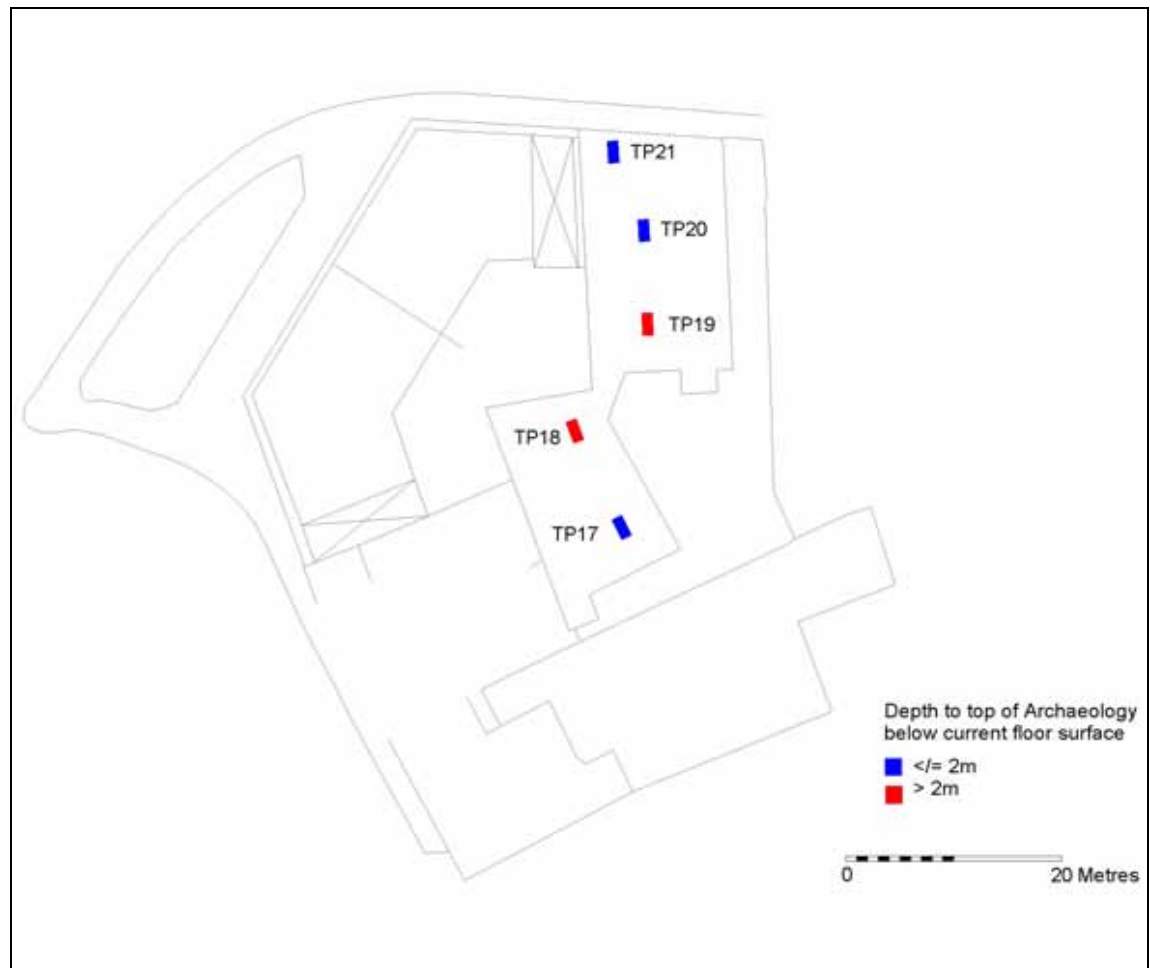
Fig.3 – Test Pit location for Shire Plot F, showing depth to top of archaeology (North to top)

3.1.1 Five test-pits were excavated within the 'Stride' building area of Shires Plot F. These were located to give a broad picture of the underlying deposits across the site, including one on the periphery of the site to locate any surviving medieval frontage (Fig.3).

4.1.1 It may be observed from the summary of results presented on Fig.3 that the depths to archaeology are varied, but are shallow towards the rear and front of the building and deeper within the middle of the building. The depth of overburden varied between 1-2.5 m below the current floor surface (61.78-61.88m OD).

4.1.2 It can be stated that archaeology has not been seen above a depth of 1m from the current floor surface. However, this is based on one of the test pits (TP 17), whilst the general depth of overburden was between 1.8 and 2.5 below current floor surface. These greater depths may however reflect the consolidation of archaeological pits with garden soil, and represent a false depth to top of archaeology, meaning archaeological depths may be shallower than these figures.

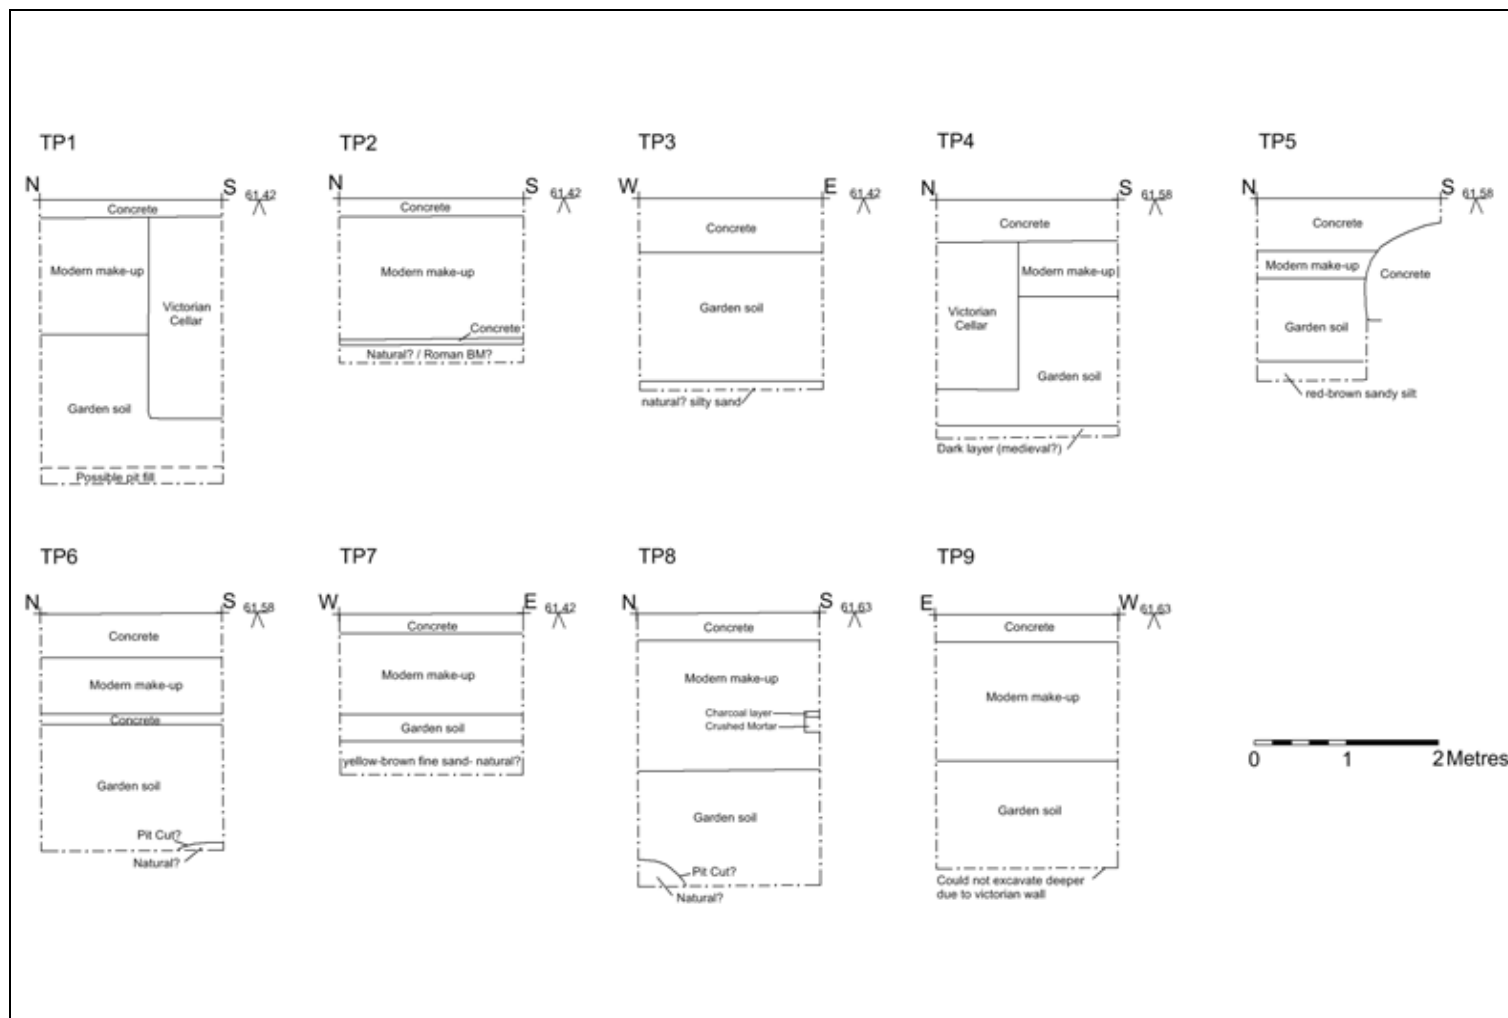
Fig.6 – Test Pit sections 1-9

3.2.4 Below is a table laying out the results of the test pits (Table 2). Noted here is the top of the garden soil, or bottom of modern make-up material or modern disturbance. In a couple of cases these have two numbers, which reflects an uncertainty and can be seen in section (Fig's.6 and 7). Secondly, the depth of archaeological deposits or natural substratum has been noted. The deposits observed have been described and interpreted.

Test Pit no.	Top of Garden Soil (metres)	Top of Archaeology or Natural (metres)	Description of Deposit Observed	Interpretation
1	1.5	3.0	Garden soil contains mortar fragments and flecks.	Possible pit
2	None seen	1.6	Pale yellow brown silty sand, occasional small rounded pebbles.	Natural substratum? Or Roman footing material?
3	0.6	2.0	Mid yellow brown slightly silty sand, frequent small to medium pebbles.	Natural substratum?
4	1.1	2.5	Mid brown orange slightly silty sand, occasional pebbles.	Medieval layer?
5	0.9	1.8	Mid reddish brown, occasional medium pebbles.	Medieval Layer?
6	1.2	2.6	Mid brownish orange fine sand and frequent small gravel.	Natural substratum? With Possible pit cut.
7	1.1	1.4	Orange yellow brown fine sand.	Natural substratum?
8	1.1/1.7	2.7	Mid brownish orange fine sand and gravel. And a charcoal and mortar layer.	Natural substratum? Possible pit cut in base and stratigraphy higher up
