**An Archaeological Watching Brief  
at Boston House,  
Abbey Park Road, Leicester.  
NGR: SK 5875 0605**

Andrew Hyam  
December 2006

*Client: Pearmain Limited*

Report No. 2006-168 © 2006

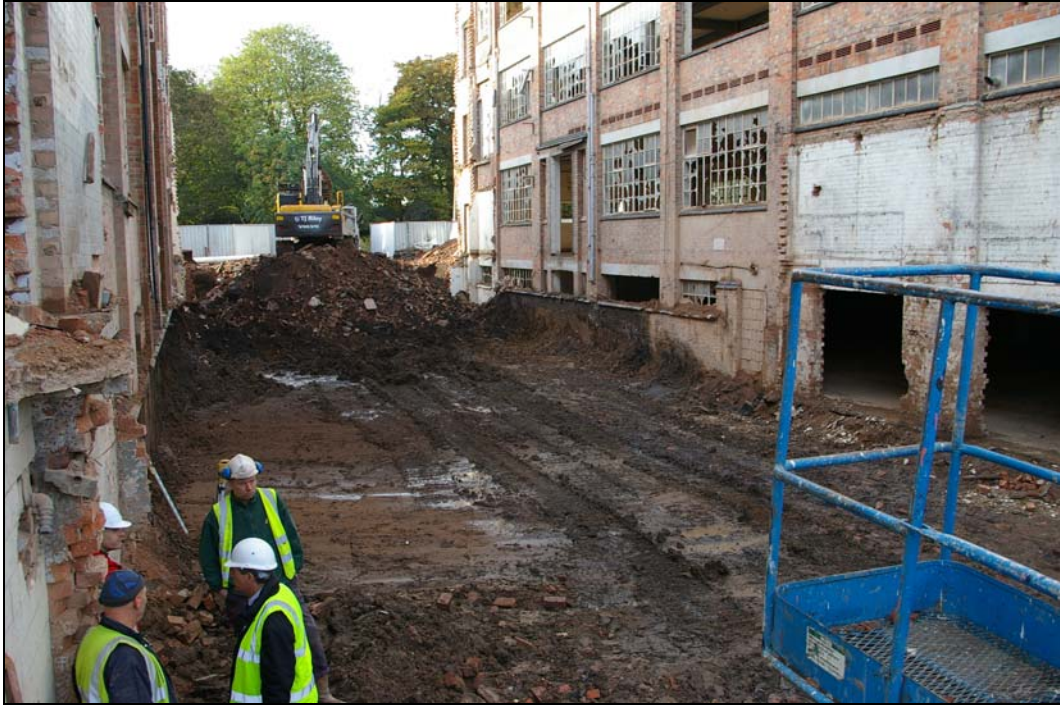
The overburden consisted of a dark red-brown silty clay which appeared to have been extensively disturbed probably during the construction of the two main wings of Boston House. Although quite badly disturbed in places, by site vehicles tracking over it, the exposed alluvial deposits consisted of patches of mid red brown clay and dark grey clay (plates 1 and 2). This masked any natural substrate across the whole of the excavated area. A small sample excavation showed the alluvial deposit to be at least 0.2m thick.

*Plate 1. Stripped car park area between wings looking south.*

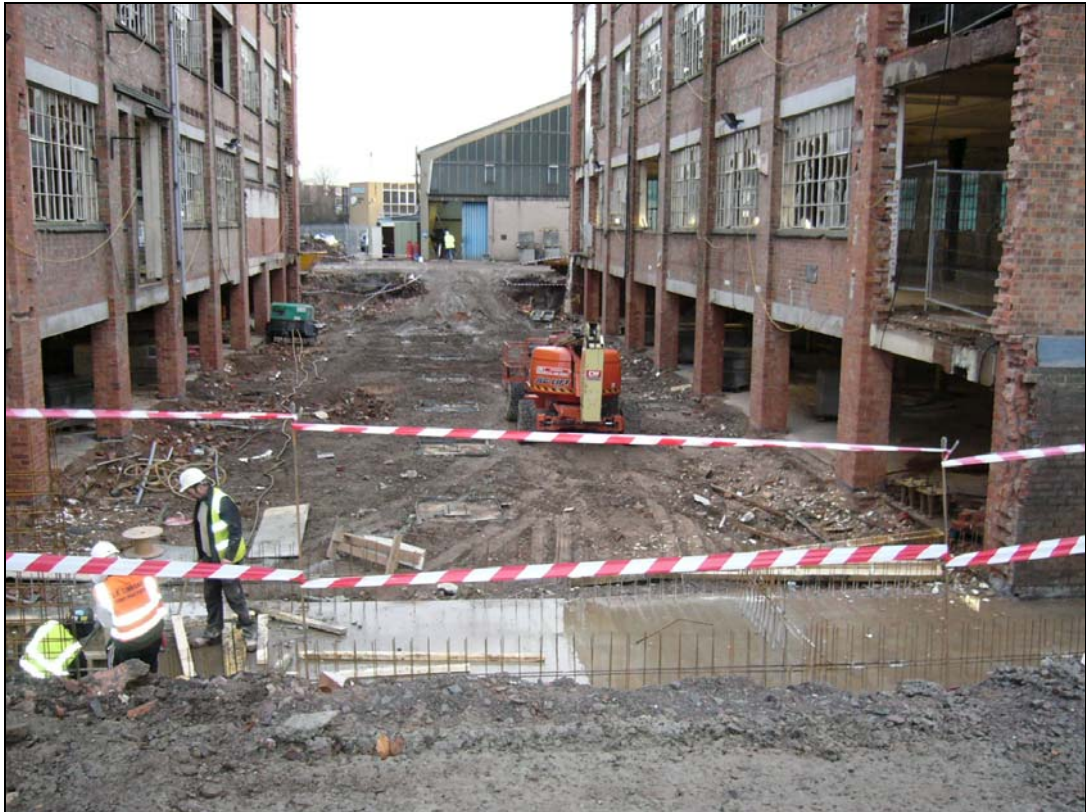
*Plate 2. Stripped car park area, looking north.*

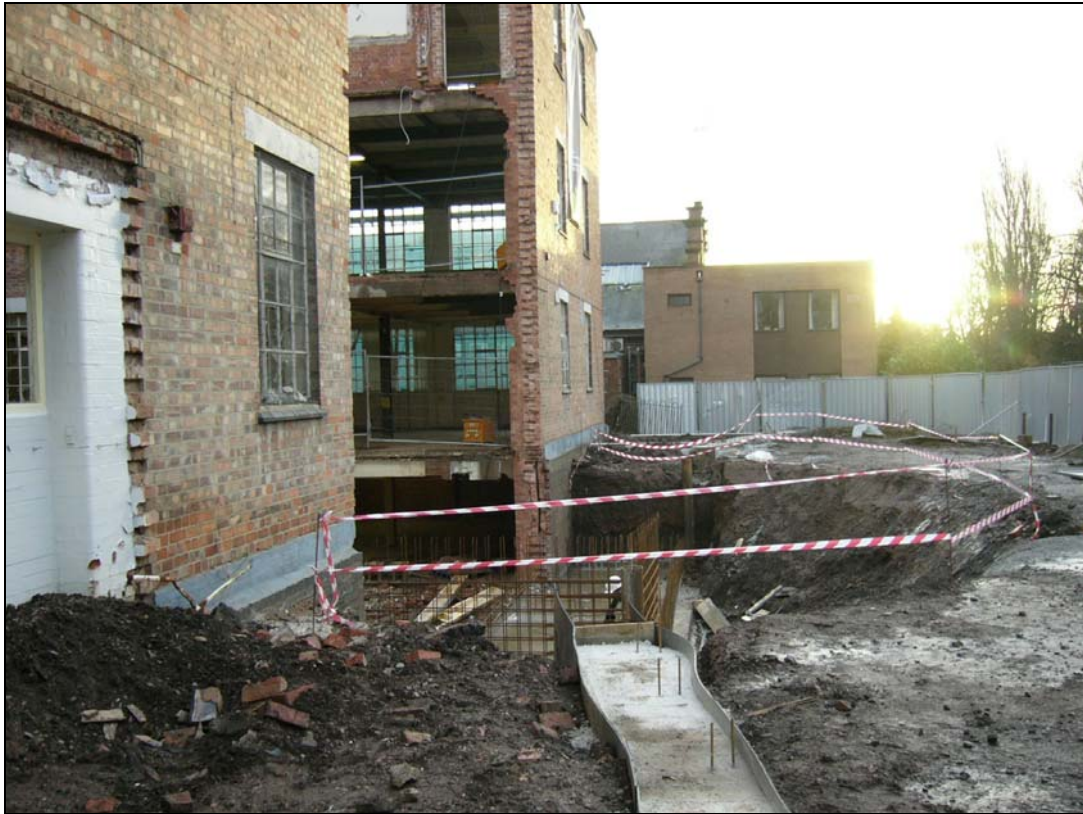
At the front, southwestern, end of the two wings the ground was very disturbed and no alluvial deposits could be seen. This was probably due to the demolition of the centre portion of the original façade which had relatively deep foundations (plate 3).

The method of construction of the front piled area and associated new foundations did not reveal any archaeological features or indeed any undisturbed ground.

*Plate 3. Modified façade of Boston House looking east. Piled foundations in front of both buildings.*
