An Archaeological Watching Brief at
Abbey Park,
Leicester
NGR: SK 5837 0608 centre

ULAS Report No. 2011-013
©2011

For: Leicester City Council

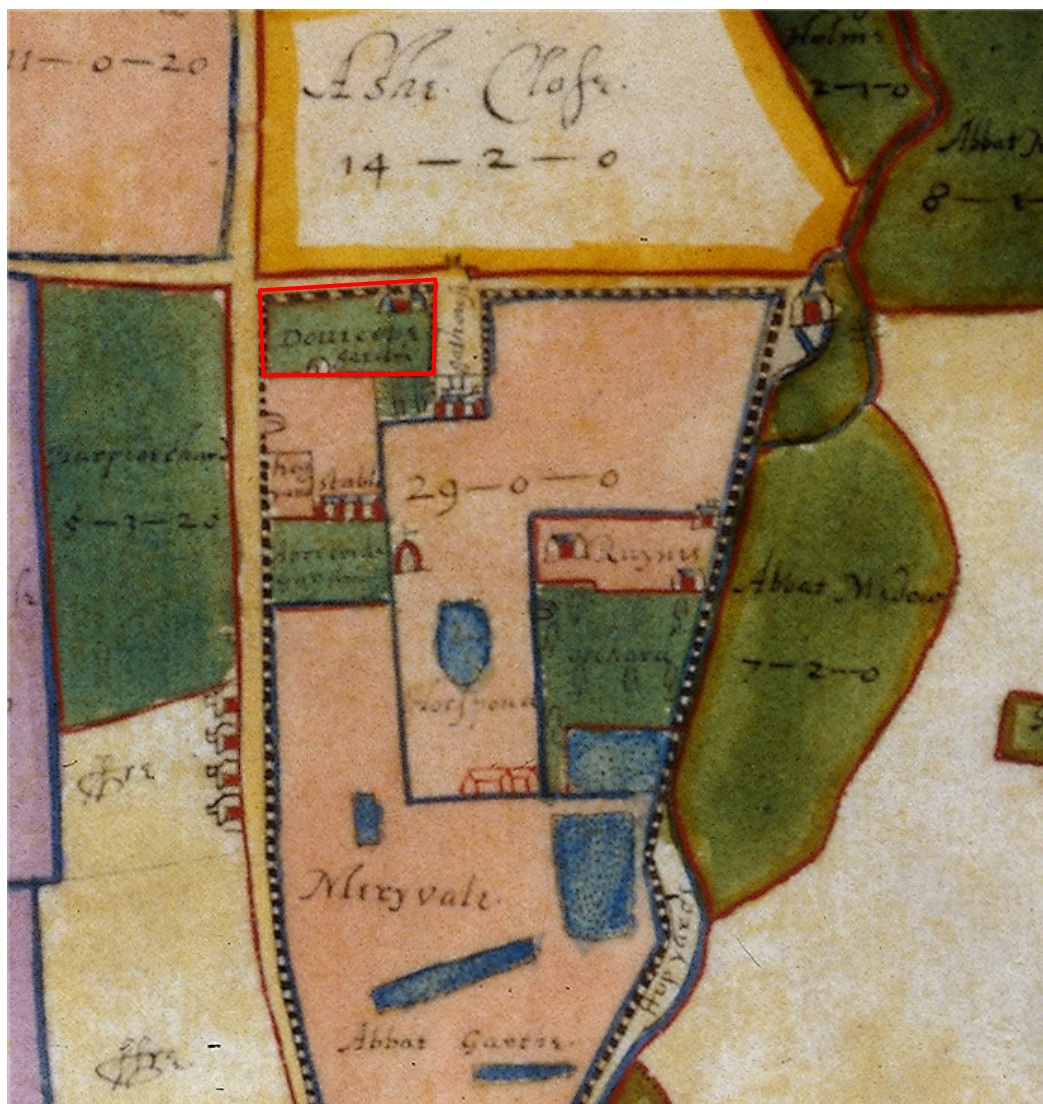
Figure 3 Detail from William Senior map (1613)
Dovecote garden highlighted, the halt-way is immediately to the east of this.

The area subject to the present watching brief runs northwards from a walled works depot continuing to the west of a modern roadway between Cavendish House and Pet's Corner and finally across the park entranceway (fig. 2). The William Senior map of the abbey site published in 1613 for the Cavendish family shows the works depot as stables and farm buildings which are thought to be part of the original abbey complex. Part of the area presently used for Pet's Corner is shown as a dovecote garden (fig. 3).

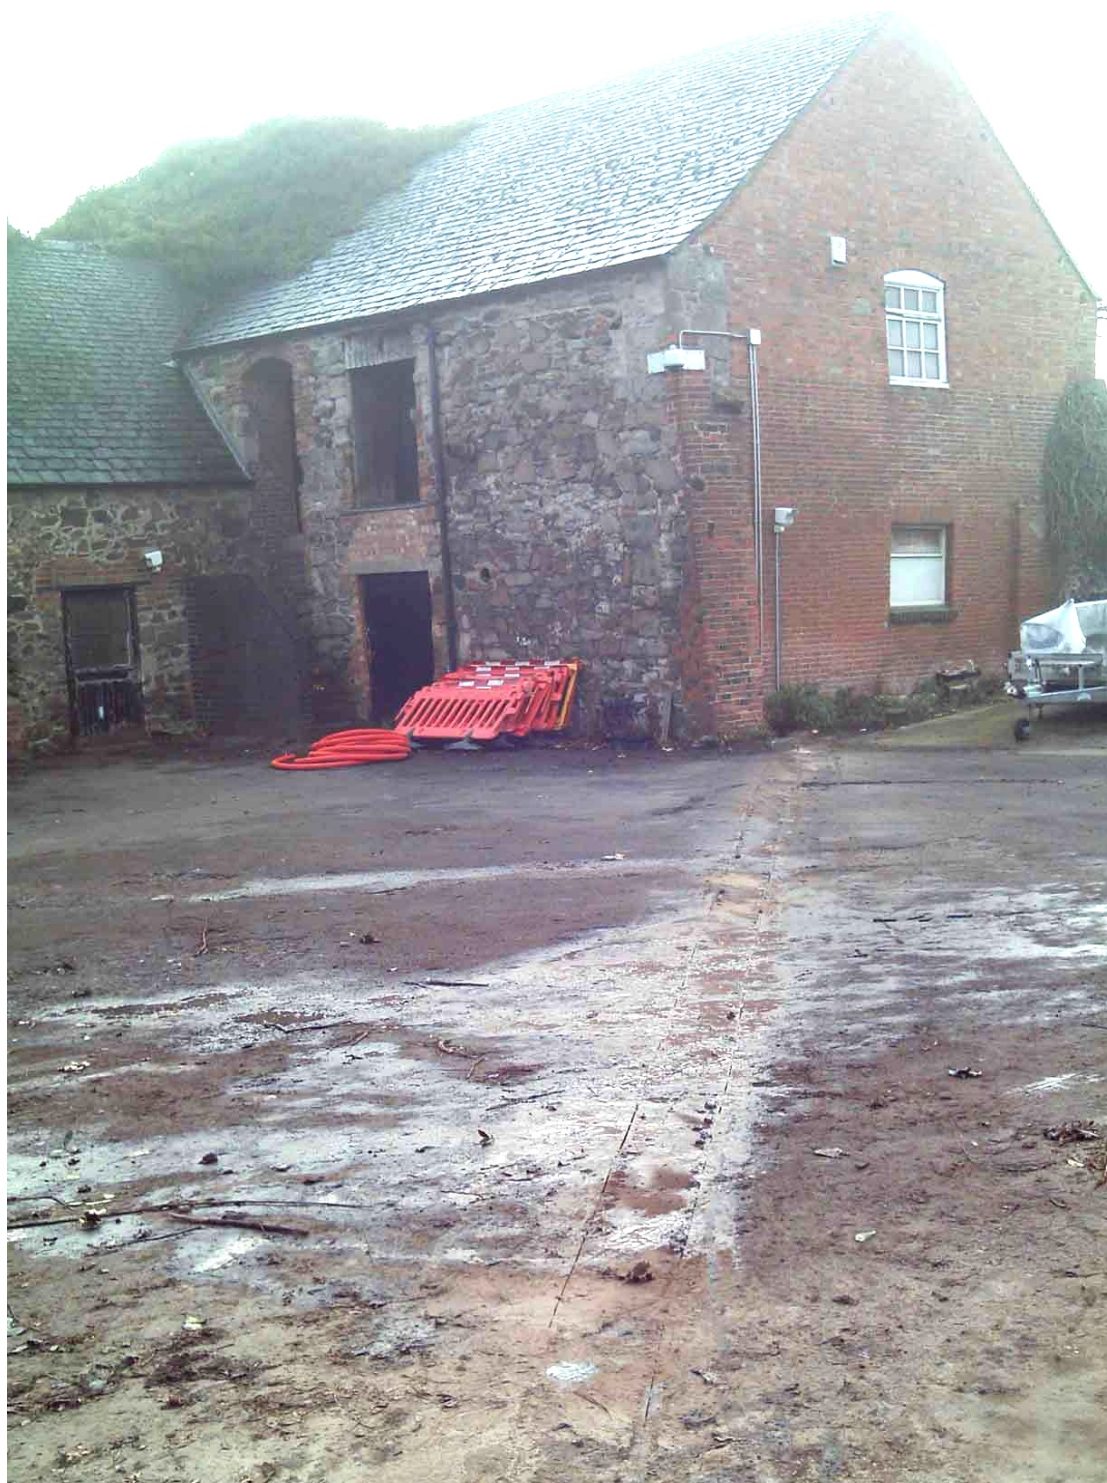
Figure 7 Depot cable trench
Asphalt cut ready for excavation. Looking south-east

The trench for the cctv cable runs from the north-west corner of a two-storey L-shaped building in the south-east corner of the depot across, in a north-westerly direction, to the south-east corner of an open fronted range running along the northern boundary (fig. 7). The depot yard is covered in a layer of heavily patched asphalt giving the impression that there have been a number of excavations into this surface.

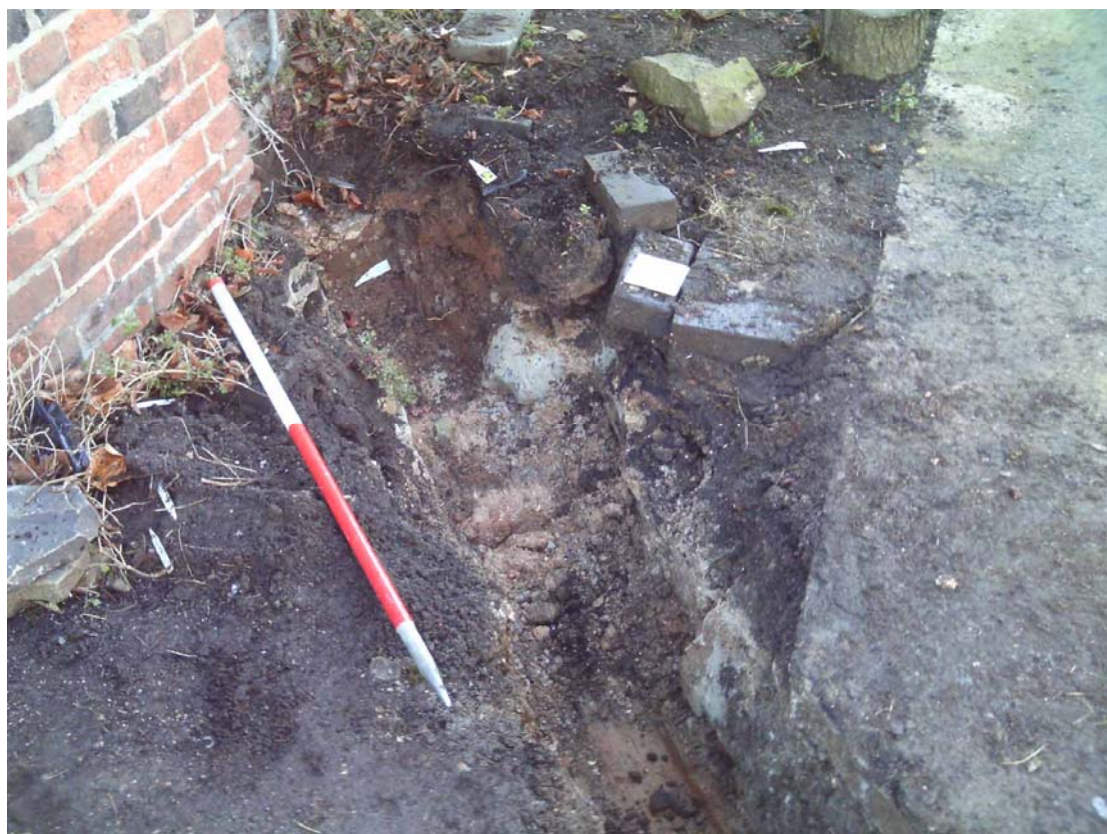
Figure 8 Foundation of stable building
Looking south-east

The trench was begun at the north corner of the west-facing elevation of the L-shaped building. This building has a stone rubble-built north-facing façade with rear and side walls of brick. Beneath the layer of asphalt and approximately 25mm of sandy bedding material was a 0.9m wide unworked block of Dane Hills sandstone within a matrix of degraded mortar and sandstone fragments (fig. 8). The stone corresponded with the front stone façade of the adjacent building and extended from east to west across the base of the trench and appears to be a continuation of the stone facade. Unfortunately the cable trench was so narrow and at such an angle that it was not possible to identify any internal floor surfaces which may still survive. Beyond this point, for the next 4.5 metres, the trench contained a heavily disturbed layer of silty clay with river washed cobbles and brick fragments scattered throughout. None of the brick fragments was large or complete enough to estimate its original size. This disturbed layer was approximately 0.4m deep beneath which was a clean deposit of pale orange brown silty clay which appeared to be the natural. The total trench depth within this area was between 0.45 and 0.55m below present ground level.

In the works depot it seems clear that the stone-fronted building continued further westwards than it does now. Senior's map also indicates that the building, identified as stables, were significantly longer in 1613. No evidence was found to give an indication of the date of construction of this building. Elsewhere in this area the yard appears to have been re-laid more than once which has destroyed any archaeological evidence.
