**Photographic survey of Historic Buildings  
at 8, Manor Road,  
Great Bowden, Leicestershire**

**NGR SK 8172 0151**

ULAS Report Number 2008-118 ©2008-118

**A Photographic Survey of 8 Manor Road, Great Bowden, Leicestershire (NGR SK 8172 0151).**

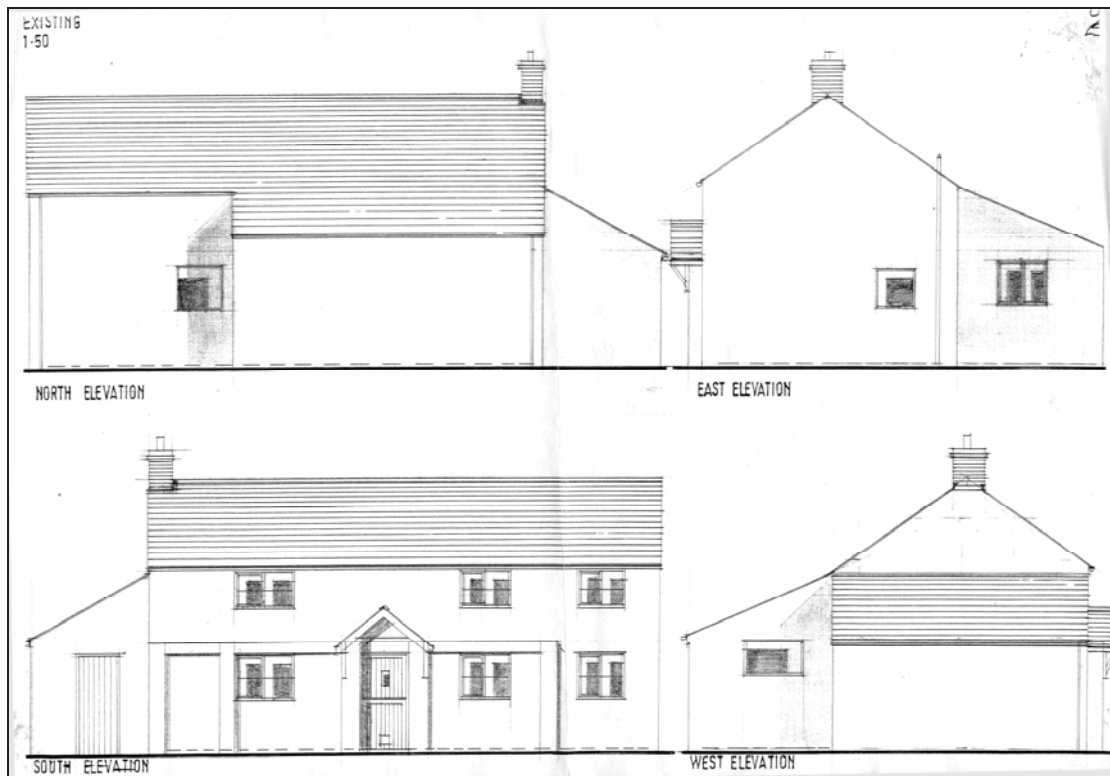
Figure 3: Scan of existing elevations (provided by the client).

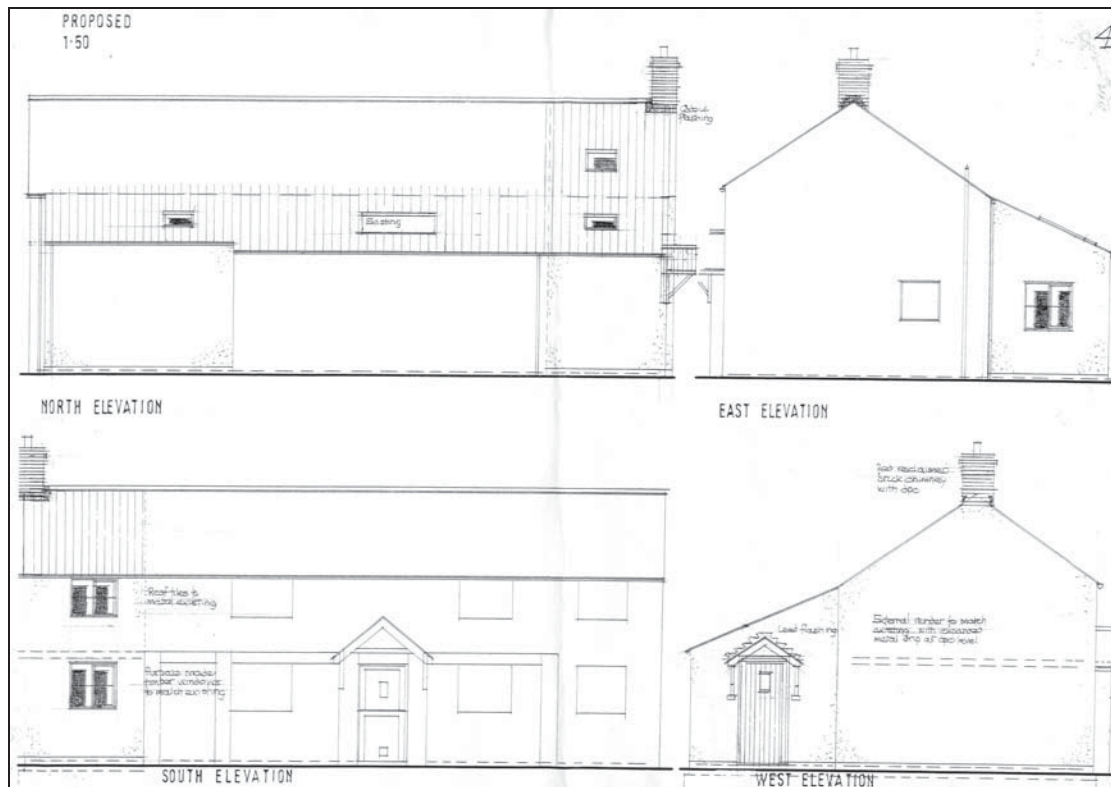
Figure 5: Scan of proposed elevations (provided by the client).

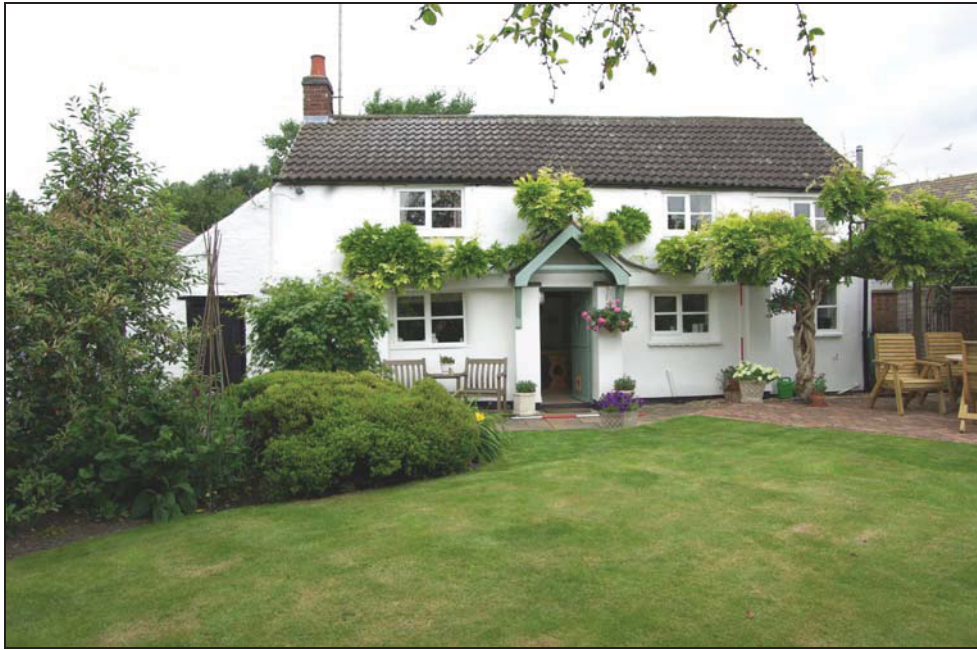
**Plate 1: The principal (south) elevation of the cottage. The outhouse is to the left of the picture. The right-hand end of the cottage has already been extended.**

The brick outhouse at the west end of the south elevation (Plate 1) will be demolished, and replaced with a two-storey extension. The chimney stack will be removed and re-built in the new western elevation. The remainder of the south elevation will remain unaltered.

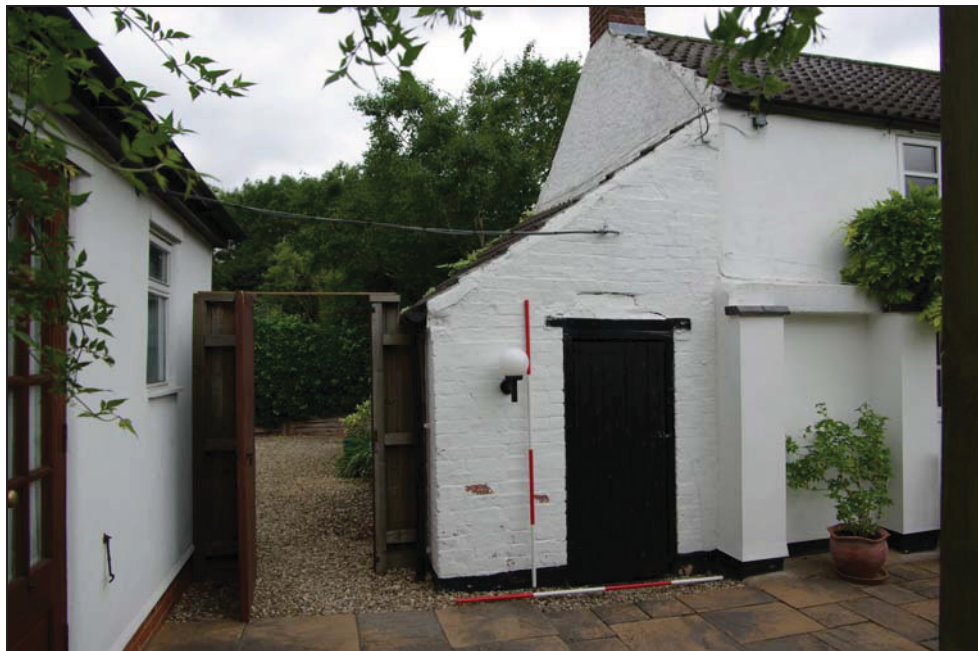
Plate 2 shows the south elevation of the outhouse. It is brick built in a Flemish bond (now painted). The outhouse door is constructed of tongue-and-groove timbers with a simple wrought iron door handle with thumb latch. The lintel is a simple squared timber. The disturbed brickwork above the lintel suggests this opening was a later addition. It is conceivable that this replaced a smaller window.

**Plate 2: South elevation of the 19th century lean-to that will be demolished.**

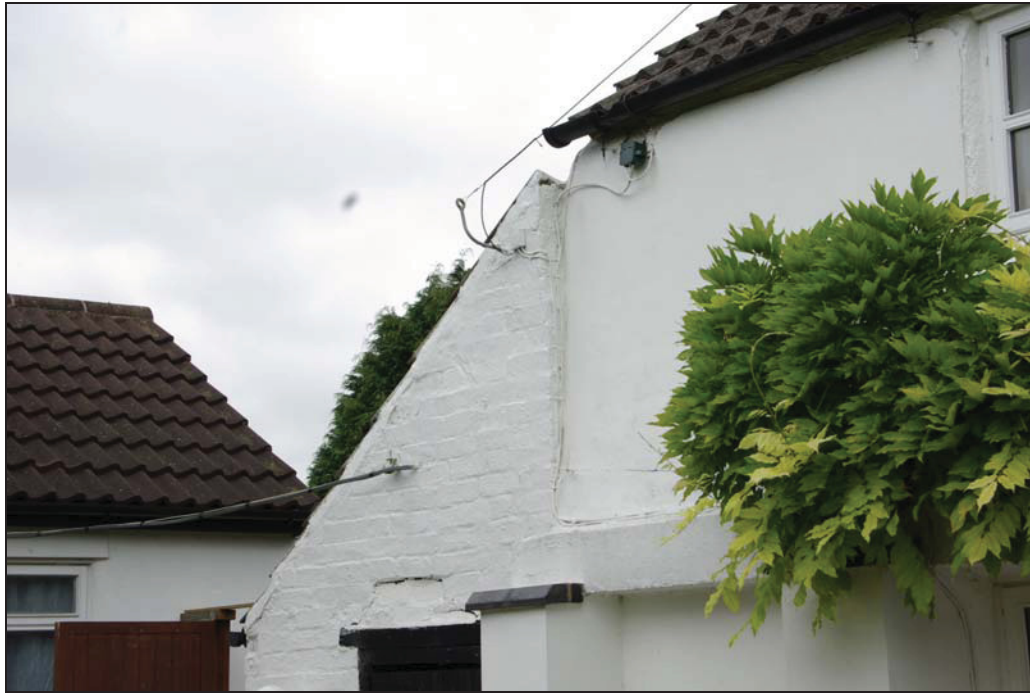
The outhouse was built up against the house with little attempt to blend the join (Plate 3). The cob wall narrows with height, while the brick wall continues straight up. The top of the outhouse therefore projects out from the main building.

**Plate 3:** The join between the brick 'lean-to' and cob walls of the original cottage.

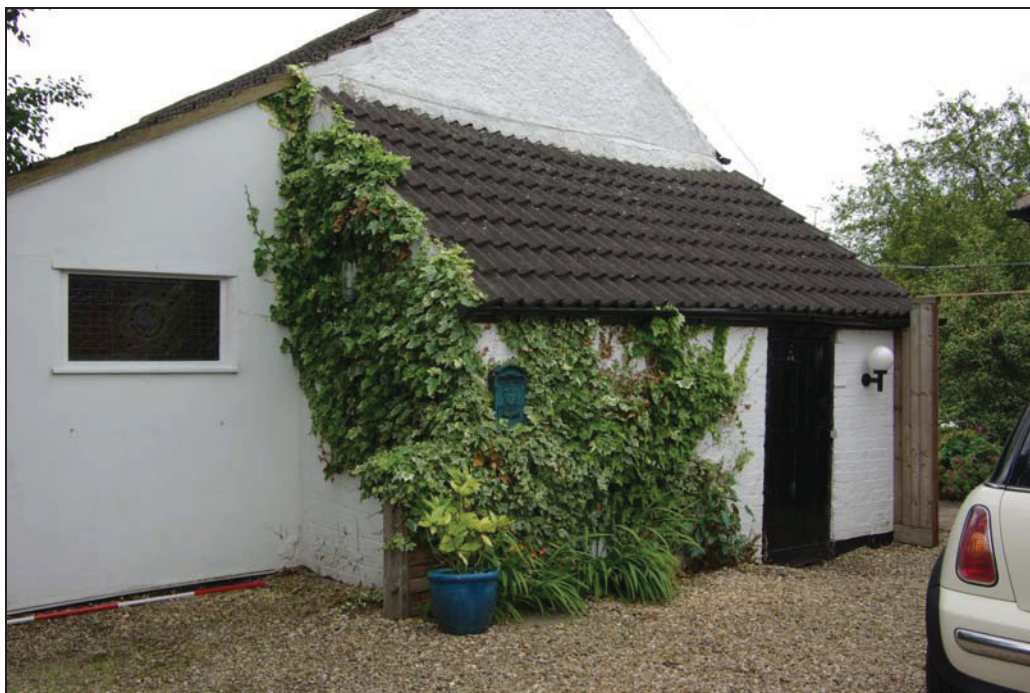
The existing western elevation (Plate 4). The outhouse has a wooden door similar to that on the southern elevation. Much of the brickwork is obscured by ivy.

**Plate 4:** The west elevation including the outhouse and the modern single storey extension to the rear of the property (left of the picture).

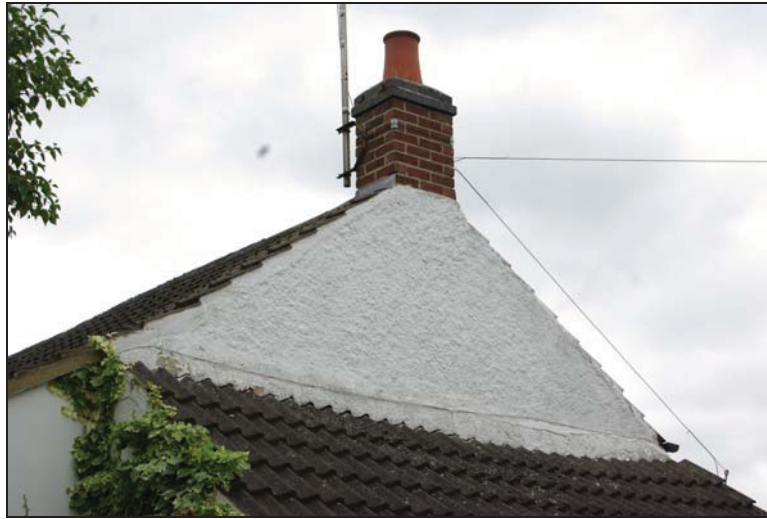
The roof rafters of the outhouse have been inserted into the cob wall. The upper portion of the gable end of the house is brick built. The whole has been rendered, so there is little visible architectural detail, but it is conceivable that the upper brick portion of the wall was added when the building was re-roofed.

**Plate 5: The top of the cob wall on the western elevation joining the upper brick segment gable wall, just above the roofline of the outhouse. The red brick chimney stack with modern pot were presumably added when the cottage was re-roofed with pan tiles.**

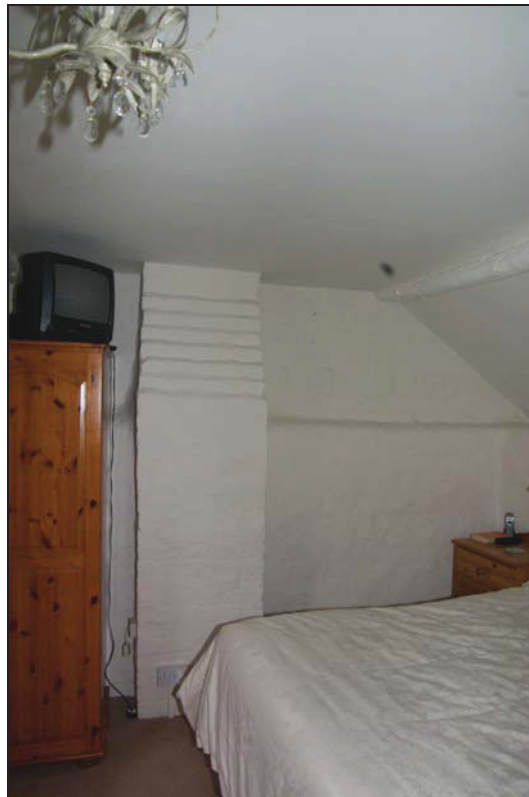
**Plate 6: Interior wall of the western elevation (bedroom 1), showing the cob wall joining the upper brick gable end of the house, and the brick chimney stack. Note the roof purlins are timbers kept 'in the round'.**

The interior of the western elevation (Plate 6) shows the brick chimney stack, the cob wall and the brick upper portion of the wall. A doorway will be inserted where the chimney currently lies.

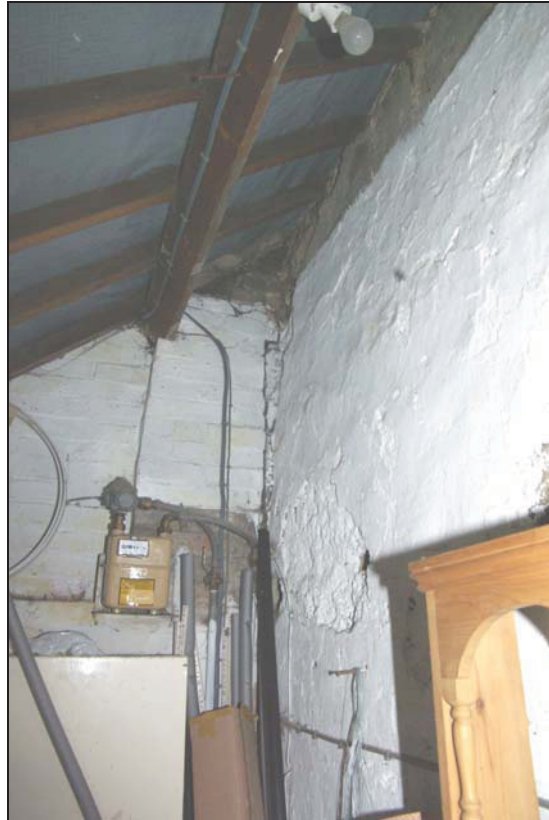
**Plate 7: The interior of the outhouse showing the rendered end of the cob wall (the exterior western elevation of the original cottage).**

Plate 7 shows the interior of the outhouse. Much of the lower portion of the cob wall will be removed to enlarge the existing lounge (Figure 2 & Figure 4).

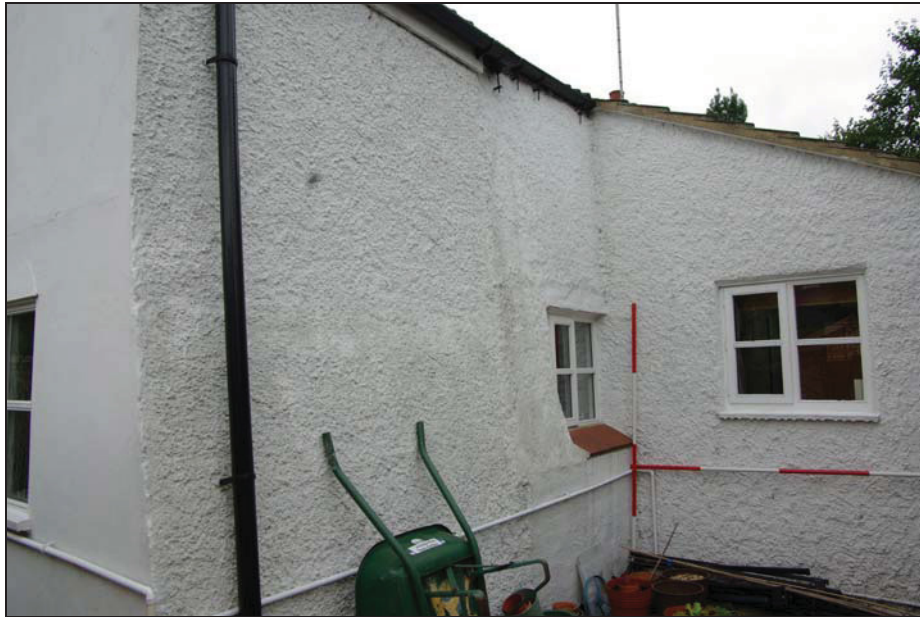
**Plate 8:** The north-east corner of the property showing the original cottage (centre) and extensions to the east (two-storey, left of picture) and north (single storey, right) elevations.

The single storey build seen on the right of Plate 8 is to be extended to encompass the full length of the northern elevation (see Figure 2 & Figure 4). The window seen to the right of the picture (Plate 8) will be enlarged to form a door opening. The window aperture in the original build (centre of the photograph) will remain unchanged.

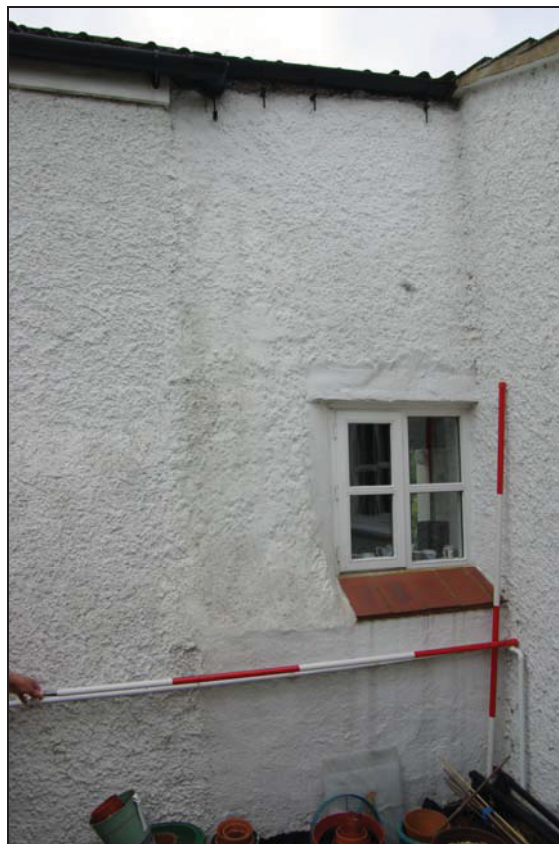
Plate 9 shows the join between the original cottage and the extension to the two-storey to the eastern elevation.

**Plate 9:** The original north wall of the cottage with replaced window joining the two-storey east elevation.
