**An Archaeological Watching Brief
At Carey's Close, Leicester
(NGR SK 5838 0438)**

**For
Askam Construction Ltd**

**ULAS Report Number 2009 – 120 Acc no A15.2008
©2009**

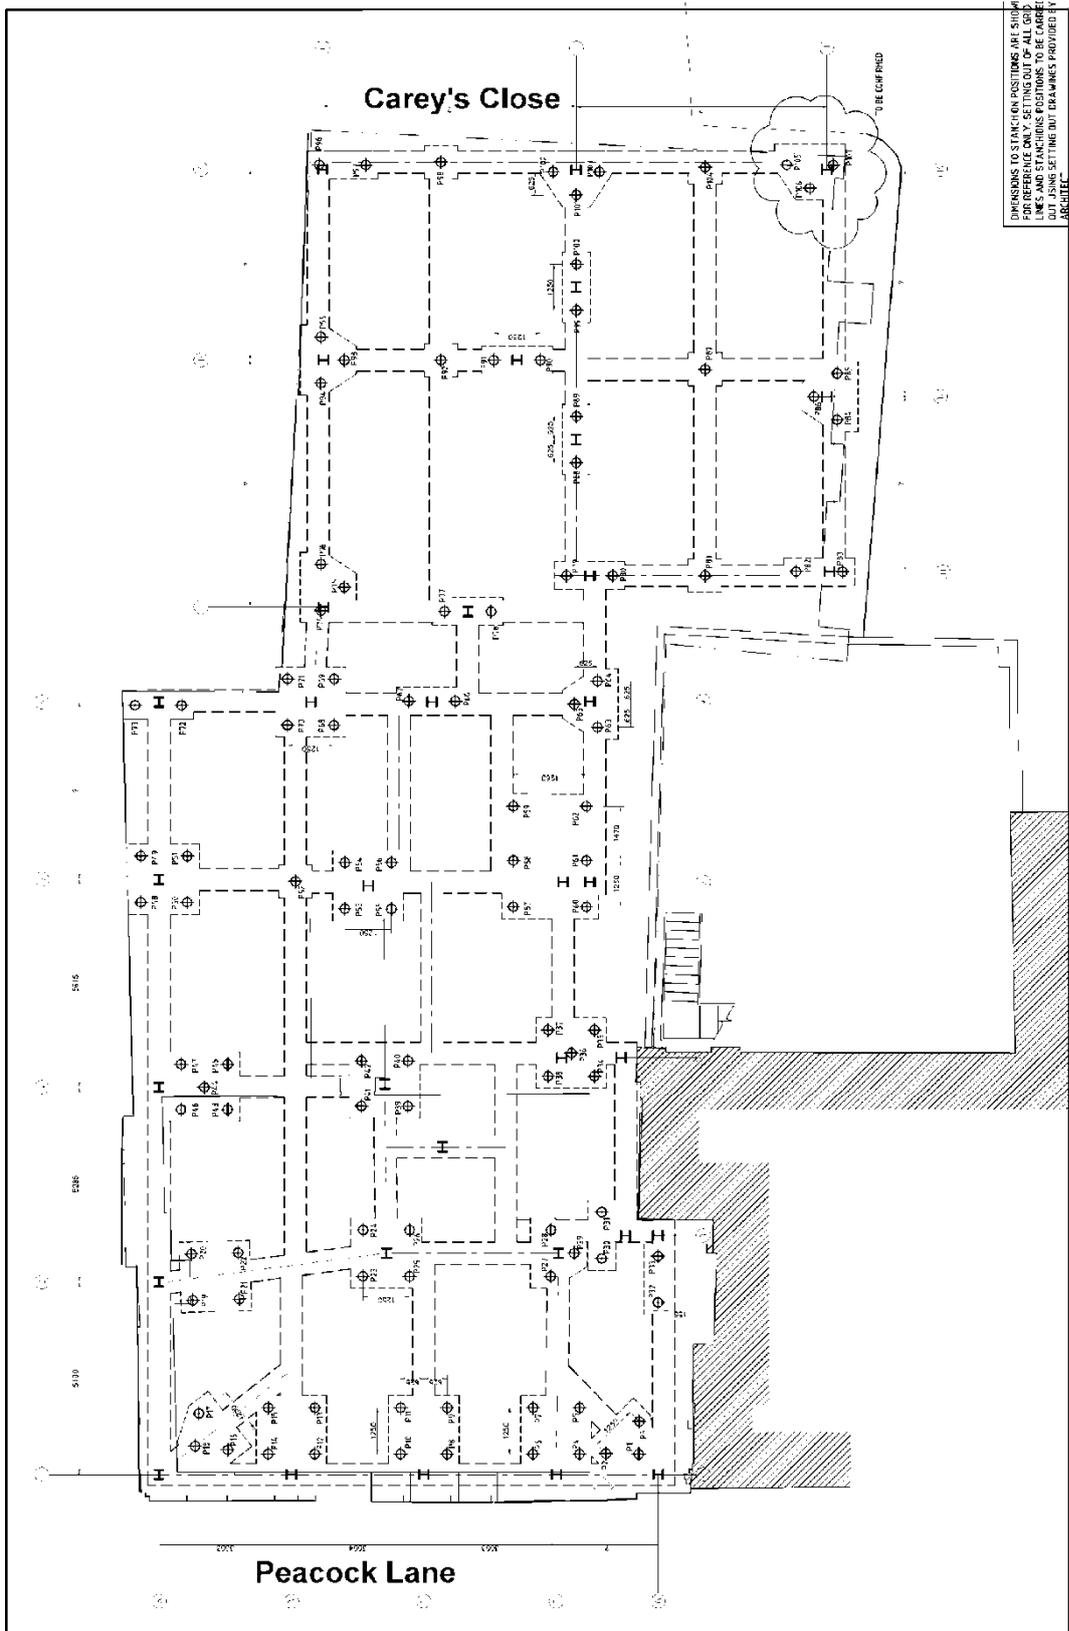
Figure 3 - The Pile plan at roughly 1:100. From plan supplied by Askam Construction Ltd

The piled foundations were designed to have a minimal impact upon buried archaeological remains. Given the depth of the presumed modern disturbance, the pile caps and ground beams were designed to sit within this deposit. Thus, the ground beam soffits were designed to go no further than 600mm below ground level and the pile cap soffits were around 1100mm below this level.

The piling scheme itself was partly designed to have minimal impact upon any buried archaeological remains. Rather than use Continuous Flight Augered piles, driven steel tubular piles were used. The locations were pre-augered to ensure that the piles would not encounter obstructions and the piles could be re-located if necessary. The other effect of the pre-augering appears to be to minimise any lateral distortion of the surrounding deposits during to pile driving (Williams, Sidell and Panter 2007, 17). A smaller number of widely spaced piles was used at the north of the site, where the evaluation had indicated better archaeological survival. This removed the need for deep pile caps and any consequent disturbance.

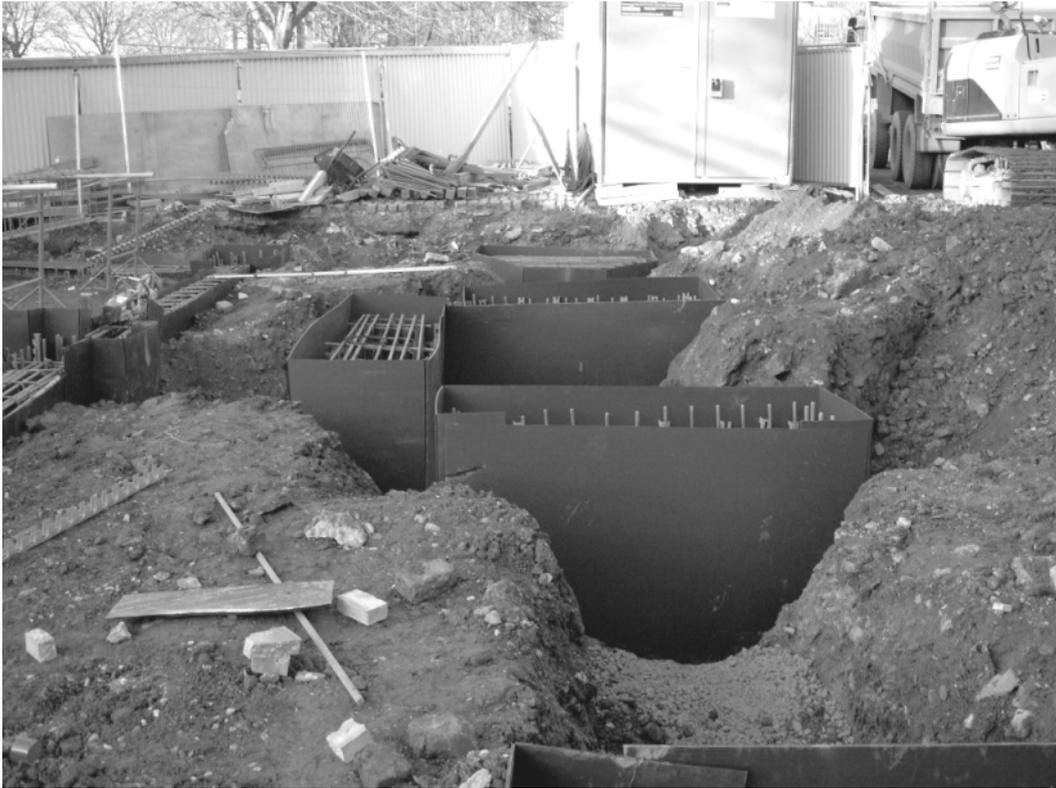
Figure 4 - The lift pit partly constructed, looking north

As well as the system of pile caps and ground beams the other potential impact was from the lift pit. This was dug to a depth of *c.*2000mm below the ground level. As this was dug through loosely compacted sandy soils this could not be closely investigated.

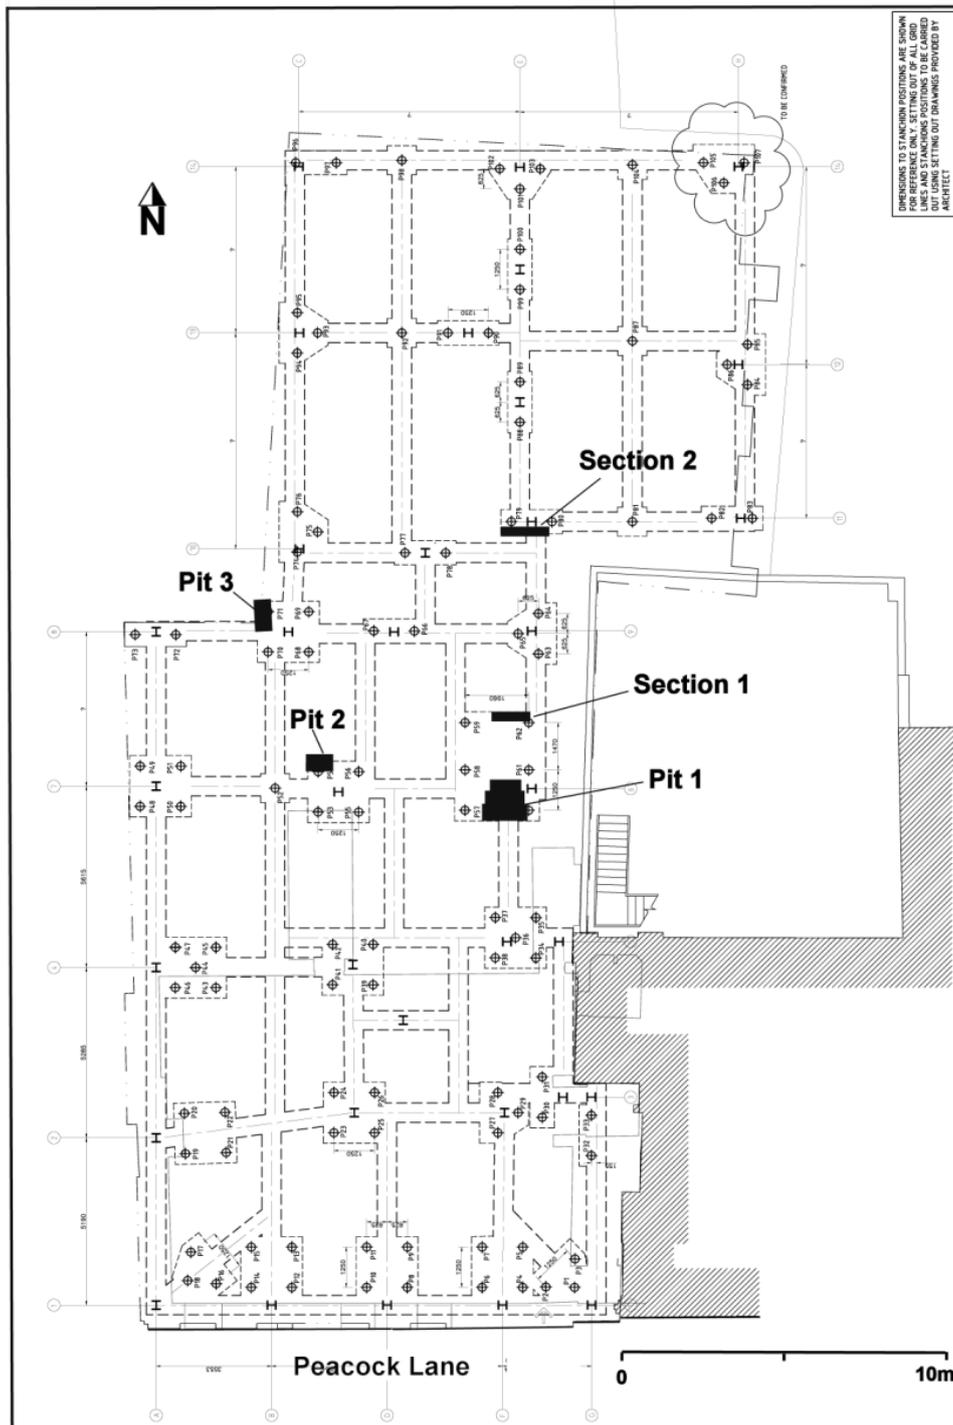
Figure 6 - The Location of Archaeological Deposits (from plan supplied by Askam Construction Ltd)

At three locations, separate pits or their fills could be distinguished (Figure 6). In the northernmost of these (Figure 7, Figure 8), a roughly bowl shaped, deposit of sandy gravel with cobbles and slates could be seen (2). Over this was a mid brown sandy silt (1). The deposits below this appeared very similar to the 'garden soils'. It is likely that this represents a surface of medieval or post-medieval date slumping down into the top of an earlier pit [8] (Figure 8 Section 2). These gravels were not seen anywhere else on site and were presumably truncated away during later phases of building work on site.

The other two pits (Figure 6 pits 2&3, Figure 9, Figure 10) both comprised reddish clay over the top of charcoal and ash deposits within the pits [21] [28]. The pits continued down below the ash but this was below 'dig level' and so could not be investigated. Both pits contained considerable quantities of sheep metapodials, mainly within the ash deposits, a small sample was taken for identification. During the excavation of the lift pit, a further concentration was visible although the pit edges could not be seen (Figure 6, Pit1)

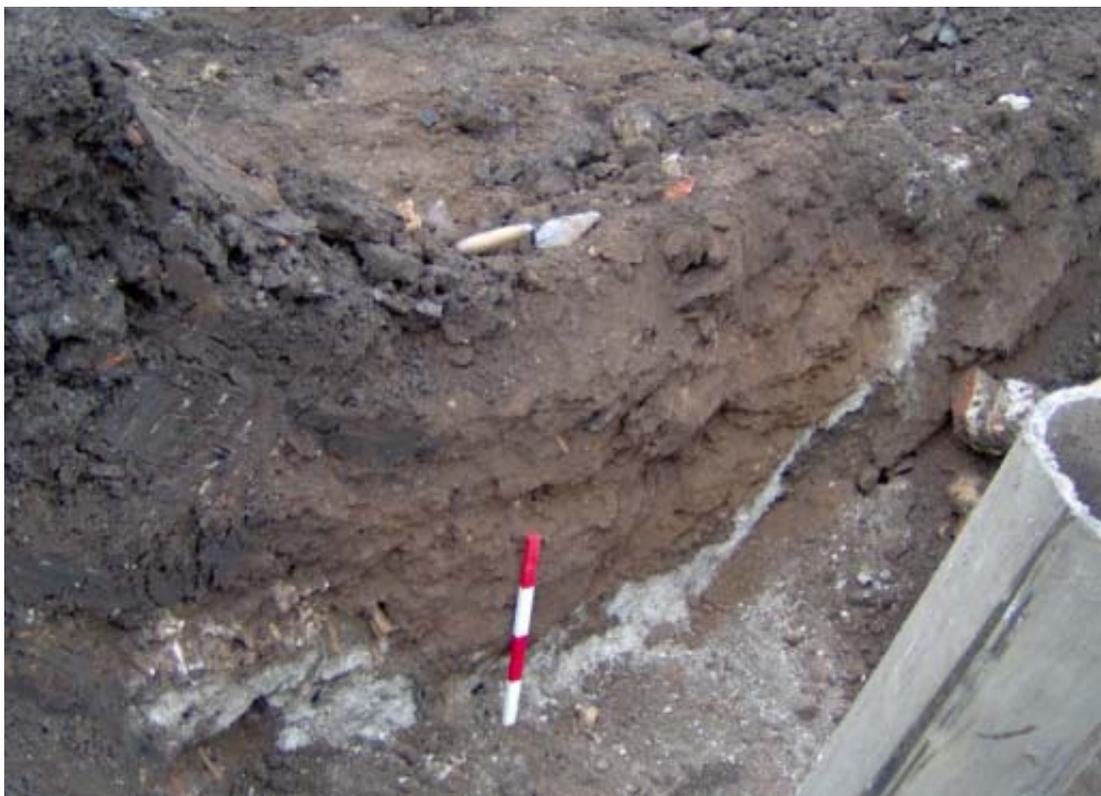
Figure 9 - Pit 3 showing ash and bone (20) in cut [21], looking west

It is likely that these deposits represent the remnants of the working of sheep hides.

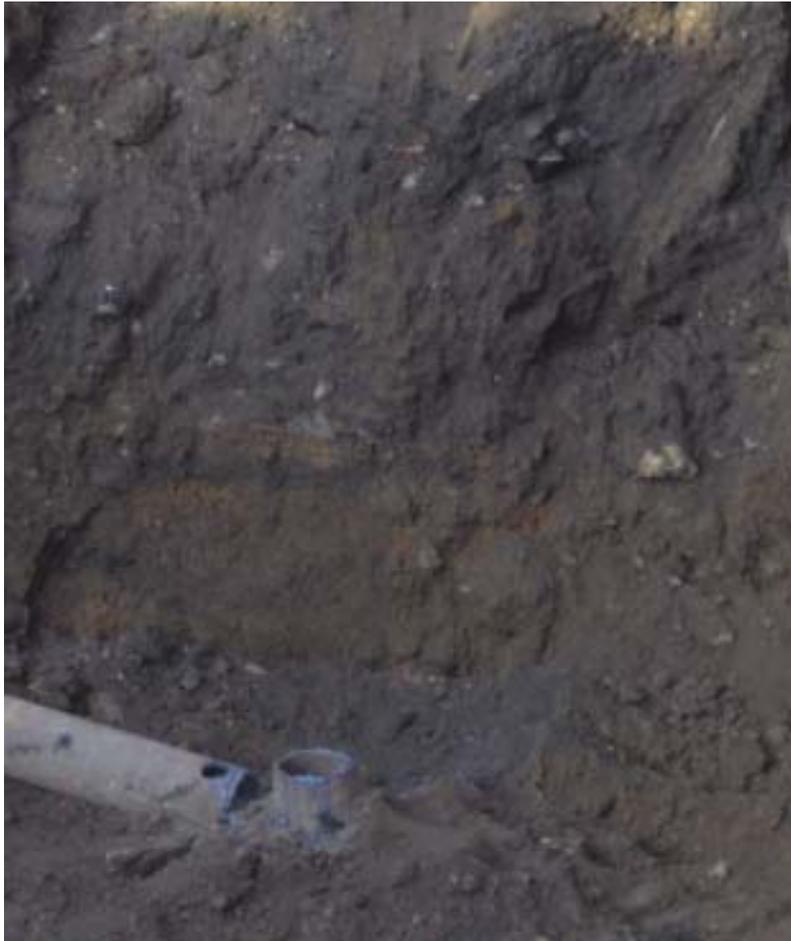
Figure 11 - Possible Roman Deposit (11) at base of lift shaft, looking north

The deepest excavations were carried out for the lift pit (Figure 11, Figure 12). This went down to a depth of *c.*2m from ground level. Although probably Roman deposits were encountered these could not be investigated closely due to safety considerations. However, inspection of the sections and of the spoil, indicated that the deposits consisted of light brown sandy silt layers (11). No evidence of stone-built walls was seen nor were any floor levels observed. Thus it seems that there were no structural remains disturbed during the excavation of the lift pit.
