**An Archaeological Watching Brief
at St Nicholas Place, Leicester
(NGR SK 583 044)**

**For
Leicester City Council**

**ULAS Report Number 2009 – 128 Acc no A9.2009
©2009**

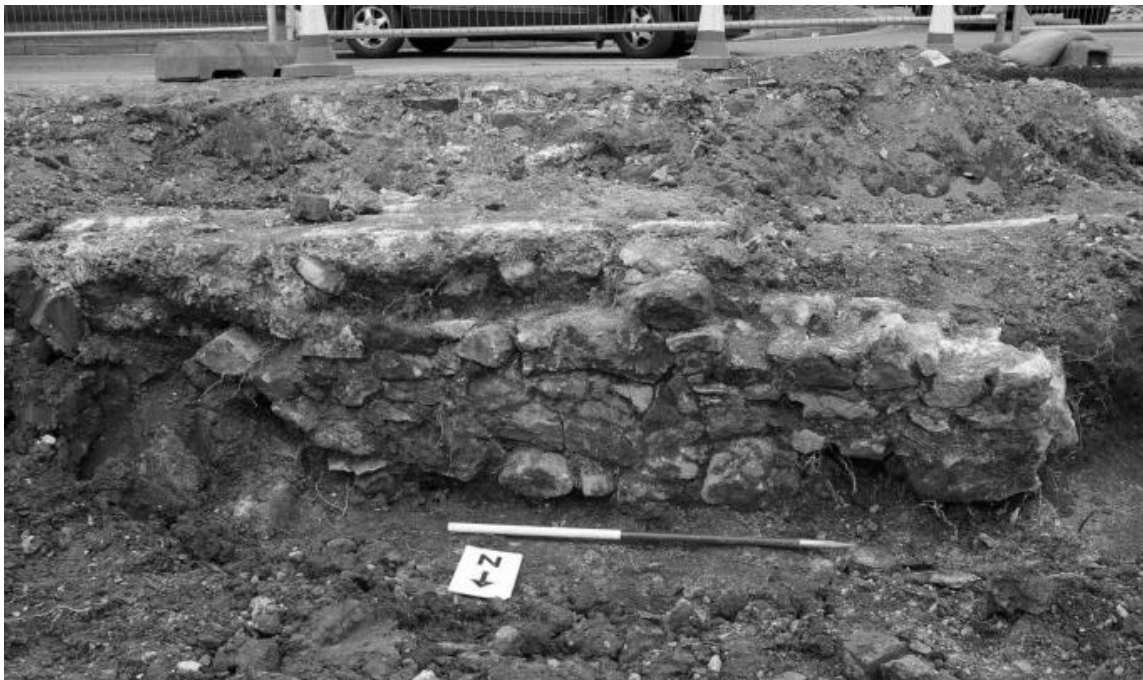
Figure 5 - Wall 1, looking south

The excavation of the phase 1 roadway revealed three fragments of walling (Walls 1-3). Wall 1 (context 3) measured 2.60m length and 0.35m wide and survived to 0.60m in height. This was aligned roughly east-west on Carey's Close (the former Redcross Street). It was built of coursed granite rubble with Swithland slate levelling and bonded with a light yellow brown sandy lime mortar.

The wall was located against the edge of site but on the south of the wall was a mid greenish 'garden soil' and on the north were late, probably Victorian soils. The base of the wall was not exposed.

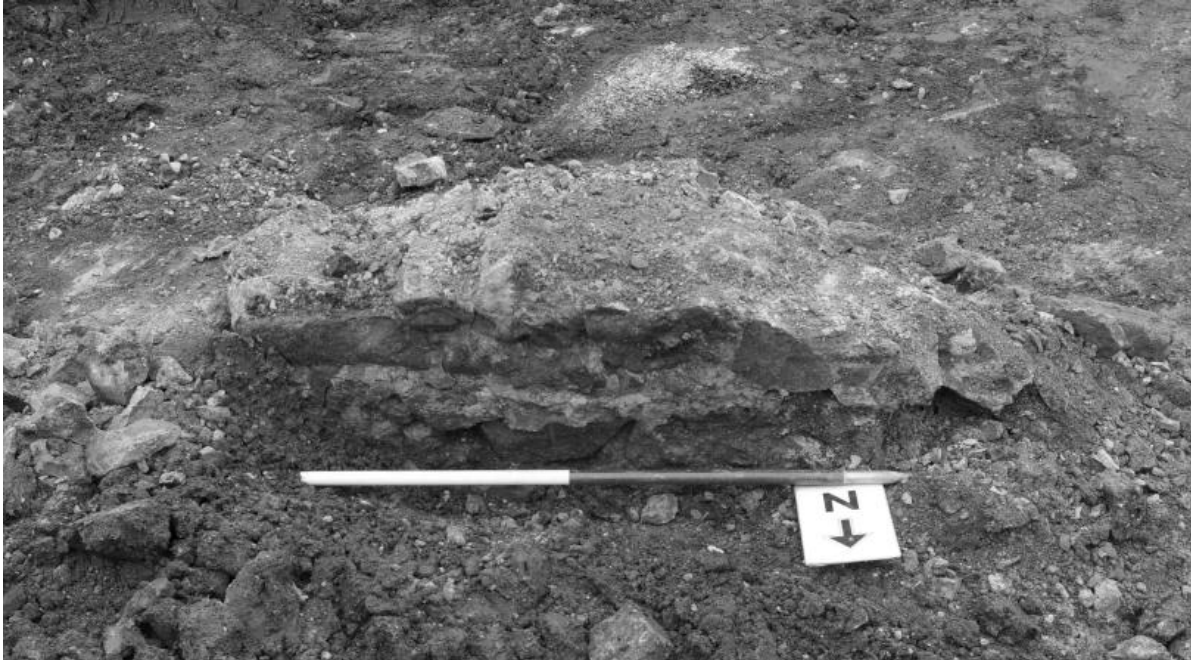
Figure 7 - Wall 2, looking south

Wall 2 (context 4) was a short fragment of coursed granite rubble however this was bonded in a hard grey mortar, probably gypsum containing charcoal fragments. However, this again

was merely the top of a wall, the rest of the wall going below Reduced Level Dig. This was on the same alignment as Wall 1.

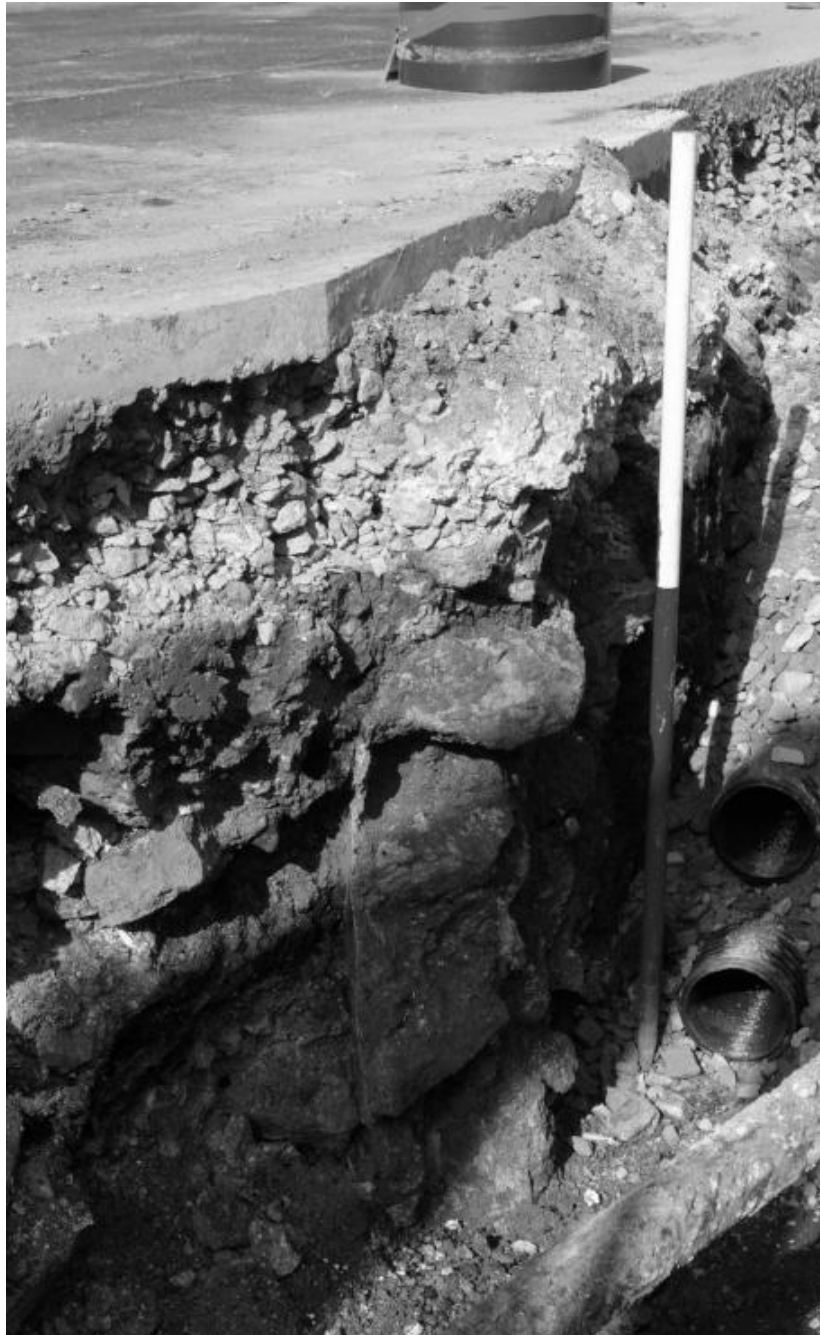
Figure 9 - Stone Built cellar, (Wall 4) with vertical plaster strip visible, looking south-west

However by the cable jointing bay, part of a stone built cellar (wall 4, context 8) was observed. Only a short fragment was visible due to later truncation. A 0.50m high fragment of walling survived, constructed of granite and Dane Hills sandstone, bonded with mid-red sandy silt with charcoal fragments. This was built against a dark grey brown silty clay soil (context 10) to the west. To the east the wall had a white washed internal face (context 9). The infill of the cellar was composed of brick rubble, mortar and ceiling plaster with lath impressions (context 11), presumably deriving from the superstructure.

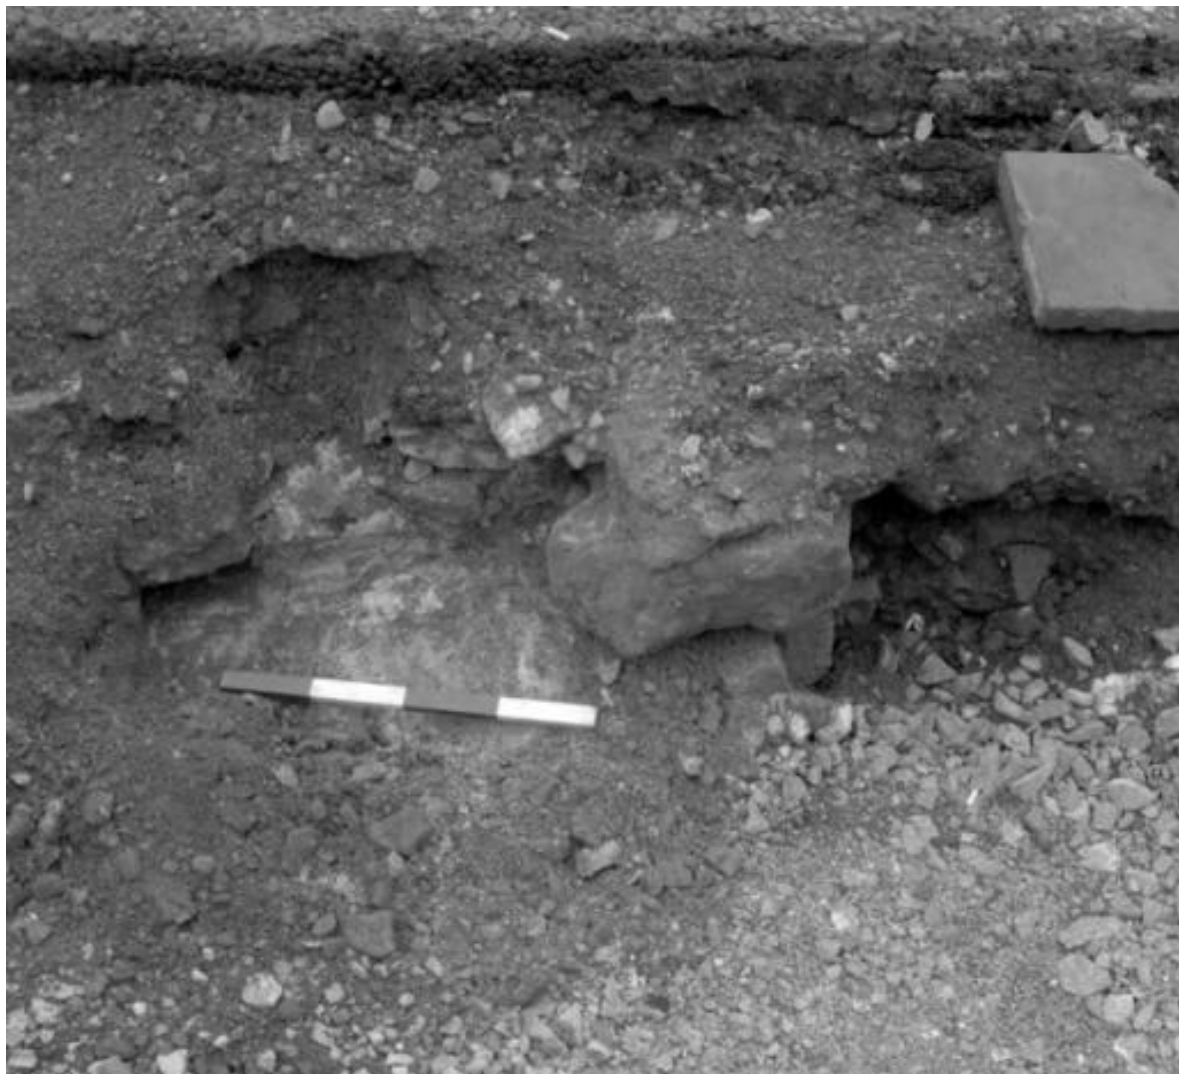
Figure 4 - Wall 5, looking west

A final observation was made during the re-laying of the kerbing. A continuous watching brief was not maintained over this due to the very shallow depth of the excavations (300m). On the east side of the site, the top of a stone-built wall (wall 5, context 12) was revealed. This was constructed of granite and Dane Hills sandstone in a light yellow brown sandy mortar. There was some brickwork adjoining the stone fragment indicating either re-use or survival into the post-medieval or modern period.

Wall 5 may be a continuation of one of the walls associated with the Golden Lion public House, the former 30, Highcross Street, again recorded on Goad Insurance Plans and the OS 1st edition map (Figure 11). This was one of a series of properties including the public house, three dwellings, a shop and a building associated with a saw mill (Meek 2000, 19).¹

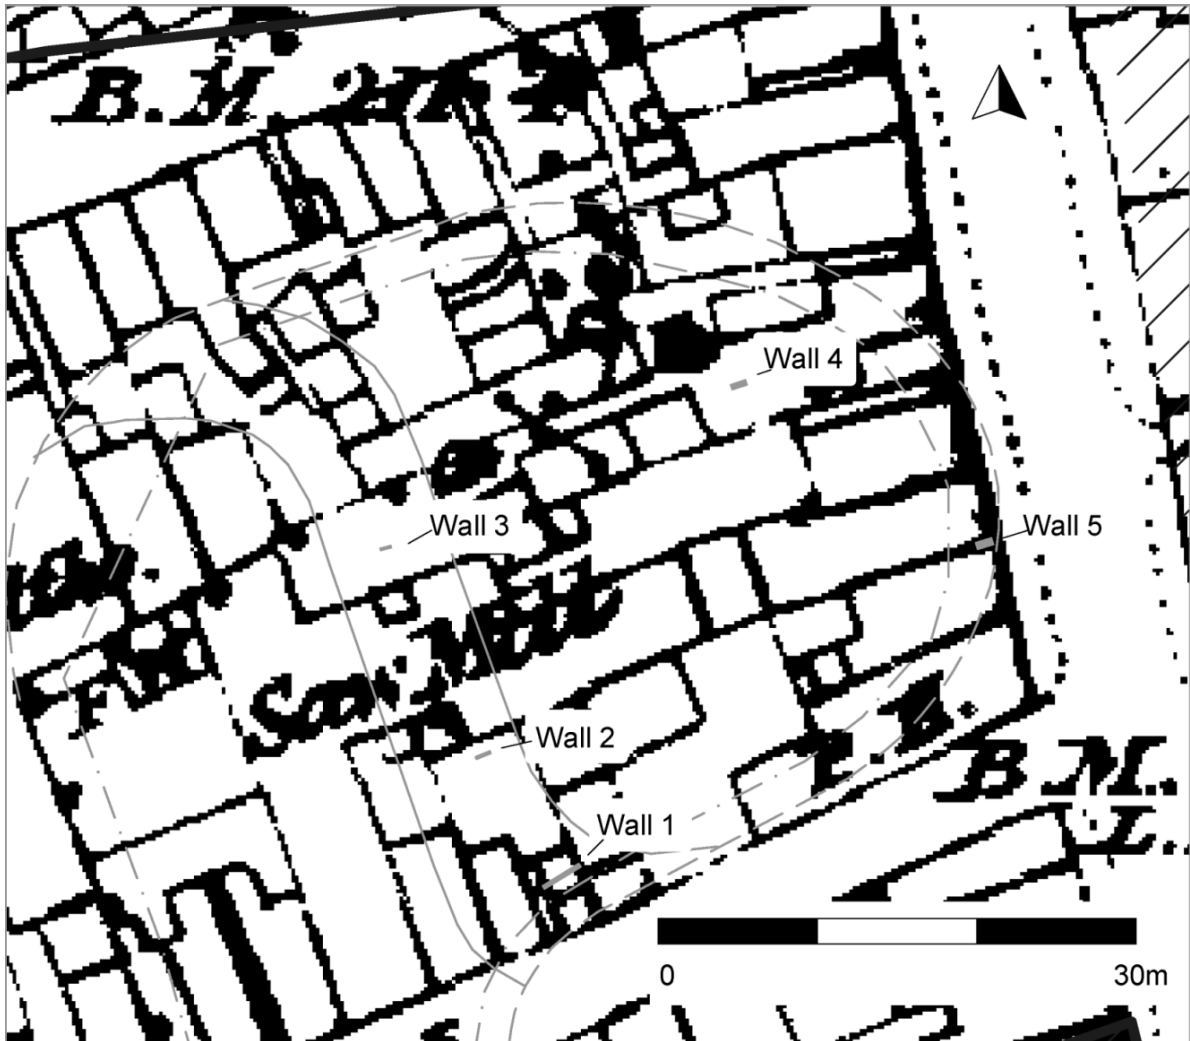
Figure 5 – Location of Walls 1-5 overlaid on 1st edition OS map.

Other walls observed were on the same alignment as walls recorded on the Ordnance survey 1st edition map (Figure 11) and, bearing in the mind the accuracy of that map, Walls 1 and 2 may be represented on the map. Walls 3 and 4 in contrast are likely to be earlier as they show no close correspondence with those on the map. Wall 4 formed part of a cellar and is likely to be of 18th century or earlier date. Of note is the alignment of walls 4 and 5 with other structures located during the earlier evaluation at St Nicholas Place (Figure 12; Meek 2000). Wall 4 is almost certainly the continuation of a parish boundary wall located in trench 3 of the evaluation (Meek 2000, 22). This is recorded on the Goad Insurance Plans (1923) and OS 1st edition.
