**An Archaeological Watching Brief
At Sapcote Playing Fields,
Hinckley Road, Leicestershire
NGR: SP 487 934 centre, Scheduled
Ancient Monument 17036**

ULAS Report No 2010-019
©2010

**An Archaeological Watching Brief
At Sapcote Playing Fields, Hinckley Road
Leicestershire**

For: Sapcote Parish Council

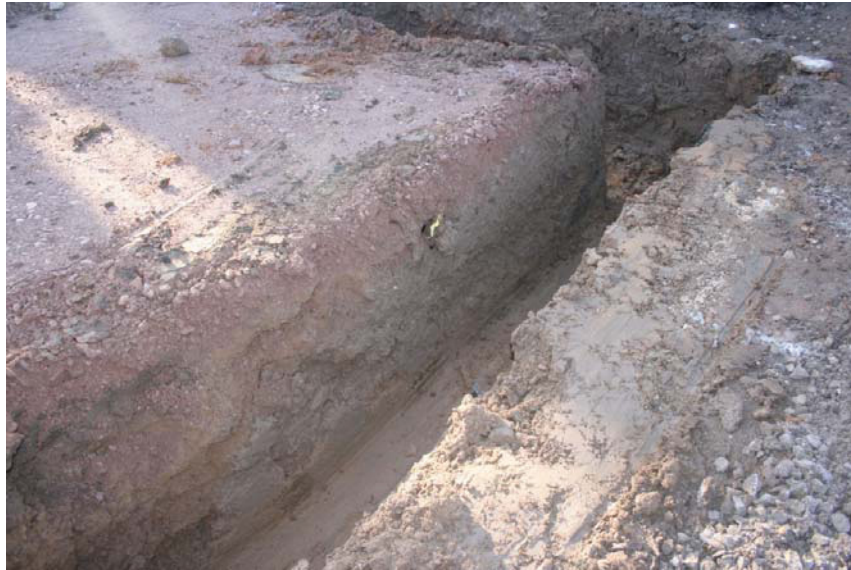
Figure 6: Feature 1 in section looking S/E.

Feature 1 was a large rounded, rectangular-shaped cut in the south-west corner of the stripped area. The full size or shape of this feature remains unknown but it was assumed to have continued running south-westward. The exposed length measured 5.37m long and 2.43m wide and was excavated to a depth of 1.00m (Fig. 6). This feature contained pale-grey silty clay that had obviously been subject to very damp conditions, suggesting it may have been water filled at one time. No datable evidence was found within this feature. Feature 1 was thought to be perhaps an early cut of the moat or possibly a pond.

Feature 1 was thought to be possibly an early cut for the moat that was allowed to silt up, and was then subsequently re-cut by Feature 2. However this feature had a slightly different alignment to the later feature and appears to extend south-westward. Similar extensions or appendages linked to the moat had been recorded on the earthwork plan of 1958, and are thought to be medieval fish ponds; this feature could be something similar.

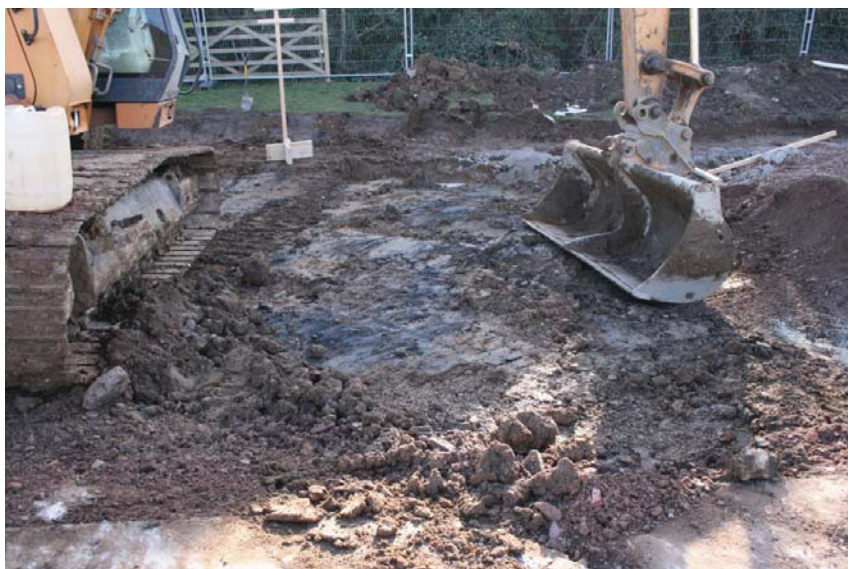
Figure 7: The dark fill of Feature 2.

Towards the northern half of the stripped area at a depth of *c.* 0.30m below ground level, a large linear feature was recorded orientated east–west (Fig. 5; Feature 2). Feature 2 measured 7.60m wide at its eastern extent widening to 8.70m to the west. Sections across the feature were exposed during the cutting of foundations suggesting a broad, gradual, sloping ditch with a rounded base measuring 1.65m deep at its eastern extent and 1.70 m on the western side. The fill comprised a very dark-grey silty clay, and again had been subject to very damp conditions, suggesting it may have been water-filled at one time (Figs 7 and 8). The only dating evidence seen within this feature (at a depth of 0.55m) was a fragment of wood which appeared to be part of a modern roofing lath.

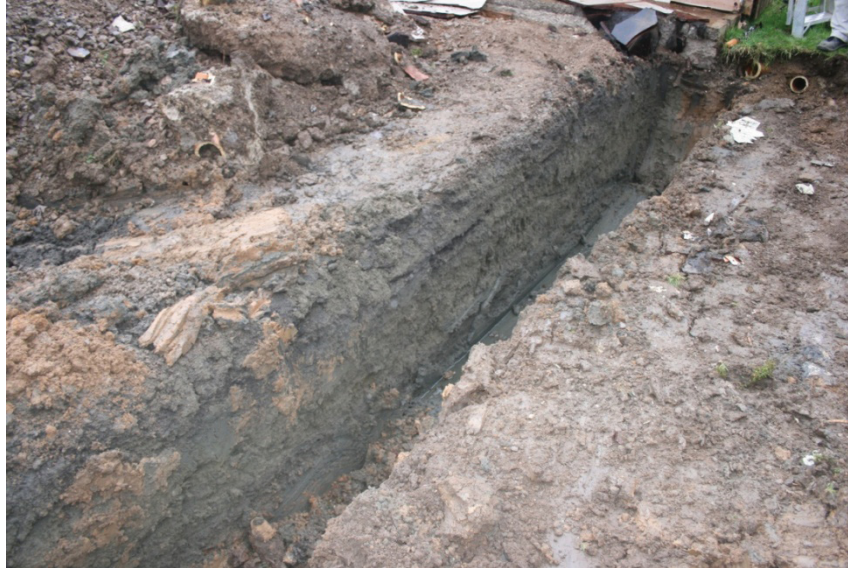
Figure 8: East facing section of Feature 2.

The north-eastern side of the feature appeared to be truncated by modern deposits. This was noted when the eastern foundation collapsed exposing re-deposited natural yellowish-brown sands and clay within a vertical cut (Fig. 9). This modern cut is thought to be associated with the backfill of either a modern service trench or an archaeological evaluation trench excavated in 1998 (Higgins 1998). Both trenches were located on the eastern side of the old pavilion running north-south across the moat.

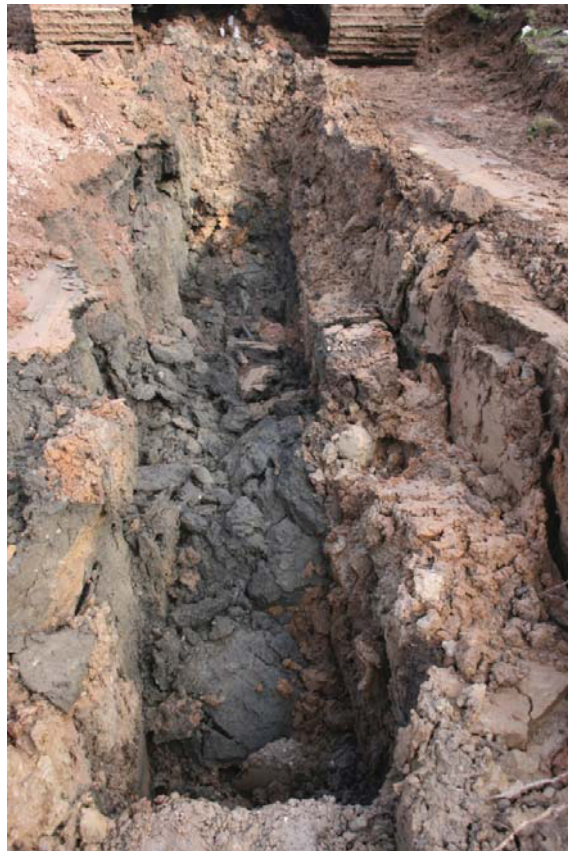
Figure 9: The collapse of Feature 2, revealing an early service or evaluation trench.
