## ARCHAEOLOGICAL WORKS AT LIBERTON HOUSE, EDINBURGH

Watching Brief and HBR

*for Groves Raines Architects  
on behalf of Jonathan & Kelly Foley*

10/00185/FUL

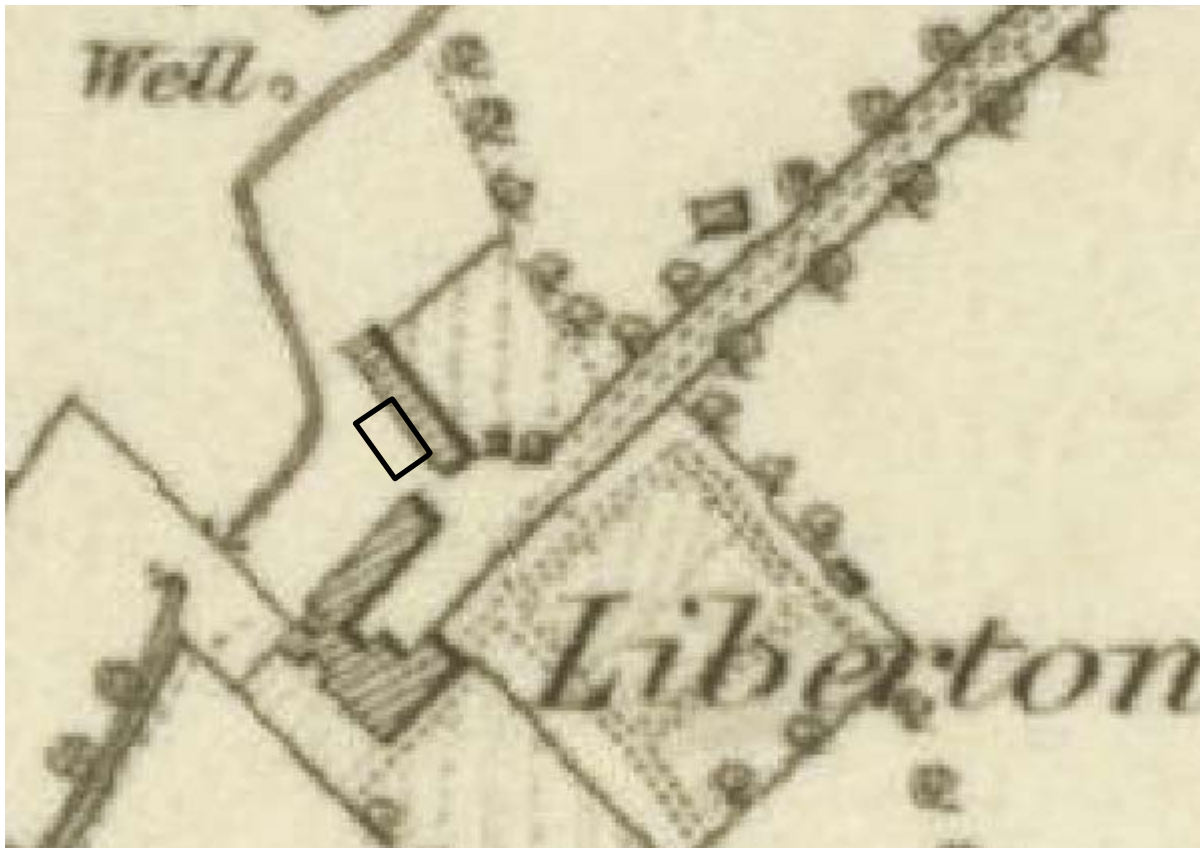
**Illus 3**

Extract from the 1856 1st edition Ordnance Survey  
Reproduced by permission of the Trustees of the National Library of Scotland

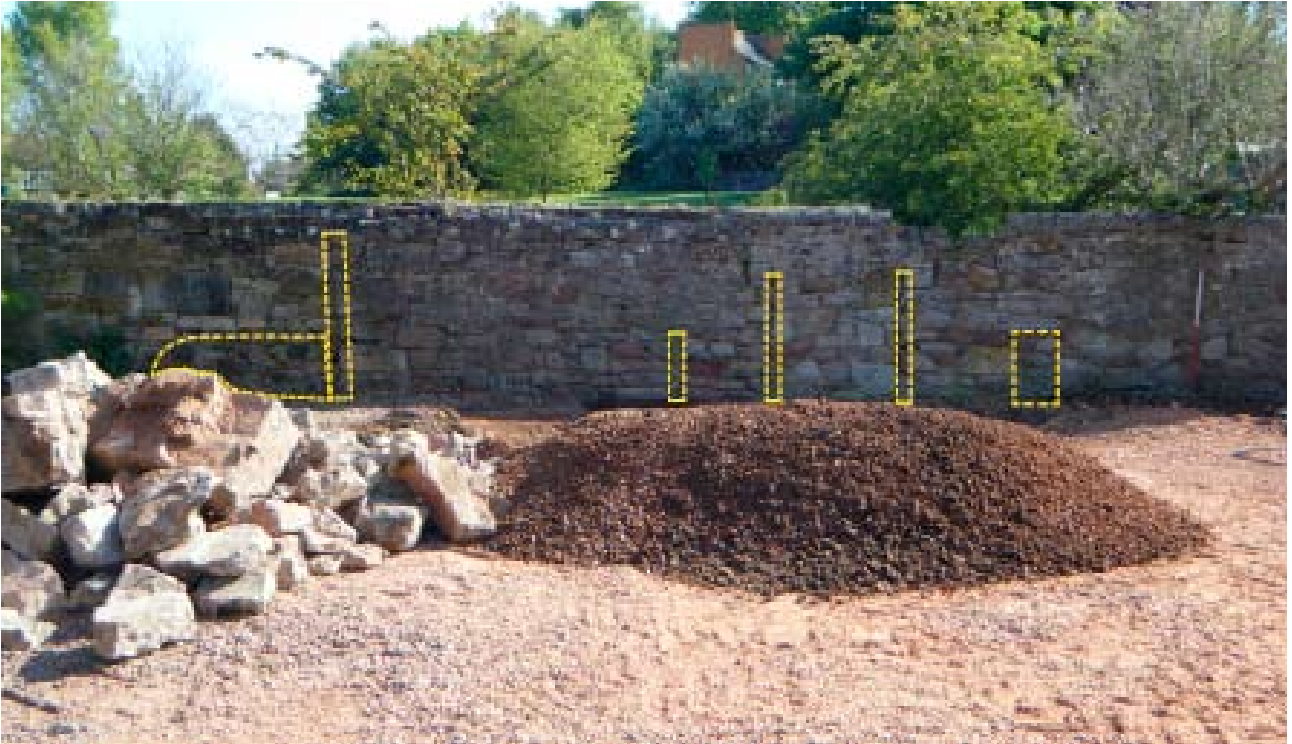
**Illus 4**

View of the development area showing the SW facing elevation of the wall  
(from left to right: F5, F1, F4, F3, F3, F2)

An area measuring 8 x 5m aligned NW-SE positioned along the SW facing elevation of an existing stone wall (Illus 4) was cleared of modern overburden comprising a

The remains of a NW-SE aligned rubble stone wall were recorded along the north-eastern limits of the development area (see Illus 2 & 4). The wall was 15m long, 0.37m thick and upstanding to a maximum height of 1.8m above contemporary ground level. The wall was in a reasonable condition with the exception of a small section of the NE facing elevation that had recently collapsed. It was constructed of rubble stone throughout with a cement

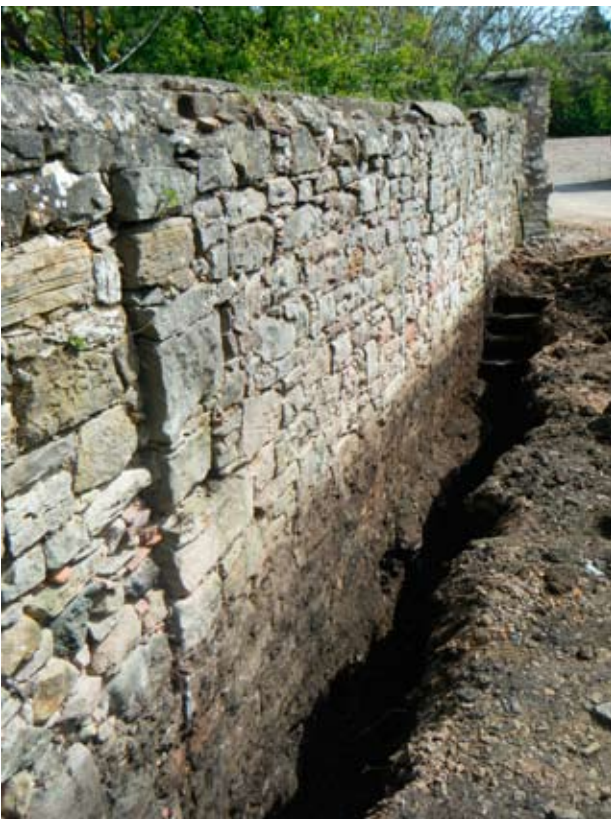
**Illus 5**

Detail of Trench 1 along the upstanding wall facing SE

shallow layer of gravel. Following this a foundation trench (Trench 1) 8m long and 0.6m wide was excavated along the SW facing elevation of the existing stone wall (Illus 5) that formed the north-eastern limits of the development area. The trench was excavated to a maximum depth of 1.6m revealing the wall foundation and natural geological deposits of alluvial clay. Two distinct layers of material were revealed within the trench section. The upper layer comprised between 0.1m to 0.25m of compacted sand and rubble. Below this was a 1.5m thick layer of re-deposited grey/black loam mixed with occasional ash deposits. A significant quantity of frogged bricks, 19th/20th century ceramic fragments and discarded bottles (including one with a date stamp of 1910) were recovered from this layer, particularly at the NW end of the trench. This material was interpreted as a modern waste dump. At the base of the trench was a tile drain above pale yellow clay, interpreted as a natural geological deposit. No old ground surfaces or garden soils were encountered.

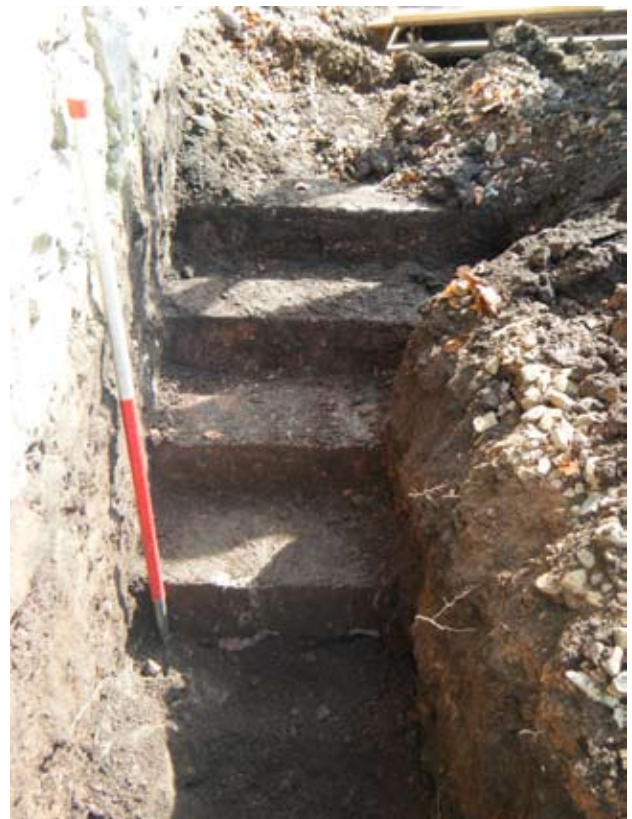
**Illus 6**

Detail of stone steps at the SE end of Trench 1

At the SE end of Trench 1 was a set of stone steps (Illus 6) abutting the stone wall. It was not clear how these steps related to the wall or what date they represented as no floor level or surface was recorded at the base of the steps. The steps were probably later in date than the wall as they were clearly machine cut stone and were not keyed into the wall.

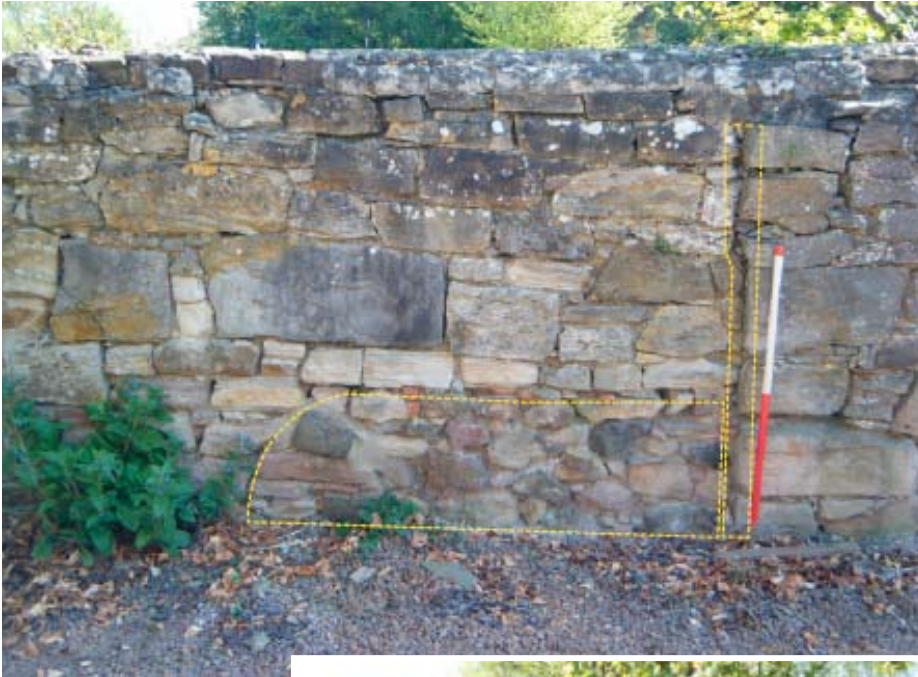
**Illus 7**  
SW facing elevation of the wall showing F5 (left) and F1 (right)

The main feature of the SW facing elevation was a possible phase/construction line. This was represented by a vertical construction line (F1) (Illus 7) 6.5m from the NW end of the wall. This line continued to the foundation stones 1.3m below the contemporary surface level. The stonework immediately to the SE side of this line (large roughly cut stones forming basic quoins) projected slightly from the remainder of the wall to the NW (see Illus 4). This seemed to indicate that this was the W corner of the original building. This was further confirmed by a section of smaller rounded rubble stones (F6) recorded on the NE facing elevation (Illus 8). This section (F6) probably

On the supposed later section of wall to the NW a small area of the wall comprised of smaller rounded rubble stone (see Illus 7) with a cement bond (F5). This was also visible on the NW facing elevation (see Illus 8). This was topped by a course of larger squared stones. This feature may represent a slightly earlier phase of construction for the lower part of the wall although the construction lines were not very clear and it may be that the wall above this had been repaired more recently.

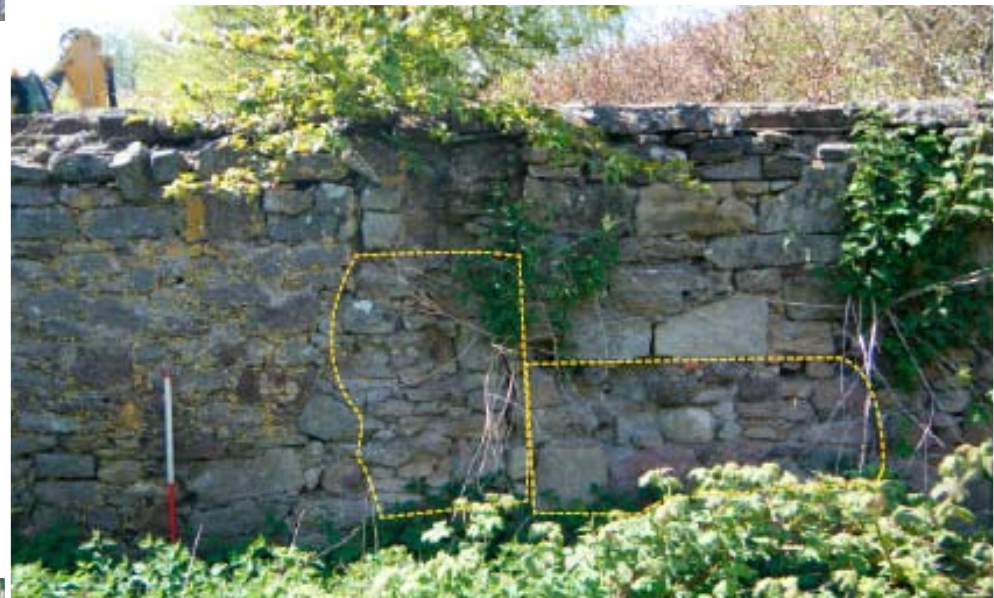
**Illus 8**  
NE facing elevation showing F6 (left) and F5 (right)

represented the remains of the return wall that would have continued from the W corner of the original building. Assuming this interpretation is correct would therefore suggest that the NW end of the wall is a later phase.

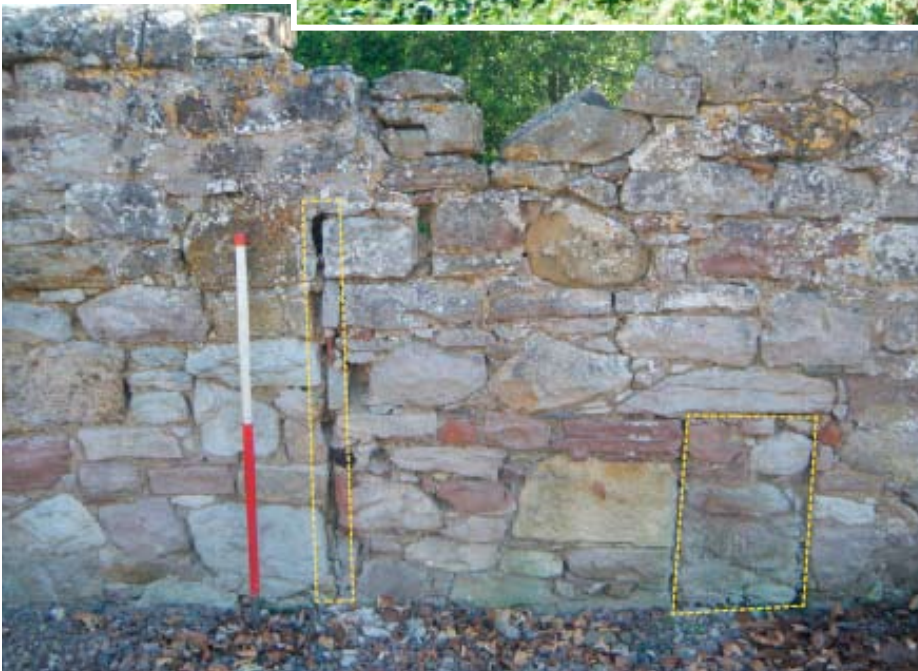
**Illus 9**  
Detail of F2 (right) and F3 (left) on the SW facing elevation

The SW facing elevation of the supposed earlier section of wall also included three further features of note. The first of these (F2) was a small rectangular shaped series of narrow slots in the wall (Illus 9). This may have represented a small stone-blocked window, although the surrounding rubble wall showed no indication of a distinct stone surround or lintel. The slots of this feature may have been more indicative of an external feature built into the wall such as a drain hopper. Two further vertical slots (F3) (Illus 10) immediately to the NW were initially thought to be evidence of a blocked doorway but again no surround stones or lintel were evident. These may instead have represented slots for an external timber feature such as a lean-to. Both these features were only recorded to the contemporary ground level and unlike F1 did not continue to the foundation stones at the base of the wall. Given this, it may indicate that these two features (F2 and F3) represent later features inserted into the wall once the contemporary ground surface has been instated. A further feature recorded on this section of wall

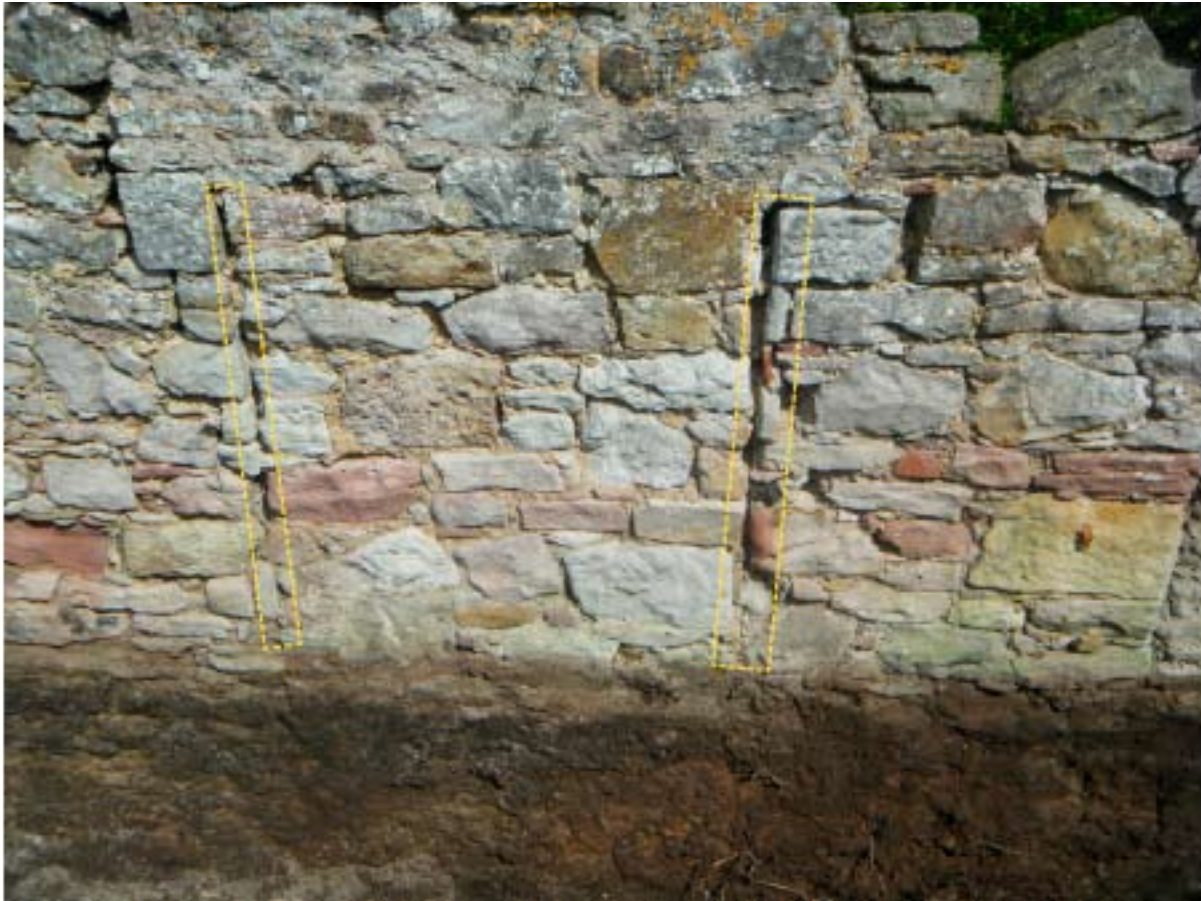
**Illus 10**

Detail of F3 on the SW facing elevation

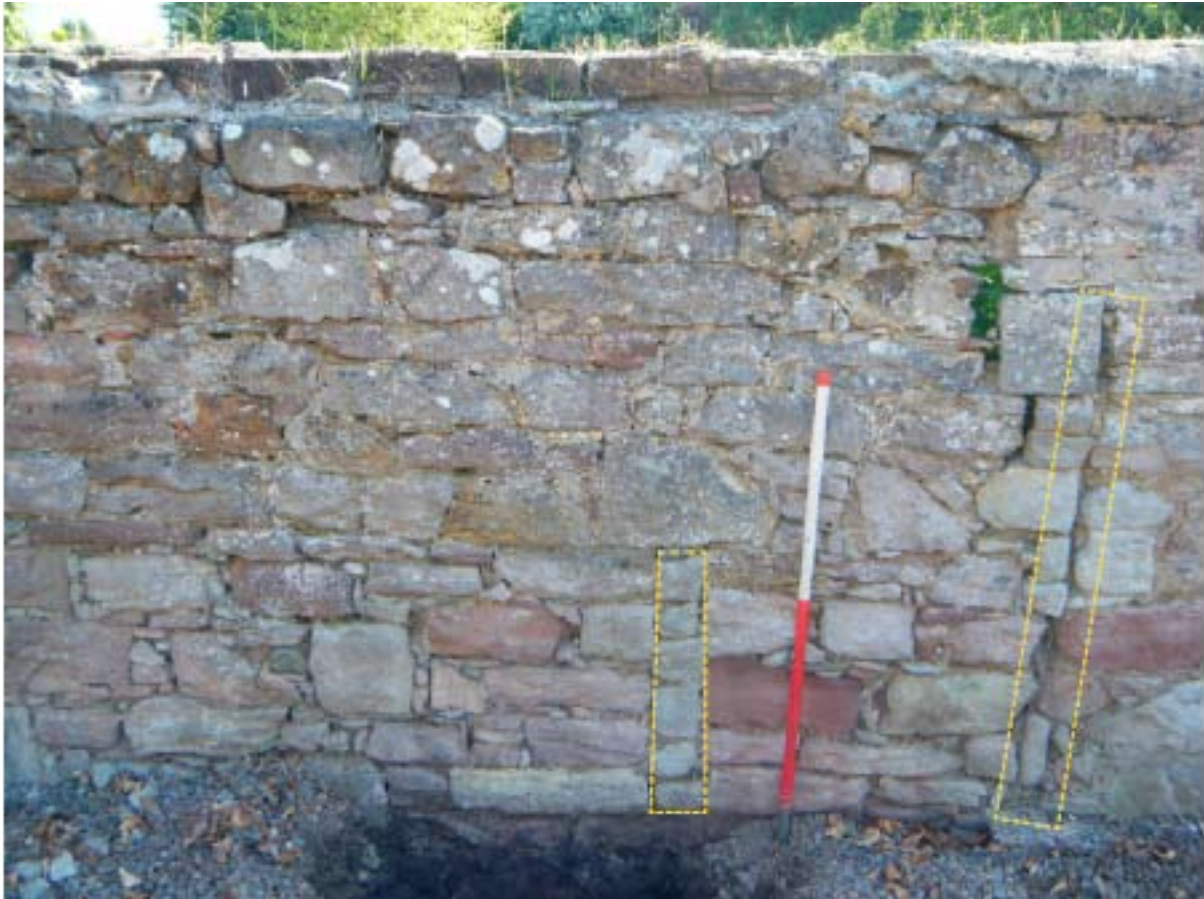
**Illus 11**

Detail of F4 (left) and F3 (right) on the SW facing elevation

was a vertical row of small stones (F4) (Illus 11) although it was unclear as to what if anything these represented.

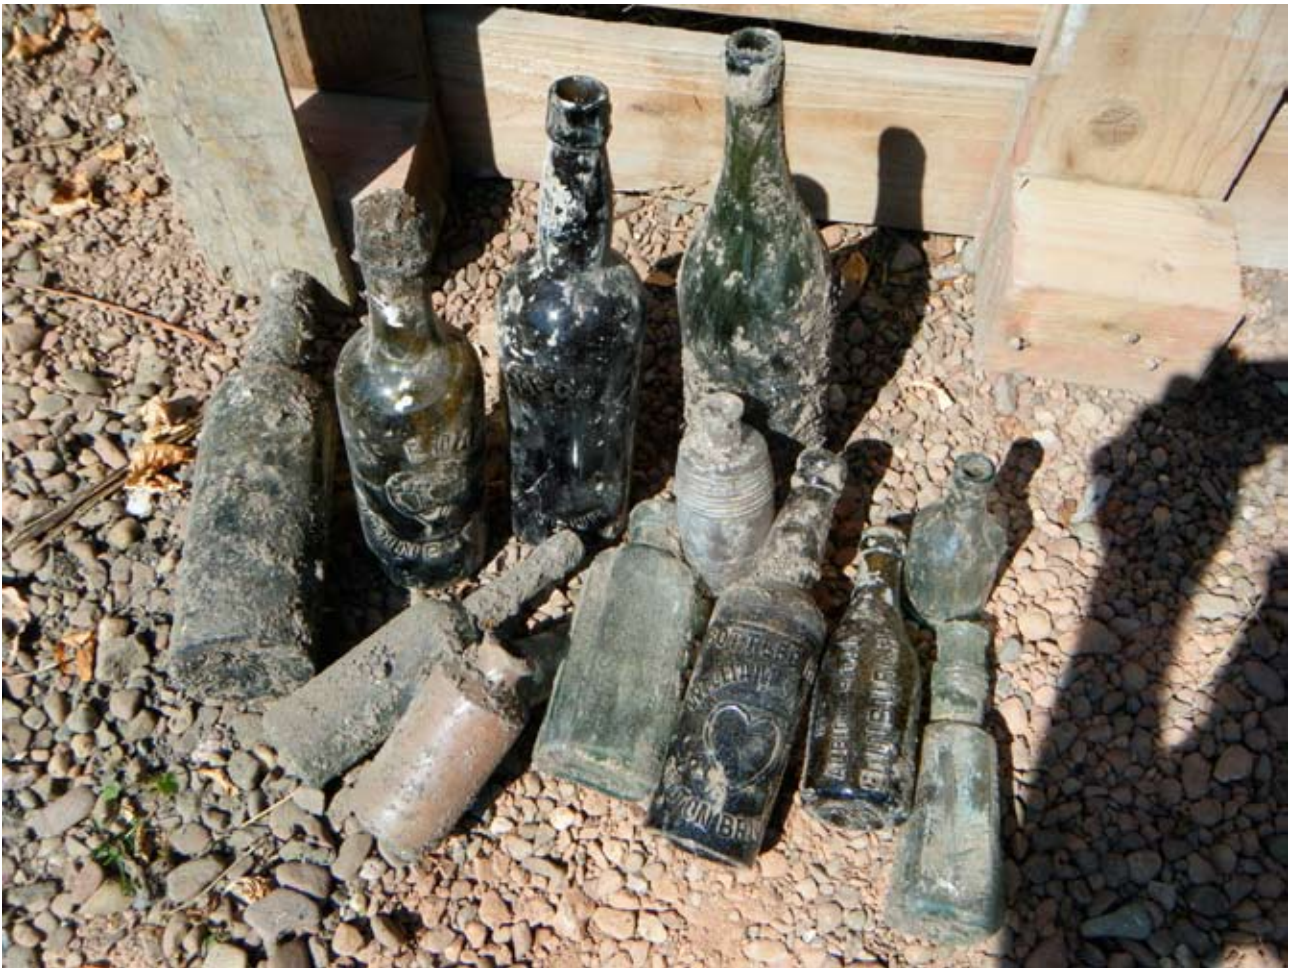
**Illus 12**

Display of the bottles recovered from N end of the foundation trench
