Date: September 2011

Project Code: MEWB08

**M80 Stepps to Hags Improvement Scheme:
Report on Archaeological Monitoring of Works during
Construction Phase**

PROJECT SUMMARY SHEET (MEWB08)

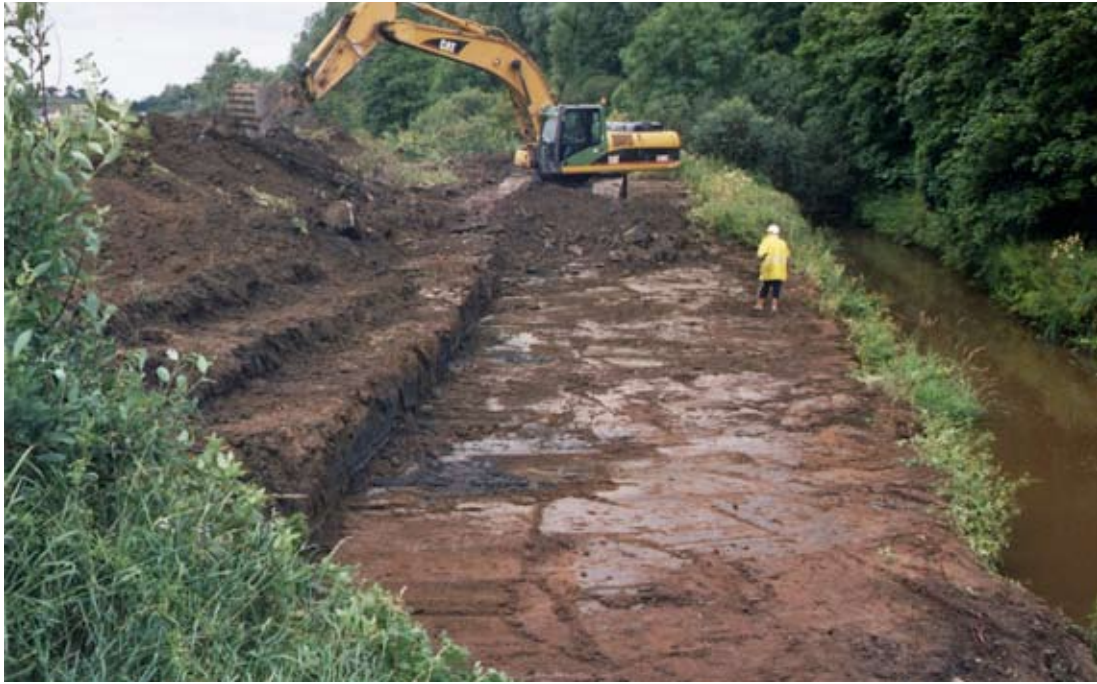
Illus 7

In the south-west part, the construction works reduced the ground level by approximately 2m where Luggie Water passes under the A80 (Illus 7). Buried topsoil [136] consisting of light brown sandy silt was exposed at the base of the excavation. This was sealed by a mixed make-up deposit containing rubble and brick [137] which was itself sealed by redeposited clay loam topsoil [138].

W facing shot of excavations at Luggie Water

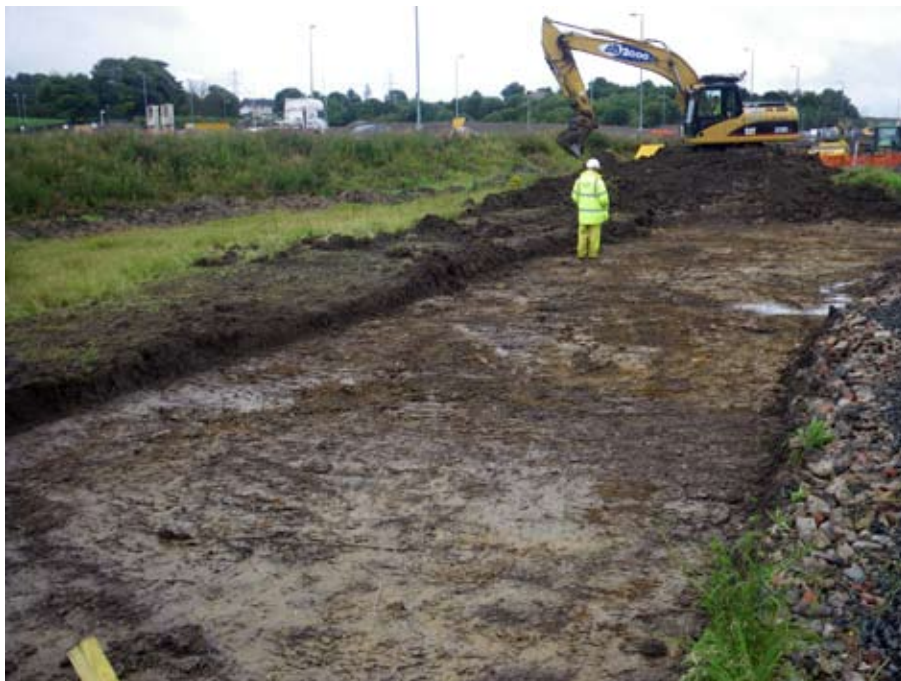
Illus 8

Topsoil stripping in the remainder of the area revealed natural subsoil consisting of mottled grey and orange clays. Overlying this was dark brown clay loam topsoil [141], approximately 0.4m in depth (Illus 8).

SW facing shot of excavations W of Luggie Water

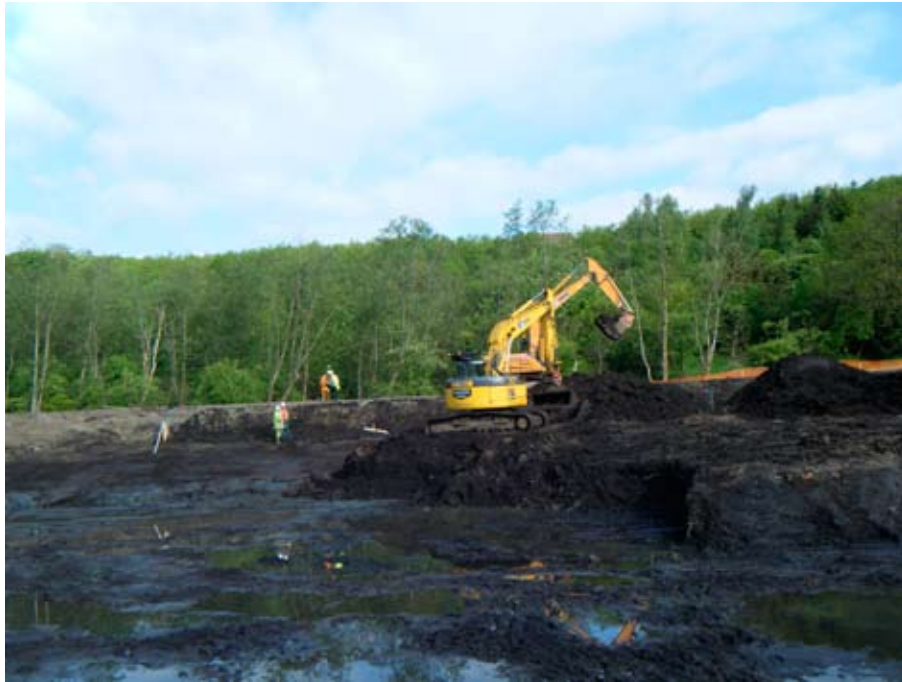
Illus 9

Excavations were relatively deep at this location; to approximately 1.7m (Illus 9). The earliest subsoil layer recorded consisted of grey blue natural clay [132], identified

at a depth of 1.5m and extending below the limit of excavation. Overlying this were two bands of peat [130 & 131], totalling 1m in thickness, and containing twig and wood fragments (Illus 10). Yellowish brown clayey silt [129] overlay the peat and was 0.1m thick. Topsoil consisting of brown clay loam formed the upper deposit and was 0.4m deep [128]. No archaeological remains were recorded.

General shot of Bog Stank excavations

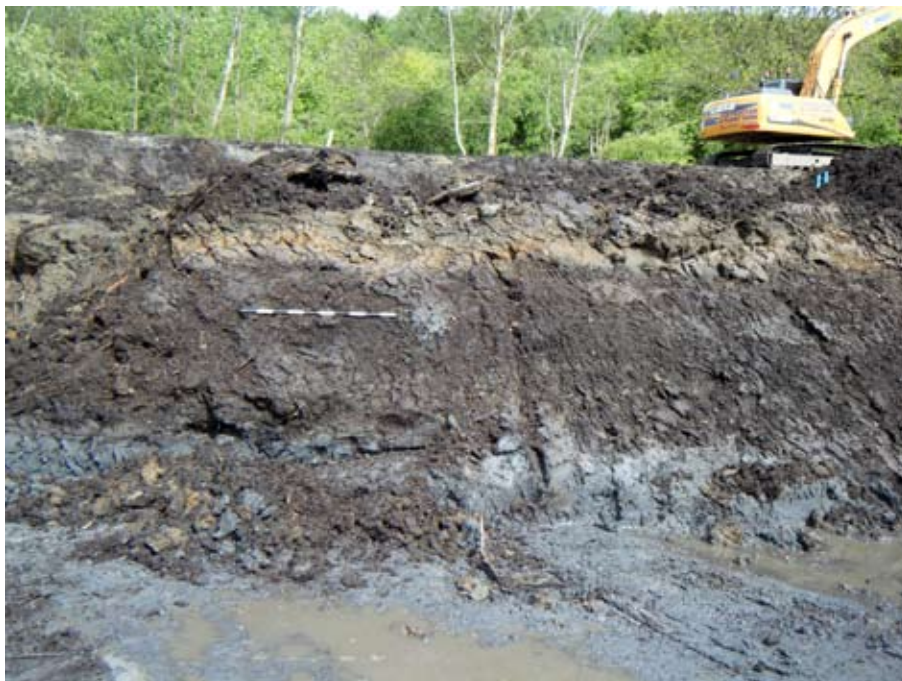
Illus 10

S facing section through peat deposits

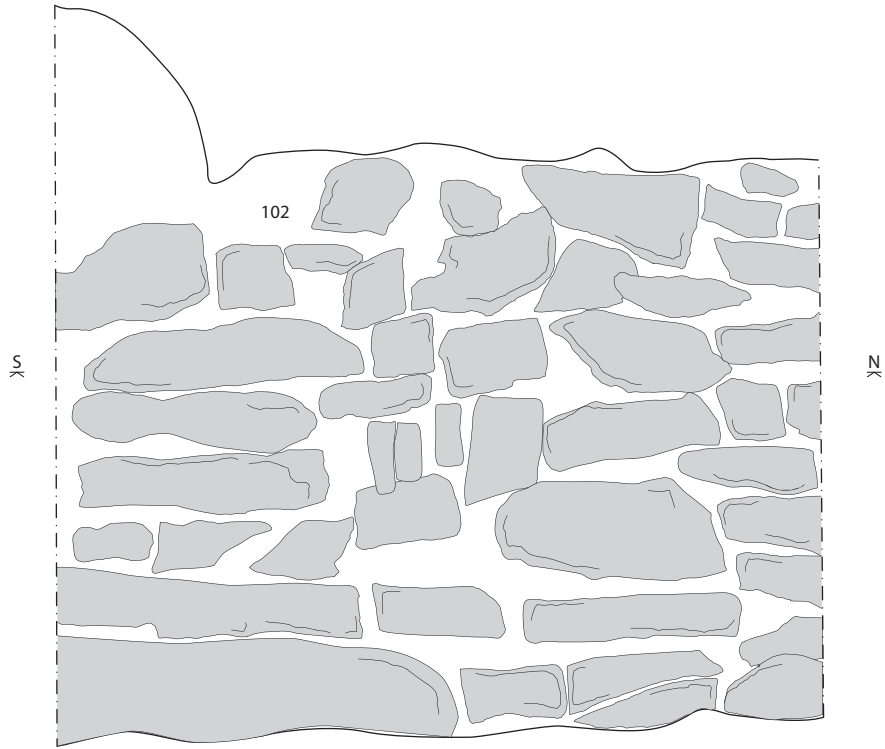
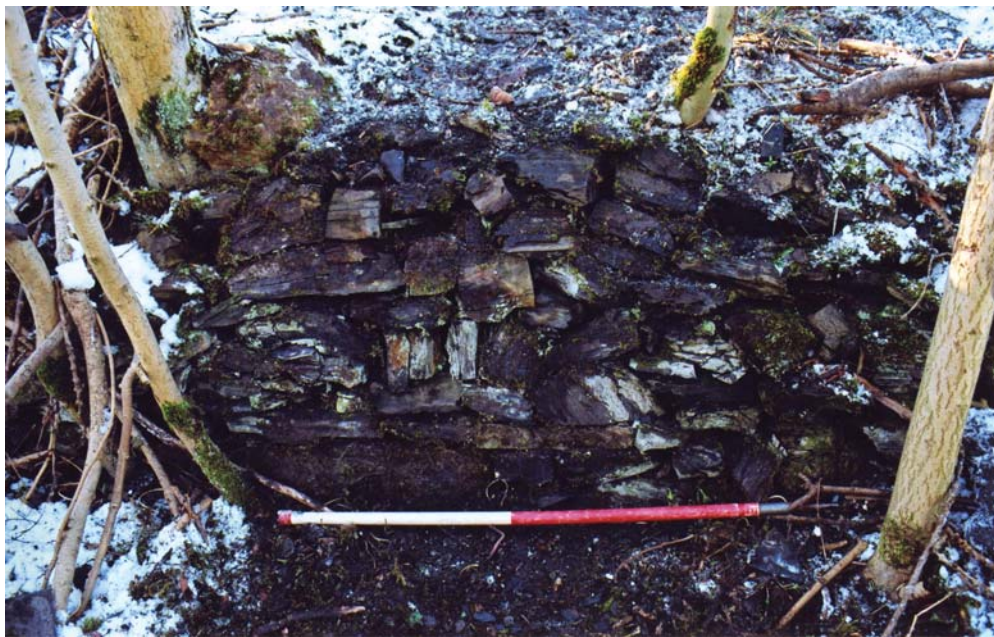
Sections were excavated through four walls to establish their dimensions and details of construction (Illus 6). The walls [101-104] appeared to act as revetments to prevent land slippage and so maintain the various trackways and levelled areas that were utilised in the lime works. Excavation showed that level ground had been created for them by cutting into the valley slope. The walls were then erected using angular rubble of 0.1-0.6m length, with random coursing and no bonding material (Illus 11 & 12). They ranged from 0.4-0.7m in both height and width. The sections revealed a shale-rich fill [105-108] behind each wall, which may represent redeposited material from mining. Ceramics recovered from [108] date to the 19th/20th centuries and are therefore consistent with the period in which the lime works were known to be active (see appendix 2).

Illus 11
E facing elevation of wall [102]

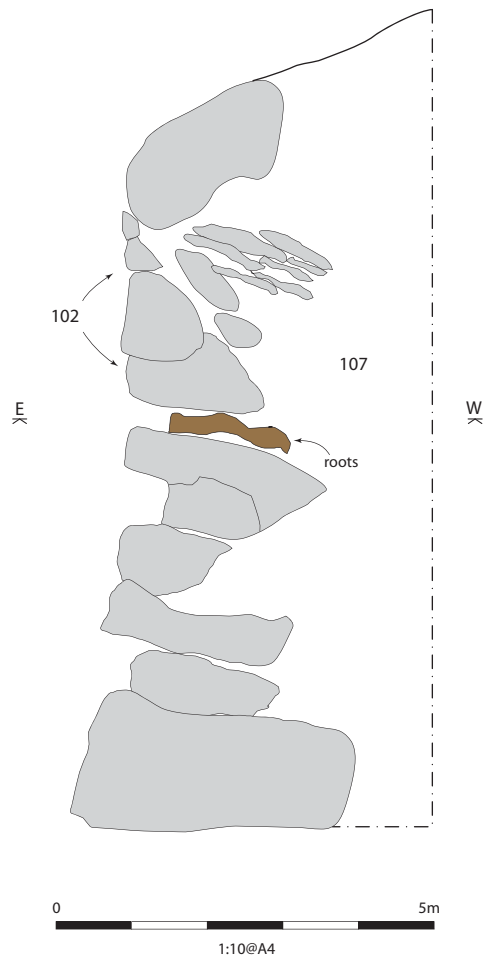
Illus 12
N facing section of wall [102]

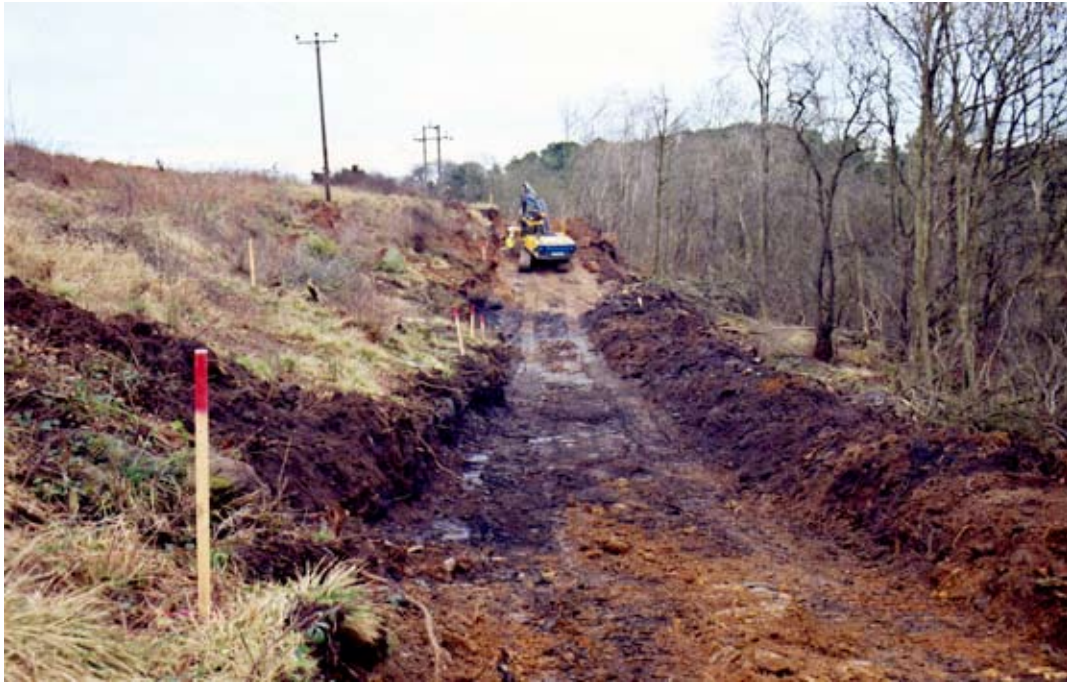
Illus 13

Monitoring of topsoil stripping (Illus 13) revealed natural geology comprising light brown mudstone and shale lenses. Overlying this were make-up deposits ranging from 0.5-2m depth, which comprised dark grey shale-rich deposits [111] as well as red brown sand and ash mixed with rubble [112]. These deposits are likely to be dumped waste material from both the mine shafts and kilns. They were sealed in places by mixed sandy loam deposit [113] which was up to 2m deep and contained slag, modern pottery, masonry and brick. Within this deposit were the redeposited remains of demolished brick structures, including a 1m section of mortared wall [110]. These remains may derive from structures in the vicinity depicted on the 1st Edition Ordnance Survey map, however may equally be introduced material dumped as overburden during construction of the A80.

E facing shot of haul road excavations at Castle Glen

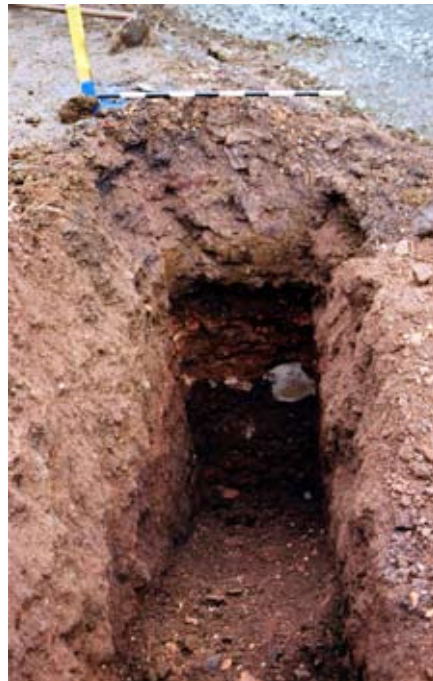
Illus 14

Four test pits were also excavated adjacent to the haul road, to a depth of 3m. They further revealed modern make-up deposit [111] containing brick, rubble, ash and shale (Illus 14). A 2m length of unmortared brick coursing [116] was also identified within deposit [111]. Natural subsoil and geology was not reached.

S facing section of test pit showing make-up deposits

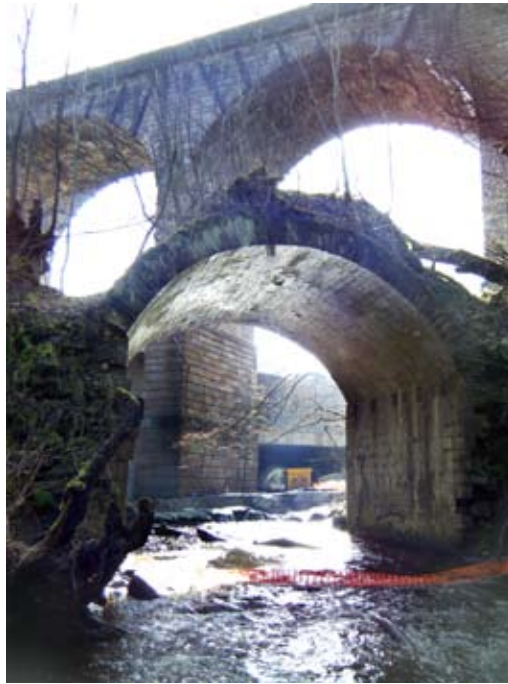
Illus 15

A wall section [133] exposed during construction works near Putlog Bridge was recorded by photographic and measured survey. The former road bridge is an 18th century single-span, depressed arch bridge which is Category C(S) listed and lies adjacent to the Castlecary Viaduct (Illus. 15). The wall section represents part of the former approach-road to the bridge and was founded directly onto natural clays. It was exposed to a length of 40m and was up to 1.5m in depth (Illus 16). Wall [133] was composed of tooled and margined sandstone ashlar, with an average size of 0.3m x 0.5m bonded by lime mortar. The surrounding area had also been reduced down to the natural subsoil and mixed modern overburden lay directly over both this and the wall. The ground reduction and dump deposits are likely to result from construction of the A80.

N facing shot showing Putlog Bridge, dominated by the Castlecary Viaduct

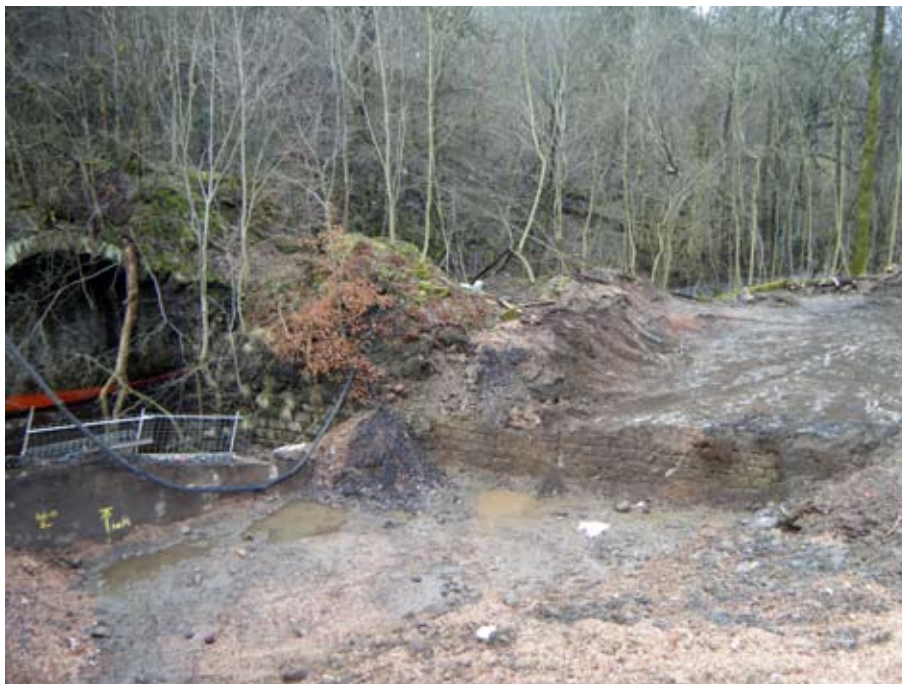
Illus 16

W facing elevation of wall forming approach to Putlog Bridge

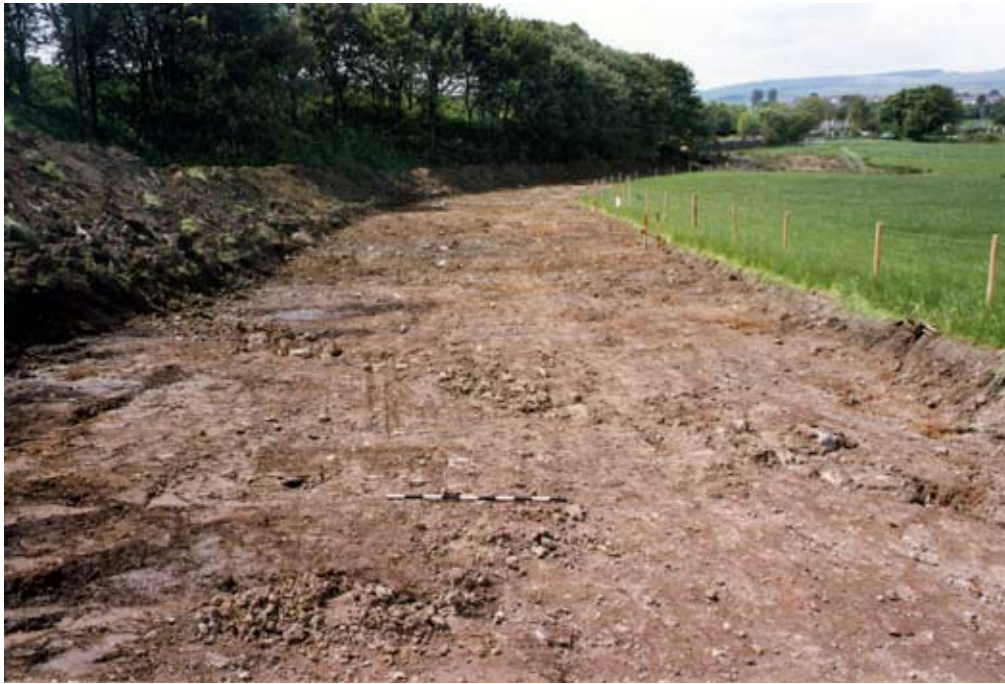
Illus 17

Monitoring was undertaken in two areas either side of the A80-B816 sliproad; immediately north of the line of the Antonine Wall. The eastern area comprised a strip of level ground which formed the edge of a grassed field. It was bordered to the south and west by a wooded embankment which rose steeply to the sliproad (Illus 17). The monitored area was approximately 220m in length and 10m wide. The natural subsoil predominantly consisted of green/grey clays and orange gravels. Midway along the strip, a 0.4m deep peat layer [121] had formed where the ground was considerably boggy. Frequent ceramic field drains were also recorded at this location. Overlying the subsoil deposits at intermittent points was modern overburden [142] comprising rubble, ceramics and blaes which is likely to derive from landscaping for the sliproad. This was sealed by redeposited sandy loam topsoil [143], approximately 0.2m deep. No archaeological features were recorded.

N facing shot of Castlecary cycle link excavations

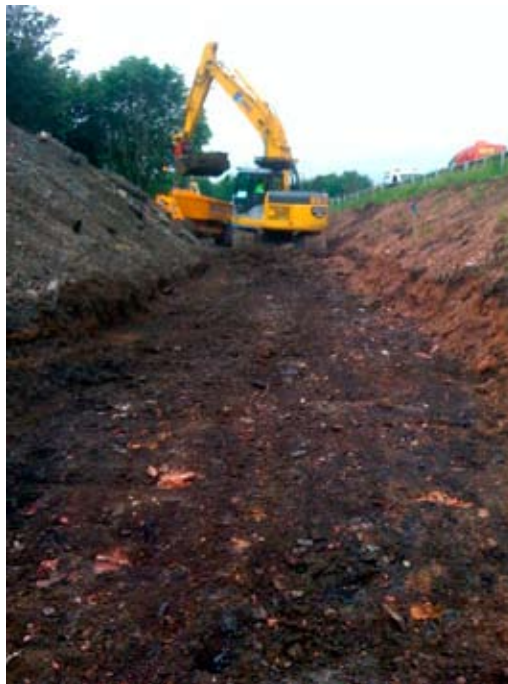
Illus 18

The area immediately west of the sliproad comprised a 4m wide strip at the base of the road embankment. Previously wooded, the area had been stripped of vegetation prior to monitoring. Excavations were approximately 1m in depth and did not expose natural subsoil. A mixed modern deposit [144] of dark brown loam, shale and red blaes was revealed, containing construction materials including kerb stones and concrete blocks which were assumed to derive from previous road building (Illus 18).

N facing shot of slip road excavations
