NEWBRIDGE INDUSTRIAL ESTATE, EDINBURGH

Data Structure Report of an Archaeological Evaluation

for Northern Trust

July 2011

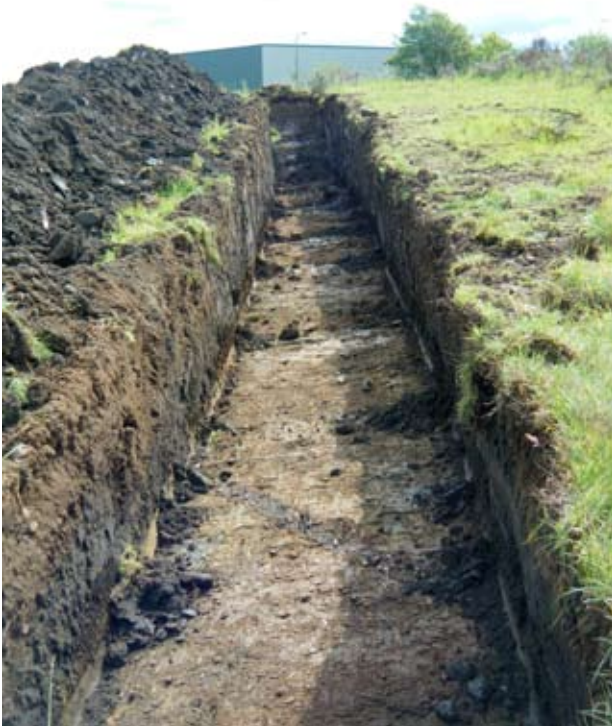
Illus 2
View of Trench 01

sandy clay). A rubble field-drain and two cultivation furrows, all oriented N-S, were present in Trench 01 and are likely to be reasonably contemporary. These were not investigated owing to the depth of the trench (Illus 2).

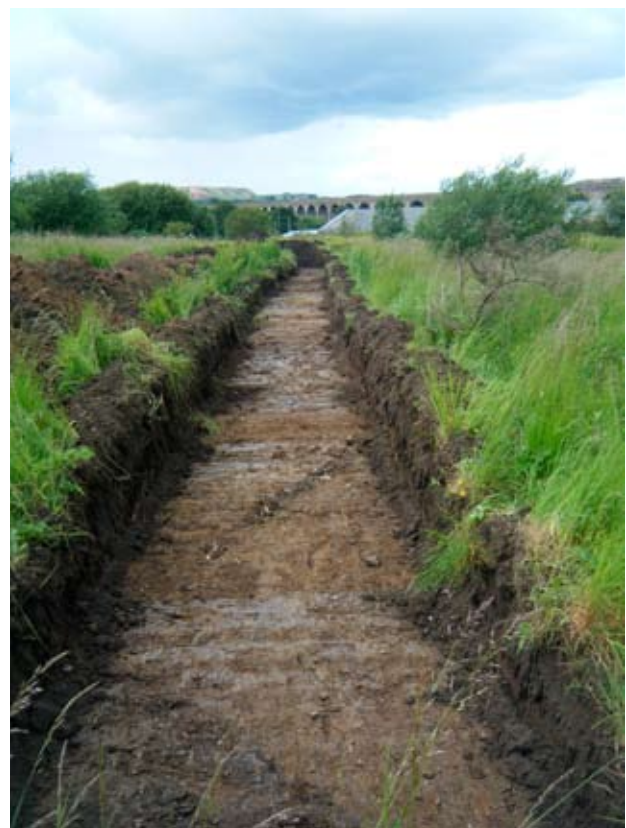
Illus 3
View of Trench 02

The majority of the trenches contained field-drains (both rubble and ceramic) with Trenches 02 and 03 also containing ephemeral remains of cultivation furrows

(Illus 1). These were up to 1.5m wide, 0.05m deep, oriented N-S in Trench 02 and SW-NE in Trench 01.
