200 OLD DUMBARTON ROAD, GLASGOW

Archaeological Evaluation and Watching Brief

for Watkin Jones Construction

November 2011

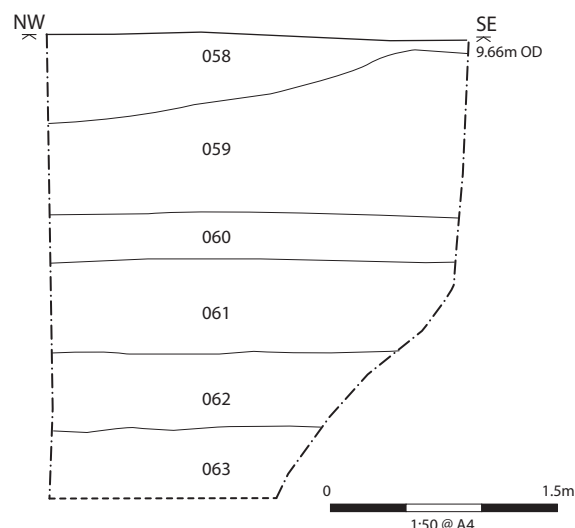
Illus 2

SW facing section of Test Pit 2

Excavation within Test Pit 2 (Illus 2) revealed the natural bedrock at 3.1m below ground level (6.56m AOD). This was sealed by a 0.4m thick layer of light brown sandy loam [063], containing a concentration of pantile roof tiles and sandy mortar. A dark brown sandy loam [062], 0.5m thick, sealed this layer and was in turn sealed by a 0.6m thick layer of sandy loam and demolition debris [061]. A further three layers [060], [059], and [058], comprising 19th and 20th century demolition debris sealed this layer.

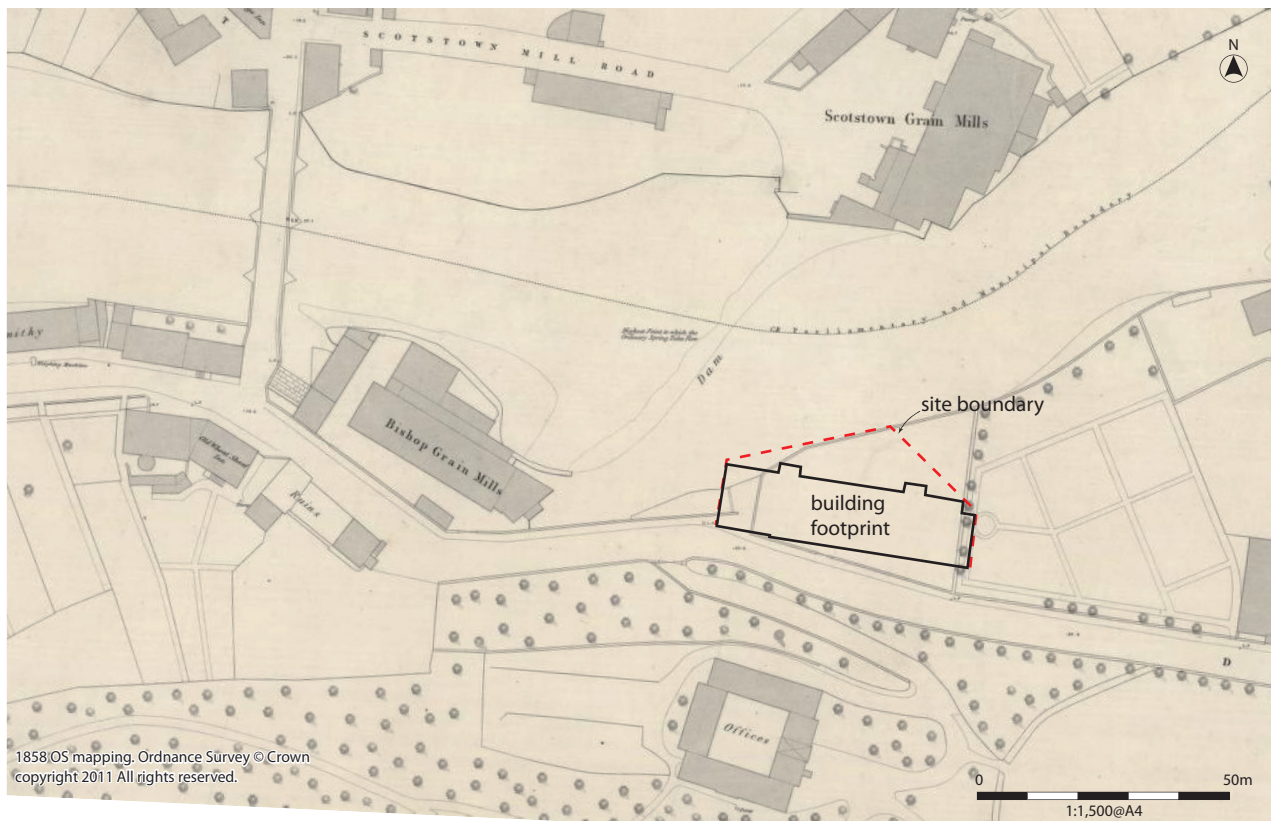
Illus 4
1858 OS map

between mill sites mapped on the 1858 (Illus 4) and 1894 (Illus 5) OS maps. The main archaeological potential was for the presence of earlier water management features and mill structures (email from WoSAS 3/5/11); these are shown in the vicinity of the site on the 1747–55 survey by William Roy, but cannot be located accurately.

The wall foundations (Illus 3) located during the watching briefs on the southern and northern halves of the site, relate to the building shown on the 1894 OS map (Illus 5). This building was built at some point between 1858 and 1894 as it is not shown on the 1858 OS map (Illus 4) of the area. These foundations were built into a levelling layer which sealed the former ground surface revealed during the test pitting. No evidence for any earlier or unmapped structures were revealed during the watching brief.

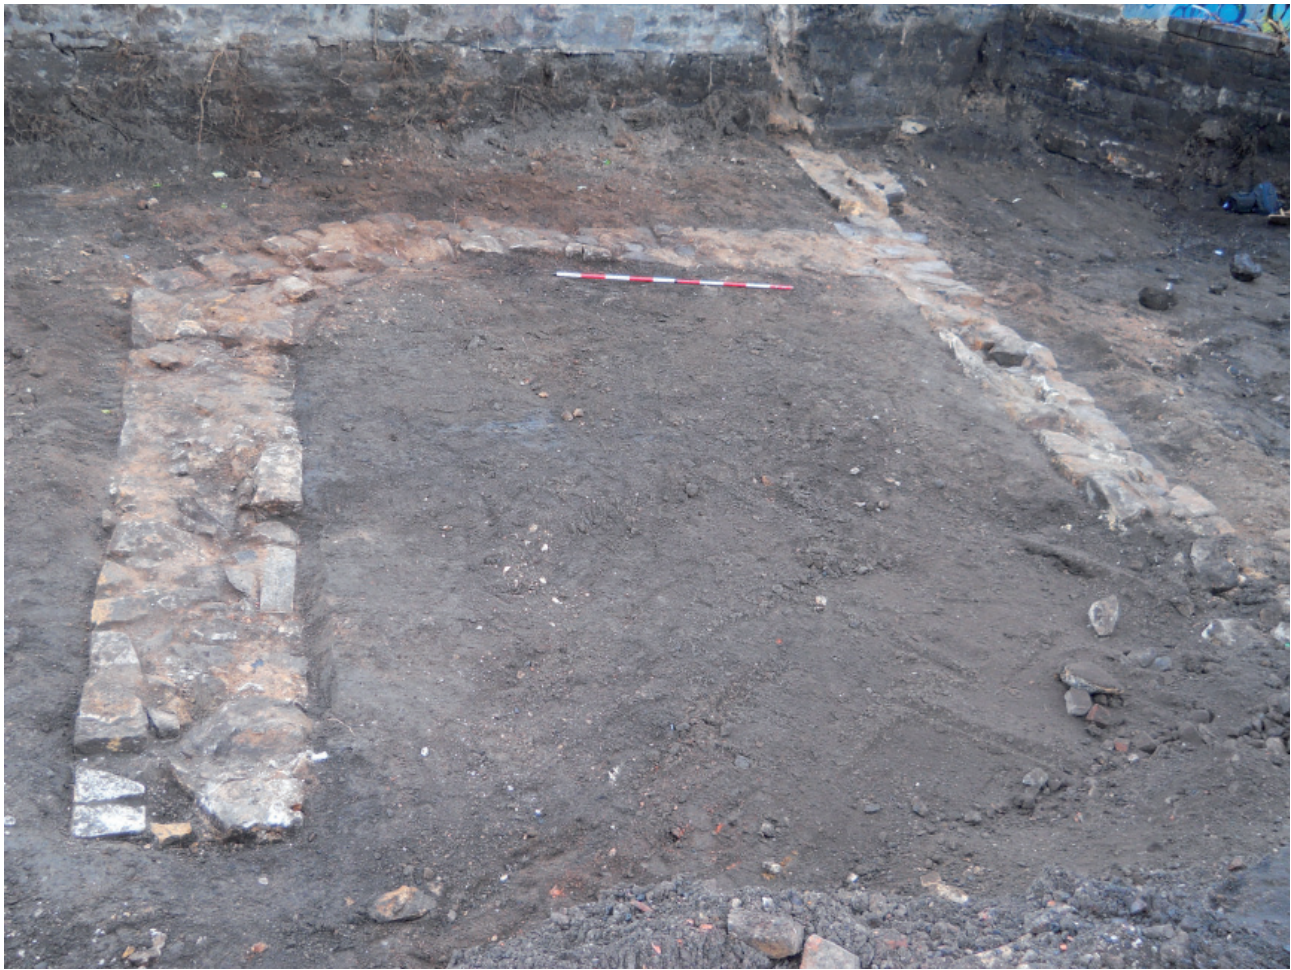
Illus 6

Walls [100], [101] and [102]

Wall [100] ran NNE-SSW, turning onto an ESE-WNW alignment at the NNE end, forming a rough L shape and bonded into Wall [101] at the ESE end. Wall [101] was aligned NNE-SSW, and both walls measured between 0.8 and 1.0m in width and were constructed of sandstone blocks sitting on a brick cement base 0.2m thick. The continuation of these walls to the southwest, along with a brick structure abutting Wall [100] to the WNW was observed during the watching brief during excavations of the southern half of the site.

A further sandstone wall [102], with a stone buttress [103] was encountered abutting Wall [101] to the NNE running into, and truncated the retaining wall for the River Kelvin. This wall also had a brick cement base and is likely to be contemporary with the other walls noted above.
