## LANARK MEMORIAL HALL, LANARK

Archaeological Watching Brief

for Mansell Construction Services Ltd

CL/09/0190

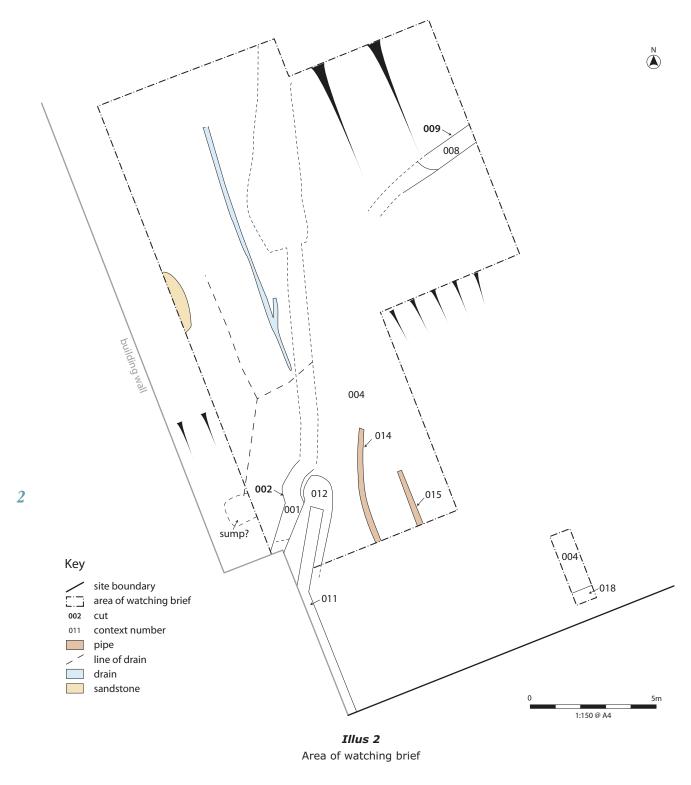
An area approximately 30m x 8m was excavated under archaeological supervision abutting the Memorial Halls eastern elevation. This trench, which was excavated for the proposed basement was 0.7m to 1.5m in depth due to its orientation on the slope of the hill. Against the eastern limit of the site adjacent to the basement area the ground was reduced to approximately the same level as the halls internal floor. A small test pit 0.8m x 3m was also excavated against the front of the site.

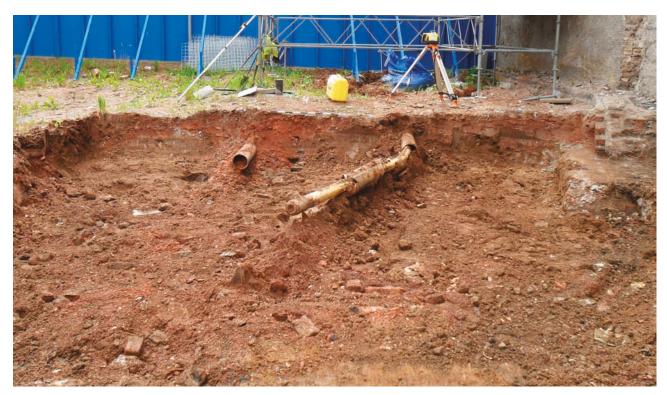
**Illus 3**North facing section of basement area

No significant archaeological deposits were encountered. The basement area was characterized by a simple profile of a mixed deposit of topsoil/demolition rubble [003] 0.3m to 0.5m deep overlying reddish brown clay sand natural [004]. This was cut by numerous modern service trenches and wall foundations associated with the construction of the Memorial Hall and Cargill Club: [002], [006], [005], [013], [014] and [015].
