Project Code: FHLE11  
Date of report: December 2011  
Client: City of Edinburgh Council

Fort House, Leith, Edinburgh:  
Desk-based Assessment and Historic Building Recording

Archaeological Desk-Based Assessment and Historic Building Recording

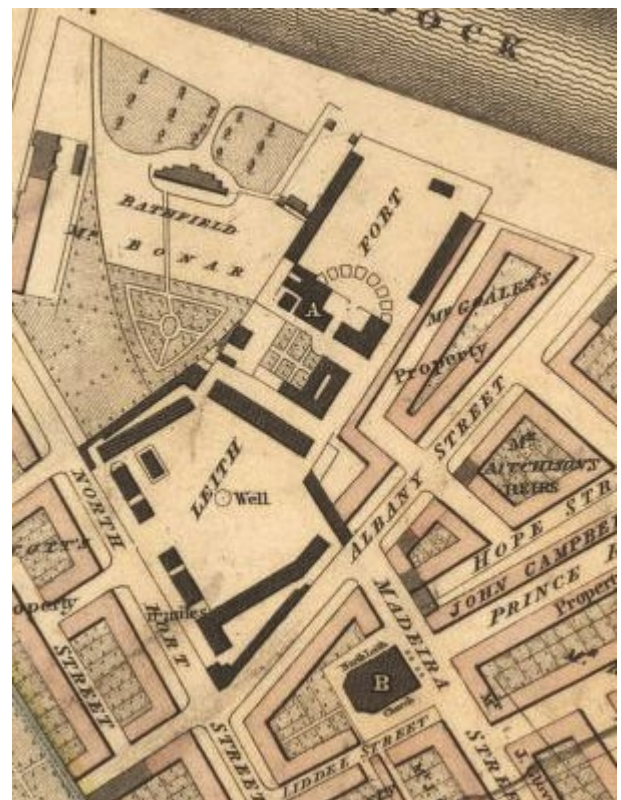
Illus 4: Kirkwood 1817

The earliest map to show the new extension and modifications to the fort in detail is Kirkwood's plan of 1817 (Illus 4). This shows the buildings much as detailed on Watt's plan but in addition shows a building against the western wall and south-western corner; a building to the north of the western gatehouse and the building comprising the shops against the eastern wall extending into the south-eastern corner. Maps from 1824 and 1837 (Illus 5 & 6) show no change to the layout of these

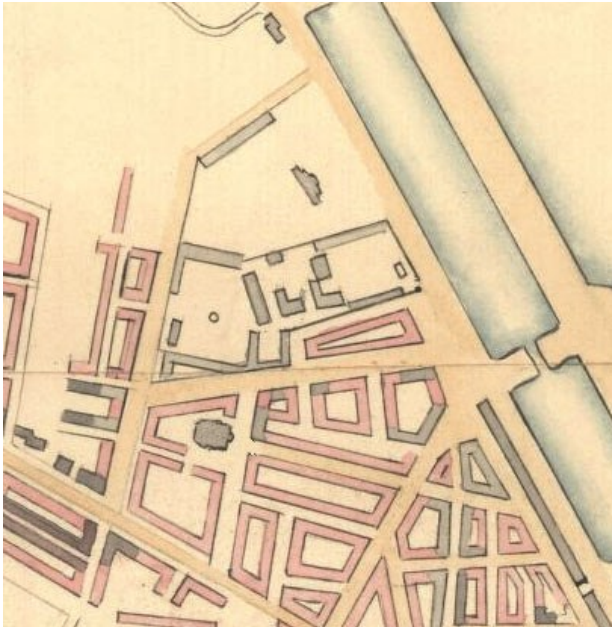
**Illus 5: Crawford 1824**

buildings, although the half-moon battery on the original fort has gone by 1824.

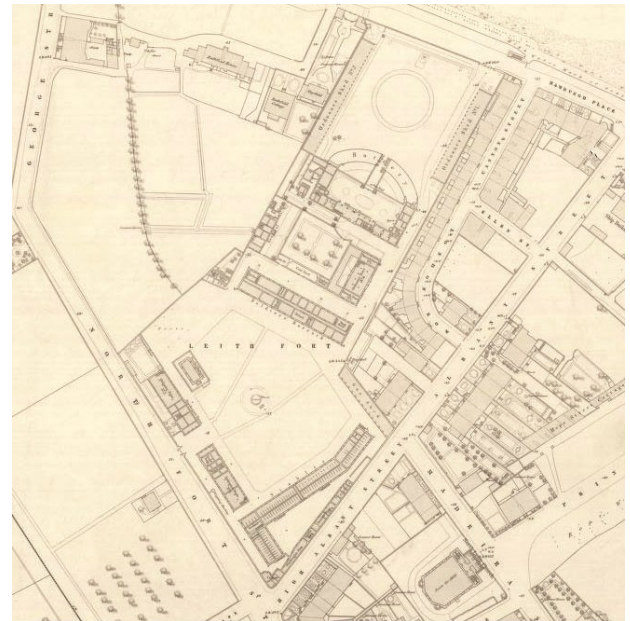
**Illus 7: Ordnance Survey 1853**

The fort was later developed as the headquarters of the Royal Artillery in Scotland (Gifford *et al* 1991, 480). This seems to have taken place in the mid-19<sup>th</sup> century. The first edition Ordnance Survey map (1853; Illus 7 & 8) shows that the buildings against the west wall and the western stable block have gone. The other buildings are labelled in detail. The Western guardhouse is labelled 'Storekeepers House' with 'Ordnance Store 2' to the west; the eastern guardhouse is labelled 'Guard Room' with 'Ordnance Store 1' to the east, with 'Prison Cells' in between. The shops along the eastern wall include Canteen, Wheelwrights shop, Smith and Farriers shop. The 'Gun Shed' remains in the north-eastern

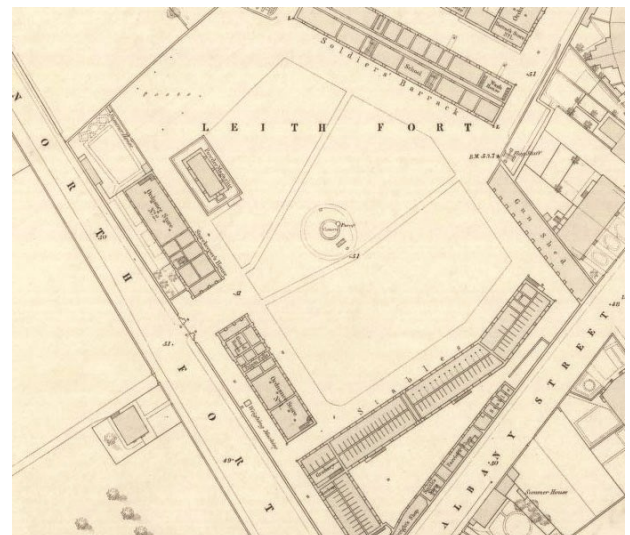
**Illus 8: Ordnance Survey 1853 – detail**

corner and there is a 'Soldier's Privy' in the north-west corner. The building in the south-western corner is the 'Summer House'. The Parade Ground is divided by paths into three and there is a well and pump in the centre.

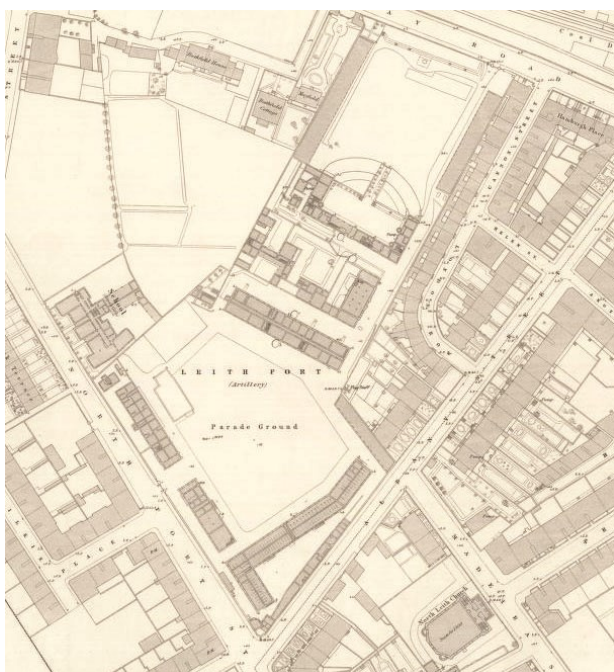
**Illus 9: Ordnance Survey 1878**

The area is labelled 'Artillery' on the second edition OS map (1877; Illus 9) and there is an additional building to the north of the western block; the well has gone. The area is labelled 'RA Depot' (Royal Artillery) on the OS map from 1895 (Illus 10) and a series of possible shooting targets are shown to the west of the eastern stable block. The area continues as Leith Fort Royal Artillery Depot on maps up until 1931, when the name is changed to Leith Fort barracks; there is no change to the layout of the buildings. By 1946-8 there are more buildings on the east and northern sides. An aerial photo from 1946 shows the western part of the site empty of buildings, with what look like large mounds of earth in this area; the guardhouses are visible and the buildings along the south side are still upstanding. There is a large bank to the rear of Area B, which is thought to hide a walled maze built in the 1960s that possibly incorporates some earlier historic fabric.

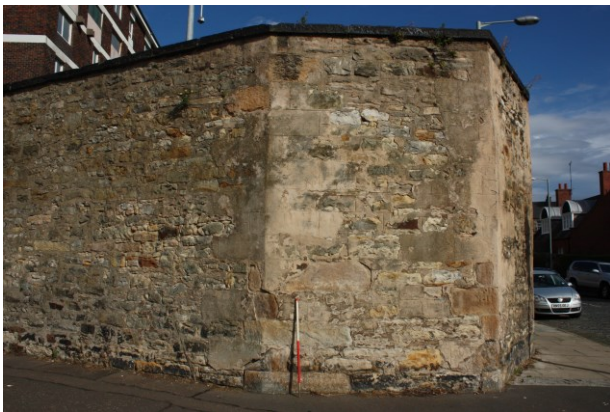
The Category B listed buildings on the site as described by Historic Scotland comprise two guardhouses, the gateway and the boundary wall; entered in the NMRS as NT27NE 288, 288.1, and 288.2 (Table 1). The boundary wall is of rubble construction with ashlar coping and bounds North Fort Street to the south, Portland Street to the east and part of the west side of the site (Illus 11). The main entrance gateway consists of a pair of corniced ashlar gate piers flanked by two round-headed pedestrian arches (McKean 1992, 221; Illus 12 & 13). The outer posts of the arches are marked with Ordnance Survey benchmarks. The eastern arch has been blocked with a black-painted metal gate.

Illus 11: Boundary Wall , Portland Street

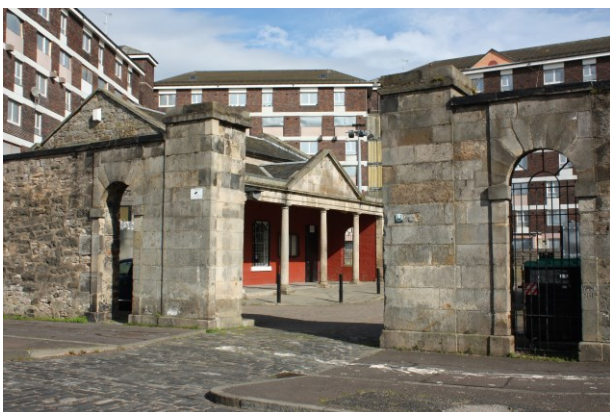
Illus 12: Gate piers and pedestrian arches

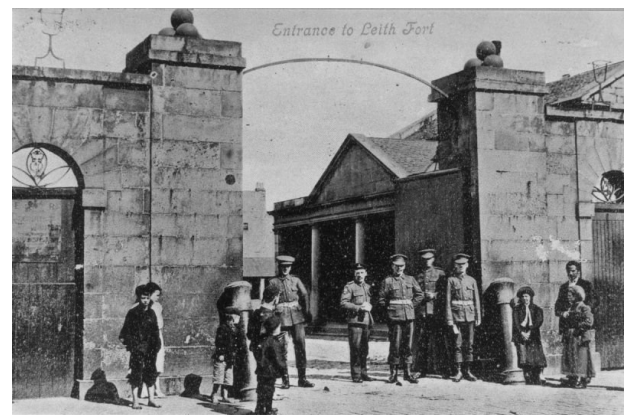
Illus 13: Old Photo of Leith Fort © RCAHMS

bays with flat roofs. The inner bays have round-headed openings and pilasters, the outer bays are plainer with oculi on the north elevations. Pedimented four-bay Roman Doric loggias face the courtyard with entablature and blocking course with pedimented central bays (McKean 1992, 221). Both loggias have been painted red on the inside and the open windows of the loggias contain black painted ironwork. The eastern guardhouse is currently used as an electricity substation, while the western guardhouse is used as the Concierge Office for Fort House. There is no evidence of the buildings that previously adjoined the guardhouses as shown on the first edition map and Kirkwood's plan.

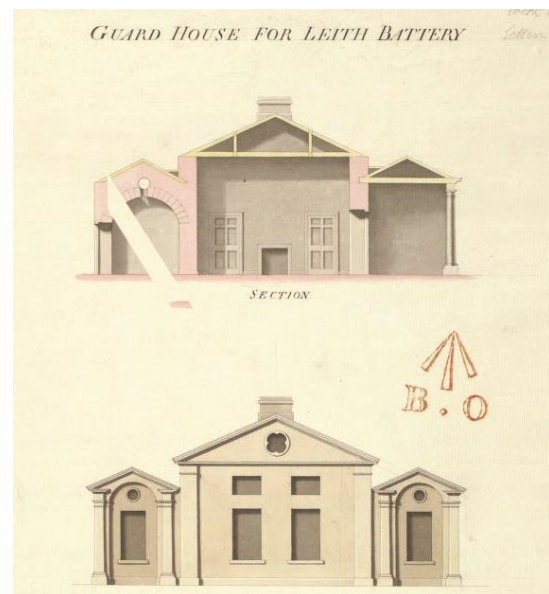
Inside the entrance is a pair of matching Palladian lodges (c1810) aligned to flank the gateway and framing the forecourt within the fort (Illus 14). Both the guardhouses comprise two-storey, two-bay structures. The walls are of sandstone rubble with droved ashlar to the front (north) and towards the courtyard, with polished ashlar dressings. The roof is covered with grey slate and has open-pedimented end gables flanked by single storey

Illus 14: Guard House Section and Elevation (Watt pre-1804)

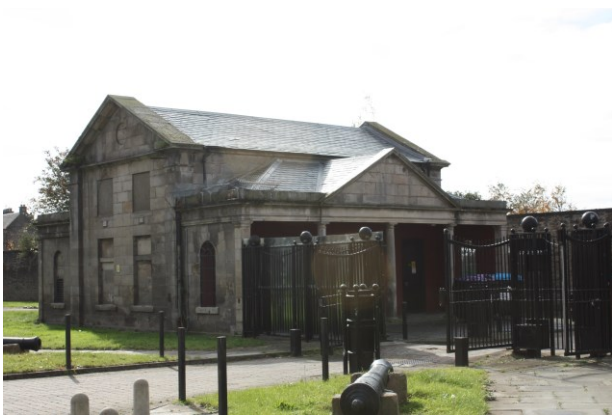
windows on the north elevation have been blocked; the window in the single storey building has been half blocked (upper) and a vent inserted in the lower half (Illus 15). The eastern elevation contains two large brown wooden doors, giving access to the rear of the building. There are two visible blocked doorways on the western side of the building. One of these is to the north of the N door, the other to the north of the S door (Illus 16, 17). They have been blocked with sandstone and are c 1.9m high by 0.8m wide. The existing doors have new sandstone lintels above. The single storey building has four rooms on the original plans of the building (Illus 18), however the first edition OS map (1853, Illus 7 & 8) shows three rooms, which corresponds with the location of the blocked and enlarged doors. All windows in the southern wall have also been blocked with the window in the single storey building replaced with a vent and a new lintel.

**Illus 15: Eastern guardhouse looking SE**

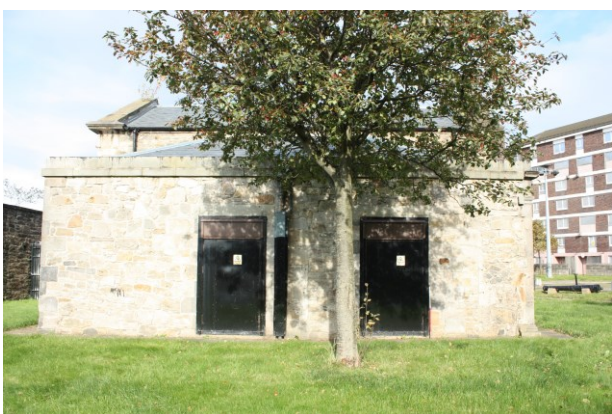
**Illus 16: Eastern guardhouse, E elevation showing blocked doorways**

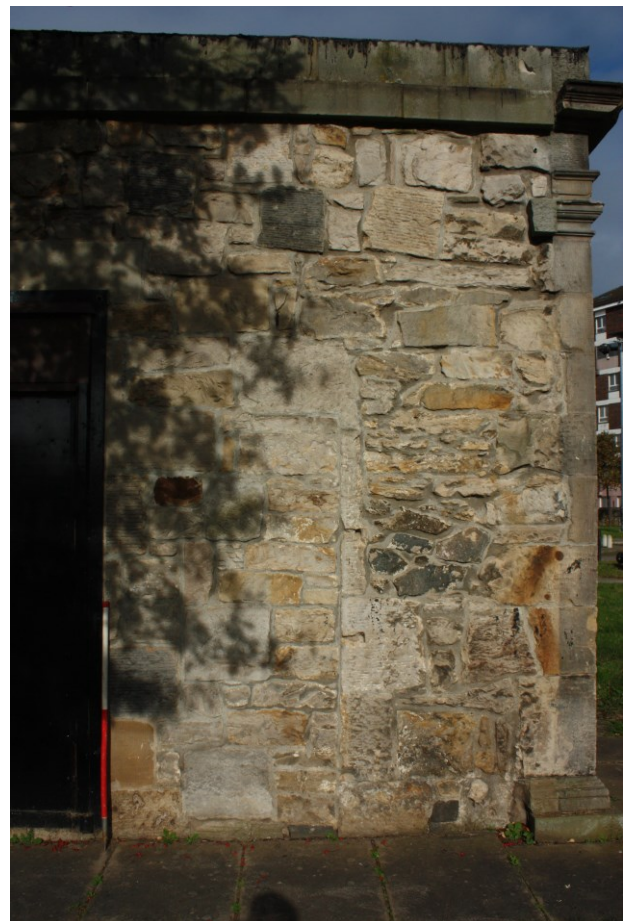
**Illus 17: Eastern guardhouse, E elevation showing blocked doorway to N, detail**

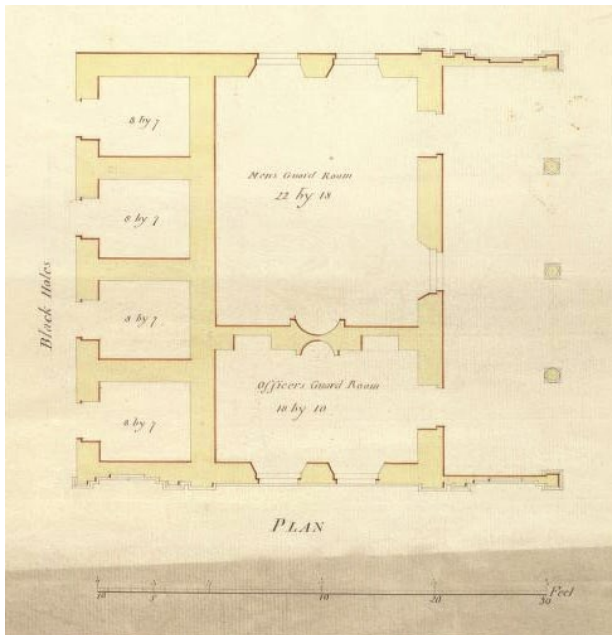
**Illus 18: Guard House Plan (Watt pre-1804)**

Internally the building has been substantially altered from the original ground plan (Illus 18), although the main divisions remain. On the lower floor the main door leads into Room 10. The walls are covered with textured wallpaper, painted cream, the floor is carpeted. There is a suspended

occupy the original east-west divisions as shown on the original plan (Illus 18). The doors for Rooms 5 and 6 are through an inserted partition wall on the west side of the hall and the door for Room 4 is through the south wall of the room, making the room somewhat larger than the other two. The three circular windows as seen on the outside west wall are on the stairs and in Rooms 5 and 6. There is a window on the north wall of Room 4, as Room 11. The first edition OS map (1853, Illus 7 & 8), however shows a slightly different layout to the original plan, with the single storey building divided into two rooms, with the staircase in the south-west corner. The building was either not completed to the original plans, had already been altered by the time of the 1853 map or the 1853 map is not accurate.

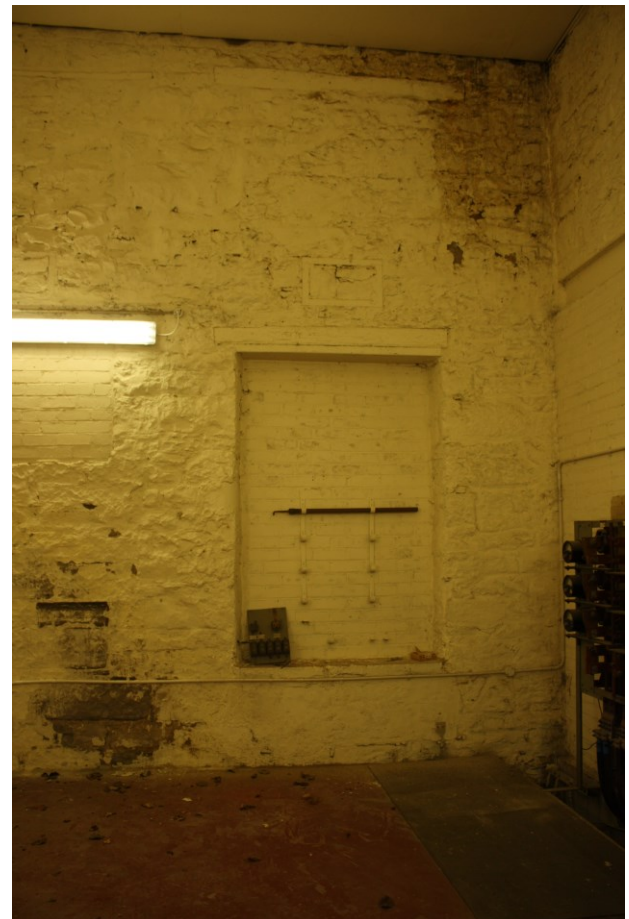
Internally the building comprises two large rooms. Room 1 is at the front (west) of the building and comprises the original Men's Guard room and Officers Guard Room as shown on the original plans of the building (Illus 18). The dividing wall has been removed, as has the upper floor and there are no remaining original features. The walls are of rubble with brick additions and have been whitewashed. The blocked windows are visible on the north wall (Illus 19). The west window has been blocked with brick and is flush to the wall, the east window is recessed; the wooden lintels of the upper storey windows are visible. A narrow metal door through to Room 2, not on the original plan, is at the centre of the east wall. There are also two vents either side of the door through to Room 2 and holes in the floor to take the electricity cables. There are two LV feeder supply switchboards on the east wall, the north serves Fort House, the south the houses in the vicinity. There is a blocked doorway at the west end of the southern wall. Two freestanding 11kv ring switches stand on the west side of the room.

**Illus 19: Eastern guardhouse, Room 1, blocked windows in north wall**

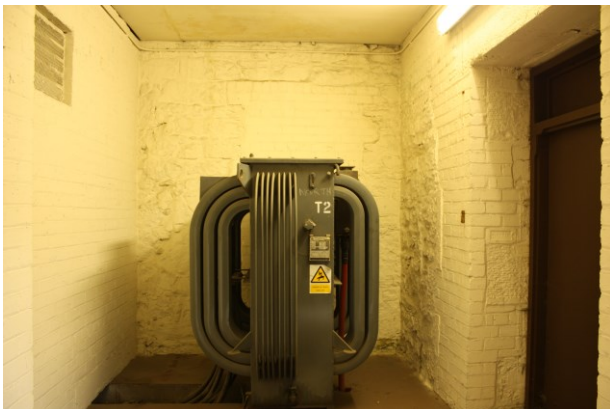
Room 2 is accessed via Room 1 or through the rear (east) doors. It comprises a single room occupying the single storey building. The dividing walls as shown on the original plan have been removed and the doorways altered as described above; the doorways have concrete lintels. The walls are of rubble with brick repairs and blocking; a number of the bricks are marked 'NIDDRIE'. The windows in the north and south walls are blocked with brick. There are two 11,000 – 450 volt transformers, one at each end of the room (Illus 20).

**Illus 20: Eastern guardhouse, Transformer 2 in Room 2**

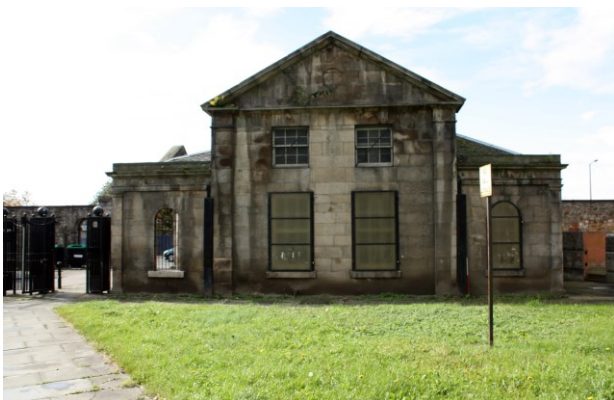
The western guardhouse is accessed from the frontage (east) through a large brown wooden door at the south end; this has a black metal cover when it is locked. The window is covered with white painted metal bars. The door to the north leads to a store cupboard. All windows on the north wall are fitted with padlocked metal grills; those on the ground floor have frosted glass (Illus 21). The west wall has three single pane circular windows with sandstone surround (Illus 22); no other features are visible. The southern wall was not fully visible due to a large metal gate.

**Illus 21: Western guardhouse, N elevation**

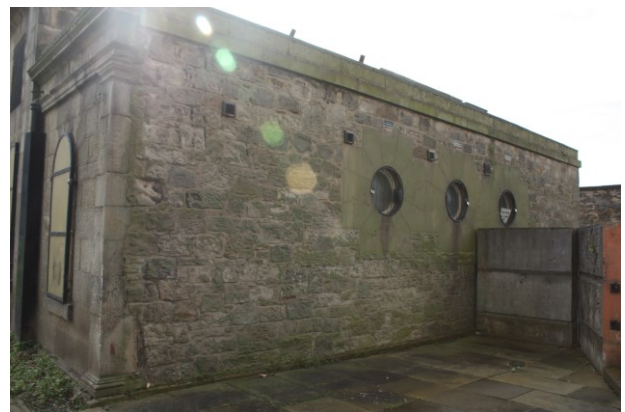
**Illus 22: Western guardhouse, circular windows in west wall**
