396–410 GORGIE ROAD, EDINBURGH

Archaeological Evaluation

for Chamic Developments Ltd

December 2011

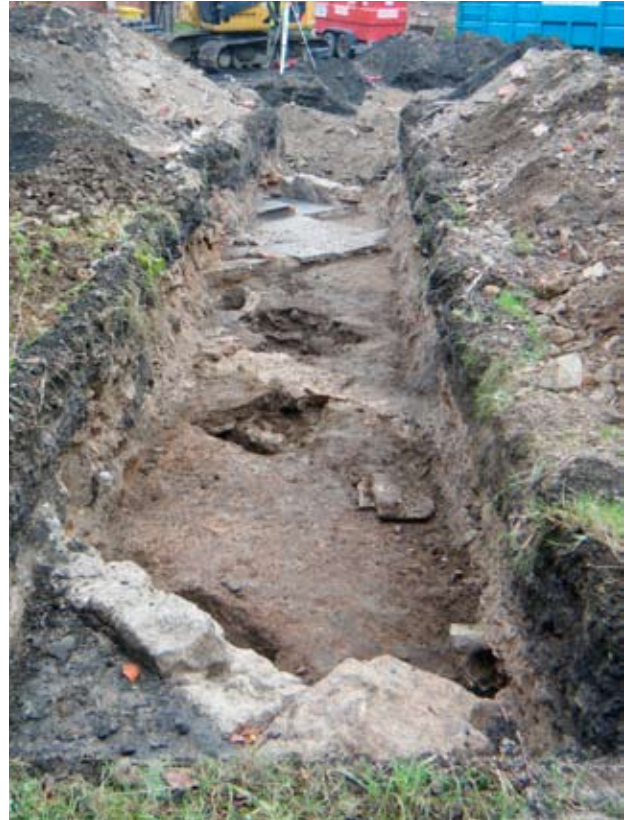
Trench 1 contained a series of walls and floor surfaces as well as two small, stone-capped culverts (Illus 3). The northernmost wall [002] was oriented east to west, was

Illus 3
View of Trench 1

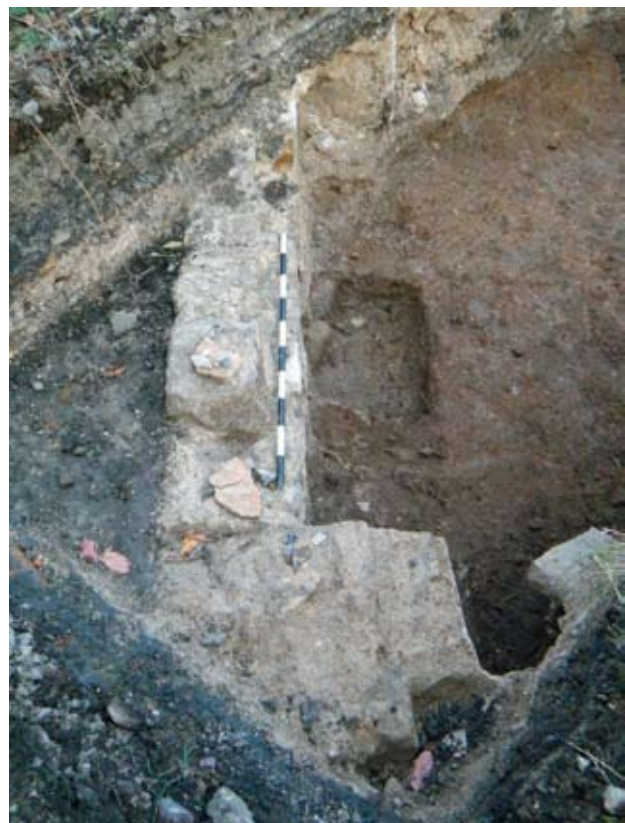
Illus 4
View of wall [002]

0.35m wide and survived to a height of 0.8m (Illus 4). It was constructed of roughly coursed, undressed sandstone bonded with lime mortar. The southern face was coated with a 20mm thick lime render with a thin, pale orange plaster skim. The wall returned to the south at the western edge of the trench. A shallow foundation cut [003] was present to the south of the wall. This was 0.8m wide and 0.15m deep.

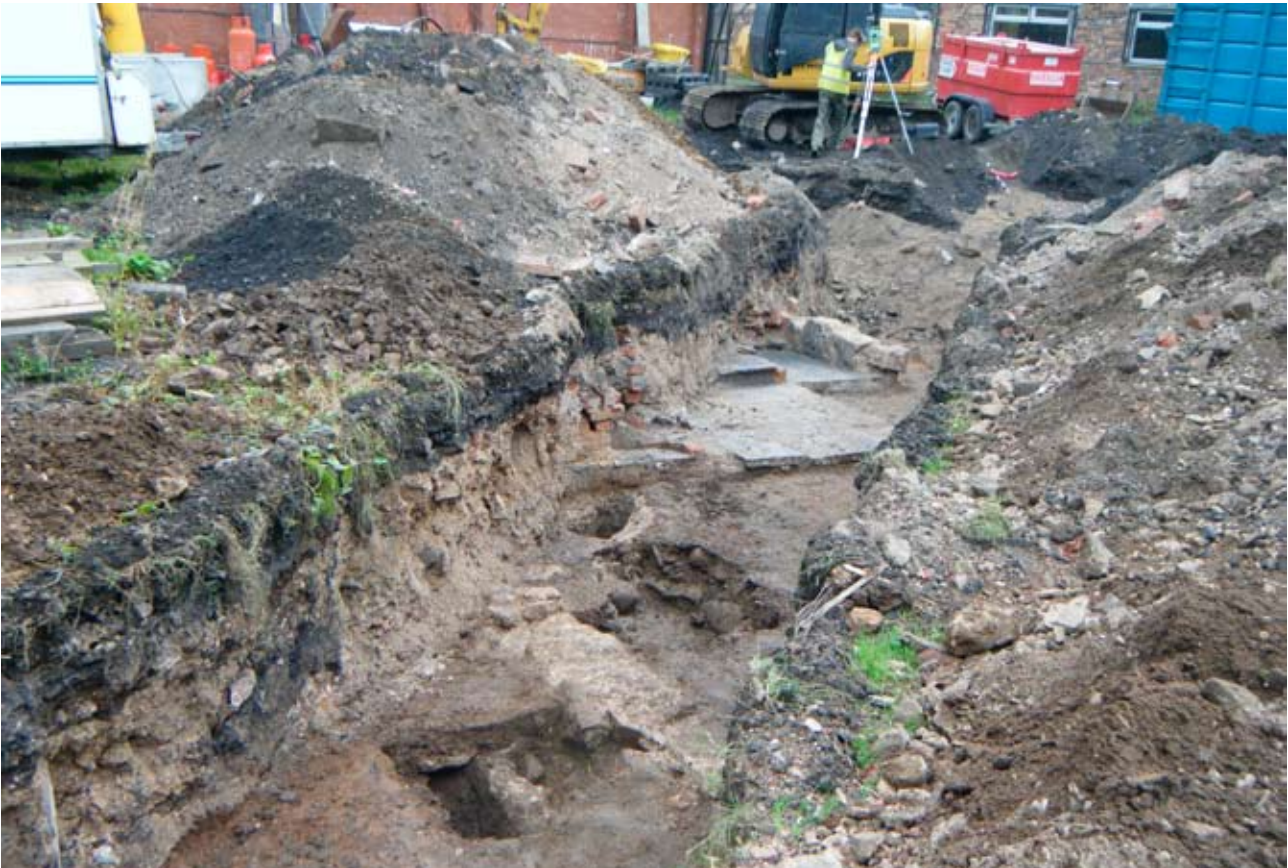
Illus 5

View of wall [009] and floor [013]

To the south of wall [009] and the two culverts was a partially surviving flagstone floor [013] consisting of very regular rectangular limestone slabs that measured up to 0.9m by 0.5m with a thickness of 0.15m. A 0.9m wide

recess, formed by a narrow factory made, brick built wall [014], was present on the southern part of the floor; the floor in this area appeared to be covered in soot. The narrow brick wall also supported a 0.37m deep stone step (Illus 5).

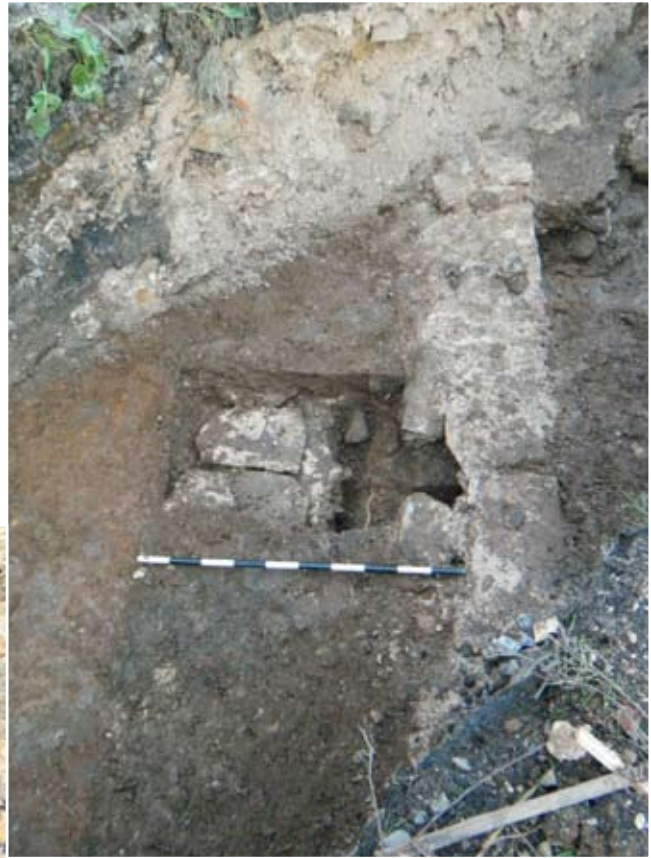
A second, less substantial wall [009], running parallel to wall [002], was found 3.5m to the south (Illus 6). This consisted of a single course of lime-mortared undressed sandstone up to 0.4m wide. On the north side of wall [009], on the same orientation, was a stone-capped culvert [008] constructed of two parallel lines of lime mortared sandstone 0.5m wide and 0.35m high (Illus 6). Several flat stones had been placed over these to cap the culvert. The culvert had silted up and contained two fills [026 and 027]. The lower fill [027] was 0.2m of dark grey sandy clay containing lime mortar fragments, animal bone and bottle glass. A similar culvert [011] was also present to the south of wall [009] except this was oriented north-west to south-east.

Illus 6 ▶
Culvert [008] and [009]

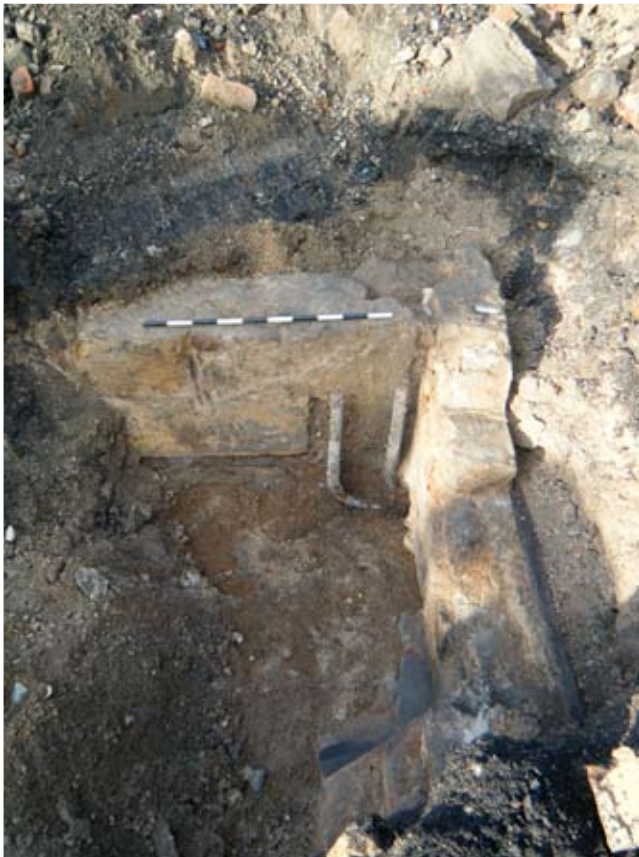
This wall was also encountered at the east end of Trench 2 where it stood to a height of 0.8m [018]. The wall returned at the end of Trench 2 where it formed the corner of a building. A large sandstone block in the return of the wall formed a possible lintel for an opening. The remnants of a single flagstone represented the remains of a floor similar to the one in Trench 1 [013]. Two cast iron pipes were located in the corner of the building and appeared to contemporary (Illus 7).

◀ **Illus 7**
View of wall [018] and floor [019]

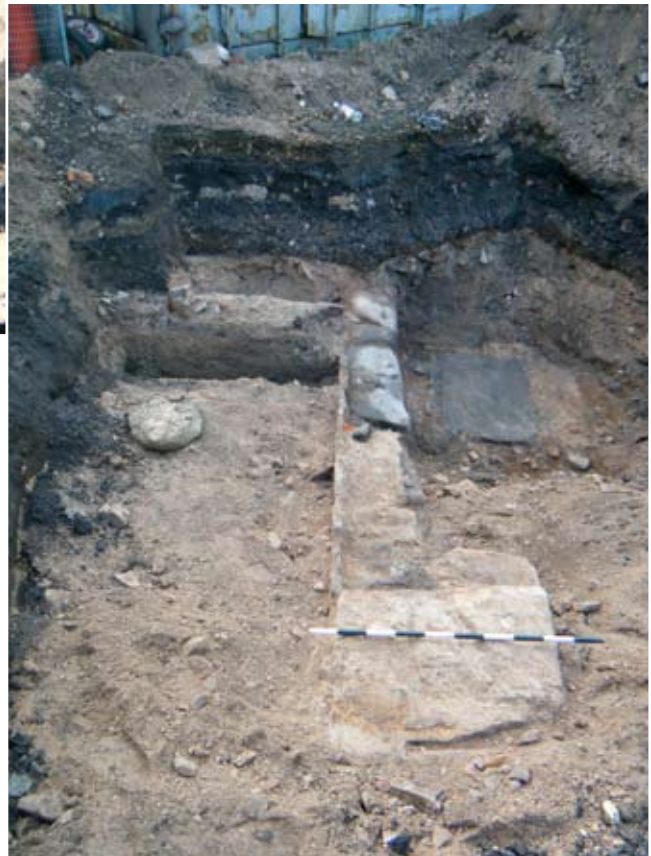
At the west end of Trench 2 was another east to west oriented wall [021] belonging to the same building

Illus 8 ▶
Wall [021] and [022]

represented by wall [018] (Illus 8). This was more crudely constructed with lime mortared roughly dressed sub-rounded sandstone and was 0.35m wide for most of its length. A single buttress was present and was 0.85m wide. This was roughly coursed to a height of 0.65m. The northern face of this wall, like wall [002] and [018], was rendered with a 20mm thick lime render with a thin, pale orange plaster skim. The southern face was rendered with cement harling. Abutting wall [021] was the remains of a floor represented by a single rectangular flagstone, measuring 0.9m by 0.55m by 0.1m, and a line of cobbles where the wall met the floor. This floor lay over a bedding of brown sand and crushed mortar [025] (Illus 9).

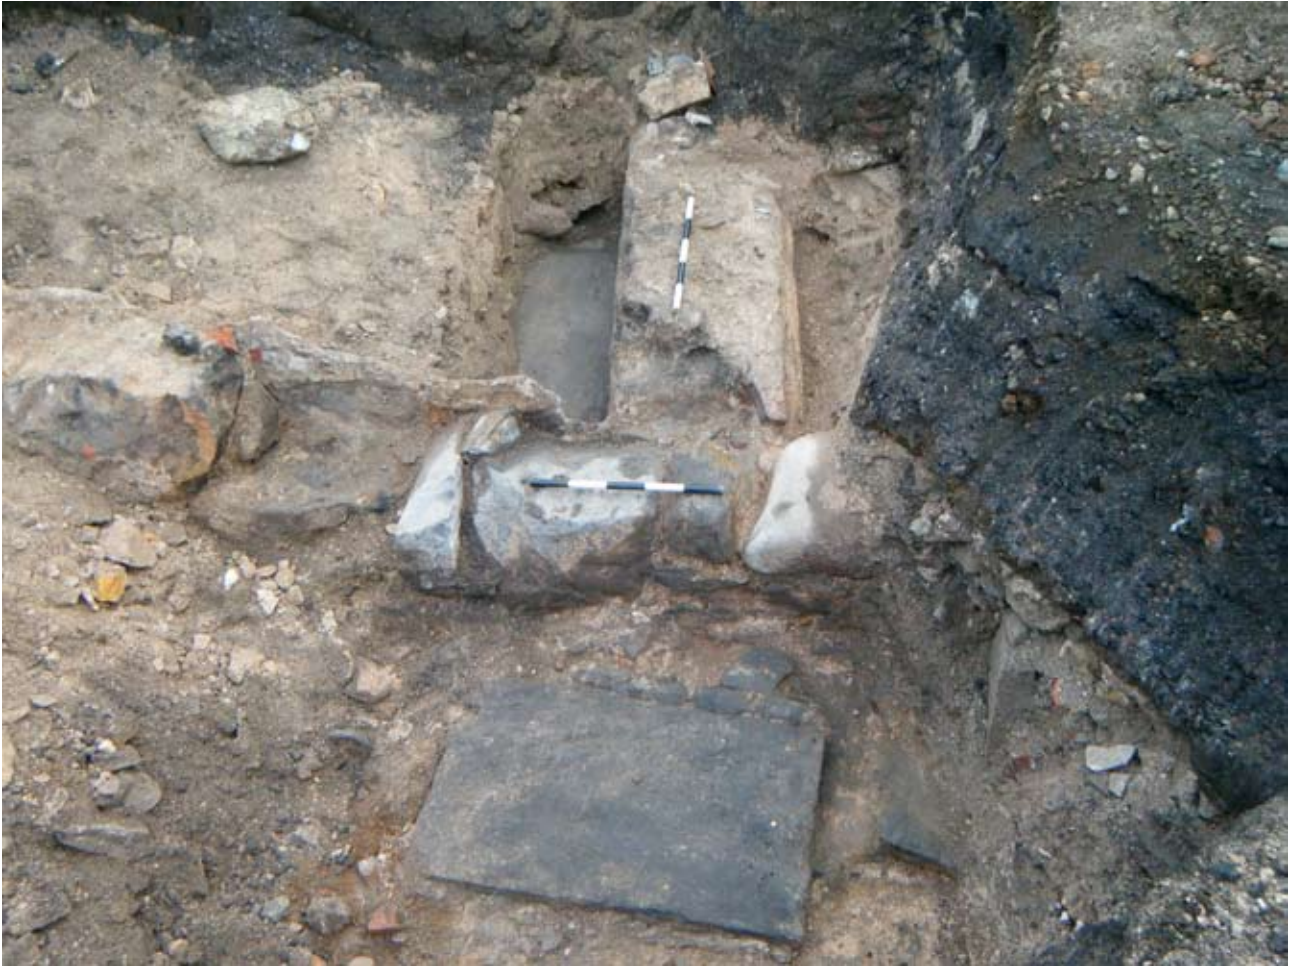
Illus 9

Wall [021], [022] and floor [024]

Another wall was present to the south of wall [021] and appeared to abut it. It was slightly thicker with a width of 0.5m. It was constructed of lime mortared roughly dressed sandstone. This wall was also rendered with cement harling where it formed a slightly acute corner with wall [021]. A very regular flagstone floor, similar to [013] was present on the east side of the wall.

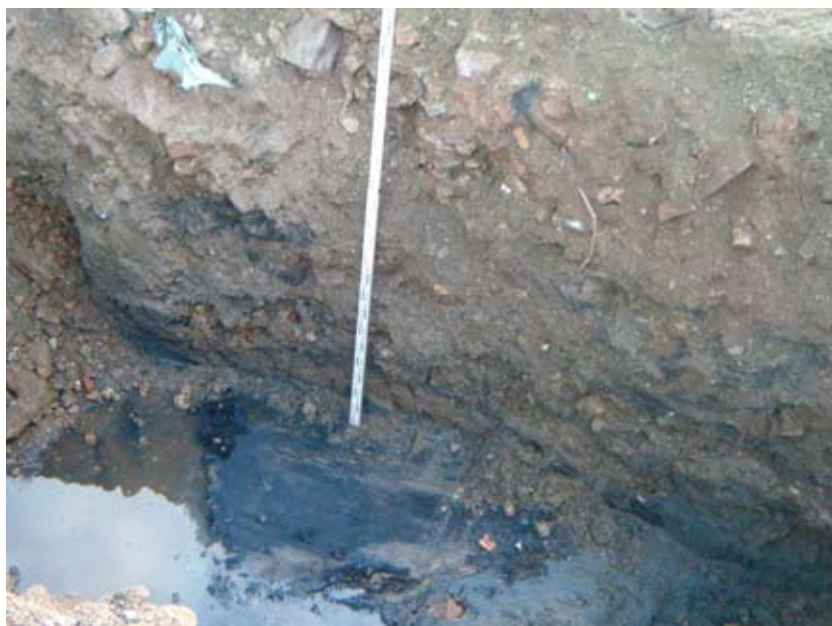
Illus 11

Wooden planks at base of Trench 4

Trench 4 and the test pit mentioned above contained the same sequence of rubble and made ground as Trench 3. A north-west to south-east oriented concrete wall of identical construction to the wall in Trench 3 was present at the west end of Trench 4. At the base of Trench 4, 2.3m below present ground surface were two rectangular areas of wooden planking with a narrow division between them (Illus 11). These had been set into the sandy blue-grey clay encountered at the base of Trenches 3 and the test pit. The planks were 0.15m wide and 0.05m thick. They were held in place by square section iron nails. It was not possible to investigate these features further for safety reasons. The structure formed by these planks respected the line of the wall present at the north end of Trench 5 [044] and it is likely that they are contemporary.

The walls encountered in Trenches 3, 4 and 5 belonged to the recently demolished 19th century mill. The wooden structure, formed by a series of planks, respects the line of these walls and is likely to be contemporary with this building. The handmade nature of the nails suggest an early 19th century date for the structure indicating they may be associated with the building’s first use. The evaluation uncovered no evidence of an earlier phase of mill.
