# Yardheads and Cables Wynd, Leith, Edinburgh

Written Scheme of Investigation for Archaeological Works

Headland Archaeology (UK) Ltd 13 Jane Street Edinburgh EH6 5HE

Client: City of Edinburgh Council

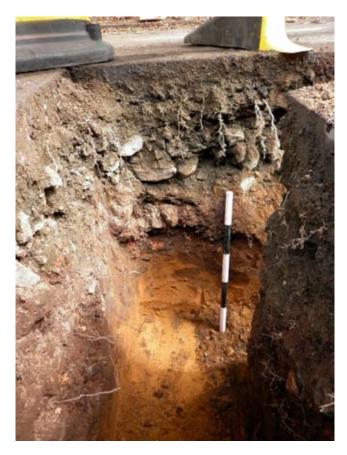
The earliest deposits exposed on site comprised beach or wind brown sands with no inclusions [021, 022] suggesting that these were formed through natural processes. Overlying these clean sands were silty sands [009, 010, 014, 020, 032] with frequent charcoal flecks interpreted as garden soils consistent with the area being utilised as backlands behind tenements.

**Illus 2**S facing section of trench showing natural sands and garden soils

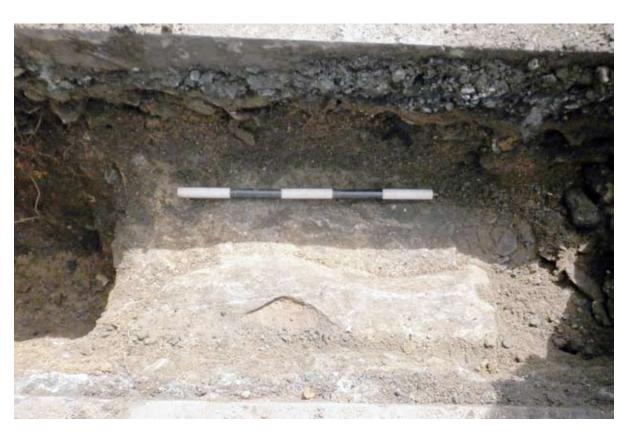
Cutting into the garden soils were four sandstone walls. Three of these [005, 015, 023] ran north-west to south-east, parallel to Yardheads. Walls [015] and [023] were constructed of dressed sandstone blocks and were thicker (0.52m and 0.74m thick respectively) than wall 005 that was 0.30m thick and of rubble construction. All of these walls were mortar bonded and where coursed [015 & 023] survived 2 courses high. The fourth wall [035] ran perpendicular to the others on a north-east south-west alignment. This was constructed of roughly squared sandstone blocks bonded with lime mortar and was 0.80m wide. Overlying these walls were deposits of crushed sandstone and brick that appear to be demolition deposits. Above the demolition deposits lay the tarmac and topsoil.

| Context | Description | | | |
|---|---|--|--|--|
| 023 | Sandstone wall foundation running E-W, constructed of squared sandstone blocks laid 1 course wide and surviving 2 courses high. Measures 0.76m wide and runs across the full width of trench. | | | |

Illus 3 Wall [023], facing E

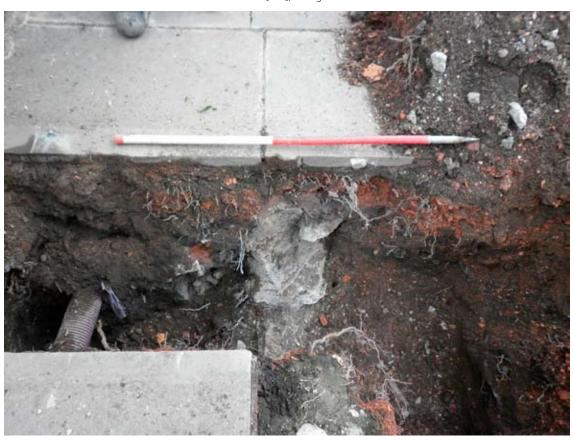
The walls seen across the site tie in well with the mapped evidence for the Lochend distillery depicted on the Ordinance Survey 1<sup>st</sup> edition mapping of the area of 1849-53. This distillery is thought to have been established by 1825. The demolition deposits overlying these walls probably originated in the demolition of these distillery buildings.

**Illus 5**Demolition deposits of brick and sandstone
