KEADBY WIND FARM, NORTH LINCOLNSHIRE

Report on audit of the construction stage of individual turbines and recording of peat deposits and presence of fossil wood encountered during construction

commissioned by SSE Renewables

May 2013

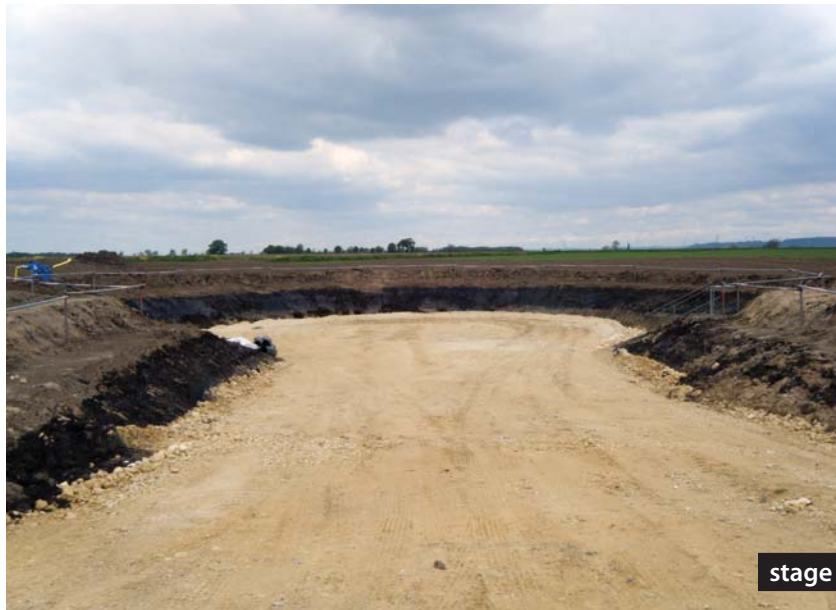
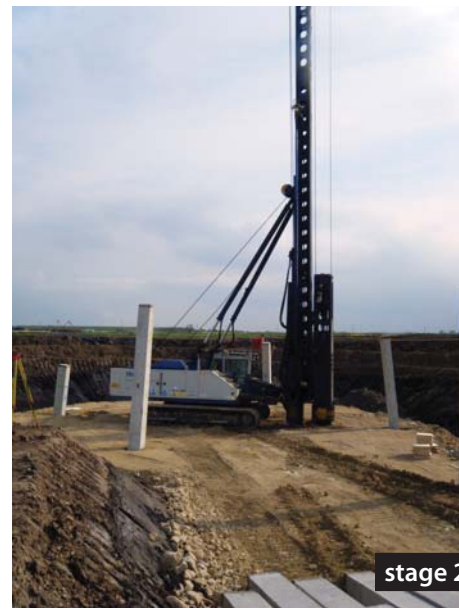
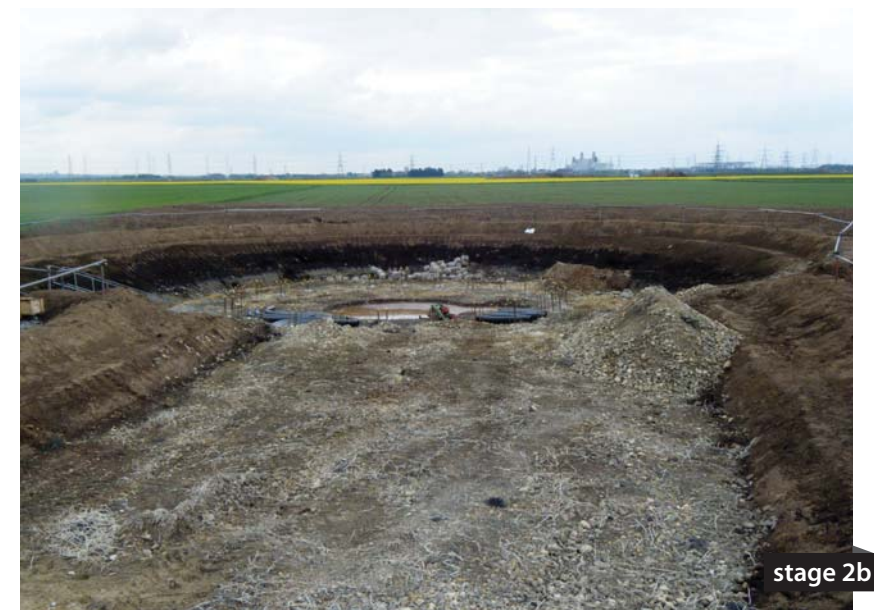
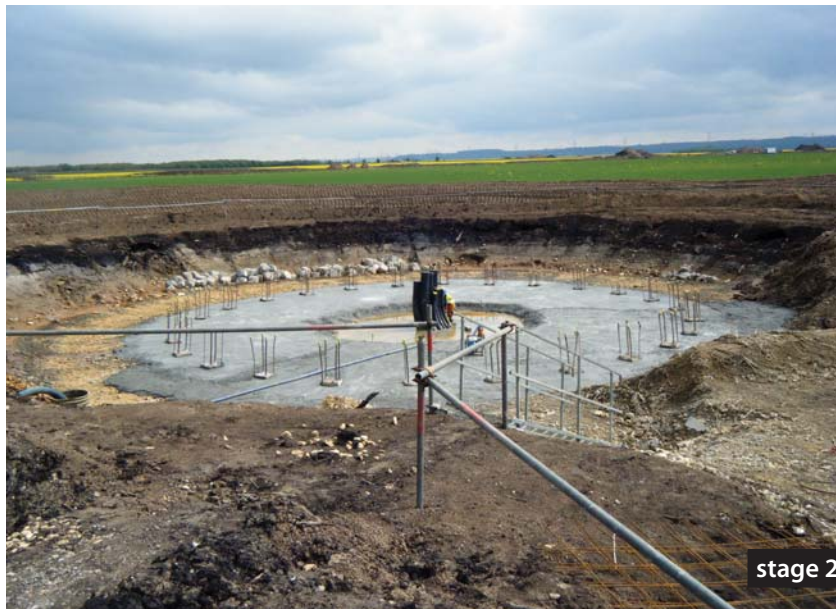
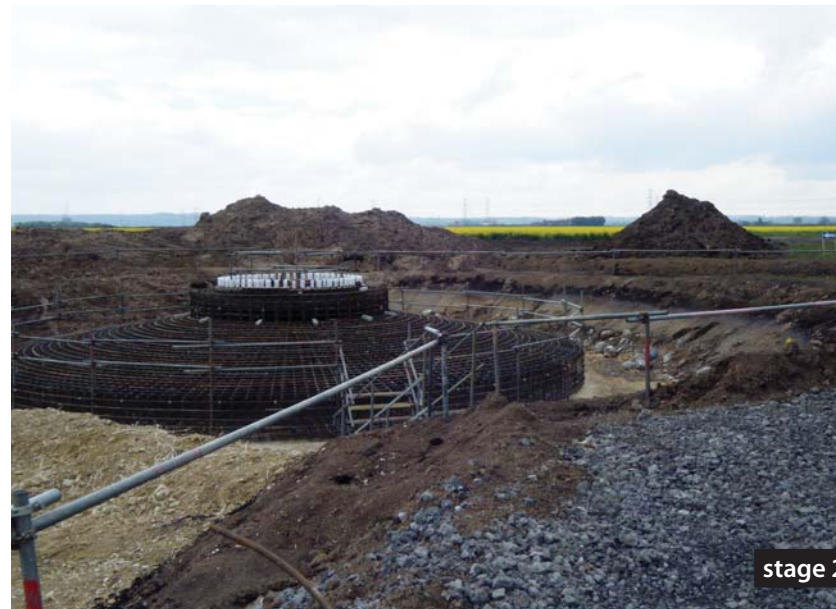
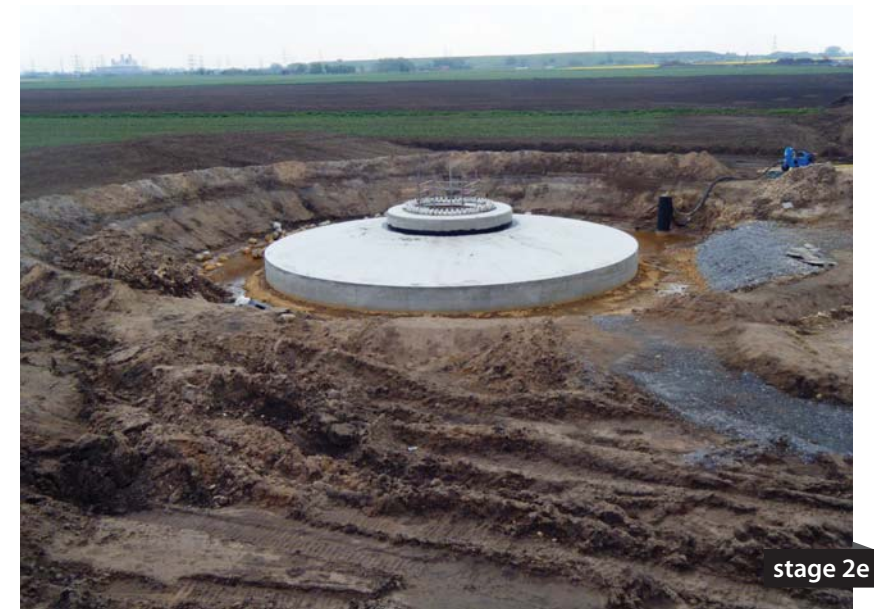
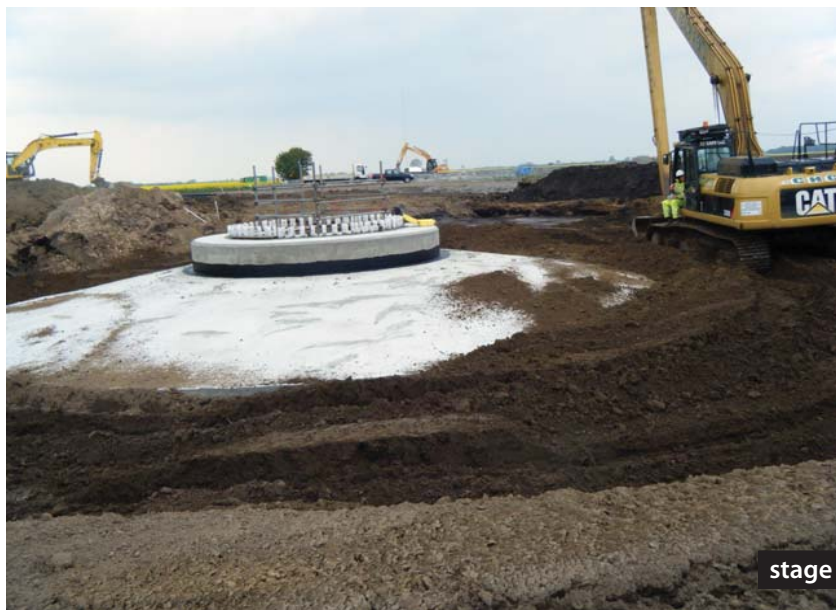
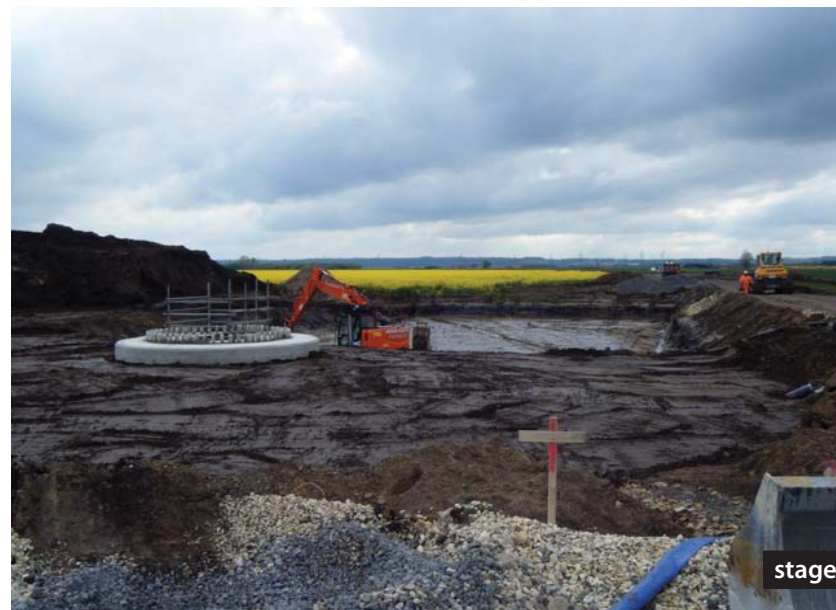
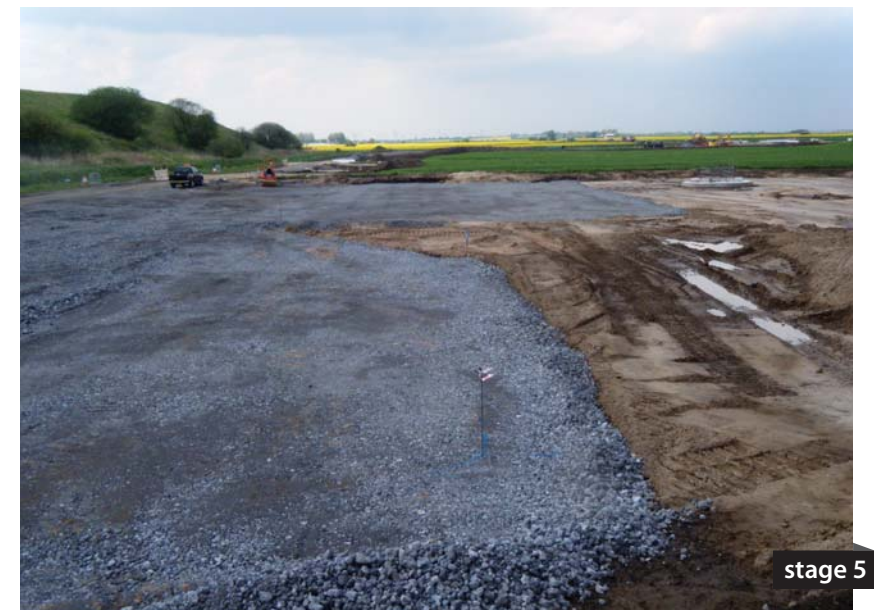
Illus 2
Different stages of turbine construction

The stages of construction were grouped into five levels (*Illus 2*):

Stage 1 Turbine base pit excavated and levelled. Construction of concrete turbine base not started

Stage 2 Turbine base pit excavated and levelled. Concrete turbine base at various stages of construction

Stage 3 Turbine base built and pit backfilled

Stage 4 Turbine base built and pit backfilled, hard standing excavated

Stage 5 Turbine base built and pit backfilled, hard standing backfilled

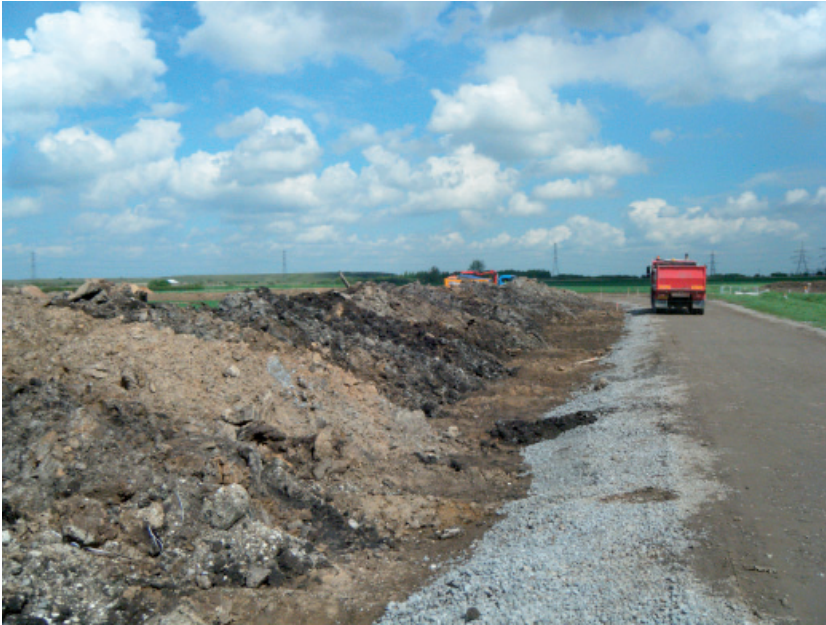
Illus 3

Fossil wood within peat spoil heap on the west side of road leading south to Turbine 06, facing north

Peat containing fossil wood was also noted in spoil heaps along the access roads at several locations indicating that peat deposits had been encountered during the road construction ([Illus 3](#)).

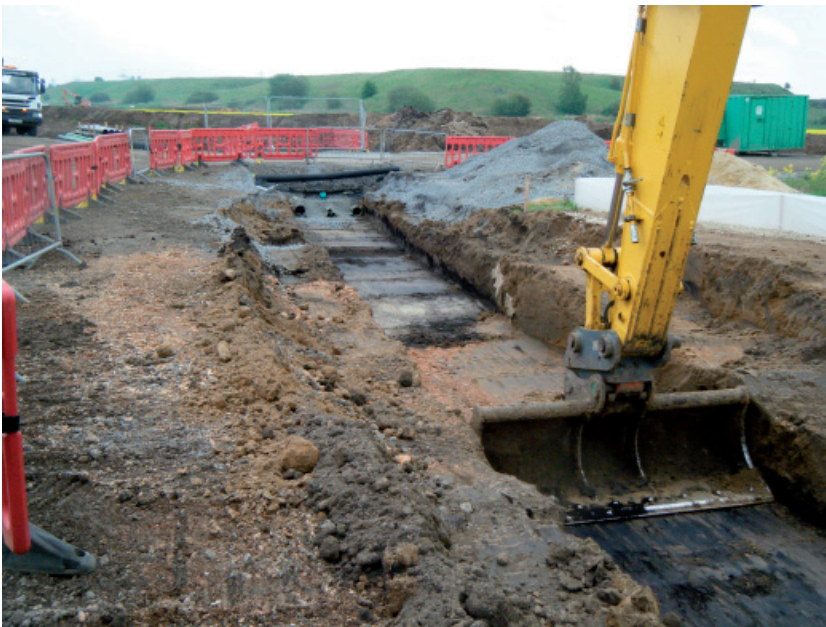
Illus 4

Peat deposit exposed in cable trench at T-junction to the south of Turbine 17, facing south

In addition to the construction of roads and turbines a network of cable trenches are required to lead the power from the turbines to the sub-station. These are generally excavated to a shallower level than the cuts for turbines and roads. Nonetheless, peat was exposed in open cable trenches seen during the visit ([Illus 4](#)).

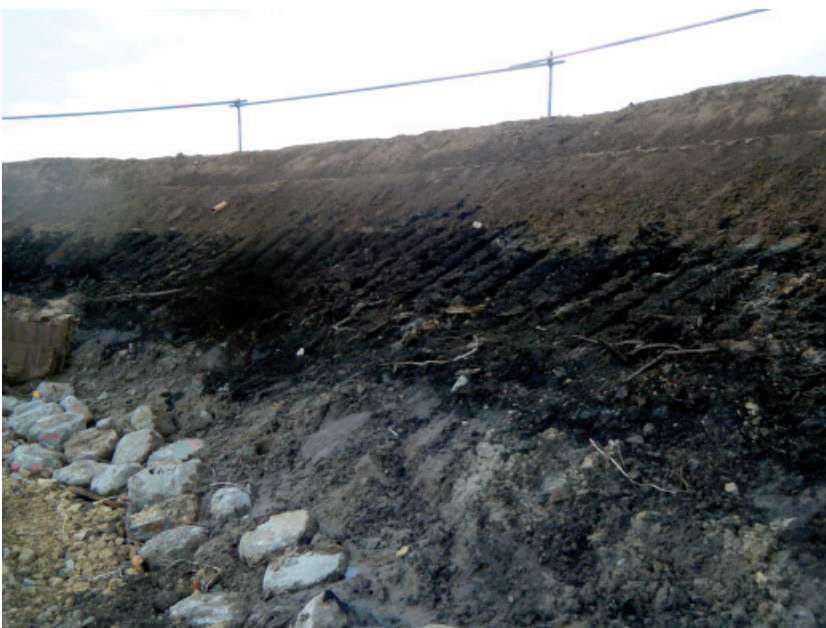
Illus 5

Horizon of fossil wood exposed within peat deposit in cut for Turbine 34, facing south

Layers of in situ peat were seen at 23 turbine locations. Some of these deposits were fairly thin but there is a clear trend of increasing thickness of the peat deposits towards the north of the site, confirming the peat depth projections based on the coring data. This peat corresponds to the previously identified 'Peat 3', identified as dating to the period ranging from the Neolithic to the Iron Age (Dalland & Timpany 2013). The deepest deposit was recorded at Turbine 34 where the peat was up to 1.9m thick.

In broad outline, the construction sequence comprises the following sequence of ground works. Firstly, the turbine base is excavated and the concrete foundation put in place. Secondly, once the base has been backfilled, the larger areas for the hard standing are then excavated and backfilled. This construction sequence has progressed from south to north. As a result of this most turbines located to the south of the Stainforth and Keadby Canal had reached Stage 5 with no opportunity to examine any exposed peat horizons. However, significant peat deposits with a high content of fossil wood were recorded in cuts for the turbine bases on the north side of the canal. In some places the fossil wood was concentrated forming a distinct horizon within the peat layer ([Illus 5](#)).
