## GRIFFIN WIND FARM, PERTH & KINROSS

*Survey of the abandoned townships of Blairnabuiag & Riebeg*

*for Griffin Wind Farm Ltd*

*March 2012*

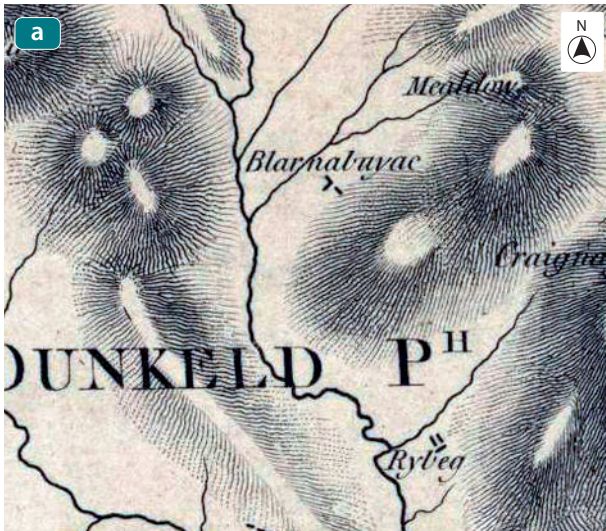
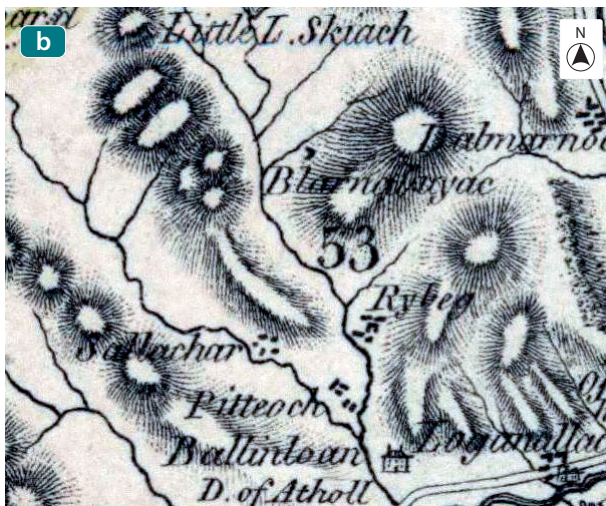
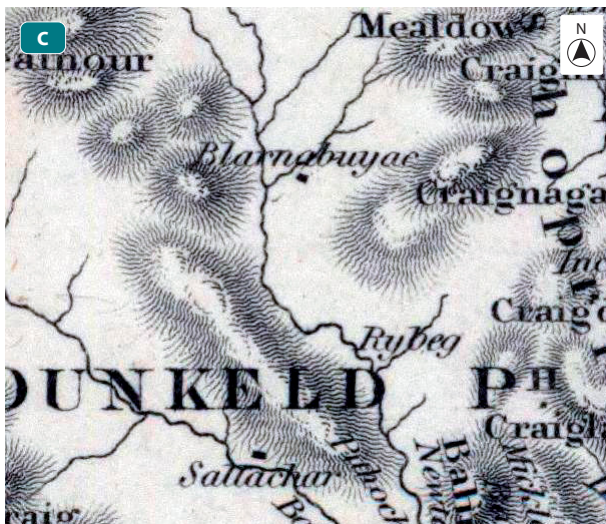
Illus 2a-c

The townships depicted on 18th maps; a) 1783 Stobie map, b) 1805 Stobie map, c) 1827 Thomson map (maps not to scale)  
 © Reproduced by permission of the Trustees of the National Library of Scotland

Neither of the townships is depicted on Roy's mid-18th century map. Both first appear on Stobie's map from 1783 (Illus 2), possibly indicating that the settlements were established in their present form in the third quarter of the 18th century. Both townships are also depicted on Stobie's 1805 map and on Thomson's map of 1827. The first detailed survey of the townships appears on the first edition Ordnance Survey map of 1863–4 (Illus 2d), at which time the buildings at Blairnabuiag are noted to have been '*in ruins*'. The same map depicts Riebeg as a single roofed building with an enclosed patch of ground in the area to the south of the burn; to the north of the burn lies the sheepfold and its adjacent shepherd's house.

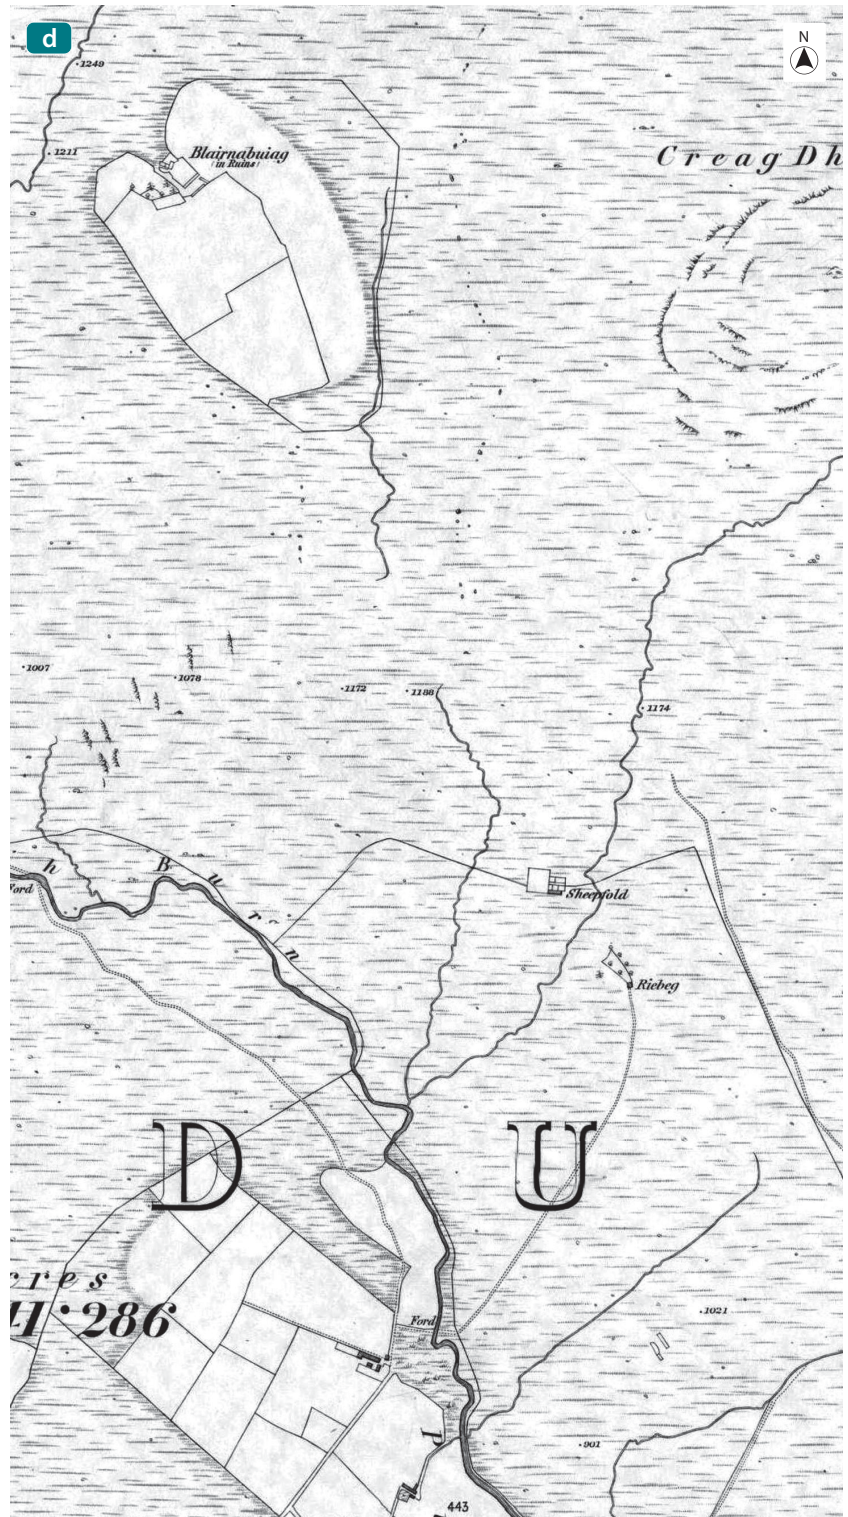
Illus 2d

Blairnabuiag and Riebeg: 1863 OS map (not to scale)  
© Reproduced by permission of the Trustees of the National Library of Scotland

The 19th century OS maps show a road leading up to Riebeg from Pitleoch, some 800m to the southwest (Illus 2d). At the end of the road the map depicts a rectangular roofed building situated at the southeast end of a sub-rectangular enclosure. The survey located a series of dykes and features that are likely to have been part of the old township but failed to identify the remains of the building and the enclosure shown on the maps. The early dykes were not mapped on any of the 19th century OS maps, but some segments are depicted on the current map, probably because they can be seen on vertical aerial photos on which the modern map is based.

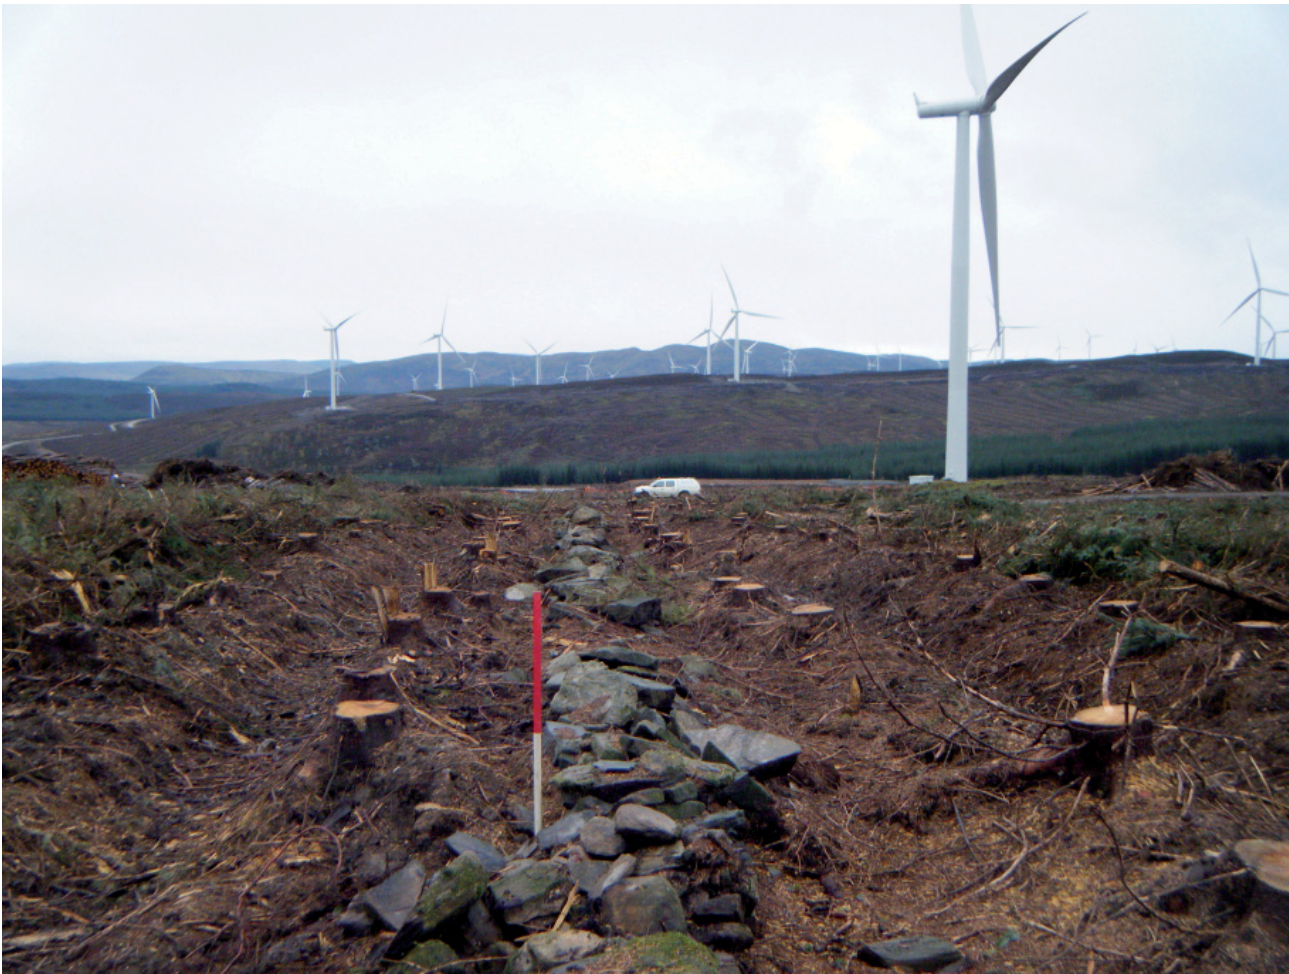
Illus 5

*Dyke [276] from the E*

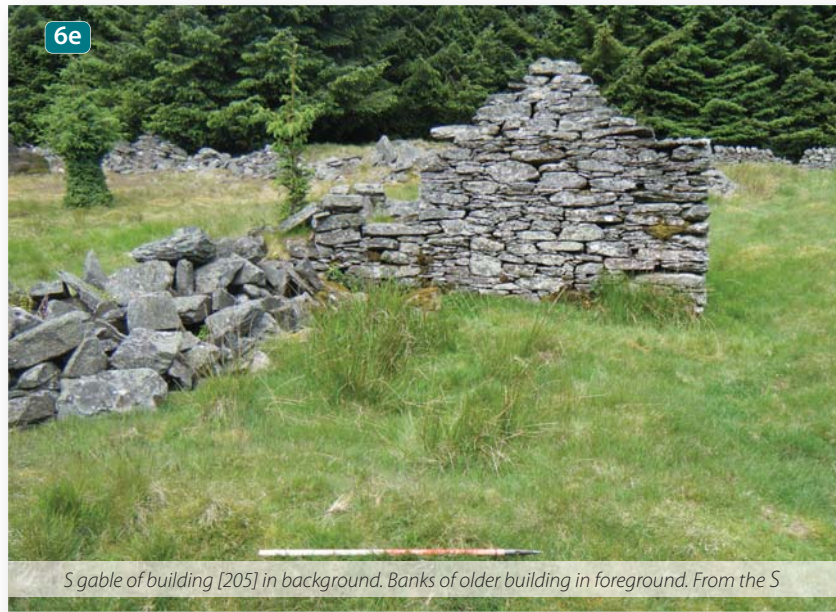
S gable of building [205] in background. Banks of older building in foreground. From the S

Building [205] is located on the north-west side of Enclosure F. The south gable stands to a height of 2.35m. It contains a splayed recess for a window, 0.52m wide and up to 0.6m high. Deep rubble covers the side walls obscuring any evidence of a door opening. Immediately to the south of [205] is an L-shaped turf-covered stony bank indicating the location of an older building [207] (Illus 6e).

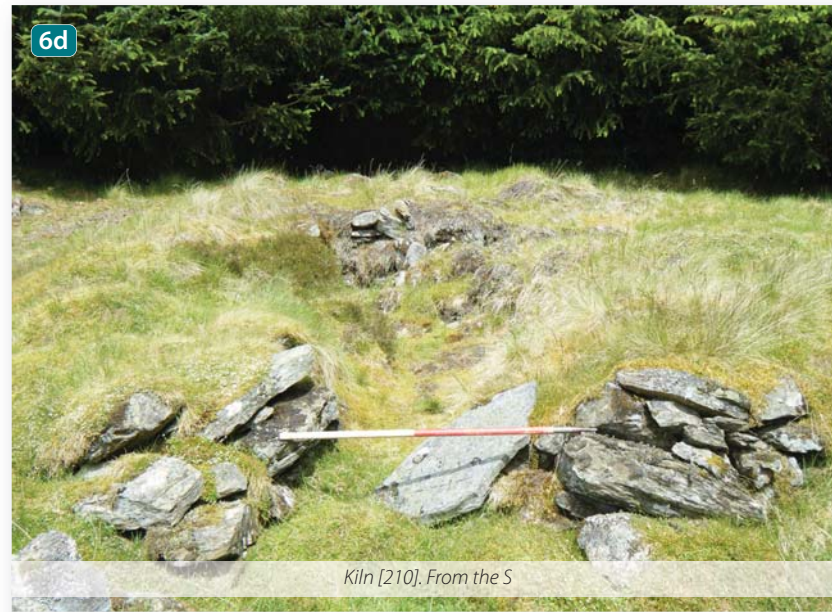
Kiln [210]. From the S

A kiln [210] is located to the north of [211] (Illus 6d). It is oval in form with a flue located to the south-west. There is a narrow gap between Buildings [209] and [211] that allows access to the kiln from the courtyard. A small building [208], possibly associated with the use of the kiln to the east, abuts the north-east end of [209].

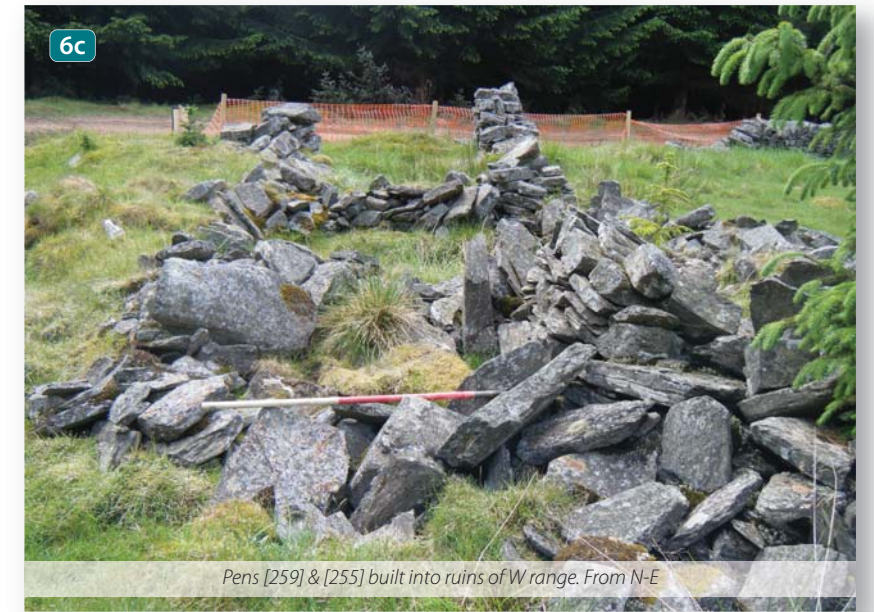
Pens [259] & [255] built into ruins of W range. From N-E

The north-west range is less well preserved. Building [209] survives up to a height of 1.2m at the north-east corner, but the south-west half of the building is barely visible. A 1m wide doorway is located in the north-west wall leading into Enclosure F. A rectangular platform, aligned with the north-west range and similar in width to Building [209], is likely to indicate the position of another building in this range. With the exception of a short wall segment [254], the building has been completely removed. A series of later small rounded pens, [213], [259] and [255] (Illus 6c), are built within and to the south-east of the foot-print of [254]. These are likely to be sheep pens built from and into the ruins of the north-west range.

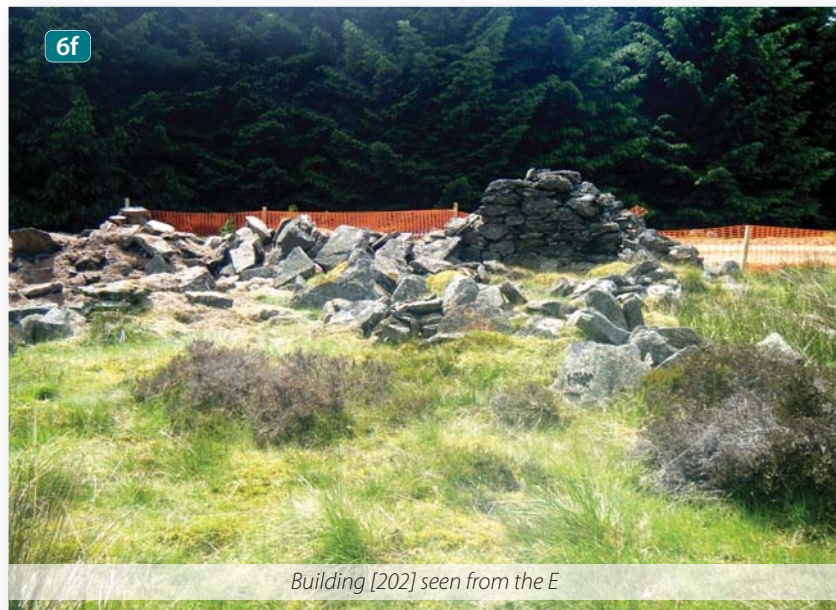
Building [202] seen from the E

Building [202] is located to the west of [205] and is aligned east to west. The western end is better preserved with the gable end upstanding to a height of 1.3m (Illus 6f). The eastern end of the building is buried under a heap of rubble. A gap in the north wall may have been the original entrance into the building. There are several heaps of rubble between Building [205] and the forestry track some 10m to the south. Two curving banks [204] and [268] emerging from beneath the rubble may be remains of older structures.

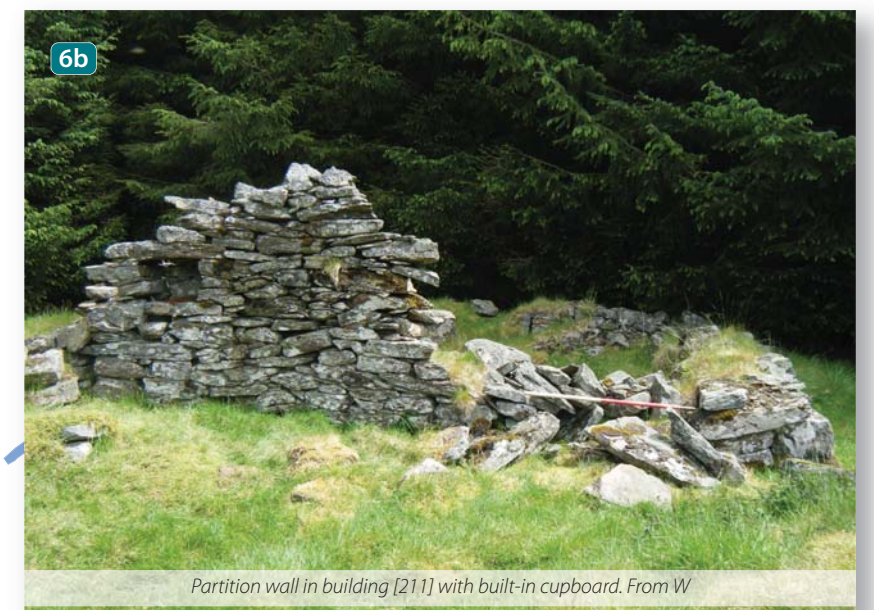
Partition wall in building [211] with built-in cupboard. From W

The north-east range comprises one building [211]. It is divided into two rooms; a larger room to the west with a smaller room to the east. The walls of the smaller room are narrower, and it appears that it has been added at a later stage. The partition wall between the two rooms is 1.8m high and has a constructed cupboard, 0.4m by 0.3m and 0.35m deep, built into its east side (Illus 6b). The building is set at an angle, creating a gap between the north-east and south-east ranges allowing access into the field to the north around the east end of [211].

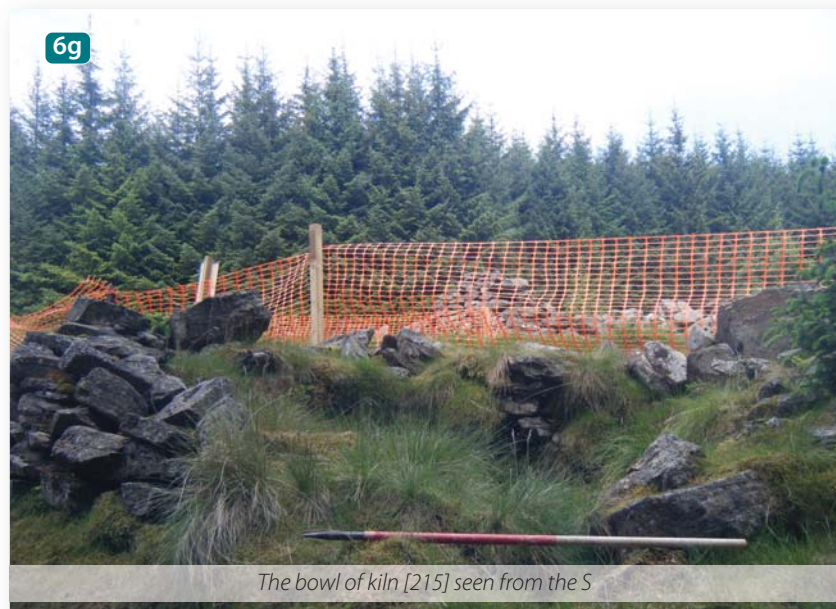
The bowl of kiln [215] seen from the S

A second kiln [215] is located some 10m to the south-west of [202] (Illus 6g). It is sub-circular in plan, 4.9m long, 4 m

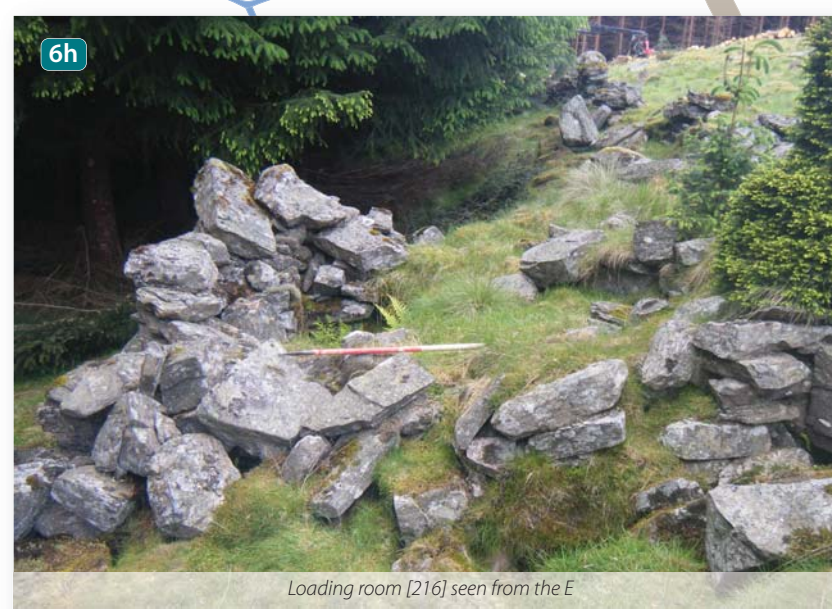
Loading room [216] seen from the E

wide and 1.1m deep and set into a corner of the head-dyke. A rectangular loading room [216] is located on the south side with a flue, measuring 1.1m wide and 0.58m deep, linking the two structures (Illus 6h).

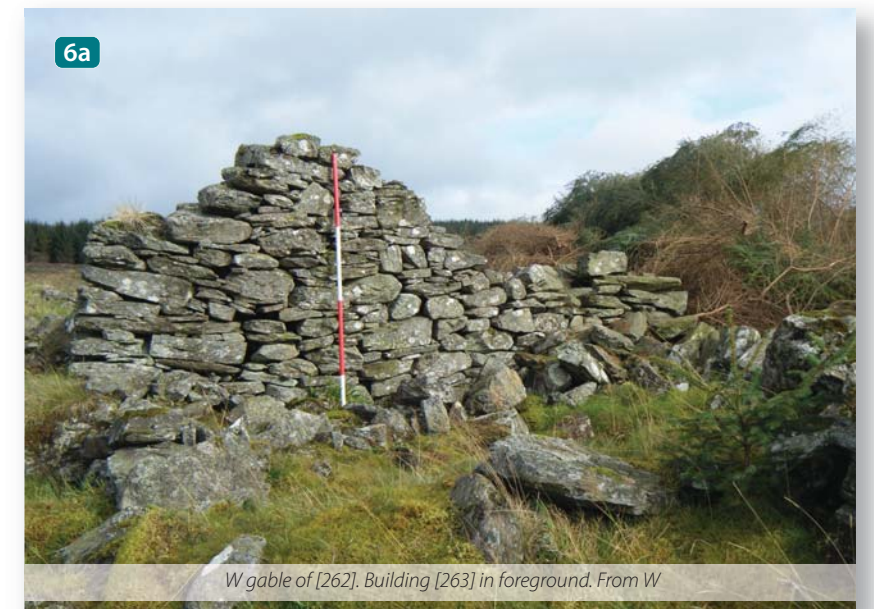
W gable of [262]. Building [263] in foreground. From W

The majority of the buildings are set into three ranges forming a U-shaped courtyard to the south-east of Enclosure F. The south-east range comprises four buildings, [261]–[264]. Building [262] was built first, with [263] added on to the south-west side (Illus 6a). The two structures are the same width and might be roughly contemporary. At a later stage the narrower structures [261] and [264] were added to either end of the two older

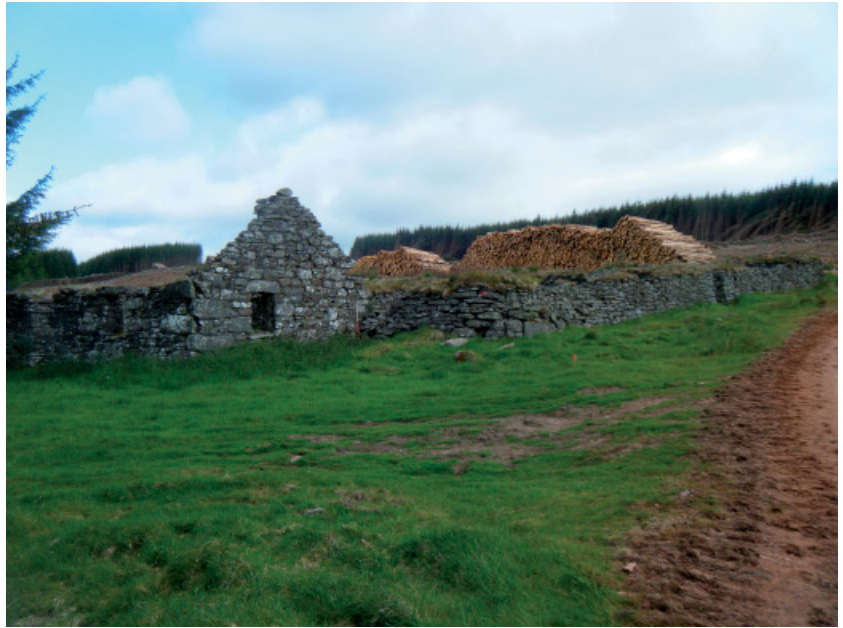
Illus 9 ▶

*Sheepfold and shepherd's building at Riebeg.  
From the S-E*

Building [243] is attached to the south-east side of the sheepfold (Illus 9). The roof and the west gable are missing but the rest of the wall-heads survive intact

with the exception of the west end of the building. The walls comprise mortared roughly dressed stone and are 0.8m to 1m wide. The east gable stands to a height of 3.75m, the other walls are generally 1.9m high. There are four 1m wide doorways leading into the building, two in the north wall and two in the south wall. A pile of rubble in the middle of the building is probably the remains of an internal wall dividing the building into two rooms. There are two windows in the east room, one in the east gable and the other in the south wall. Both windows had a stone lintel and sill, with a wooden lintel on the inside.

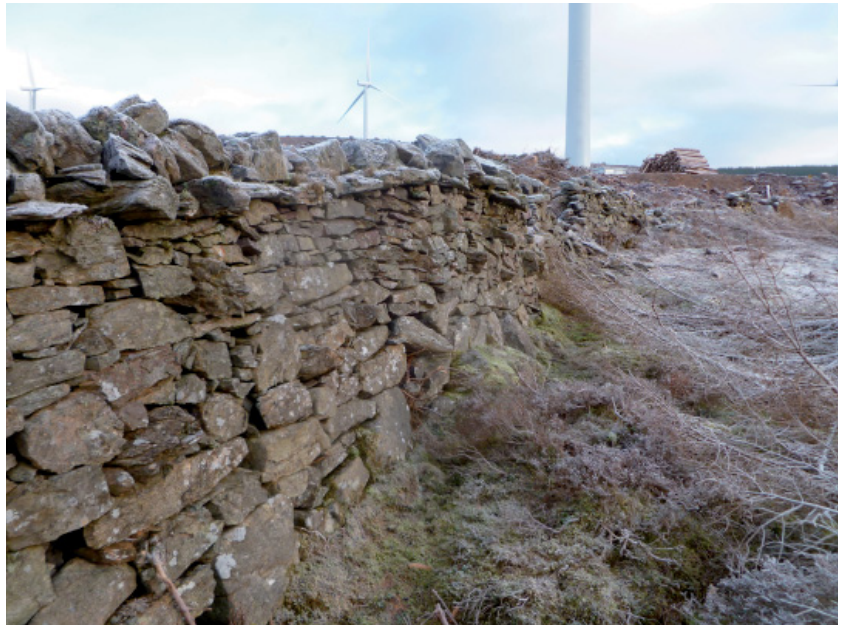
Illus 10 ▶

*[280], 18th century stone dyke. From the S-W*

Dyke [280] is some 550m long. It runs west from the sheepfold for some 250m before turning down-slope towards the Pitleoch Burn to the southwest where it abuts dykes running south along the burn. Dyke [281] is in line with [280] on the east side of the sheepfold. It runs some 220m towards the east before turning 90 degrees south. It is depicted on the modern map running south for some 1.7km before turning west and joining the dyke that runs north along the Pitleoch Burn.

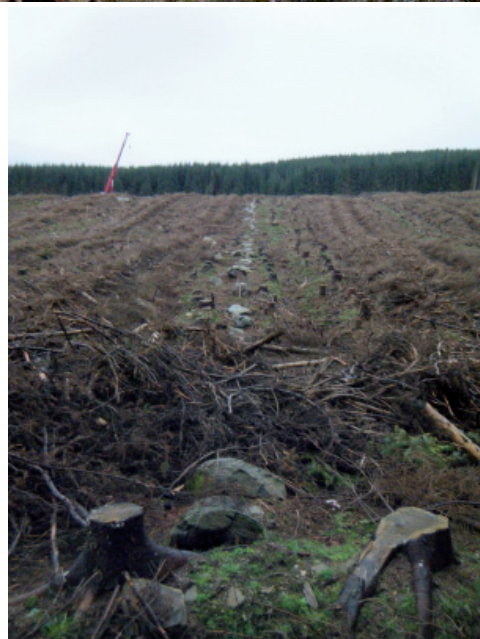
Illus 11 ▶

*[282], ruinous stone dyke. From the S-W*

outline of rectangular fields and enclosures. Dyke [282] runs straight for a distance of 147m from the north-east to southwest (Illus 11). It is reduced to an intermittent line of boulders in places and appears to be in line with the southwest segment of dyke [253] some 95m to the southwest. Dyke [221] is on a similar alignment but offset some 20m to 30m to the southeast. Only a 70m long stretch of the north end was surveyed. It is mapped on the current OS map showing that it extends a further 86m down slope to the south-west before turning southwards. The bank appears as a single line of stones, some lying horizontally, others set vertically (Illus 12). It is up to 0.5m wide and 0.3m high. There is a gap in the feature 24 m from its north end where a track-way [222] cuts across the dyke.

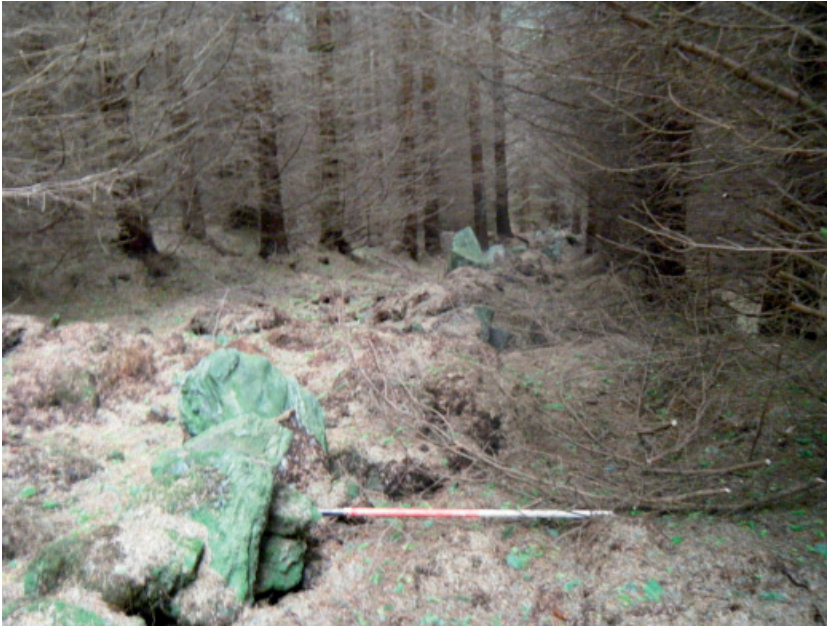
◀ Illus 12

[221], ruinous stone dyke. From the N-E

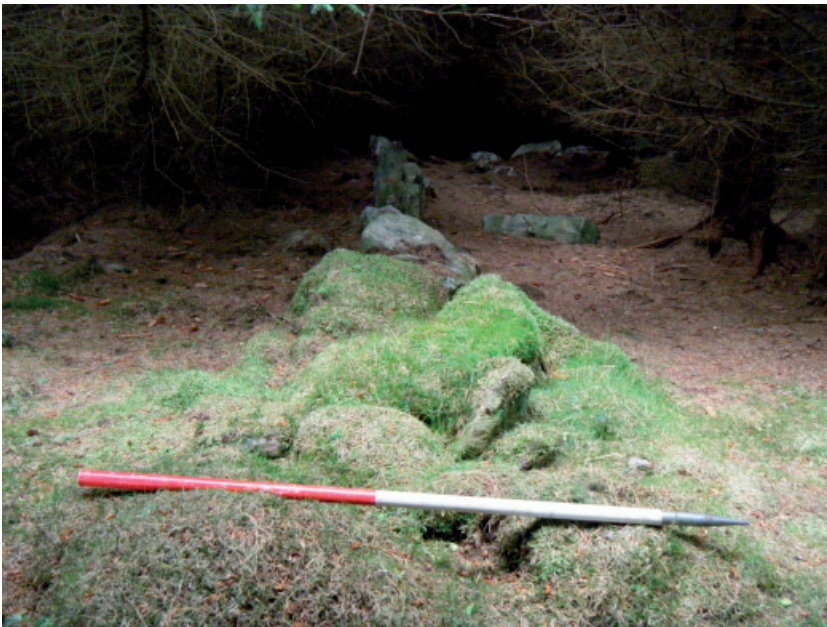
◀ Illus 13

[251], ruinous stone dyke. From the N-W

Dykes [251] and [285] are in line on a northwest to southeast alignment. Most of the dykes are defined by a line of stones of various sizes, some set on edge (Illus 13). Dyke [285] appears to terminate at the projected junction with Dyke [282], some 40m to the north-east. The two dykes, therefore, may be part of a contemporary field system.

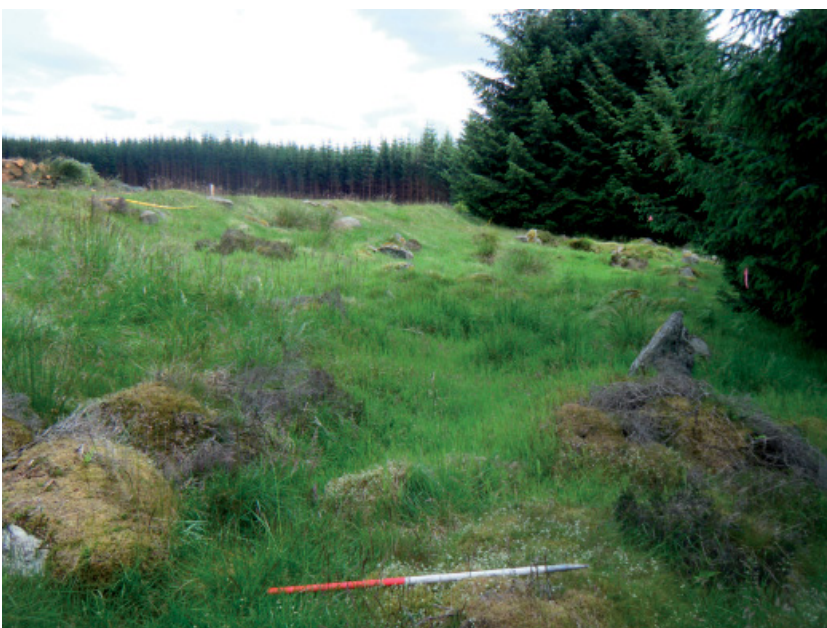
◀ Illus 14

View towards enclosures [233-6]. From the N-W

To the southeast of [237] are four sub-rectangular enclosures set up against the north side of Dyke [251] (Illus 14). Enclosure [236] at the north was identified on the basis of the return wall which forms the end of Dyke [251]. Most of the north-east long wall, however, is missing. The walls are low, mainly only one course high and up to 0.7m wide. Internally the structure measures 21m long and some 5m wide.

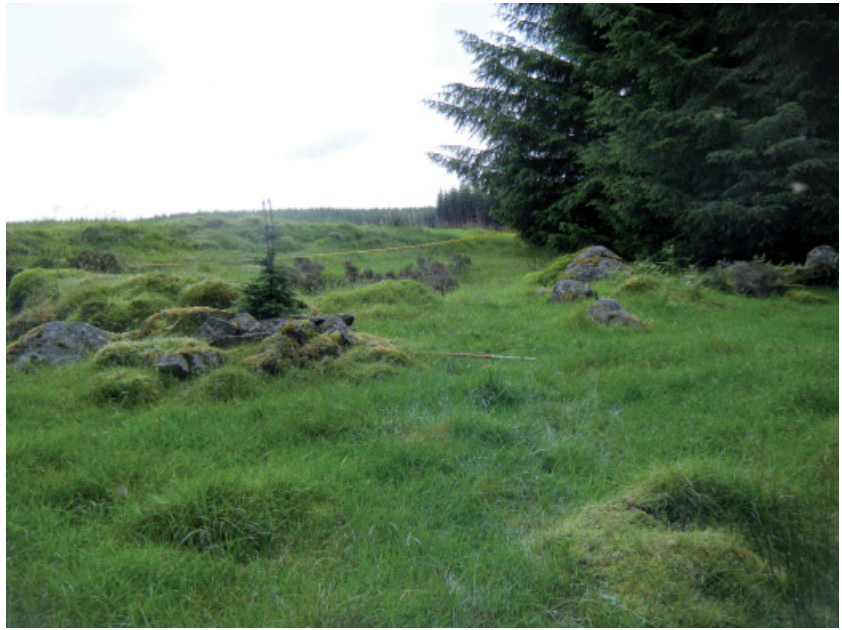
**Illus 15** ▶

*Enclosure [233] seen from the W*

Enclosure [233] is located southeast of and in line with [234]. The structure is defined by a marked cut into the slope to the northeast and the wide turf and stone bank to the northwest forming a rectangular shape 7m long by 5m wide (Illus 15).

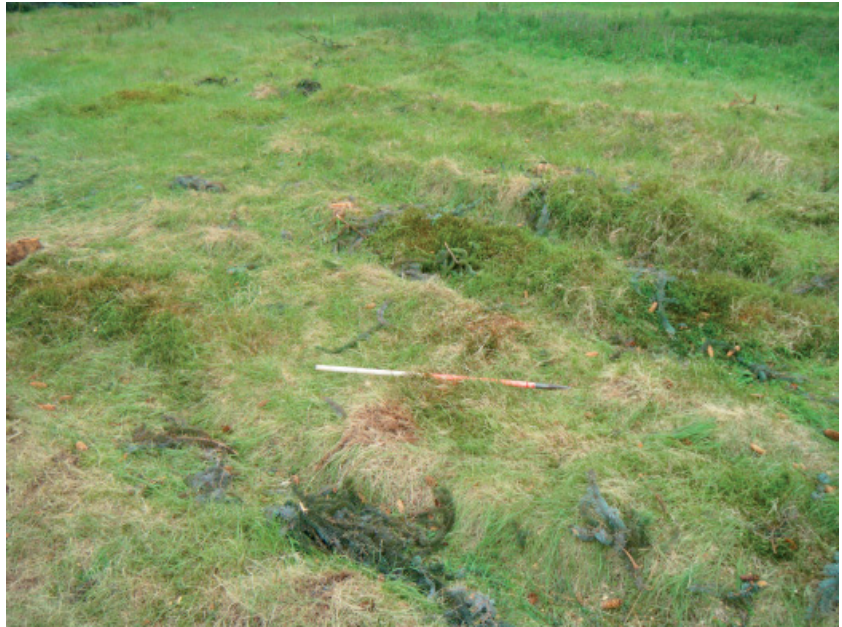
**Illus 16** ▶

*Cultivation furrows [217] seen from the N*

Some 4m to the south of [220] is a set of short linear banks and ditches covering an area of 6.2m wide by 8m long (Illus 16). The banks are spaced 0.4m apart and are 0.2m to 0.5m wide and 0.35m deep. A mound lies immediately to the west of the feature. The sides of the ditches are

almost vertical, suggesting that this feature is fairly recent. The size and layout of the feature indicate that it may be a small cultivation patch, possibly lazybeds.

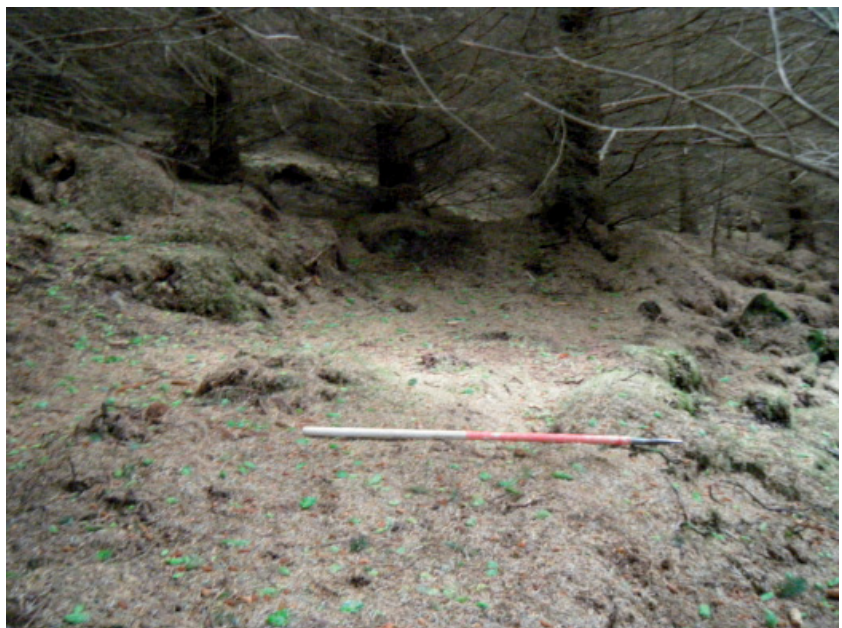
**Illus 17** ▶

*Segment of Track [222] seen from the N-W*

Remains of an old road [222] were recorded cutting into the southwest facing slope to the south of Riebeg. The road is aligned north-northwest to south-southeast. It is up to 2m wide and has been truncated by plantation furrows that make it difficult to trace through the forest (Illus 17). The best preserved segment is where it was seen to cross Dyke [221]. It is likely that it is part of the road that formerly led up to the old settlement at Riebeg from Ballinloan to the south.

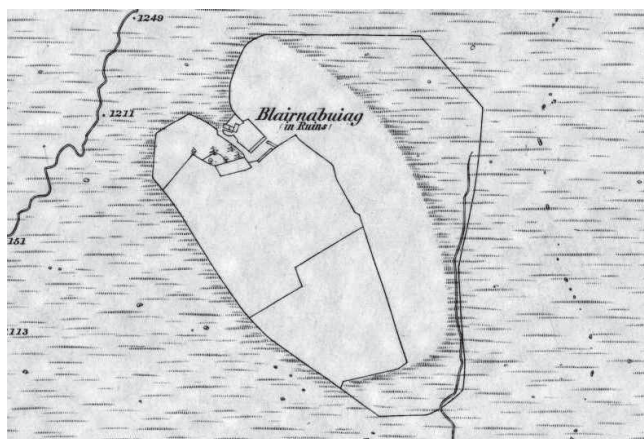
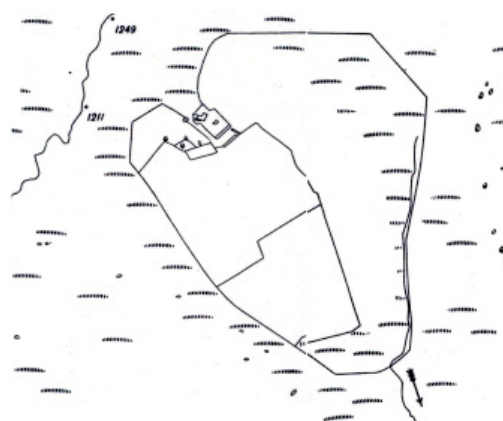
Illus 18

Layout of Blairnabuiag as shown on the two 19th century OS maps (1863 & 1898)  
© Reproduced by permission of the Trustees of the National Library of Scotland

The two 19th century OS surveys are almost identical (Illus 18), the only difference being the kiln at the west end of the township that was omitted on the earlier map but recorded in the 1898 survey.
