MID-HERMISTON STEADING, 58 HERMISTON

Archaeological Watching Brief

commissioned by Credential (Hermiston) Ltd

June 2013

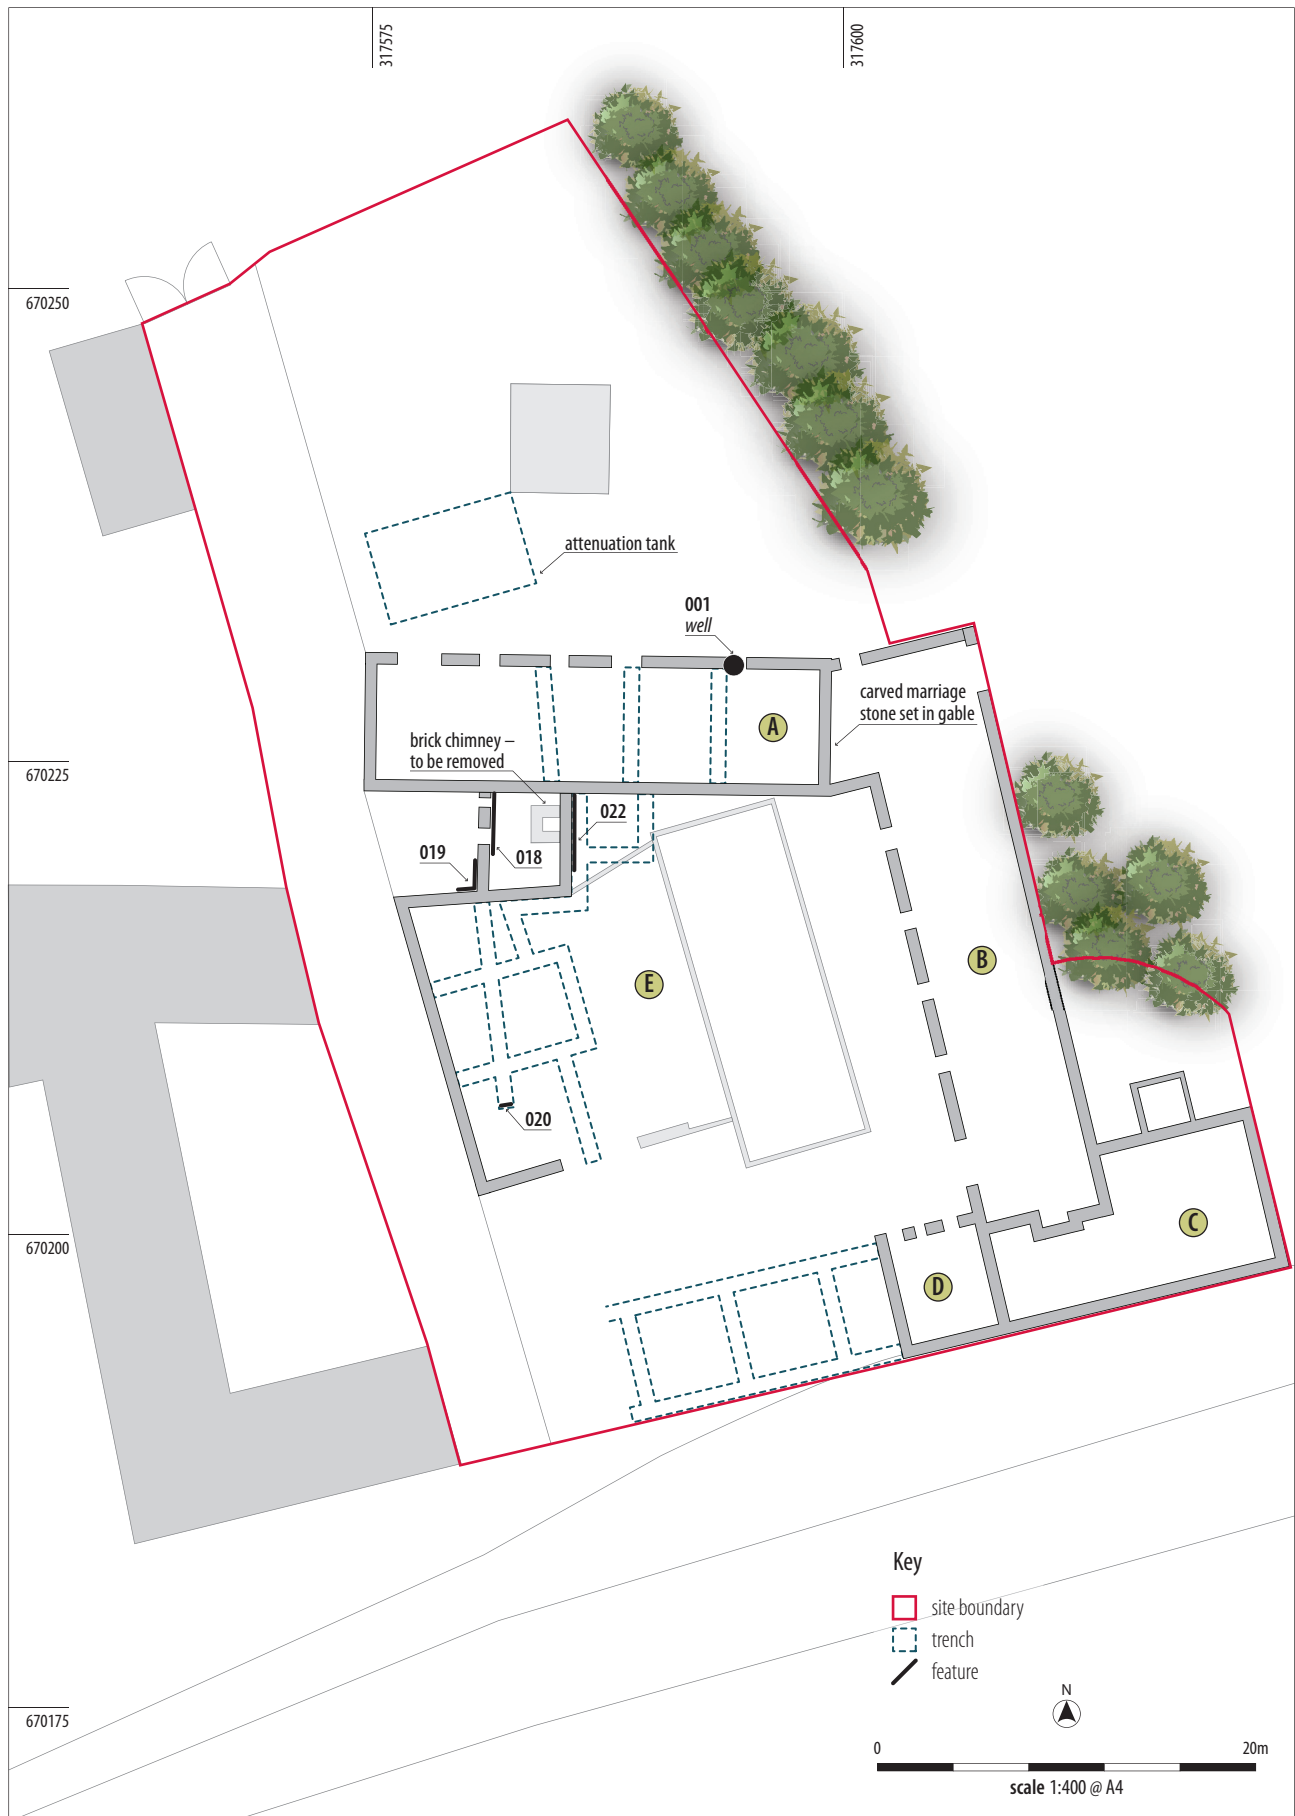
Illus 2

Plan of recently demolished building foundations and trench locations

All foundation trenches and service trenches excavated as part of the new development were monitored by an experienced archaeologist. Many of the trenches followed the line of the earlier buildings recorded on site therefore exposing the foundation walls to these original buildings (*Illus 2*). In addition to the foundation trenches a large attenuation tank trench was excavated to a maximum depth of 1.1m (*Illus 3*).

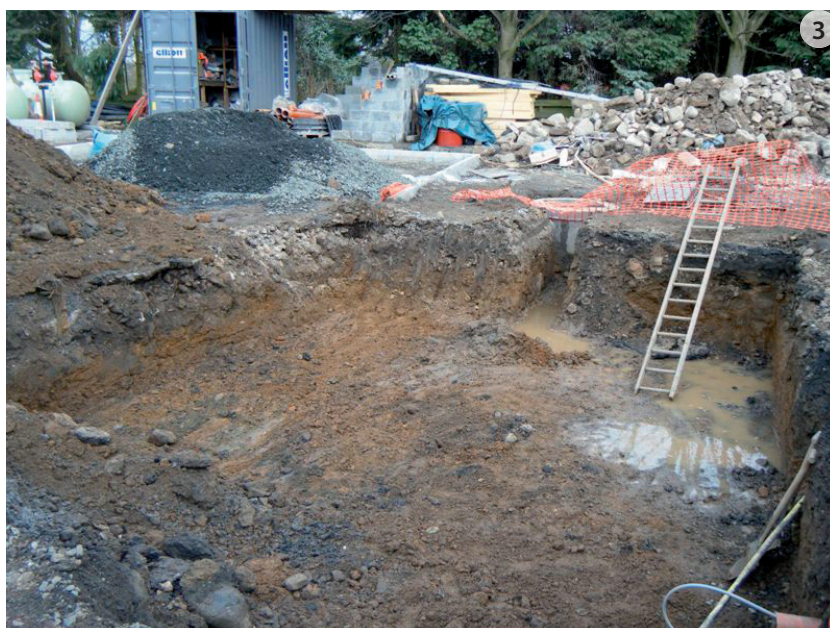
Illus 3

View of the excavated attenuation tank trench

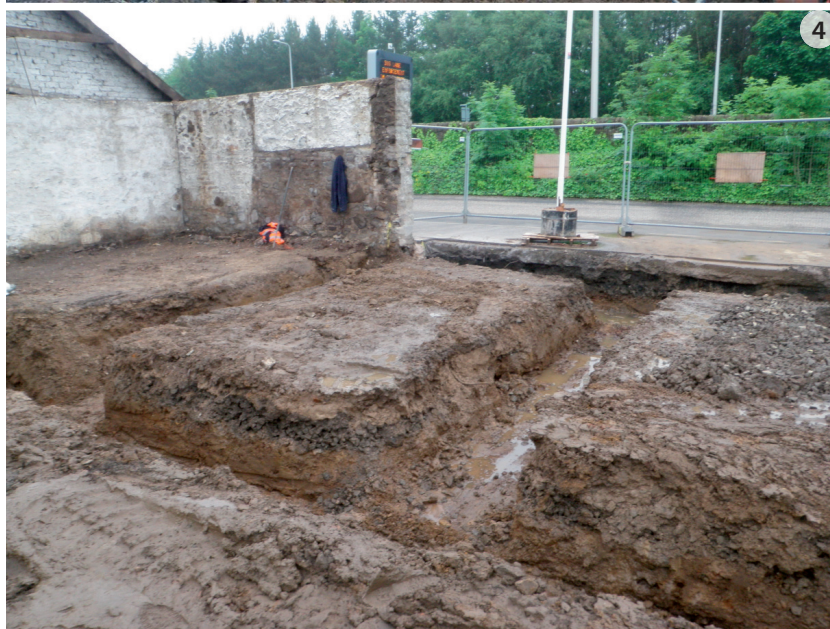
Illus 4

View of stratigraphy of the foundation trenches

An orange brown sandy clay [010] was observed at approximately 0.60m to 0.80m depth across the site and is interpreted as the geological subsoil. In places this was overlain by a 0.30m thick dark brown silty clay deposit [011] which was most likely a cultivation or garden soil. Demolition material ranging in thickness from 0.30 to 0.50m was observed above this (*Illus 4*).

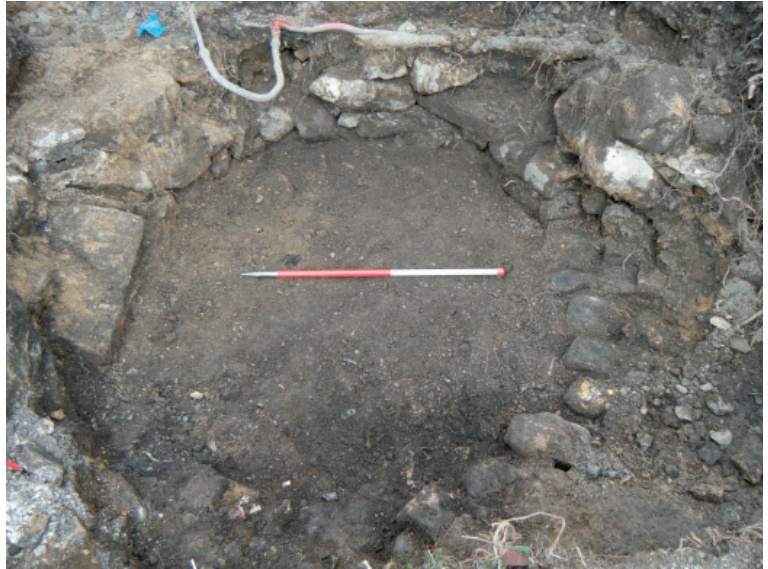
Illus 7

A number of foundation walls relating to the 18th and 19th century farm buildings previously standing on the site were also uncovered (*Illus 7*). These buildings were recorded prior to demolition by Headland Archaeology Ltd as part of the previous historic building recording works (Geddes 2008). Contexts [013] to [016] represent foundation walls for of Building A. These foundation wall contexts appear to have incorporated the capping for the well [005] into the foundations of the building. Contexts [018] and [022] appear to be foundation walls attached to the northern wall of Building E.

Foundation walls within the new foundation trenches

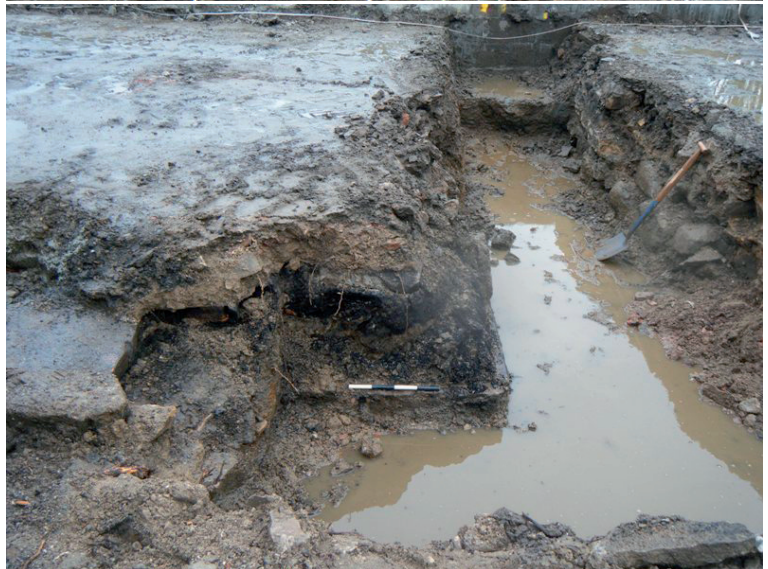
Illus 8

A small number of modern drain cuts were also observed running approximately north-south across the centre of Building E (*Illus 8*)

View of foundation trenches in area of Building E

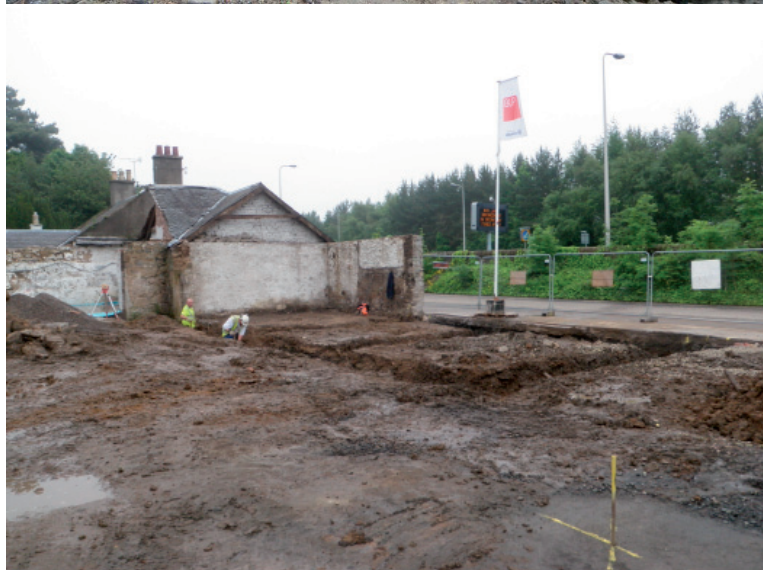
Illus 9

The decorative stone marriage plate recorded in the initial historic building record (Geddes 2008) had been reset within the walls of the new development (*Illus 9*).

Detail of the re-set marriage stone in the wall of Building E
