MOIRLANICH LONGHOUSE, KILLIN

*Assessment of the Thatched Roof
for the National Trust for Scotland*

June 2011

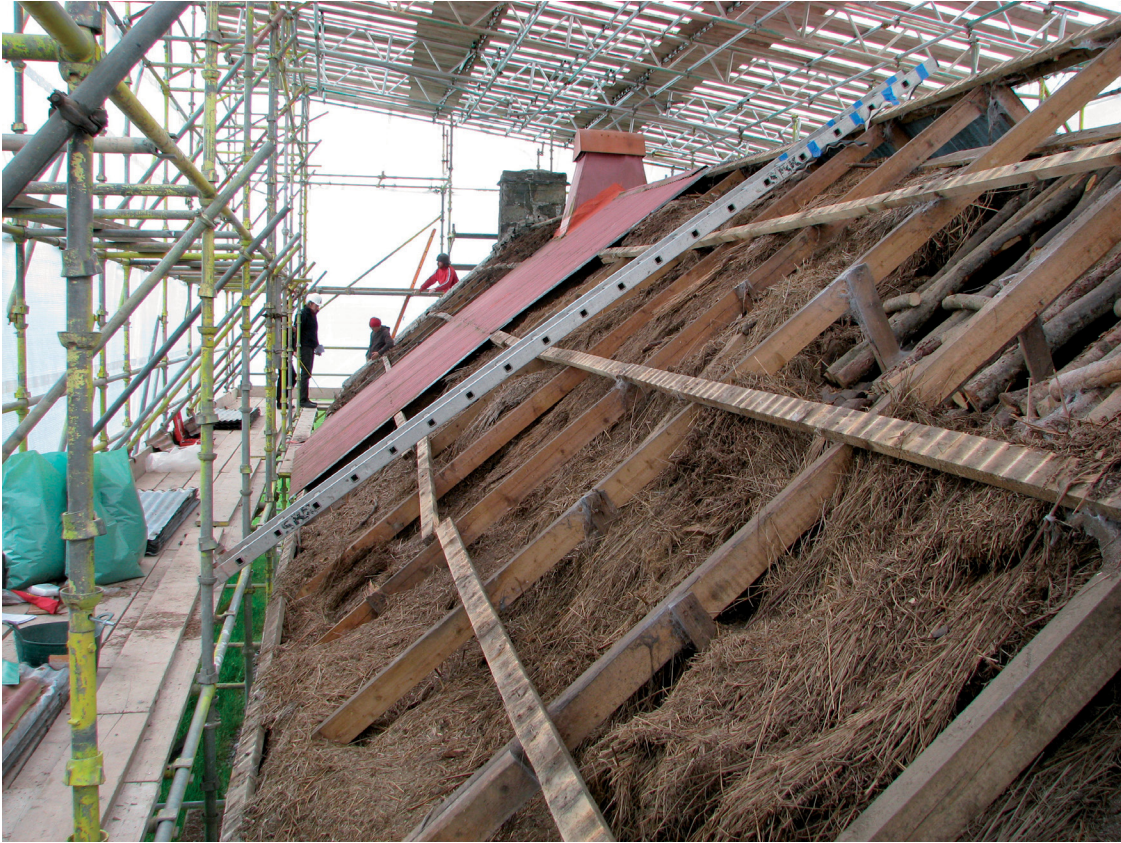
Illus 1
N pitch from the W

These notes are based on a visit to the site on 10th & 17th June 2011. At the time of the visits the corrugated iron sheets had been removed and the whole roof was protected underneath a scaffolding shell. Areas of the surviving thatch were exposed and available for inspection (Illus 1 & 2). The condition of the surviving thatch was very variable having been affected by animal disturbance (mice, insects and birds), wind erosion and water ingress. Over much of the surface, detail of the thatch was obscured by wind-blown debris.

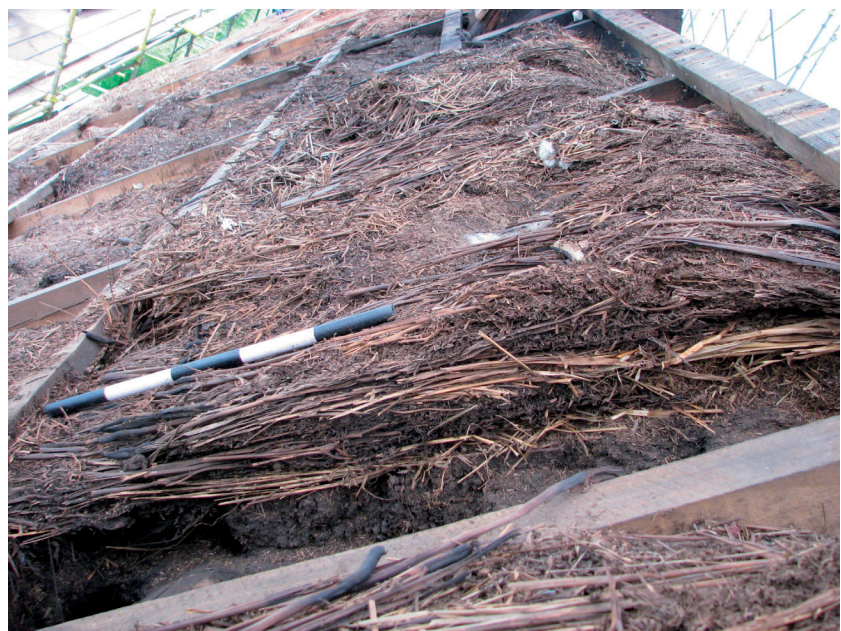
Illus 3

This comprises a thick uneven turf, much of which is exposed at the surface. Cleaning back the surface revealed that the predominant covering was bracken with the blackened stipe (root end) pointing down the pitch (except at the ridge). Small areas of cereal straw were observed but it was unclear if these related to repairs or were a part of the main thatch. Remnants of two surviving wooden pegs (crooks) were seen.

The excavation of a small 'trench' in this area produced a good section through the thatch revealing how part of it was constructed (Illus 3). The section showed it to comprise layers of bracken up to 10 cm thick separated by thin layers of oat straw (Illus 3). The whole was supported on a bed of thin turves laid vegetation side down overlying the cabers beneath.

E facing section S pitch

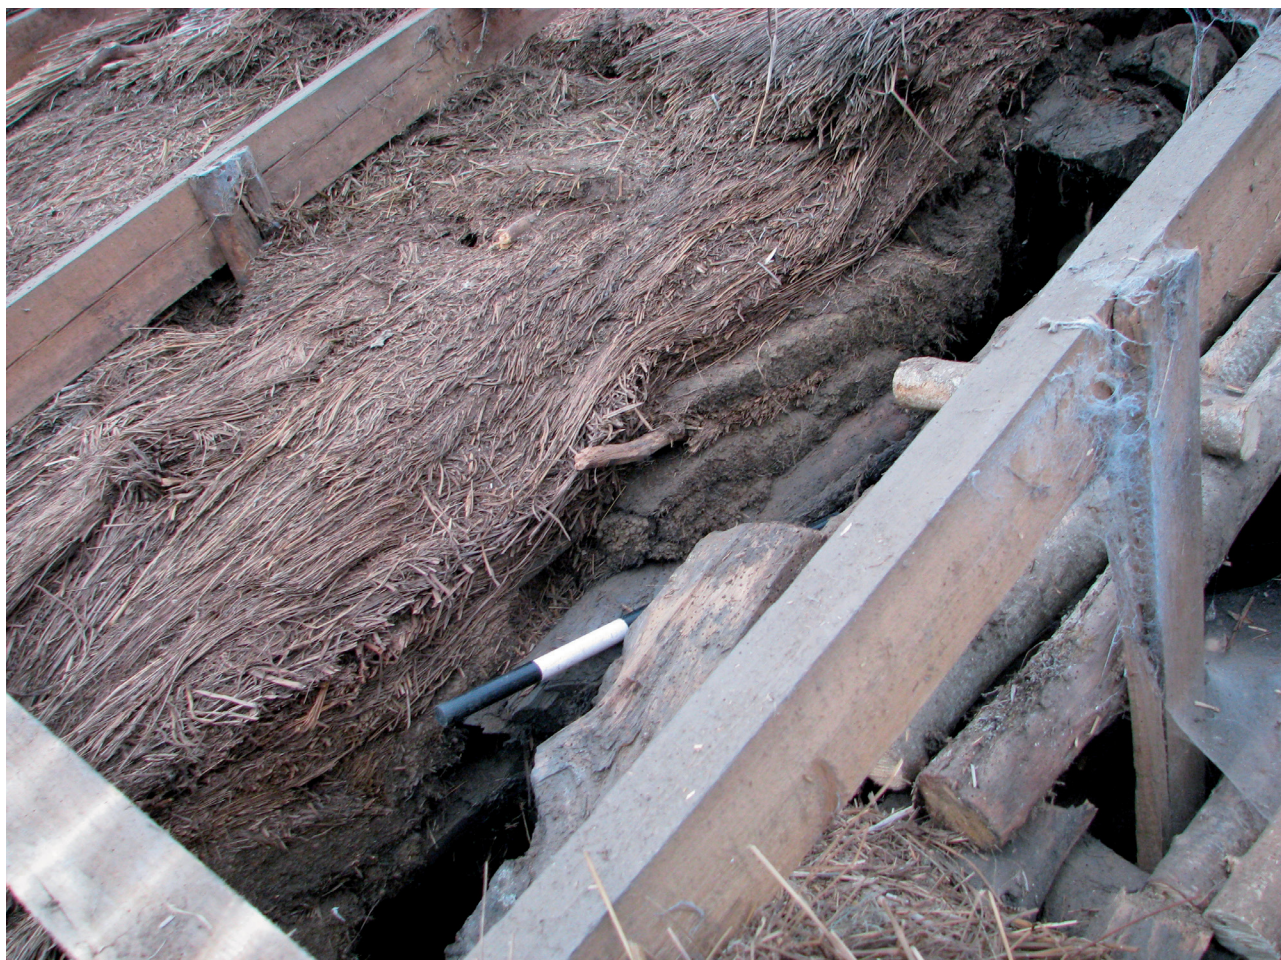
Illus 4

A good section was produced by cutting back a damaged area of thatch in the NW part of the roof. While some details remain unclear the sequence appears to be as follows (Illus 4):

- Turf - the basal layer was formed of thin turf that had been laid vegetation side down directly onto the cabers beneath.
- Rush layer - Directly above the turf was a compacted layer of rushes, primarily the jointed rush (*Juncus articulatus*) with occasional stems of soft rush (*J. effuses*). In places these seem to have been fixed in place by turves (a technique known from other sites in Scotland) but elsewhere the method of fixing could not be discerned.
- Rye straw - directly overlying the rushes was a layer of rye straw. This seemed to cover the

majority of the roof but it was not possible to work out how this had been fixed in place.

- Wheat straw - the upper layers were formed of wheat straw. This was in a good state of preservation and possibly formed the last surface of the roof before the tin roof was put on. The presence of crooks (forked pegs) in several places indicated that this surface had been held in position using a crook and caber technique where the forked pegs (c. 3-4 cm diameter) were pushed horizontally into the roof to support narrow cabers that ran parallel along the length of the roof (Walker *et al.* 1996 p. 35).

In some places there was evidence of repairs using, for example, bracken but they also ran over the ridge.

W facing section N pitch
