HOPETOUN HOME FARM, SOUTH QUEENSFERRY

Historic Building Recording & Watching Brief

commissioned by Aithrie Estates

HA Job no.: HHFQ12/01

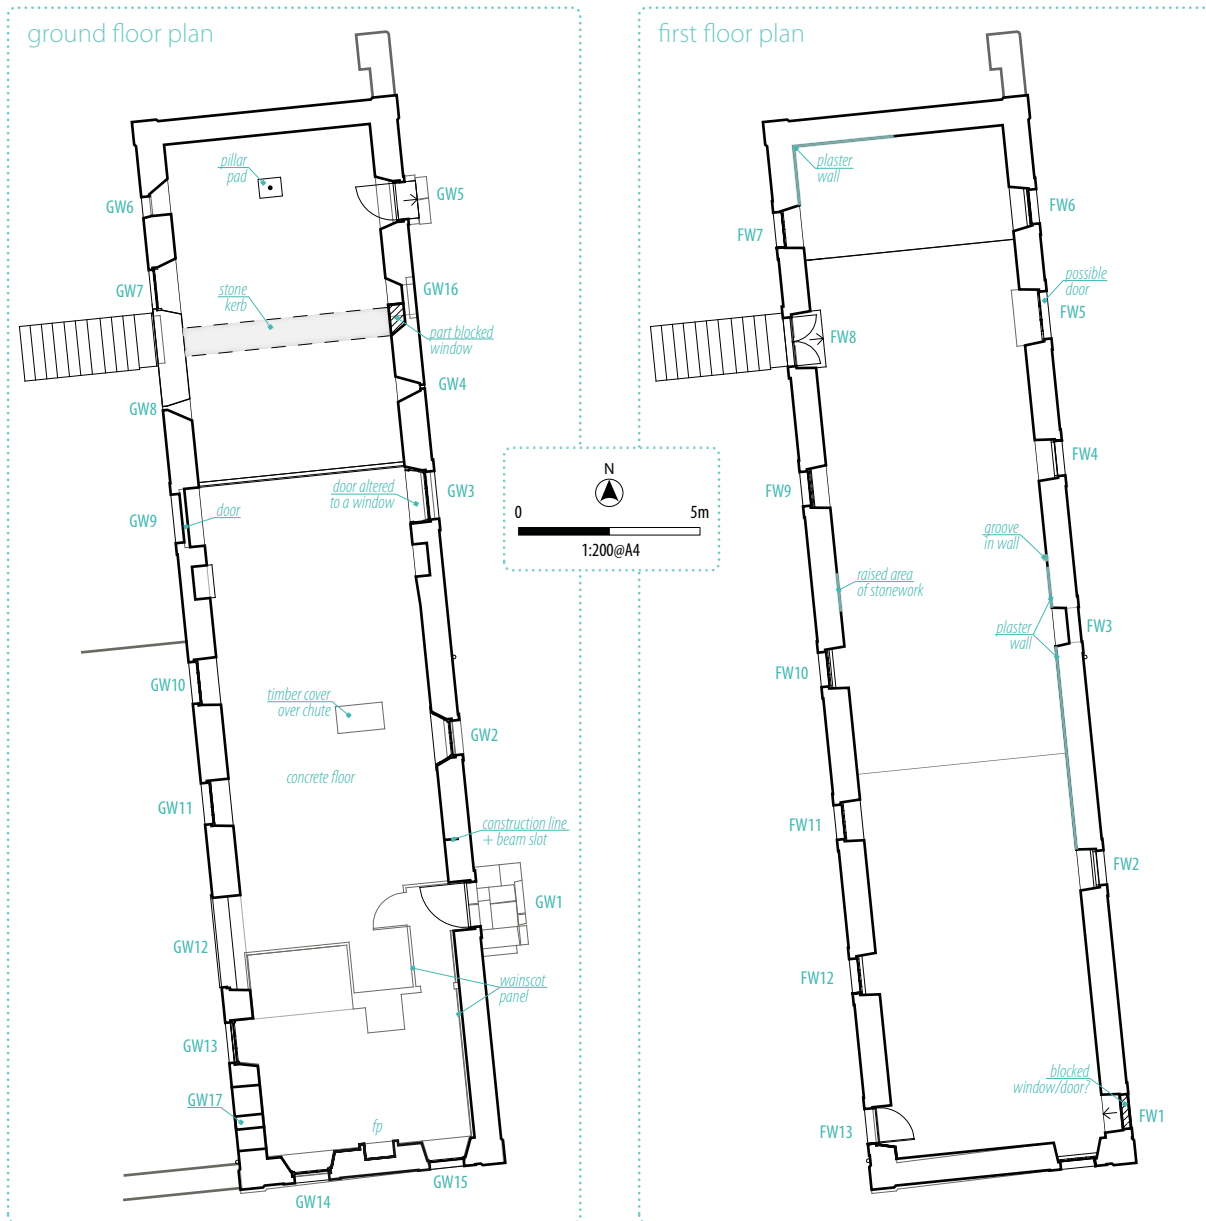
Illus 7

Ground and first floor plans of the workshop

staircase to the rear of the building. The internal configuration included three rooms to the ground floor and a single large space to the upper floor (*Illus 7*).

Ground Floor (see Illus 7)

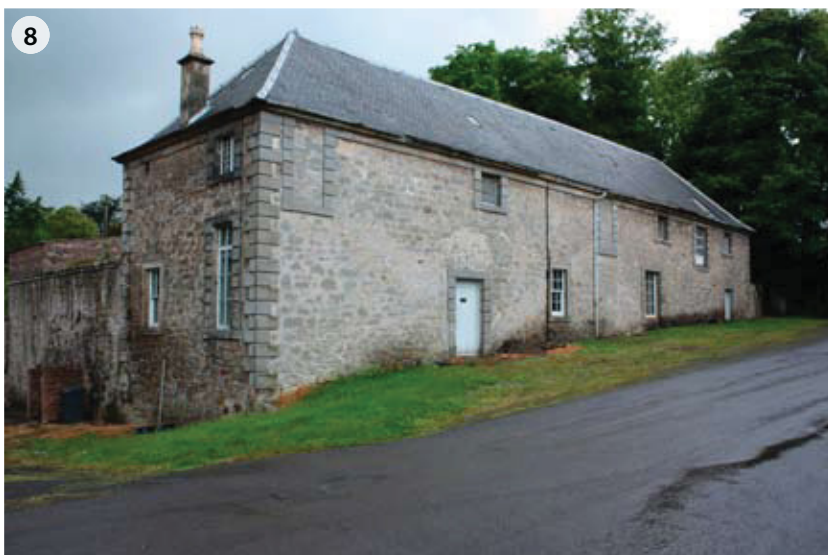
Illus 8

View of the workshop displaying the east and south elevations

The main (east) elevation displayed a recurrent pattern with alternating large and small openings displayed to both the ground and upper floor levels. This was enhanced by the prominent rusticated surround stones found on the majority of the features. This recurrent pattern was particularly prominent on the upper floor that displayed three large windows (FW1, FW3 & FW5) interspersed with three small windows (FW2, FW4 & FW6). The ground floor was slightly more complicated due to a number of variations in style.

The current main entrance (GW1) was found to the south end of the east elevation. Rudimentary initials 'TR' had been engraved on one of surround stones of this entrance, although it was unclear when and to whom these relate. The door included the rusticated stone surround which was also replicated on window (GW3) located further to the north end of the elevation. It was clear from the internal elevation, a squared internal recess continuing to the floor, that GW3 had originally been a door. These were the only two features on the ground floor that displayed the prominent

chamfered stone surround. The two other prominent openings on the ground floor, a window (GW2) and door (GW5) incorporated raised plain stone surrounds. Both these features included internal splayed recesses indicating that not only were they original openings but that (GW5), located to the north end of the elevation,

had originally been a window. Two more discrete openings on the east elevation had been stone-blocked with only faint traces of the surround stones visible on the outer façade (*Illus 9*). These two features, a window (GW16) and a vent/slot window (GW4), were much more prominent on the internal elevation of this wall. It was clear from the evidence that on the ground floor only the original doors (GW1 and GW3) included the decorated surrounds.

The six upper floor features all displayed the signature rusticated stone surrounds. Two of the large windows (FW1 & FW3) had been stone-blocked and two of the three small windows had timber vents inserted (FW2 & FW4). Window FW5 located close to the north end of the elevation was slightly wider than the other windows, suggesting it had originally been a loading door. This was further indicated by the internal design of the opening showing a recess to the floor. It was also possible that the other two blocked windows FW1 and FW3 may have been loading doors as the internal recesses to these were also to the floor, although both of these were slightly narrower than FW5.

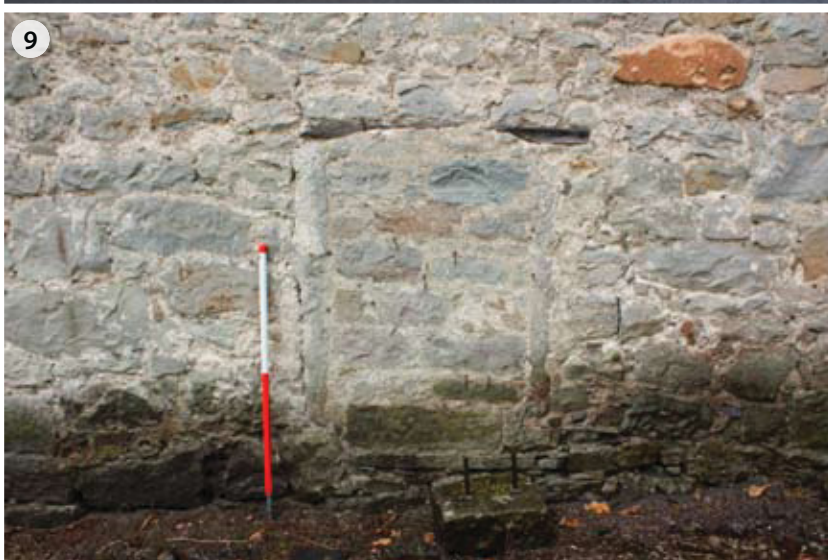
Illus 9

Detail of stone-blocked opening GW16

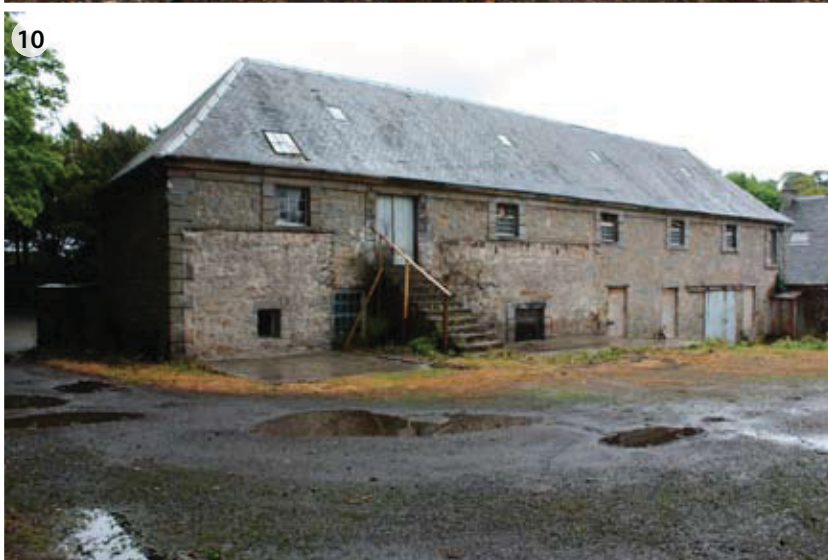
Illus 10

General view of the external west elevation

Although the recurring pattern of the openings of the east elevation was not mirrored to the rear (west) elevation of the building it was clear that the main details were similar. Of all the openings on the ground floor only the original doors (GW9 & GW12) included the rusticated surround stones and this decoration was repeated on all the upper floor openings.

Instead of the recurring pattern the west elevation displayed a sense of demarcation dividing the elevation into three areas. This was certainly more prominent on the ground floor where the northern third of the elevation comprised two windows (GW6 & GW7) with rubble stone surrounds on the ground floor immediately north of an external stone staircase leading to an upper floor entrance (FW8). Just to the south of the staircase was a narrow slot window (GW8) that completed the first area. It was far from clear if this demarcation was repeated internally.

The central area of the ground floor included a door (GW9) and two windows (GW10 & GW11). The door displayed same the rusticated stone surround recorded on the other ground floor doors suggesting it was an original feature. The lower half of this door was initially masked by a raised concrete pad that formed a floor surface for a subsequently demolished lean-to structure (first identified on the 1916 OS). The concrete pad was removed as part of the development revealing the full extent of the door (*Illus 11*). The door seems to be the primary entrance to the rear ground floor level of the building. A segmented brick relieving arch was evident on the internal elevation of this door which was also copied on door GW3 located opposite GW9 on the east elevation. Immediately south of the door were two plain boarded-up windows (GW10 and GW11) with rubble stone surrounds and timber lintels. The internal recess of both these windows were squared and not splayed. This would suggest that these windows were secondary features that had been inserted at a later date.

The southern end of the ground floor elevation comprised a large timber slide door (GW12) and a window (GW13) with rubble stone surround and timber lintel. The door included the raised rusticated stone surround although it was not clear if the northern side of the

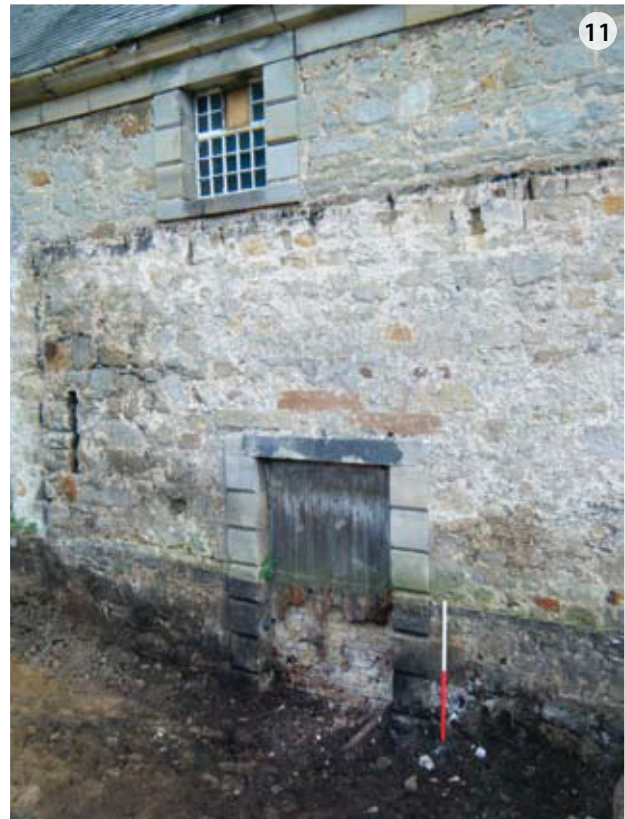
Illus 11

Detail of door GW9 and slot GW8

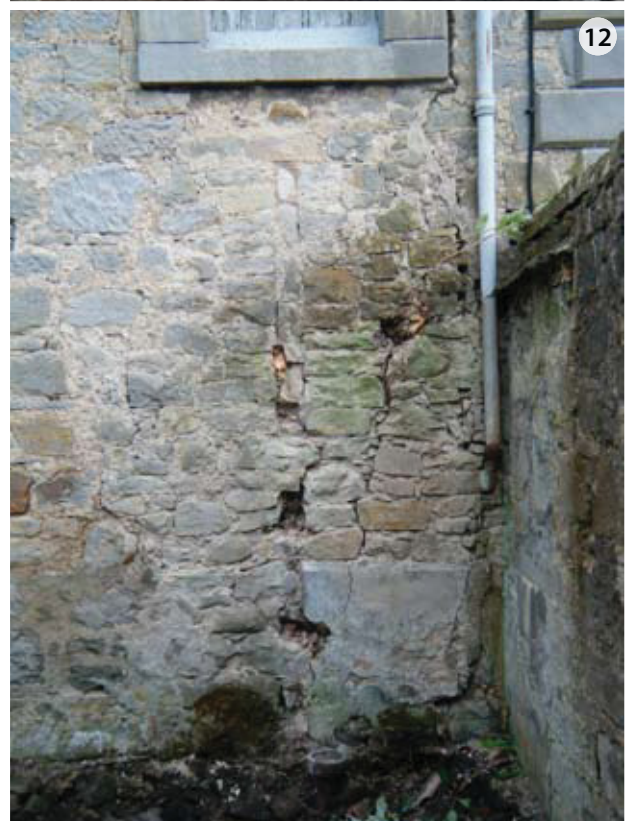
Illus 12

Detail of blocked window slot GW17

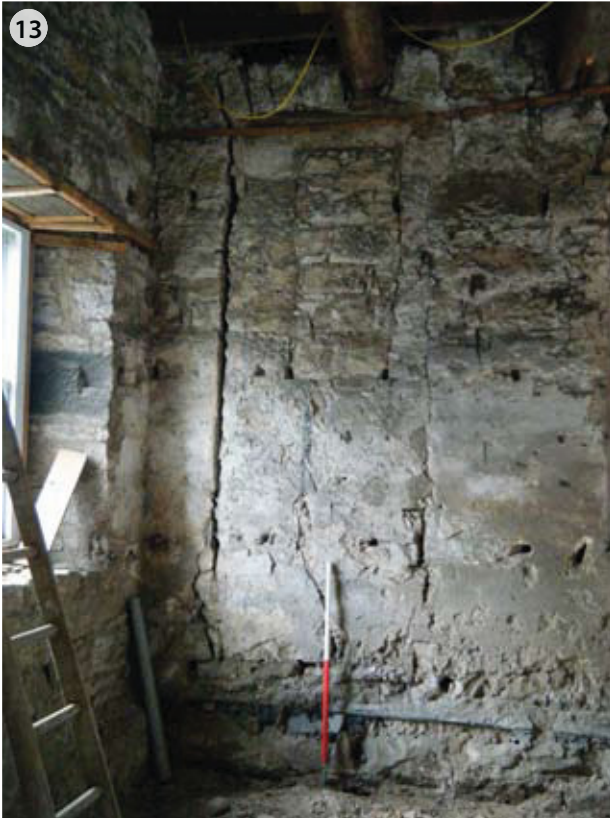
Illus 13
Internal view of stone-blocked feature GW17

removal of the wainscot panelling from the west wall revealed the stone blocked door and slot window (GW17) mentioned above (see Illus 13).

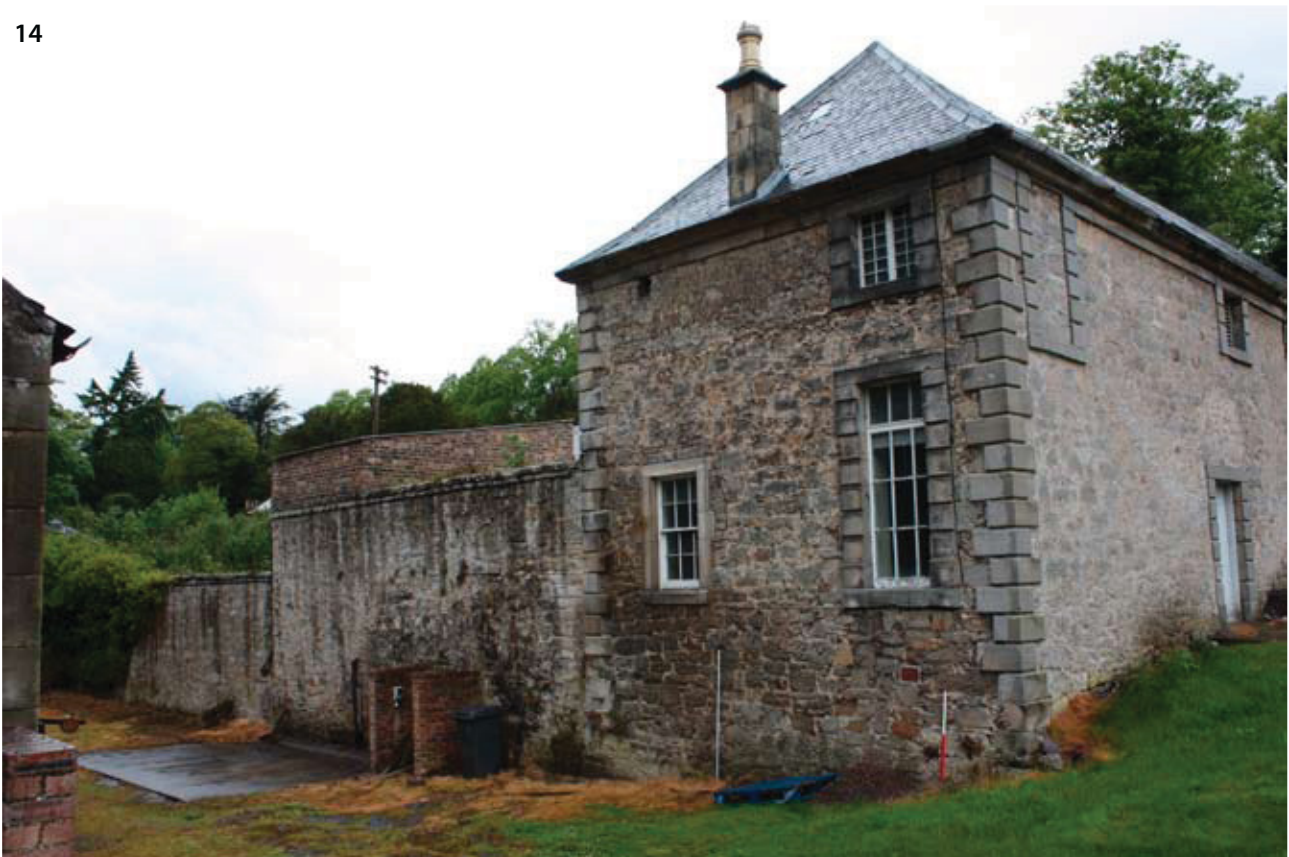
Illus 14
General view of the external south elevation

The south end of the building was considerably taller than the north end due to the building being constructed across a gradual slope leading down from north to south. The south elevation incorporated three windows, two to the ground floor and a single upper floor window. Two of the windows displayed the rusticated stone surrounds, a tall one to the ground floor (GW15) and a smaller one to the upper floor (FW14). A third window (GW14) with a raised plain stone surround was located to the ground floor. The internal recess of this window was splayed suggesting it was an original feature, although this was far from certain. The chimney was also located at this end of the building comprising a plain ashlar construction with a raised moulded capstone.

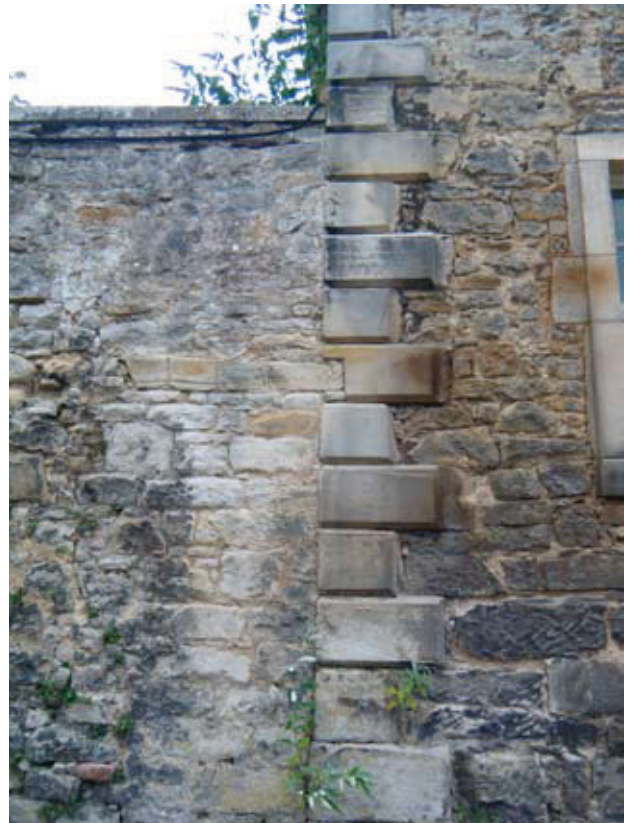
Illus 15

Detail of the wall abutting the south-west corner of the workshop

A rubble stone wall abutted the west side of this elevation continuing to the west (Illus 15). This may represent the remains of the wing of the building marked on the 1st and 2nd edition Ordnance Survey maps. A very faint linear raggle mark high up on the south elevation of the workshop may also represent the location of this structure but this was far from conclusive. A small cutaway (visible on Illus 15) in one of the quoin stones was noted at the height of window GW14. It was unclear what this represented although it could have been the location of a beam slot associated with the extant extension.

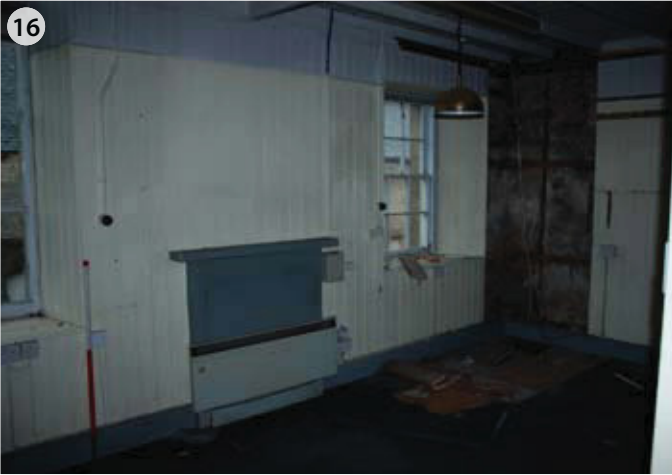
Illus 16

View of the wainscot panelling in the office

The initial phase of building recording revealed the ground floor to be divided into three separate areas. A small office decorated with wainscot panelling throughout was located the south end of the floor (Illus 16). This was entered via a short timber-panel lined corridor leading from the current main entrance (GW1). The south wall included the only fireplace recorded in the building. This was flanked by two sash-and-case windows (GW14 & GW15) (Illus 17). The opposing timber panel wall included a built-in cabinet that partially masked the sliding door (GW12) located on the west elevation. The

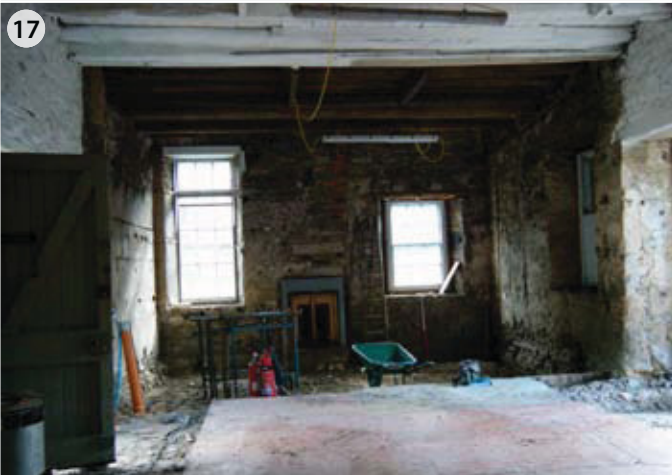
Illus 17

View of the office space with the walls stripped

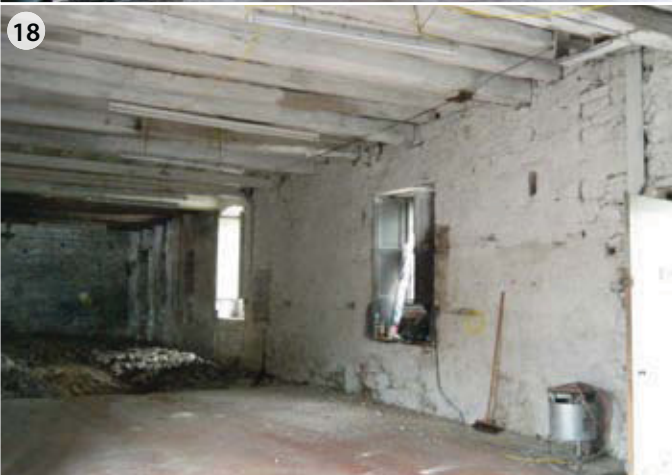
Illus 18

View of the internal ground floor east wall

The two windows (GW2 & GW3) on the east wall (Illus 18) included timber panel shutters. Window (GW3) also included a segmented brick relieving arch and had originally been recessed to the floor, the lower half having been bricked blocked, indicating that this had once been a door. The gap in the hedging to the front of the building depicted on the 1st edition Ordnance Survey also suggests a door existed in this location. The opening (GW9) on the opposite wall was constructed to the same design and had also clearly been a door. Two small alcove/recesses were recorded on opposing east and west walls just to the south of doors GW3 and GW9. The other two windows (GW10 & GW11) on the west elevation (Illus 19) were recessed into the wall but without splayed sides suggesting they had been inserted later. A series of beam slots were noted on the south side of the east wall that probably represent evidence of an earlier internal structure on this wall.

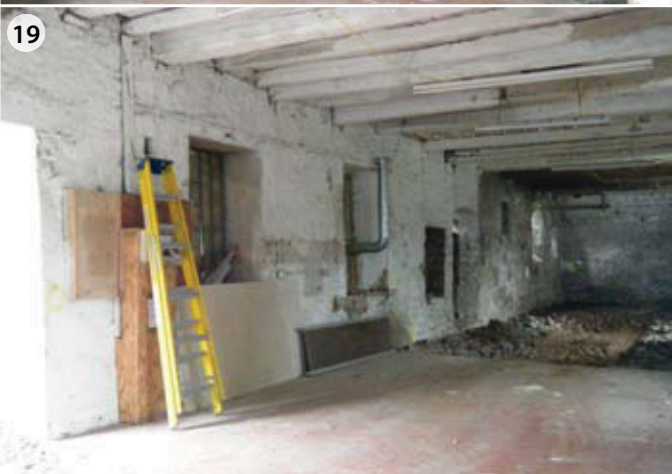
Illus 19

View of the internal ground floor west wall

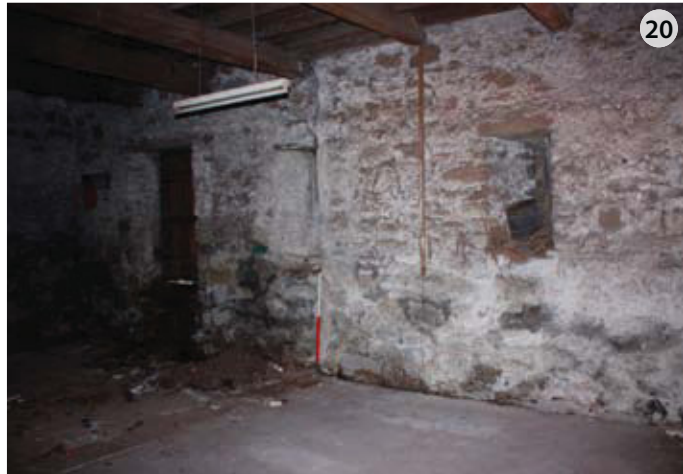
Illus 20

Detail of the openings at the north end of the east wall

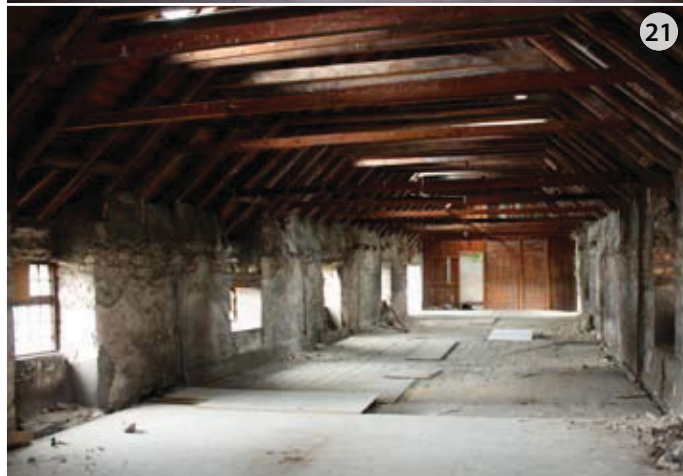
Illus 21

General view of the first floor internal walls

stone walls and exposed roof rafters (Illus 21). This floor probably represented the store room of the building. The walls were mainly painted rubble stone but some plasterwork was evident, particularly to the south side of the room. A number of features were recorded on the walls including a vertical line of chamfered stonework just to the north of door FW13. A slight construction line immediately north of window FW10 on the west wall lined up with the end of a section of plaster wall on the east wall, just north of window FW3. These features probably represent later use of the building as opposed original use.

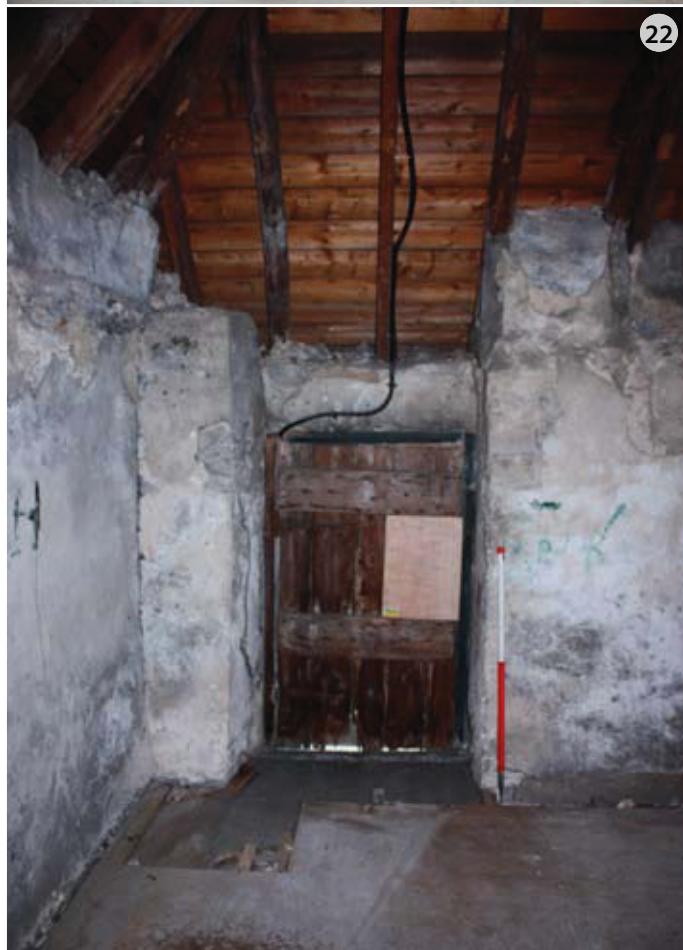
Illus 22

Detail of opening FW5 on the west wall of the first floor

Besides the current entrance (FW8) a loading door (FW13) (Illus 22) was located at the south end of the west wall. As mentioned above, a staircase is depicted on the 1st edition Ordnance Survey that would have led to this door. These two doors flanked a series of four windows (FW9 – FW12). On the opposing east wall a large casement window (FW5) recessed to the floor was located opposite the current main entrance. This window may originally have represented a further loading door. Two further tall windows were recorded on the east wall (FW1 & FW3) and these also included recesses to the floor but were considered to have always been windows as they were slightly narrower than (FW5). The roof had clearly been replaced and it was not clear if any of the rafters were original. Across the northern half of the room a number of cut stubs of original cross beams were recorded projecting from the east and west walls just below the wall head. These may represent the remains of an attic/mezzanine space used for additional storage.

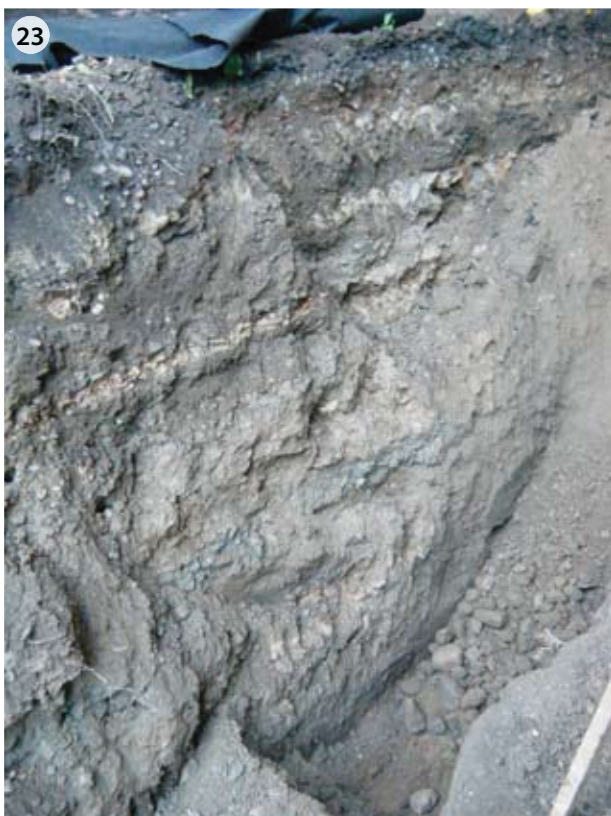
Illus 23

West facing section of the attenuation tank trench

The attenuation tank was located within the lightly wooded area 50m to the south of the workshop immediately west of a modern road surface leading south from the workshop. The tank trench was approximately 3m² and excavated to a maximum depth of 1.8m. This revealed a considerable amount of made ground with three distinct layers (001), (002) and (003) of re-deposited material covering the orange/yellow geological subsoil (006) (Illus 23). Due to health and safety issues relating to the depth of the trench a closer inspection of the sections

was not feasible. It was clear from the soft nature of the material being excavated that this was all re-deposited made ground. It was possible that this material in-filled a natural valley or even covered a drainage channel (a culvert was recorded further to the north running under the steading) although this was not verified.

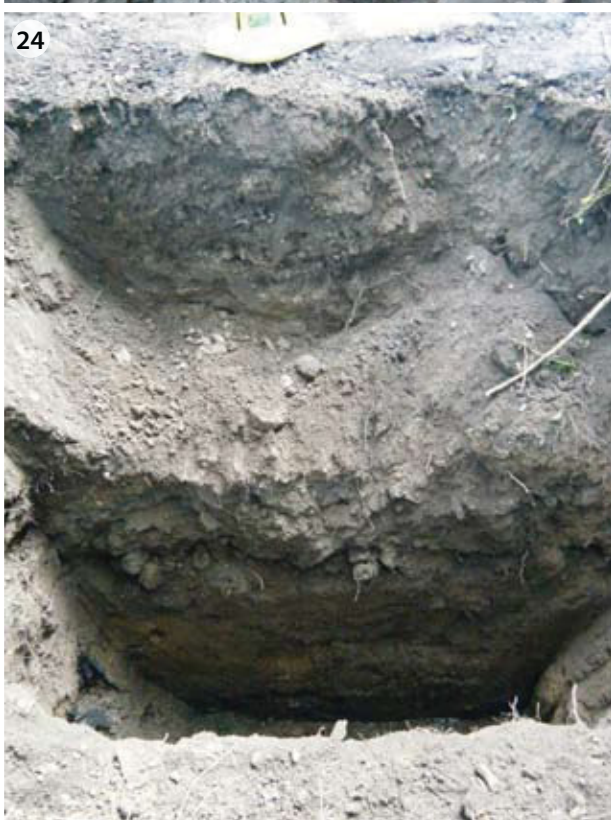
Illus 24

Detail of the west facing section of the attenuation pipe trench

From the attenuation tank a pipe trench 30m long continued south along the edge of the road. At the south end of this trench the depth reached a maximum of 3.3m without reaching the geological subsoil. Again the three layers of made ground were recorded. Close to the location of the attenuation tank a layer of large stone cobbles (004) covered in a thin layer of lime mortar was recorded below these layers over 2.5m below the current road surface. Under the cobbles was a shallow compact dark grey silt (005) overlying the orange/yellow sand geological subsoil (006) (*Illus 24*). Again a closer inspection of these layers was not possible due to health and safety concerns. These cobbles were only recorded in the west facing section of the trench suggesting they may represent an earlier road surface leading to the farm as they seemed to continue on the same alignment as the modern road above. Further trenches close to the attenuation tank revealed the same deep deposits of made ground suggesting the whole area had been raised, possibly when the modern road was laid although the exact date of this is unknown and the map evidence is inconclusive.

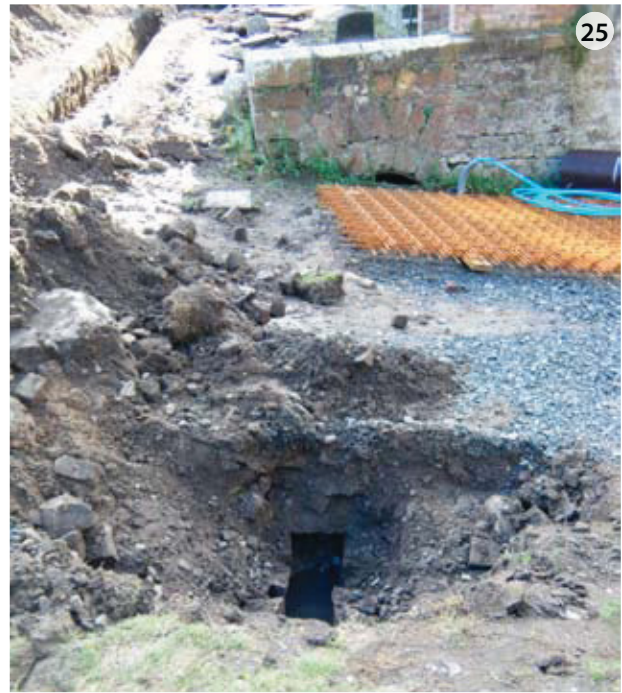
Illus 25

View of the culvert running towards the steading wall

Between the workshop and the steading a north/south aligned stone-lined culvert was revealed 0.5m below the road surface immediately west of the service pipe trench. The culvert headed towards an arch in a stone wall attached to the east side of the steading (*Illus 25*).

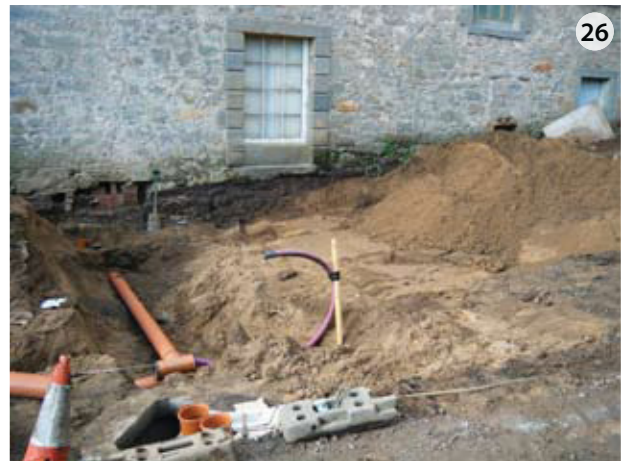
Illus 26

General view of the sand layer to the front of the workshop

To the front (east) of the workshop various ground works revealed approximately 0.4m of topsoil over the geological subsoil which comprised of laminated orange/yellow sand (*Illus 26*). This geological subsoil was also exposed in the wide trench excavated around the east, north and west perimeter of the workshop indicating that the wall footings cut into this layer (*Illus 27*).

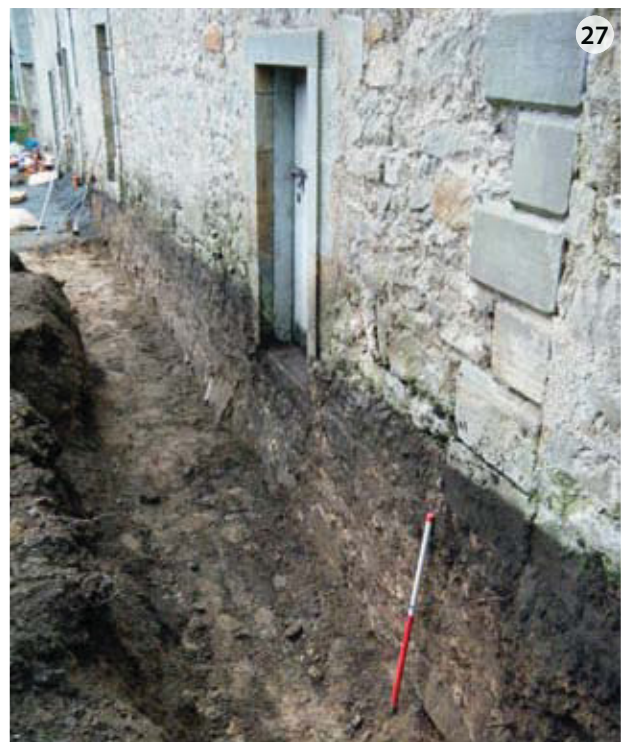
Illus 27

View of the trench excavated along the front of the workshop
