## SETON SANDS HOLIDAY VILLAGE

*Phase 1 extension archaeological evaluation*

*for Bourne Leisure Ltd*

November 2012

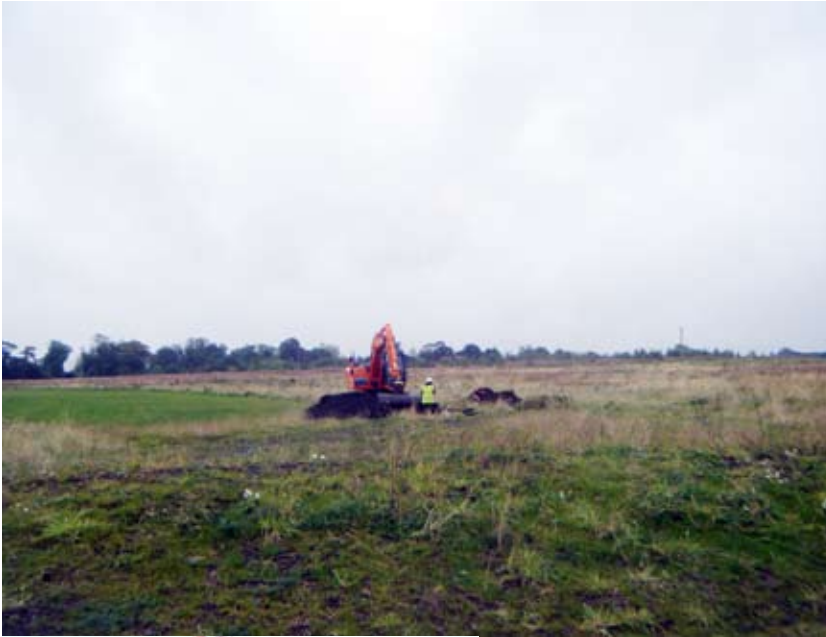
◀ **Illus 2**

*General view of the evaluation area*

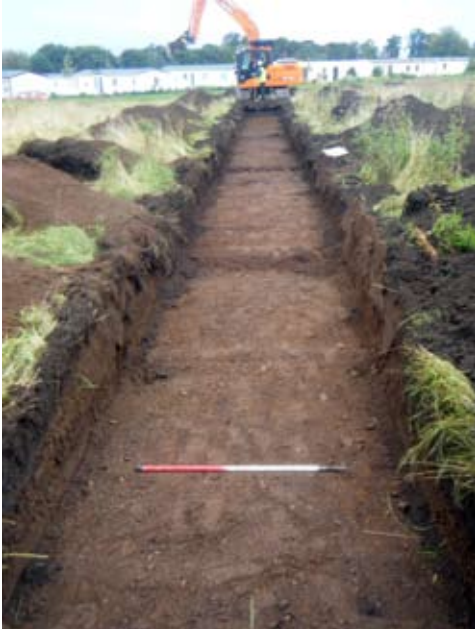
◀ **Illus 3**

*Detail of Trench 8*

Orientation:	E-W
Length (m):	61m
Width (m):	2m
Max. depth:	0.5m
Avg depth:	0.45m
Context / Descr. / Depth	Loam / topsoil / 0.4m – Sand and gravel subsoil changing to yellow sand and bedrock to the E half.

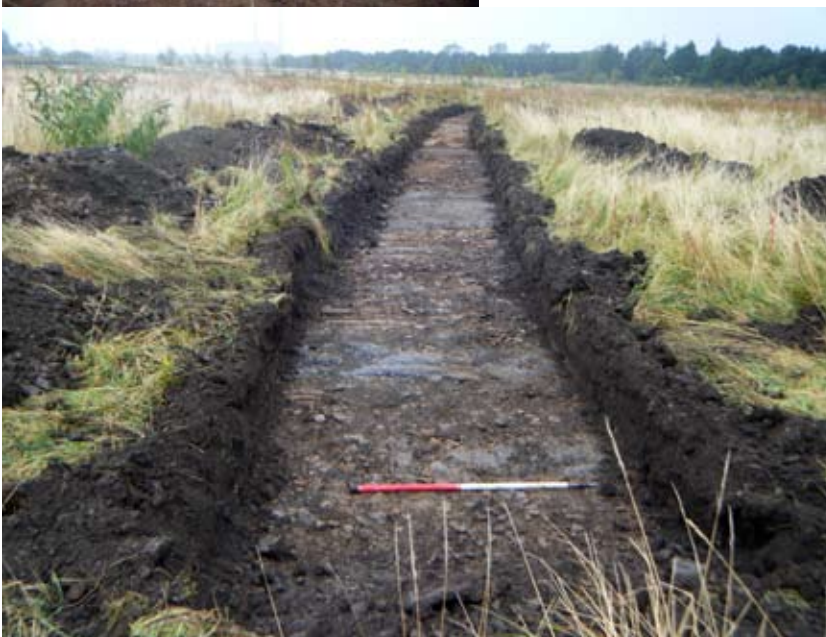
◀ **Illus 4**

*Detail of Trench 12*

Orientation: NE-SW  
Length (m): 32m  
Width (m): 2m  
Max. depth: 0.6m  
Avg depth: 0.5m  
Context / Descr. / Depth Loam / topsoil / 0.45m – Sand and gravel subsoil. Modern cut with timber post located 22.5m from the SW end.
