Project Code: TIGL08  
Planning Consent Ref No: F/APP/2006/4605  
Date of report: June 2010  
Client: Trump International Golf Links

## TRUMP CHAMPIONSHIP GOLF COURSE, MENIE ESTATE, ABERDEENSHIRE, SCOTLAND

Report on Watching Brief on Marram Grass planting  
& for the construction of the championship golf course

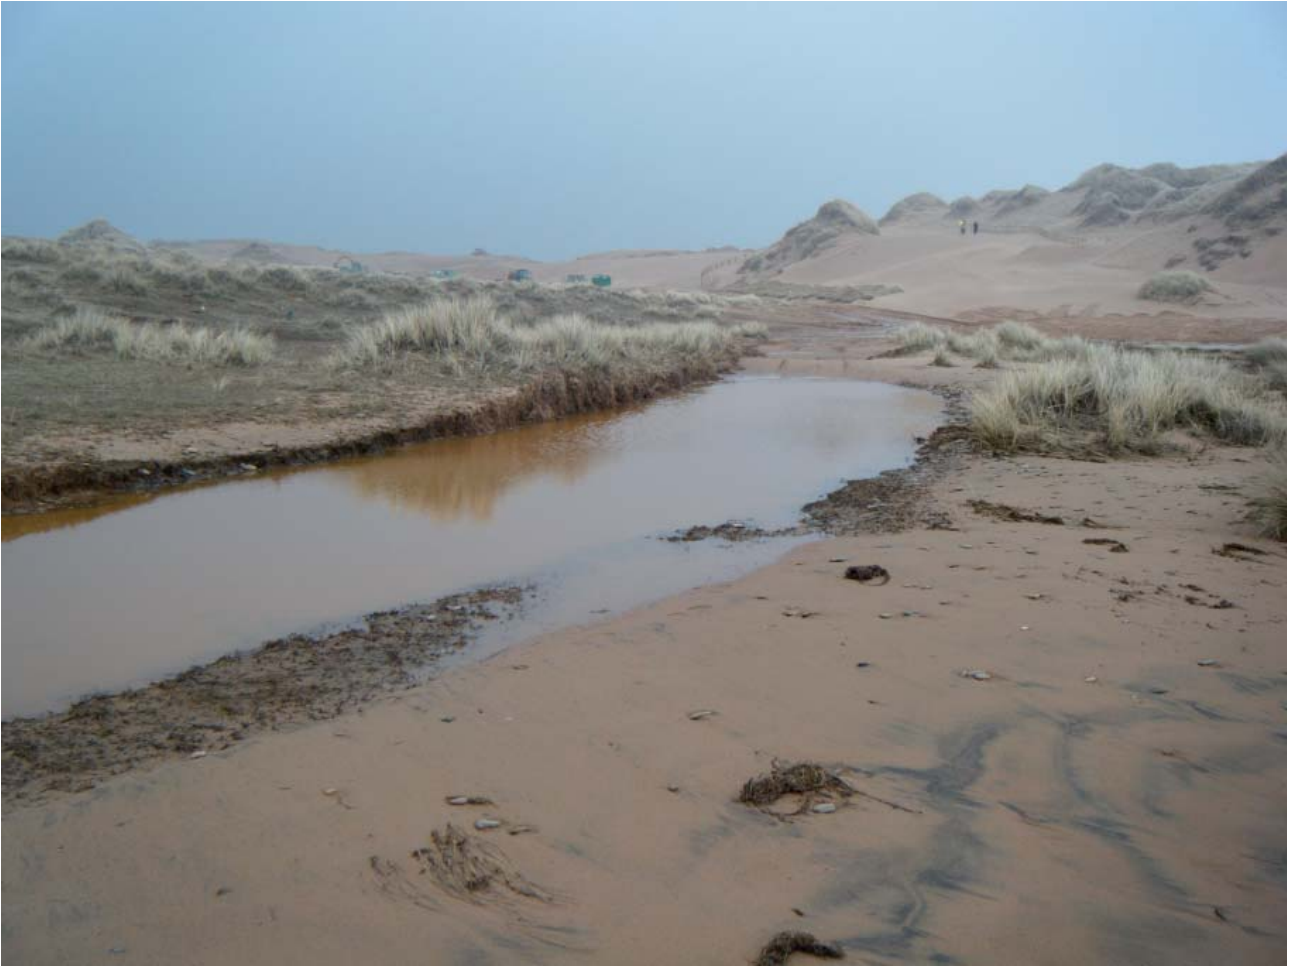
**Illus 4**

Prior to the golf links construction previous use of the old track that ran along the north side of Flint Scatter 1 had disturbed the deposits in this area. The use of the track for access revealed new deposits as numerous worked flints were noted in the low sections along the edges of the track corridor. A new flint scatter was noted to the south of Flint Scatter 1 (Illus 3, 4).

Scar along edge of track. From SSW

At the time of the site visits the Marram Grass planting did not disturb any archaeological deposits. However, there was evidence that further parts of Flint Scatter 1 and a previously unknown flint scatter (numbered 3) to the south of Flint Scatter 1 had been revealed by the use of the old track. This appeared to have happened prior to our site visits.
