OLD HIGH SCHOOL, INFIRMARY STREET, EDINBURGH

Archaeological Excavation

commissioned by The University of Edinburgh

May 2014

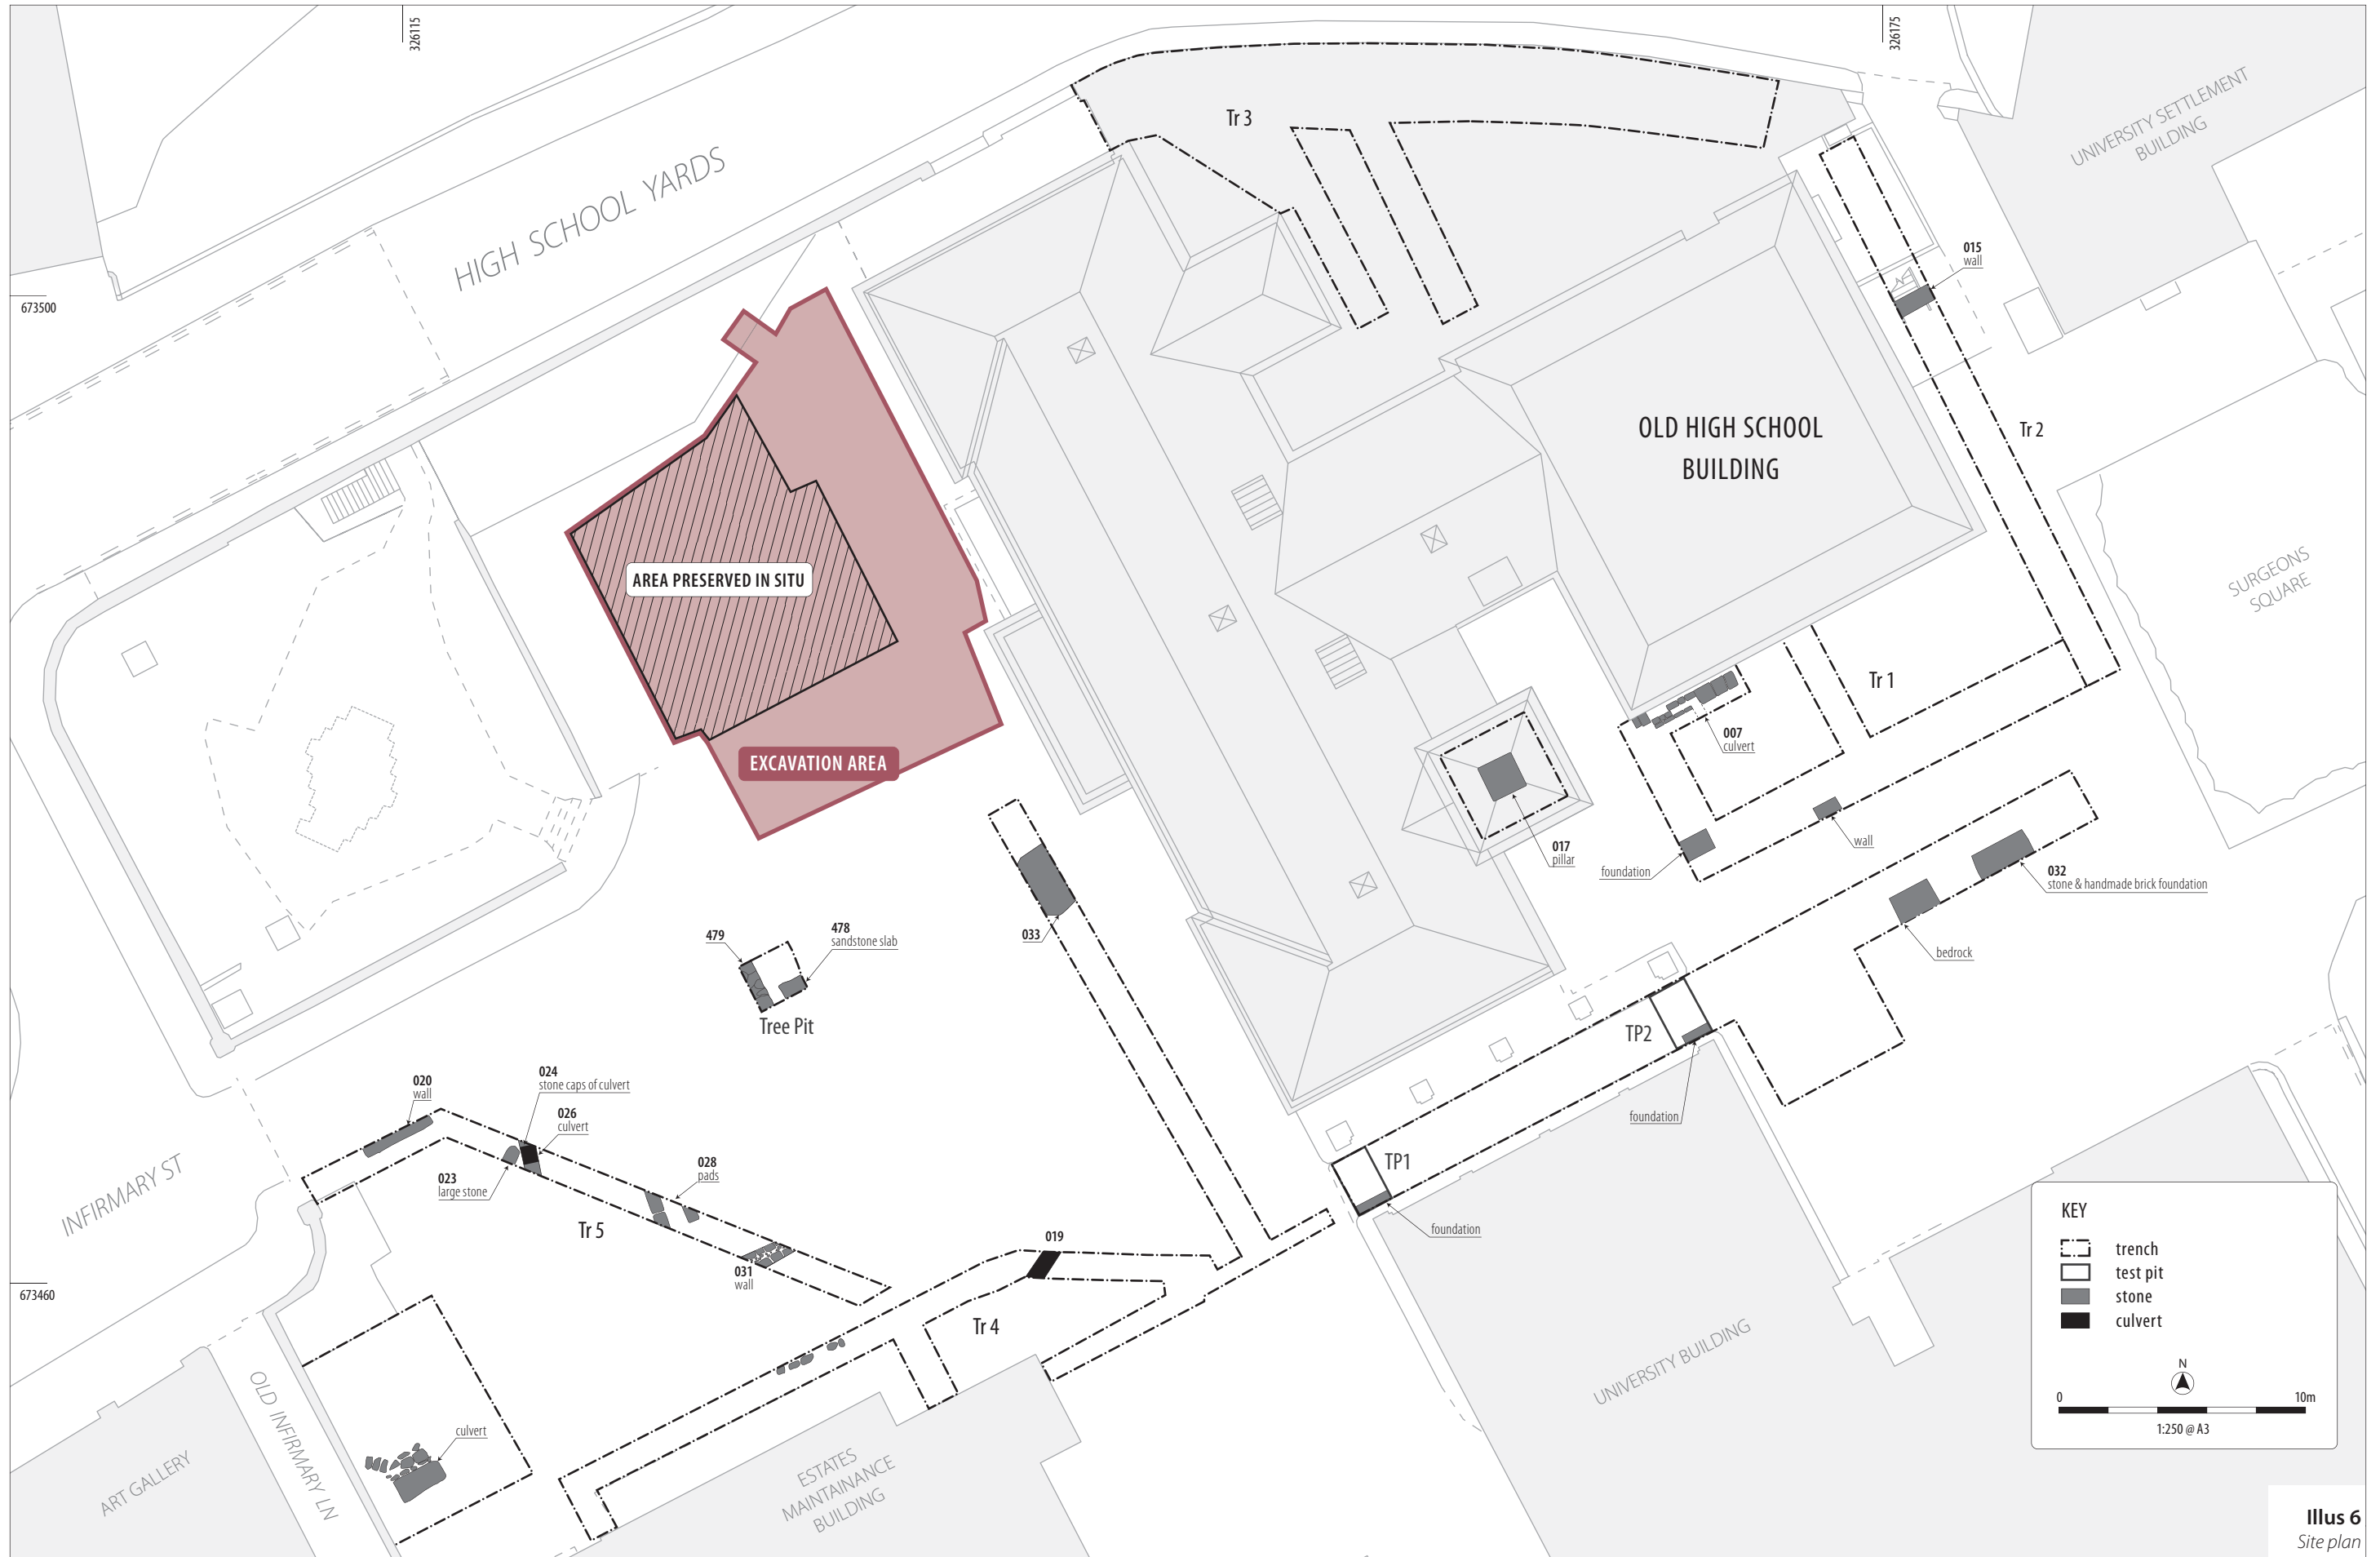
Illus 6
Site plan

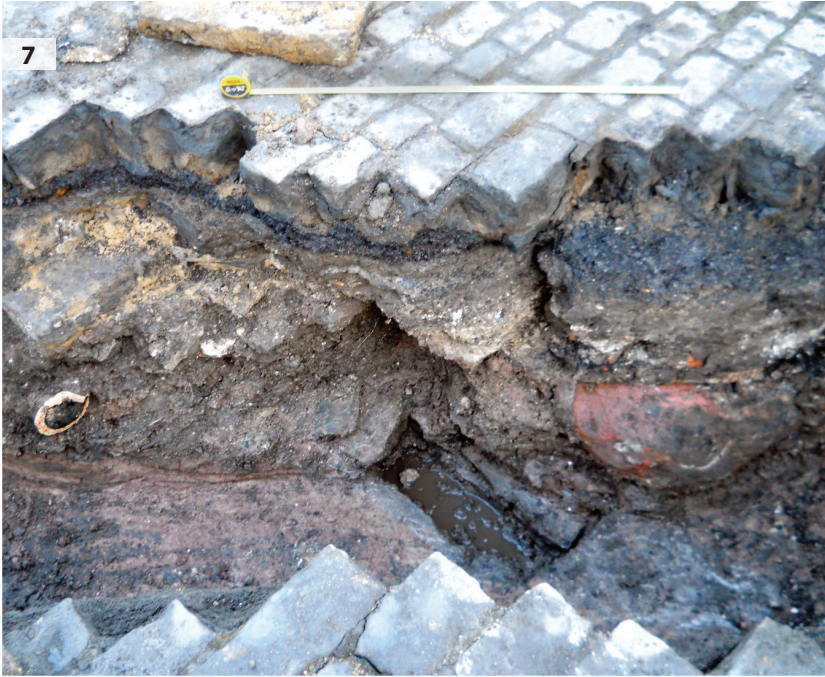
Illus 7

View of culvert [026], facing NE

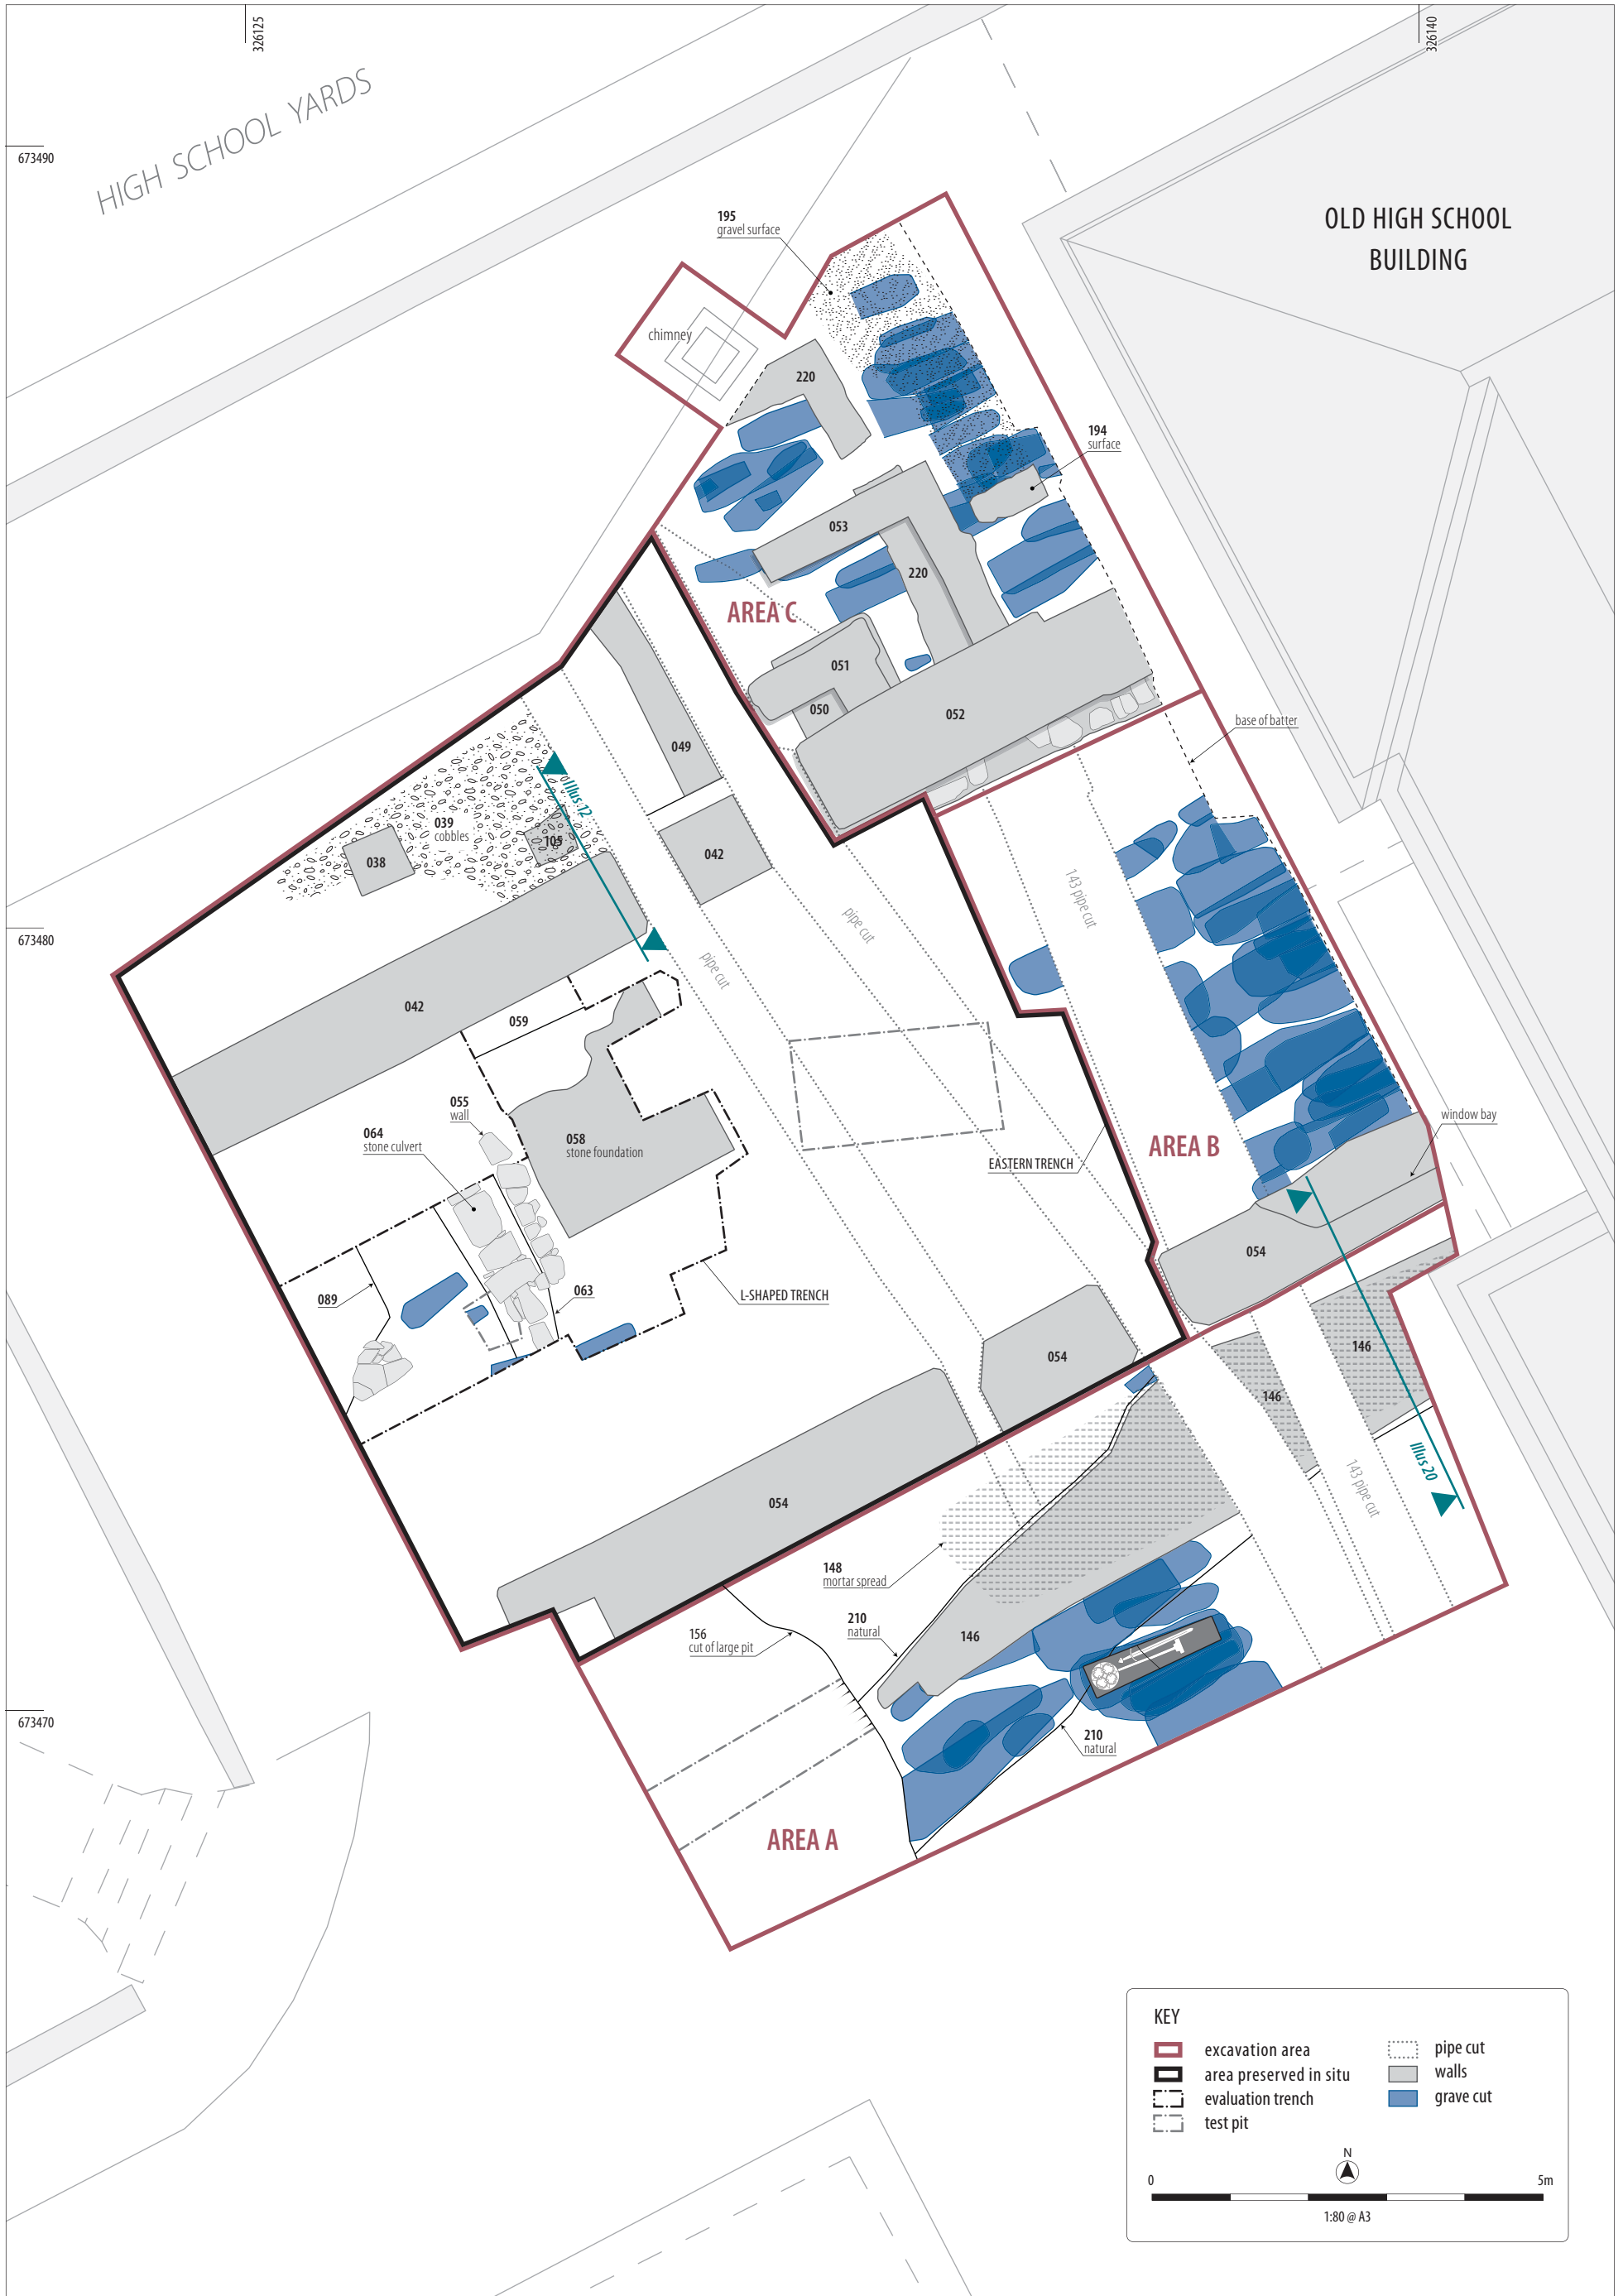
Illus 9
Plan of excavation

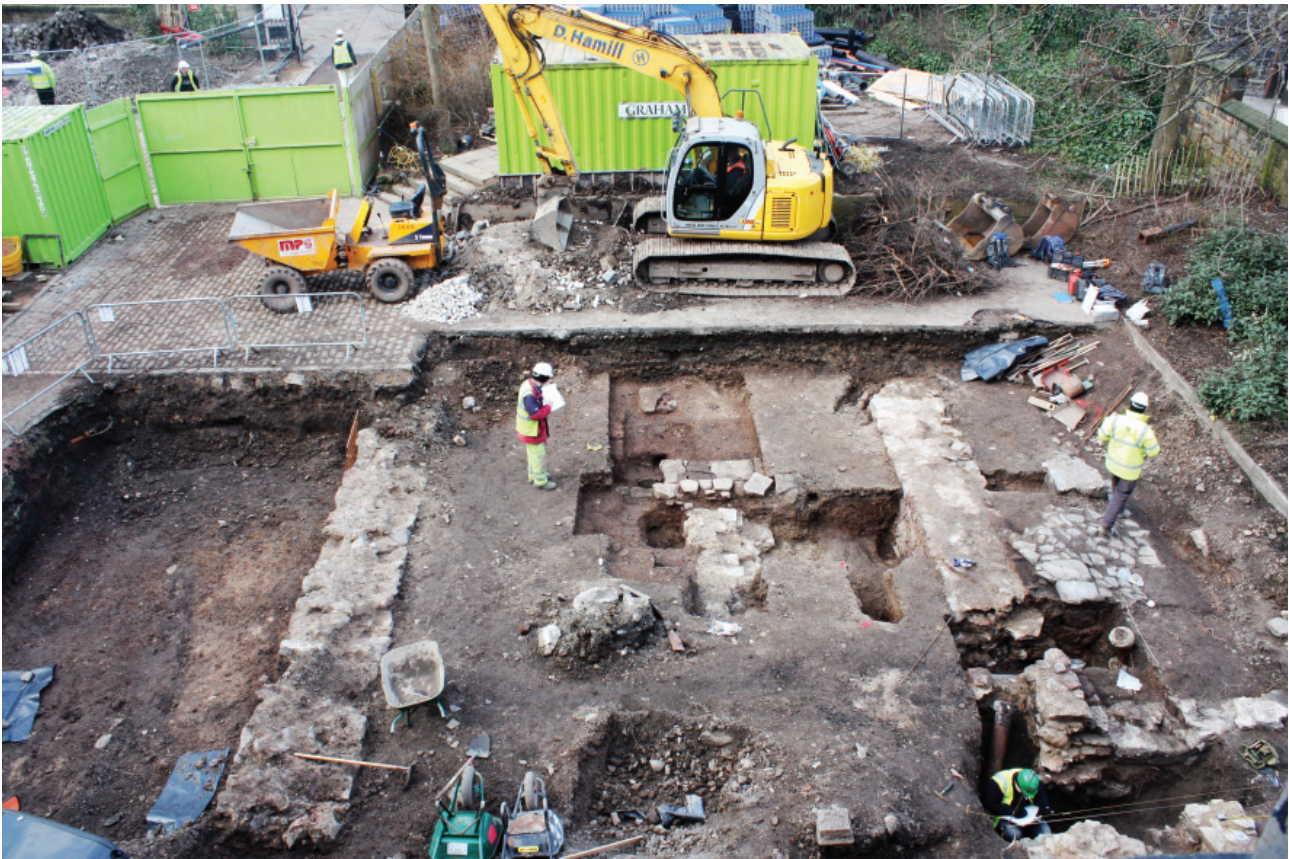
Illus 10

View of excavation area, facing SW

The remains of a substantial building were represented by two large walls that ran parallel and were oriented NE-SW (**Illus 10**). The southernmost wall [054] was constructed with a mixture of roughly hewn red sandstone and grey limestone bonded with a compact light yellow-grey lime mortar. It was consistent in width, at 1.2m, along its visible length and stood to a height of 0.9m. The construction was random uncoursed sandstone. The wall was not faced suggesting the building was rendered to mask the coarse stonework or, more likely, that this was the foundation course of the building. The length of the wall exposed measured 11.63m though the full extent of the wall extended outwith the excavated area.

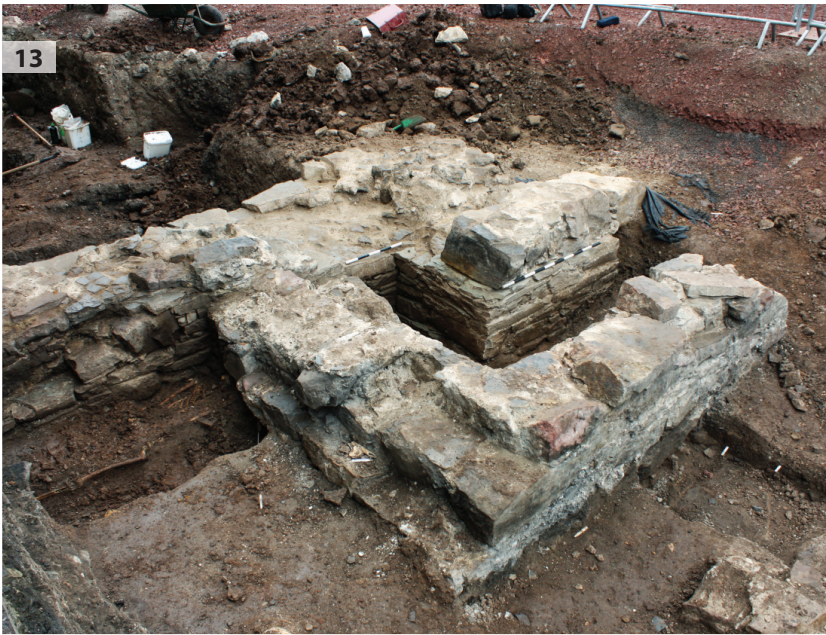
Illus 13

View of Area C showing wall [053], facing S

To the south of wall [042], in the south-west of the excavation area was an L-shaped section of wall [053] projecting at right angles (Illus 13). This formed a rectangular structure measuring 2.3m by 2.48m. The wall was constructed of lime-mortared yellow sandstone blocks. These had been roughly faced and no tool marks were noted. Some were sizable and measured up to 0.7m by 0.4m by 0.25m high. Four courses were present and the wall

stood to a maximum height of 0.85m and was 0.53m wide. A small foundation step was present on the west side of the wall. This was 0.2m deep. The wall had been truncated on the east side by the cut for a ceramic sewerage pipe.

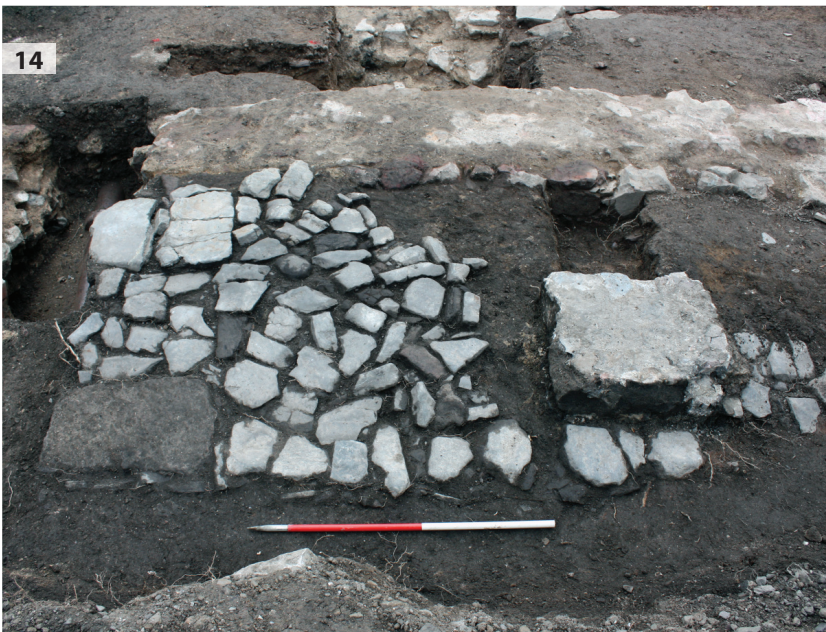
Illus 14

View of cobbled surface [039] and pad [038], facing SE

Towards the eastern side of the cobbled surface was a square stone pad [038]. This measured 0.7m by 0.7m and was 0.25m high. It was located 0.9m from wall [052] and was constructed of a single course of roughly-hewn limestone capped with a mixture of slate and lime mortar. It is possible that the stone pad was a column base.

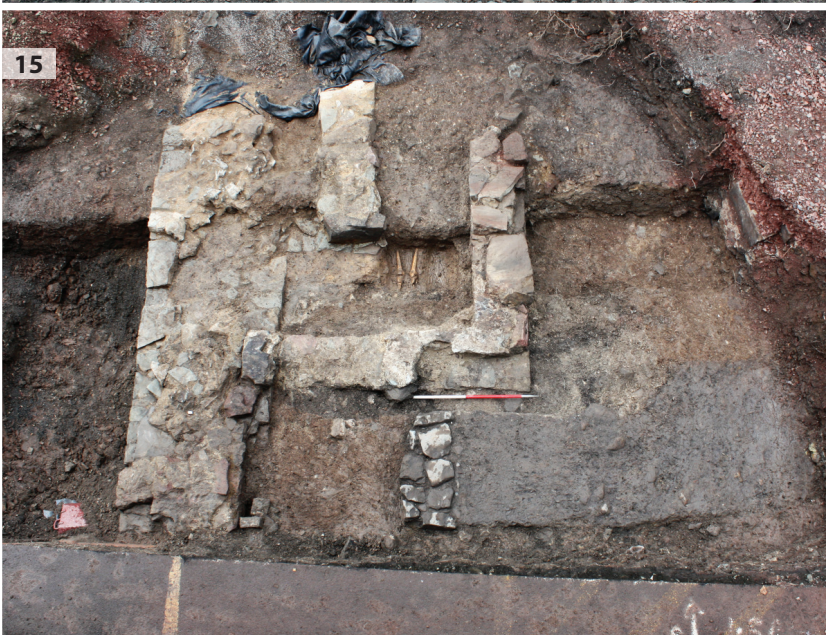
Illus 15

View of Area C showing surface [195] and edging [194], facing SW

To the west of wall [042] was another surface likely to be associated with the building. It consisted of a compact silty clay gravel surface [195] sloping slightly to the north. Some disarticulated bone had been compressed into the top of the surface. It measured 3.2m by 1.4m and was between 0.03m and 0.05m thick. At the north end of the surface were the remains of a cobble edging [194] to Surface 195. The stones were sub-

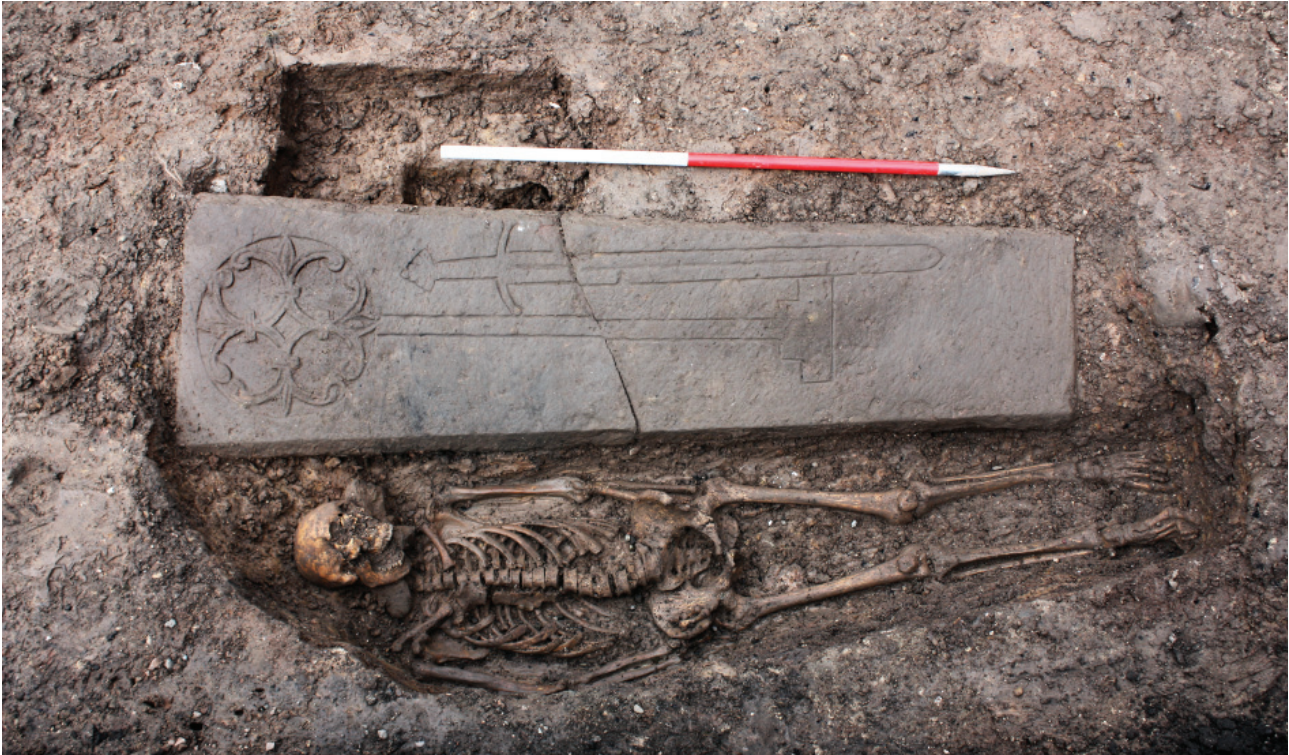
Illus 21

View of Skeleton 09 and grave slab [133]

Another body had been buried over Skeleton 11 and lay adjacent to the grave slab (133). This had been placed in a cut [132] that measured 2m in length, was 0.48m wide and 0.45m deep. The body (Skeleton 09) was complete and had been placed with arms at the side and the hands slightly beneath the pelvis (**Illus 21**). A number of iron nails were found in the grave on the left side but not around the whole body suggesting they might not be coffin nails. Fragments of copper alloy lace tags (SF04 and SF05) were recovered from this grave as well as an iron object (SF06) that lay on the right clavicle of the skeleton. Pottery dating from the 13th–15th century was present within the grave fill, although this may be intrusive.

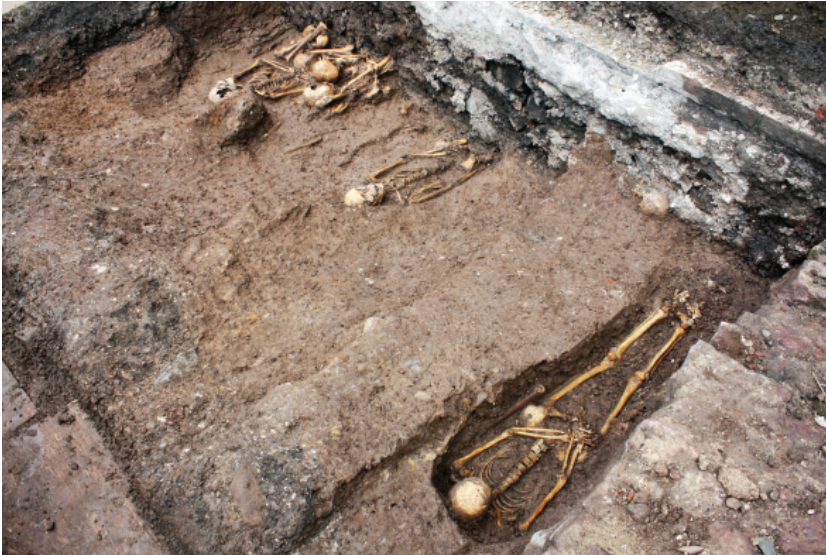
Illus 25

View of Area B, facing N

The row of burials closest to the Old High School was the densest in terms of number of burials (Illus 25). The majority had been truncated by the foundations for the Old High School and as a result only the upper half of the burials had survived (Illus 26). As with the middle row those at lower levels had the poorest bone preservation.

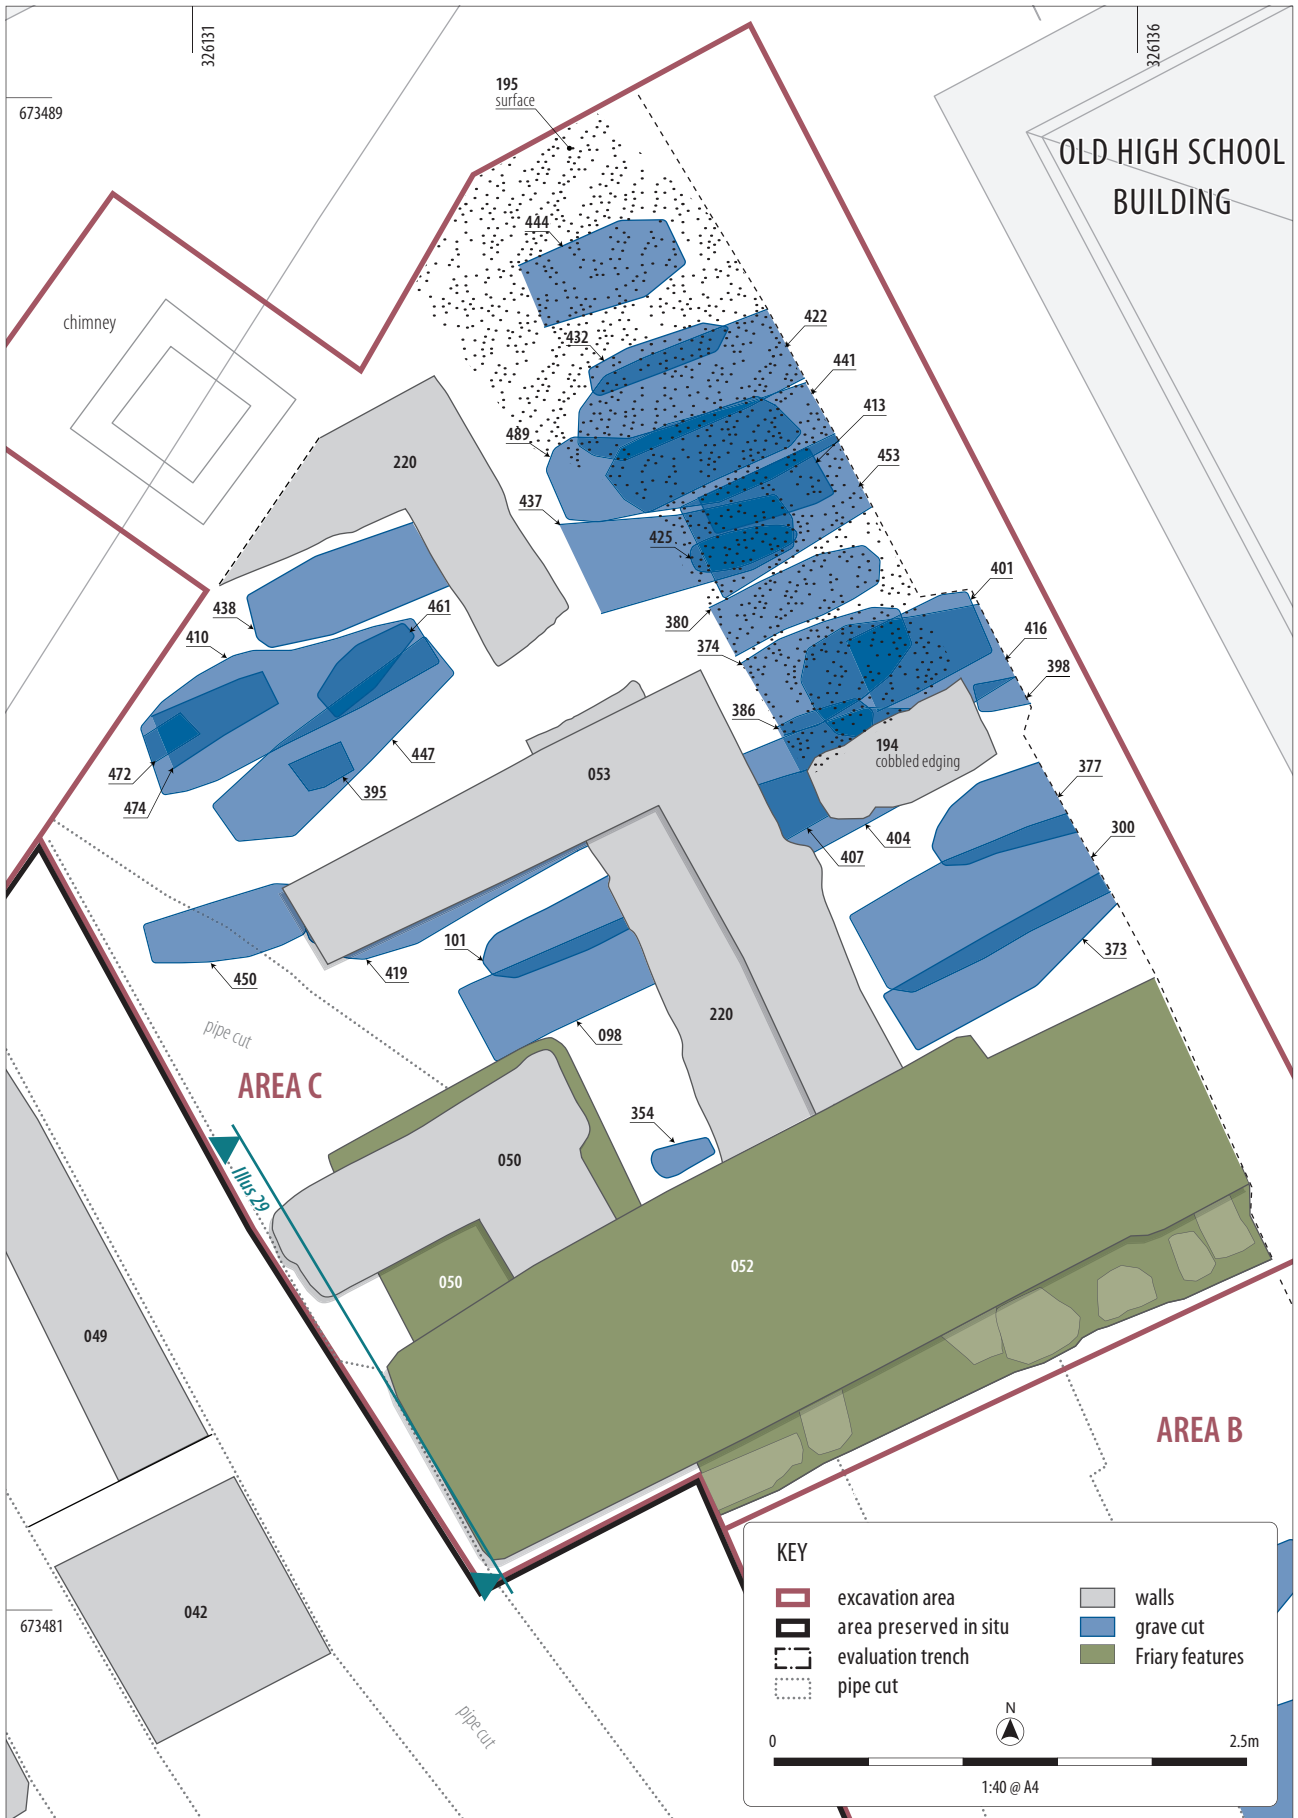
Illus 27
Plan of Area C

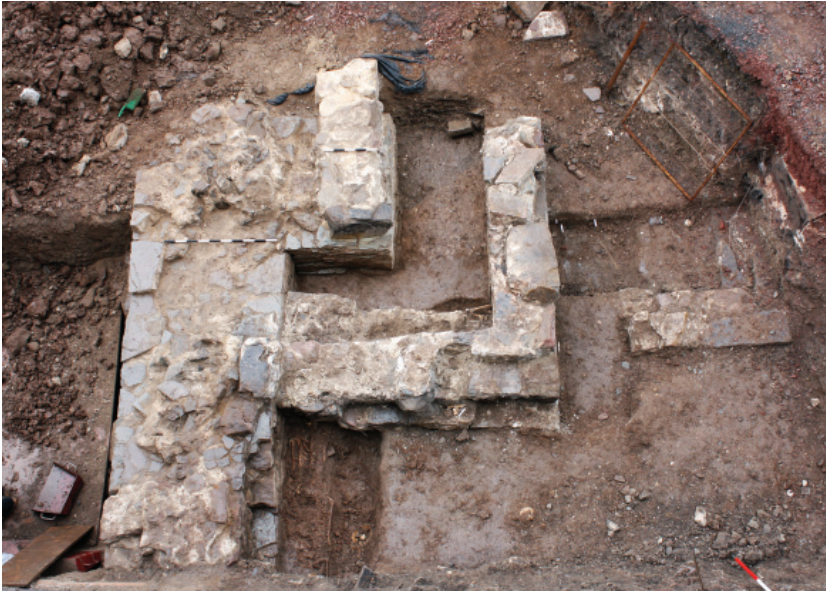
Illus 28

View of Area C after removal of surface [195] and surviving Friary walls (1260–1560)

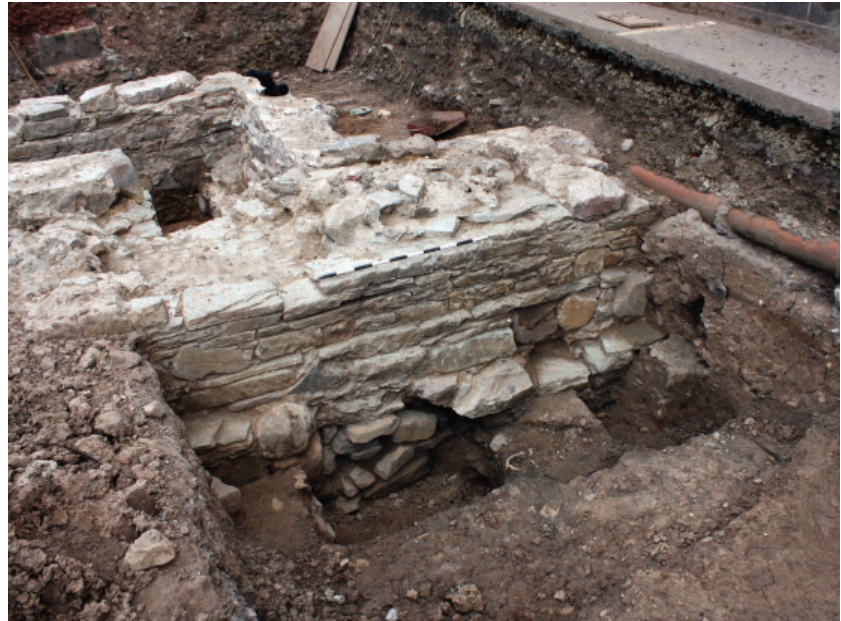
Illus 30

View of wall [052] showing scarcement, facing N

The scarcement found on the wall in Area C suggests that the interior of the building was on the south side of this wall indicating that the burials in Area B were inside the church. Field observations of the bones in this area showed them mostly adults with less evidence of disease and better teeth suggesting a better quality of life than those buried outside the church in Area C.

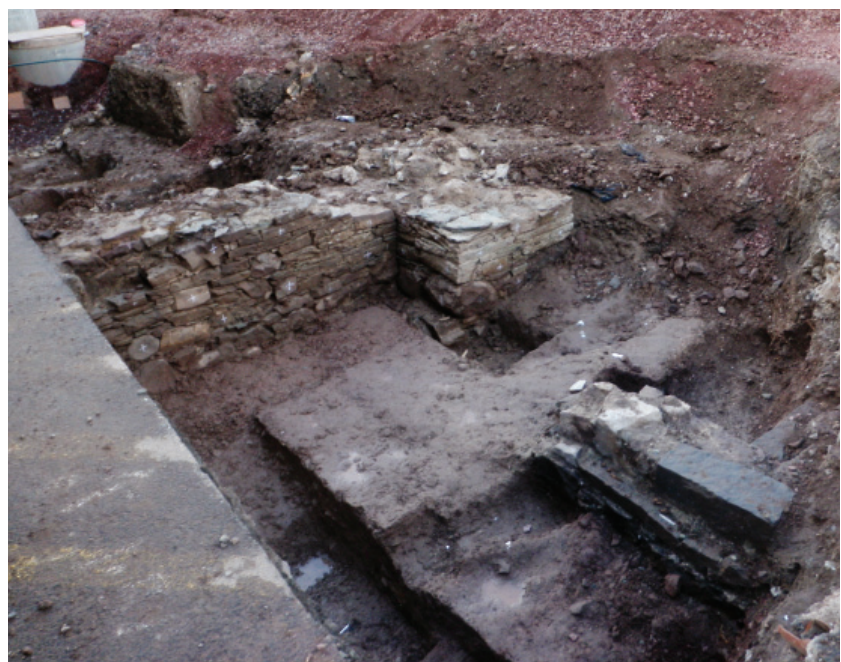
Illus 31

View of wall [052] and buttress [050]
