# CASTLE DOW FORT, STRATHHTAY, PERTH AND KINROSS

*Archaeological Measured Survey*

*for Forestry Commission Scotland*

*March 2013*

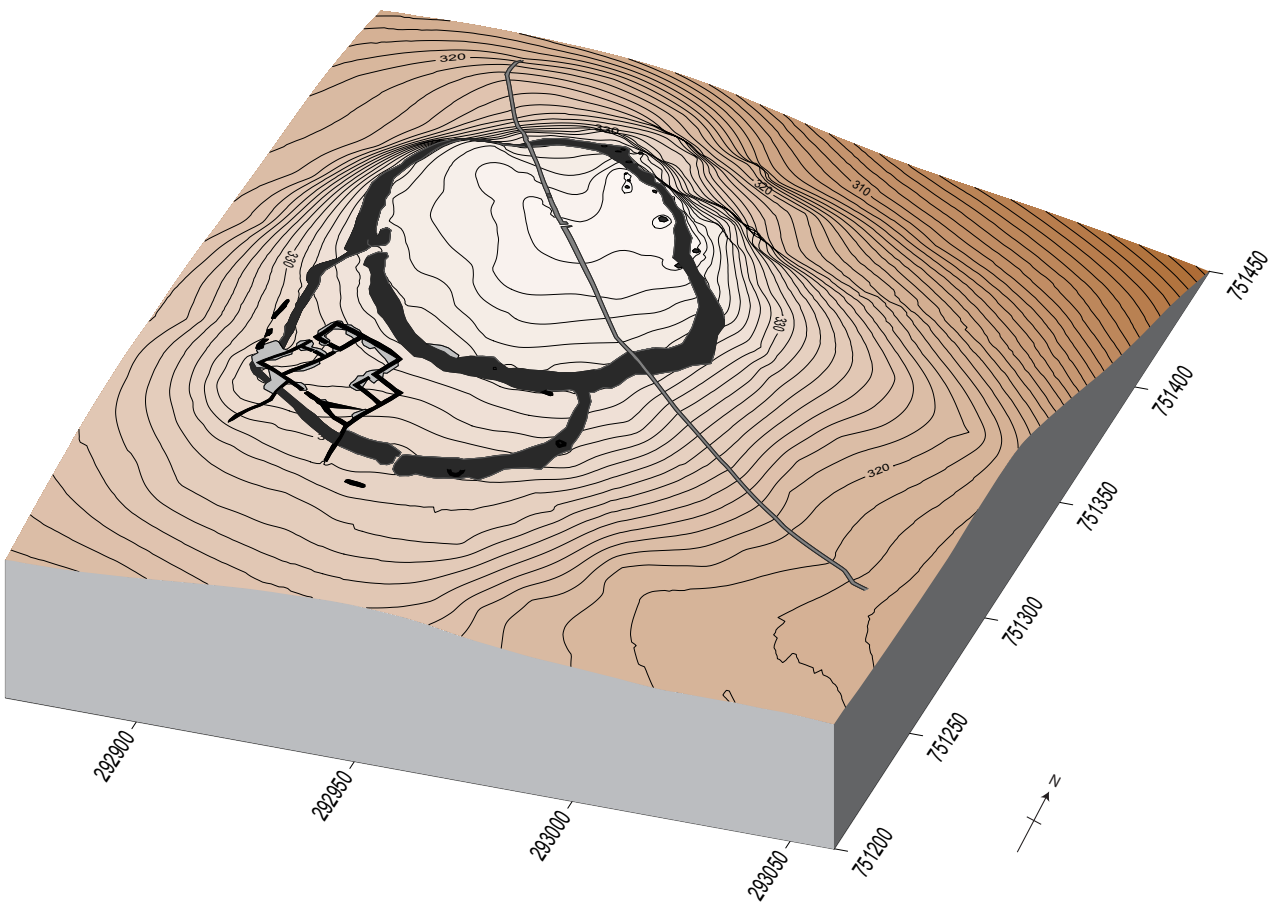
**Illus 5**

Digital terrain model of Castle Dow seen from the south-east

The fort is located on a rocky hill (*Illus 5*) on the south side of Strathtay with extensive views to the north, east and south over the valley and River Tay some 270m below. The fort is largely covered in mature heather but with some segments of the rampart still free of vegetation.

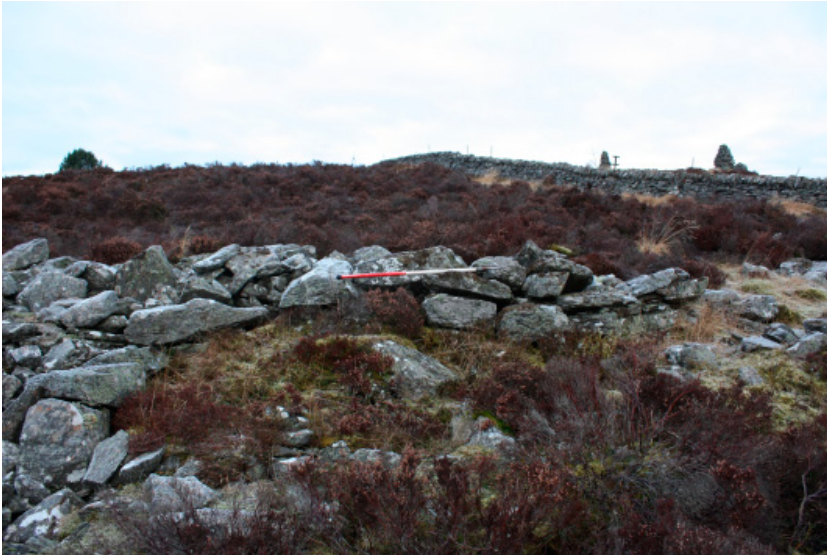
◀ **Illus 6**

*Remains of outer face of the main rampart to the east of the junction with the annexe, facing north-west*

The fort is oval, aligned north-north-west to south-south-east and measures some 97m by 64m internally, covering an area of 5,000m<sup>2</sup> (*Illus 4*). The stone rampart is collapsed and spread up to 7m wide. However, segments of the outer face survive along the south side of the fort (*Illus 6*). The best preserved segments of the rampart indicate that it was originally some 3m wide. The north side of the fort runs along the top of a steep craggy slope. The rampart is ill-preserved along this side with large segments missing.

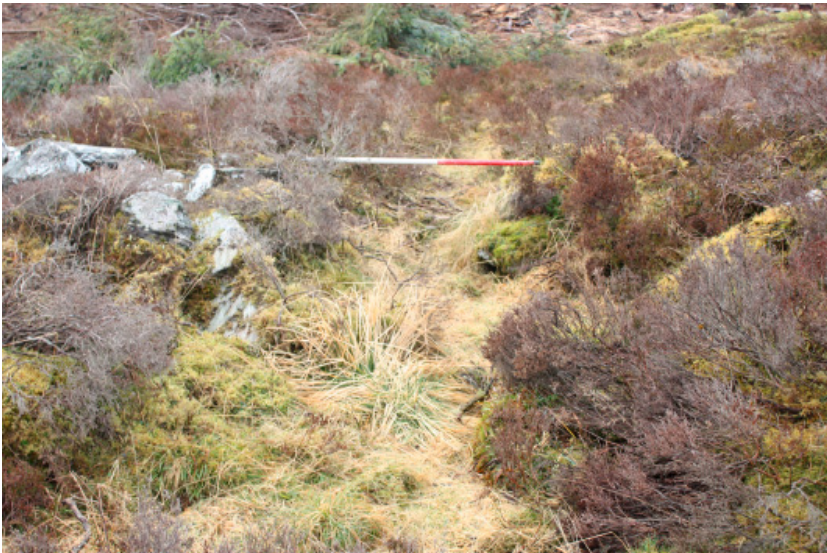
◀ **Illus 7**

*Entrance into the annexe, facing south*

An annexe is situated on the lower ground to the south-west measuring some 85m north-west to south-east by 26m wide covering an area of some 2,160m<sup>2</sup>. The annexe is defended by a stone rampart spread up to 6m wide with segments of the rampart face surviving on the south side. There is an entrance into the annexe from the south that is indicated by a narrow gap in the annexe wall, 0.6m to 0.9m wide (*Illus 7*). On the west side of the entrance evidence of both the outer and inner faces of the rampart survives indicating that the rampart was some 2m wide at this point.

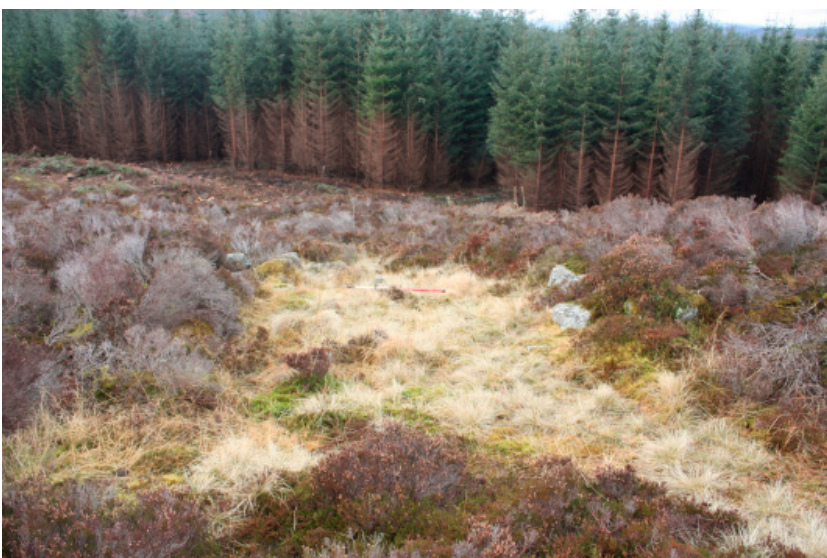
◀ **Illus 8**

*Entrance into the main fort at the N end of the annexe, facing south-west*

The entrance from the annexe into the fort is 2.9m wide and is situated at the north end (*Illus 8*).

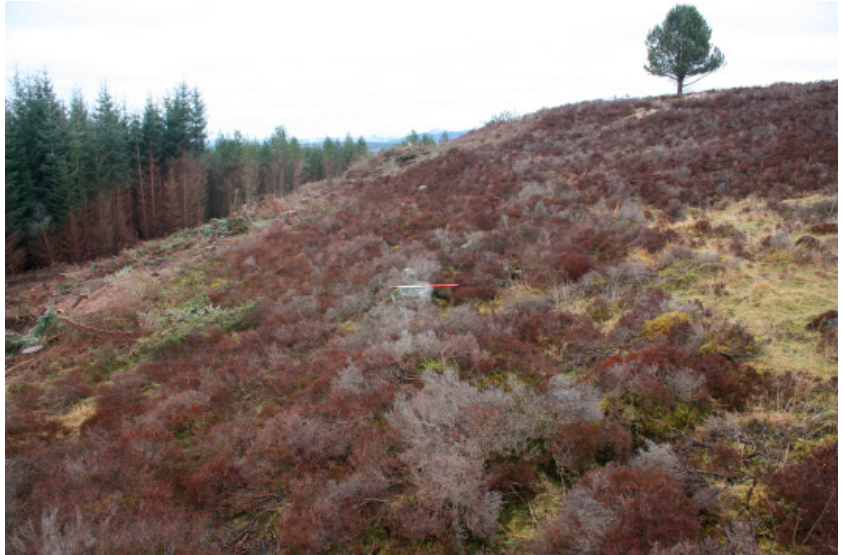
**Illus 9** ▶

*View along the west annexe rampart, facing north*

Remains of further outer defenses are located outside the western half of the annexe. It extends from the entrance and around towards the north end. These remains consist of a fragmented turf-covered stony bank (*Illus 9*) along the west side that runs into a marked shoulder in the terrain curving around the south-west side. A short bank segment some 7m to the south-west of the entrance is in line with the edge of the shoulder to the west and may represent the east end of this outer defense. Previous surveys (NMRS NN95SW 14) have referred to traces of a ditch associated with this outer defense. Two very shallow elongated depressions that were recorded within the east end of the shoulder may be what were interpreted as a ditch.

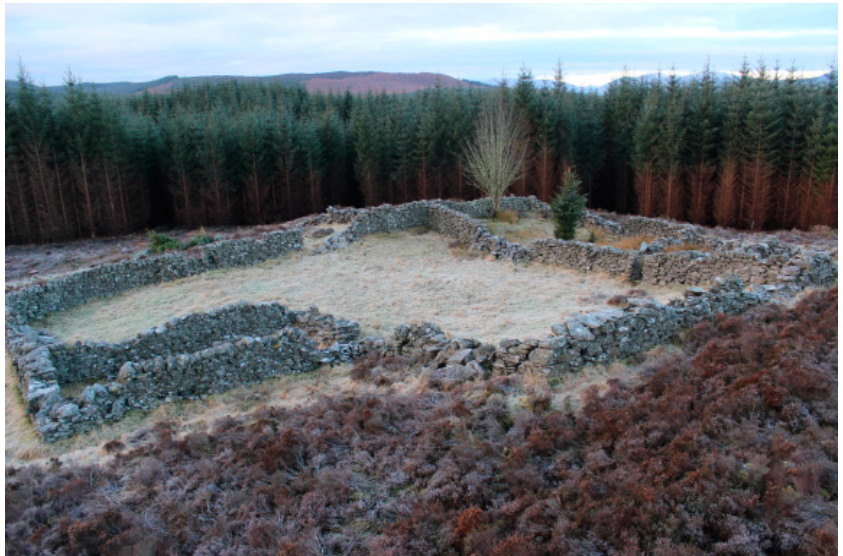
**Illus 10** ▶

A series of recent features have been built in and around the fort using material from the rampart. The main feature is a sheepfold situated within the western half of the annexe (*Illus 4,10*). The building of the sheepfold has left a 40m wide gap in the annexe rampart. The structure is sub-rectangular, measures 31m by 23m

*Sheepfold facing south-west*

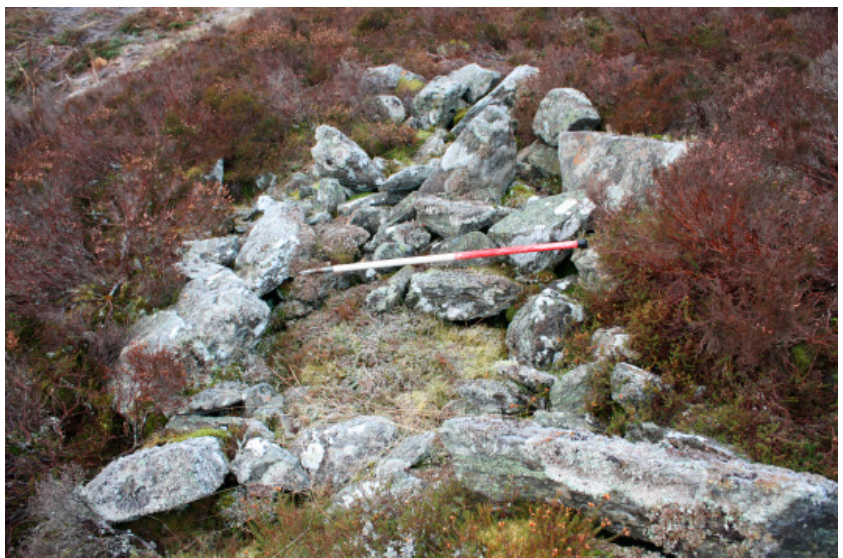
**Illus 11** ▶

*Small square feature built into the annexe rampart, facing south-west*

Two other features recorded along the south-eastern annexe rampart may be associated with the use of the sheepfold. A small sub-rectangular structure was built into the collapsed rampart rubble to the south-east (F2 *Illus 4*, *Illus 11*). The structure measured some 0.8m by 0.9m internally and was defined as a sub-rectangular, flat-based area framed by stones. There was no clear evidence of it being surrounded by stone walls.

The small sub-rectangular feature (F2, *Illus 4*) is built into the rubble of the collapsed annexe rampart. It is not well preserved and may represent a small unfinished sheep pen.

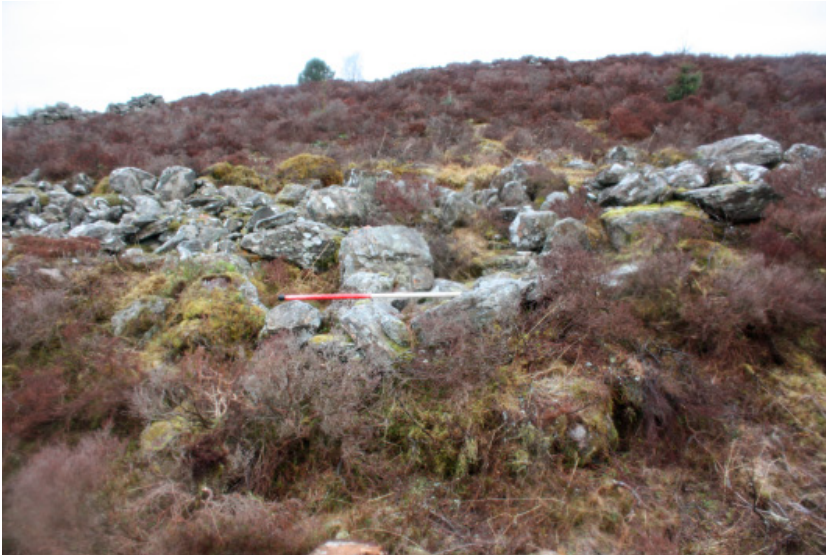
◀ **Illus 12**

*D-shaped feature built up against the external face of the annexe rampart, facing north*

A second feature was located some 12m to the east of the annexe entrance. It was a semi-circular stone bank, up to 1m wide, built up against the rampart face forming a D-shaped feature (F3 *Illus 4*, *Illus 12*). The feature measured 2.2m east-west by 1m wide internally. The interior of the structure was filled by stones. A large stone slab at the west end was set at an angle, resting on the rampart and leaving a gap beneath the stone that contained disarticulated animal bones (*Illus 13*).

The in-filled D-shaped feature (F3, *Illus 4*) contains animal bones. This could indicate that it represents the burial of animal cadavers. Putting the dead animals in a hollow in the rampart rubble might have been easier than digging a hole in the ground.

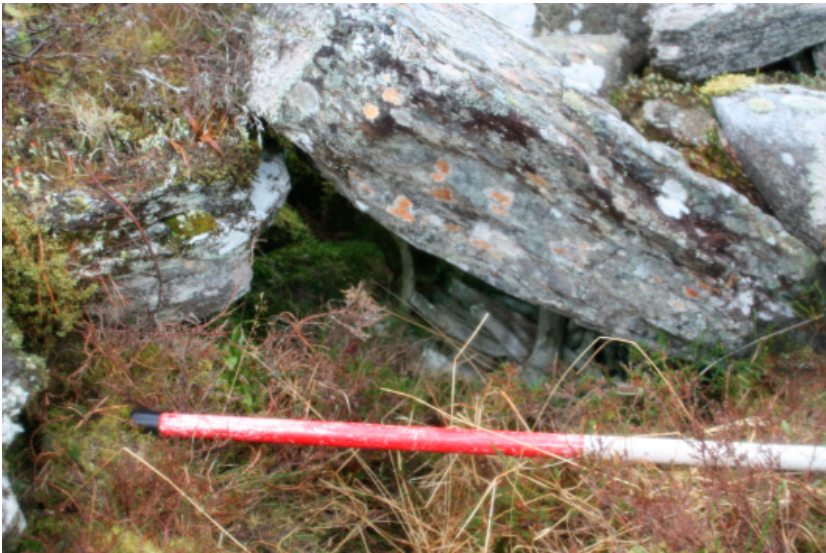
◀ **Illus 13**

*Animal bones visible under stone in D-shaped feature, facing east*

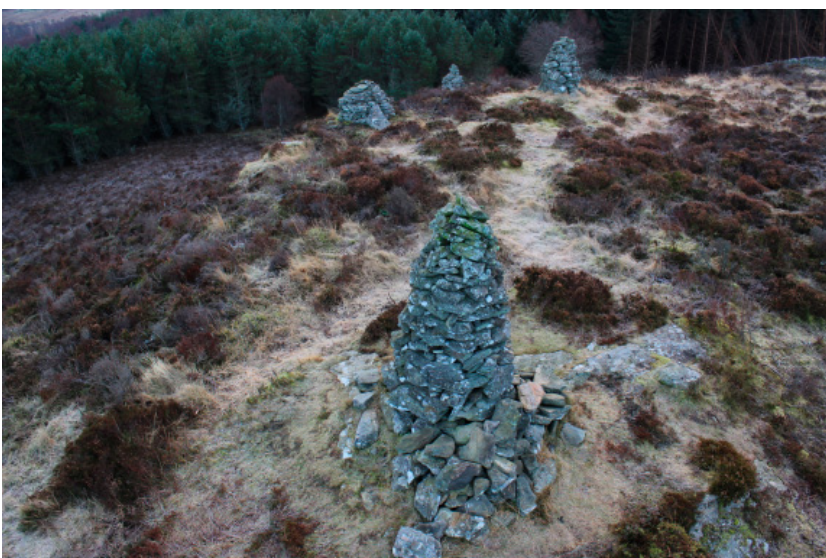
◀ **Illus 14**

*View towards marker cairns along the east rampart, facing south-east*

A series of marker cairns of various size from 0.3m to over 2m high have been built along the rampart where it runs along the top of the steep east-facing slope (*Illus 4*, *Illus 14*). There are 15 cairns along this side of the fort presumably all built from rampart material. In addition to the 15 cairns on prominent ground to the east, there is a small cairn built into the south-west side of the main rampart.

The 15 marker cairns along the eastern rampart have all been built on prominent ground. The rampart is much denuded in this area. Although some of this can be due to material robbed to build the cairns it is also likely that some of the rampart has collapsed down the steep slope to the east. Material from the east rampart may also have been used to build the stone dyke some 20m to the west.

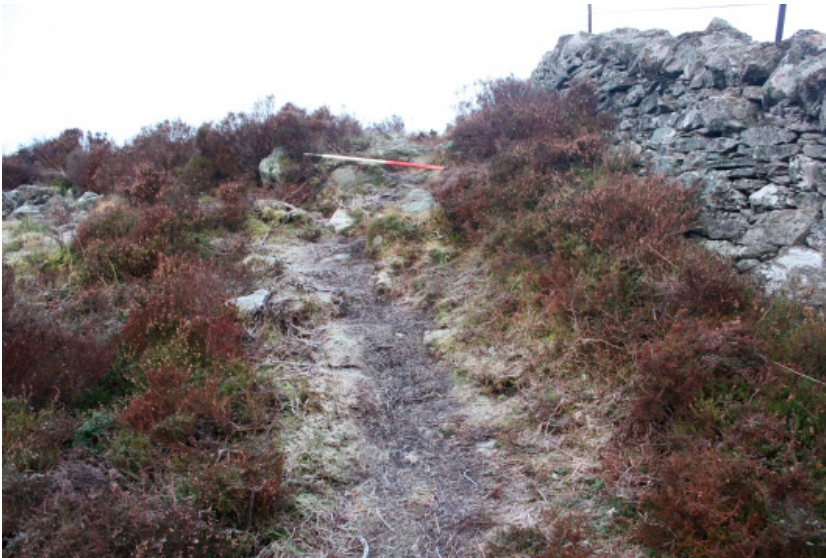
◀ **Illus 15**

The monument appears to be very stable with few sign of any recent damage. There is a footpath that leads into and across the fort from the south along the west side of the dyke. Near the middle of the fort it branches off to the east through a gap in the dyke leading up to the east rampart. Further north there is a short spur leading off to the west along the north rampart. There are three minor patches of erosion within the paths; one where the main path crosses the south rampart (*Illus 15*), one in the path leading off to the east (*Illus 16*), and also within the path along the north rampart (*Illus 17*).

*Erosion in the path where it crosses the main rampart on the south side of the fort, facing north-west*

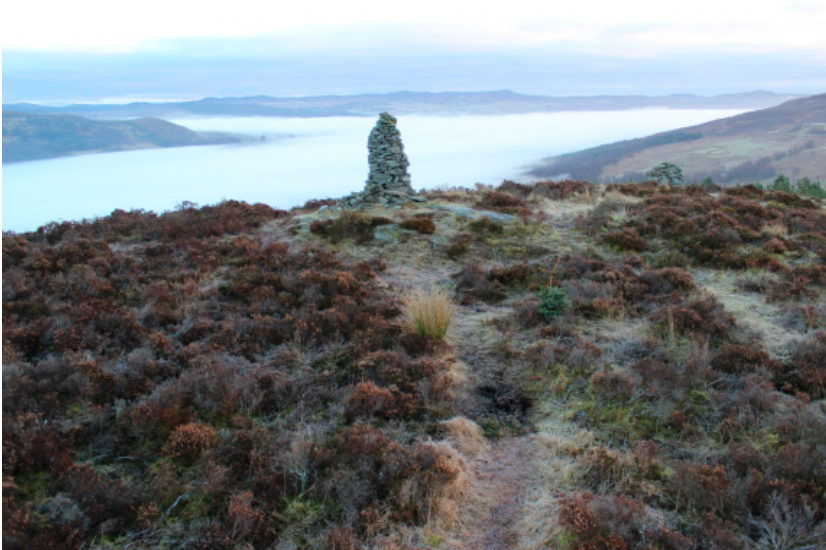
◀ **Illus 16**

*Erosion in path leading up to Cairn 12, facing east*

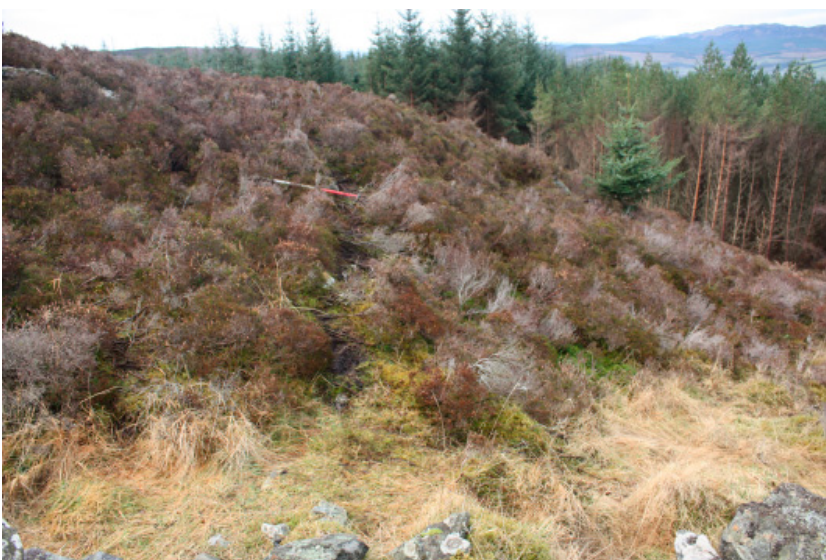
◀ **Illus 17**

*Slightly eroded path along the main rampart on the north side of the fort, facing west*
