**Non-Invasive Archaeological Investigations for the Aberdeen Western Peripheral Route
(AWPR Package)**

**ACCESS FROM THE NORTH PROPOSAL
(THE THIRD DON CROSSING)**

Cruives Enclosure Wall (Site A29)
Topographic Survey

Report Reference No: AWPR-TDC-002

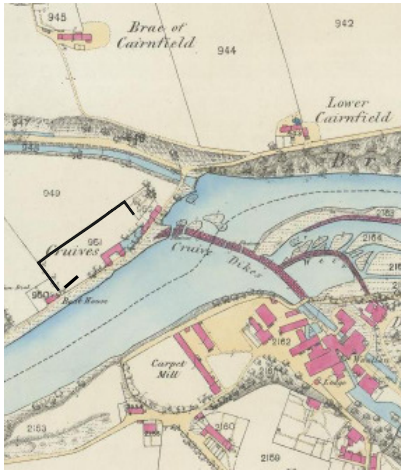
Illus 2

- 3.1.1 The Ordnance Survey map of 1869 (Aberdeenshire, LXXV.3) depicts the enclosure on the north bank of the River Don (Illus 2). It is conjoined to the west with a boathouse enclosure (Site A28). Within the enclosure the map depicts a large, roofed U-shaped building open to the south-east named Cruives and a range comprising four roofed

Cruives Enclosure and associated buildings on 1869 1st Edition OS 25 inch-Aberdeenshire Sheet LXXV.3 (Old Machar)

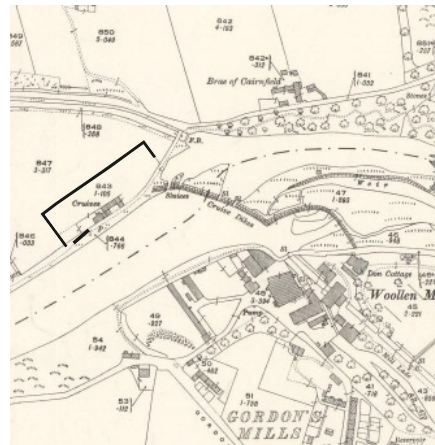
Illus 4

buildings to the east. Cruives is shown on the 1901 (Illus 3) and 1926 (Illus 4) editions of the same map, along with a second roofed building immediately to the west. The main building is visible on 1948 vertical aerial photographs (CPE/Scot/UK 316, frames 2071-3), although it appears at that time to have been reduced to a single range. The range of buildings had been demolished by 1901 as shown on the 1901 and 1926 Ordnance Survey map editions and aerial photographs. Current Ordnance Survey maps depict the enclosure but not the buildings.

Cruives Enclosure and associated buildings on 1926 Edition OS 25 inch-Aberdeenshire, Sheet 075.03

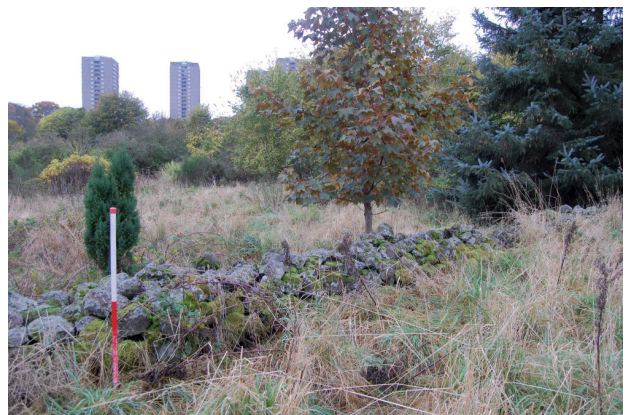
Illus 6

- 3.2.5 The north wall is the most substantial and contains the best-preserved part of the enclosure. It mostly lies on a 1m wide base made from larger stones (not easily visible in most places) with the wall on top being slightly battered and tapering to a width of between 0.6 and 0.7m (Plates 7-15). The north wall stands to a maximum height of 0.8m, though its average height is c. 0.5-0.6m. At its west end the north wall is less well preserved and is only 0.2-0.3m high (Plates 14 and 15).

a) Section through northern enclosure wall

b) View of profile location- northern enclosure wall, facing south-west

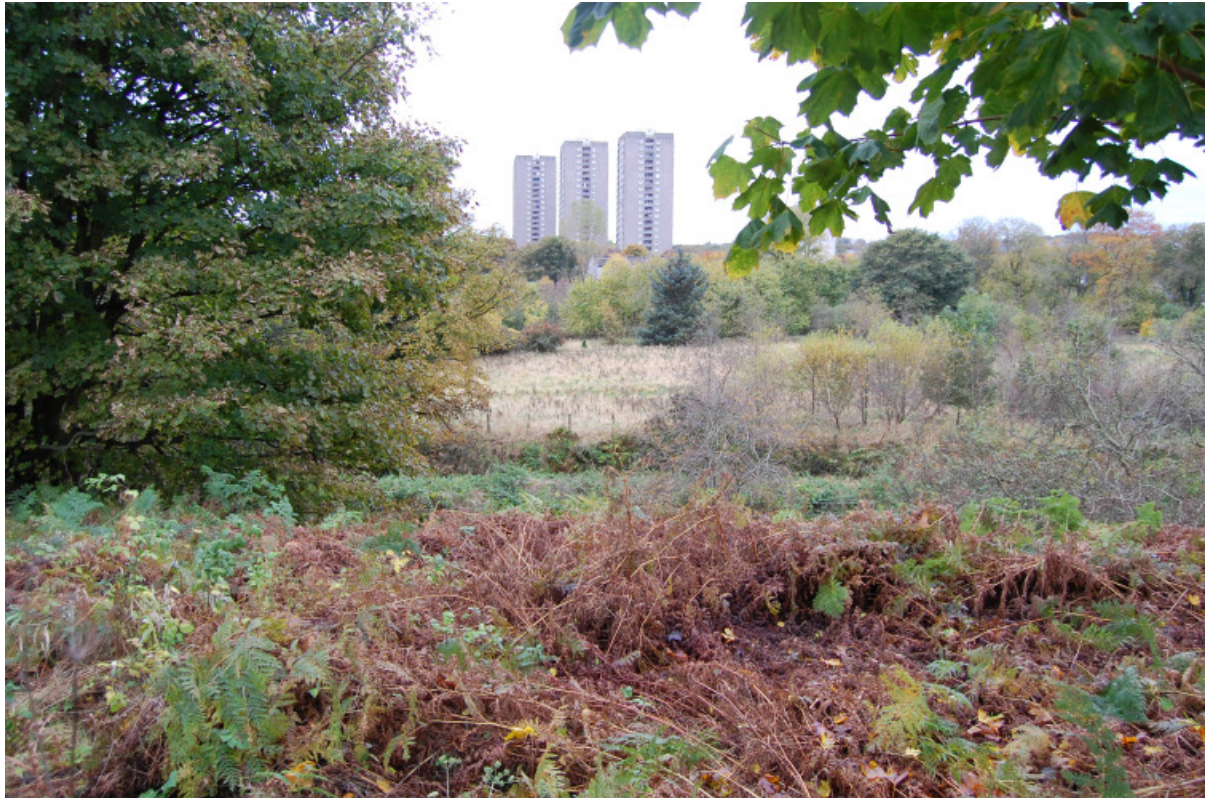
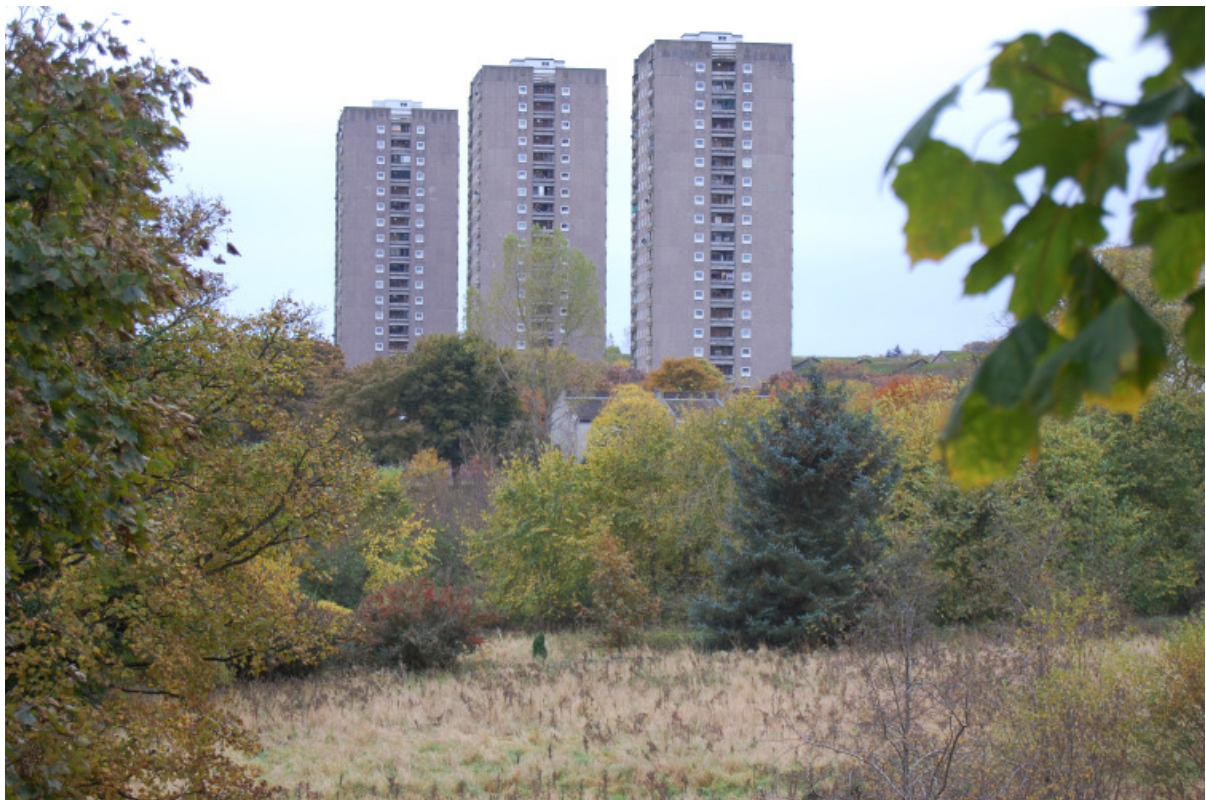
- 3.2.1 The field survey revealed that the enclosure is situated on flat land on the northern bank of the River Don at an average height of 9.5m OD; a minimum height of 9.1m and a maximum of 9.7m was recorded (Illus 5). Currently the survey area is extremely overgrown with trees covering the majority of the enclosure wall and dense vegetation being present within the enclosure and its immediate surroundings (Plates 1 and 2).

Plate1: Cruives enclosure- General view from the north, facing south-east

Plate 2: Cruives enclosure- General view from the north, facing south

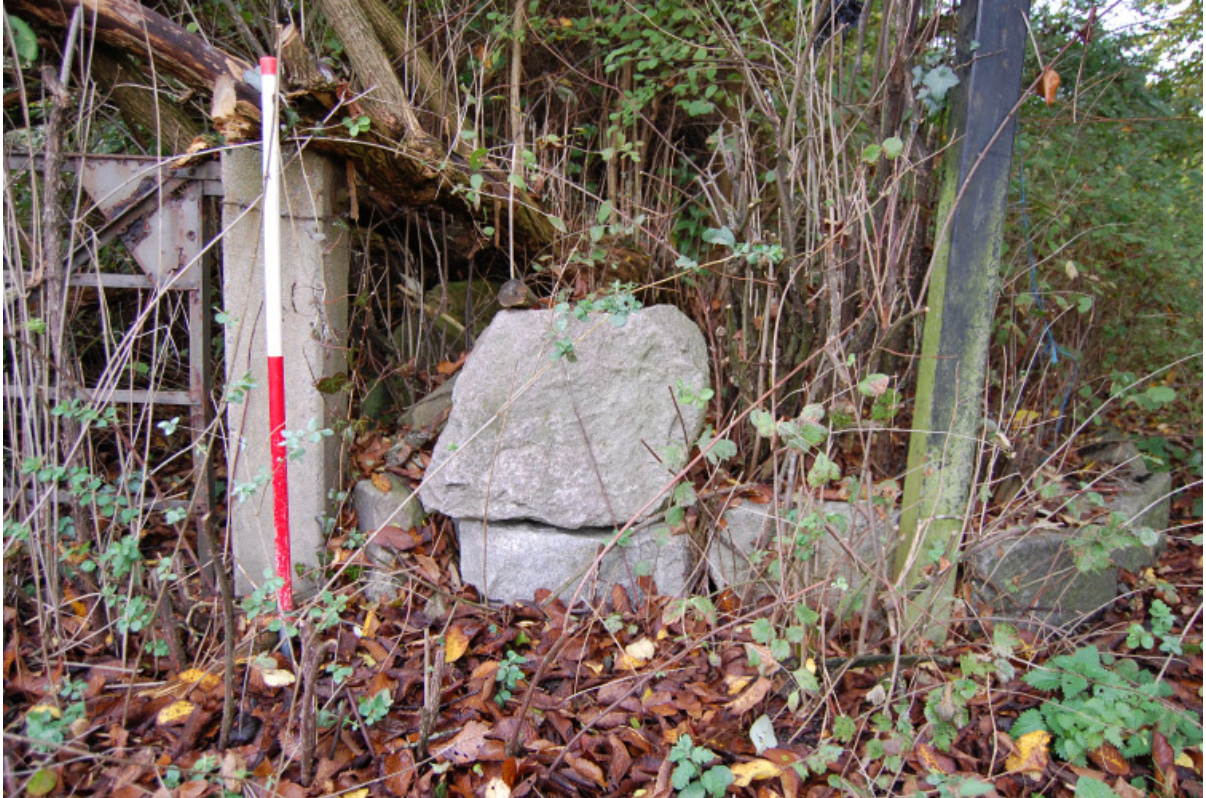
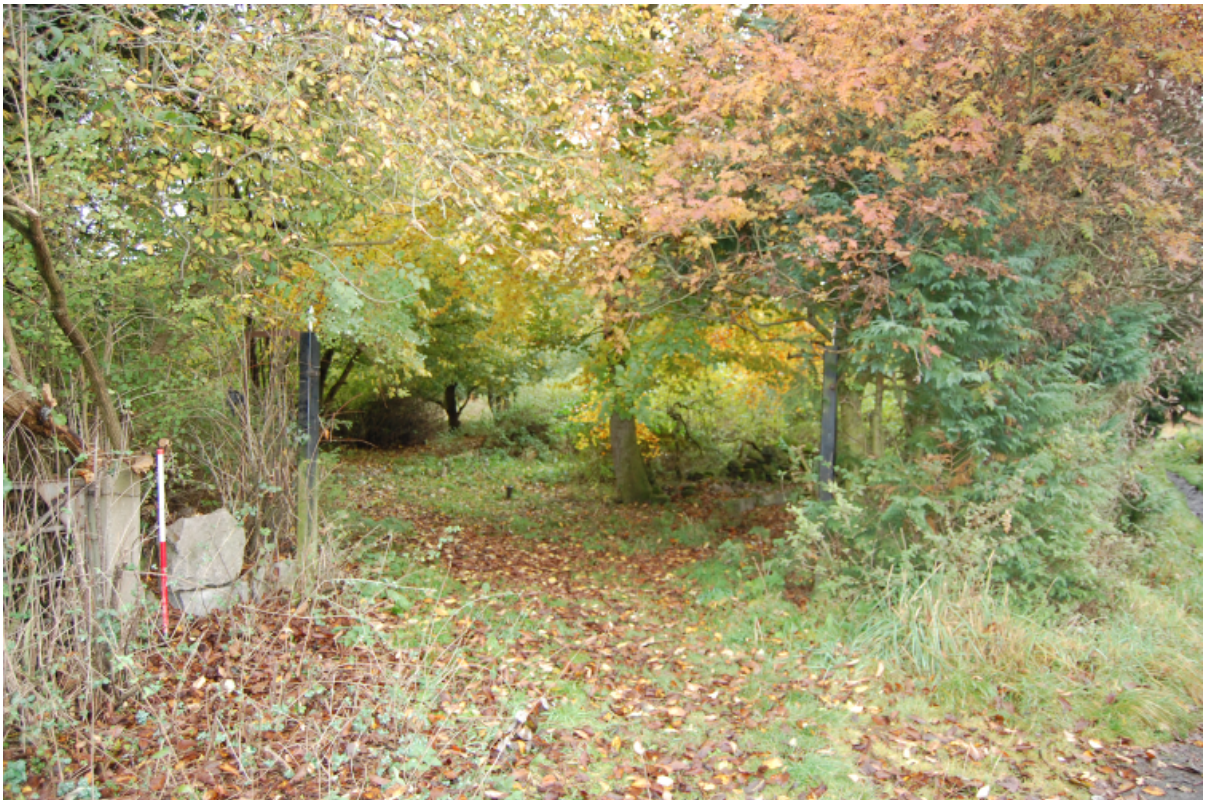
- 3.2.2 The enclosure is oriented south-west to north-east measuring 105m by 40m. The survey found the enclosure wall to be in variable states of preservation. The drystone wall forming the enclosure survived reasonably well to the west and north but less so to the east. The majority of the base of the enclosure wall survives. The south-west corner of the enclosure had been modified, the map sources do not show an entrance at this location, where the wall terminated to accommodate an entrance to the interior area (Plates 3 and 4).

Plate 3: View of southern limit of Cruives Enclosure Wall – west wall, facing north

Plate 4: View of southern limit of Cruives Enclosure Wall – west wall, facing north-east

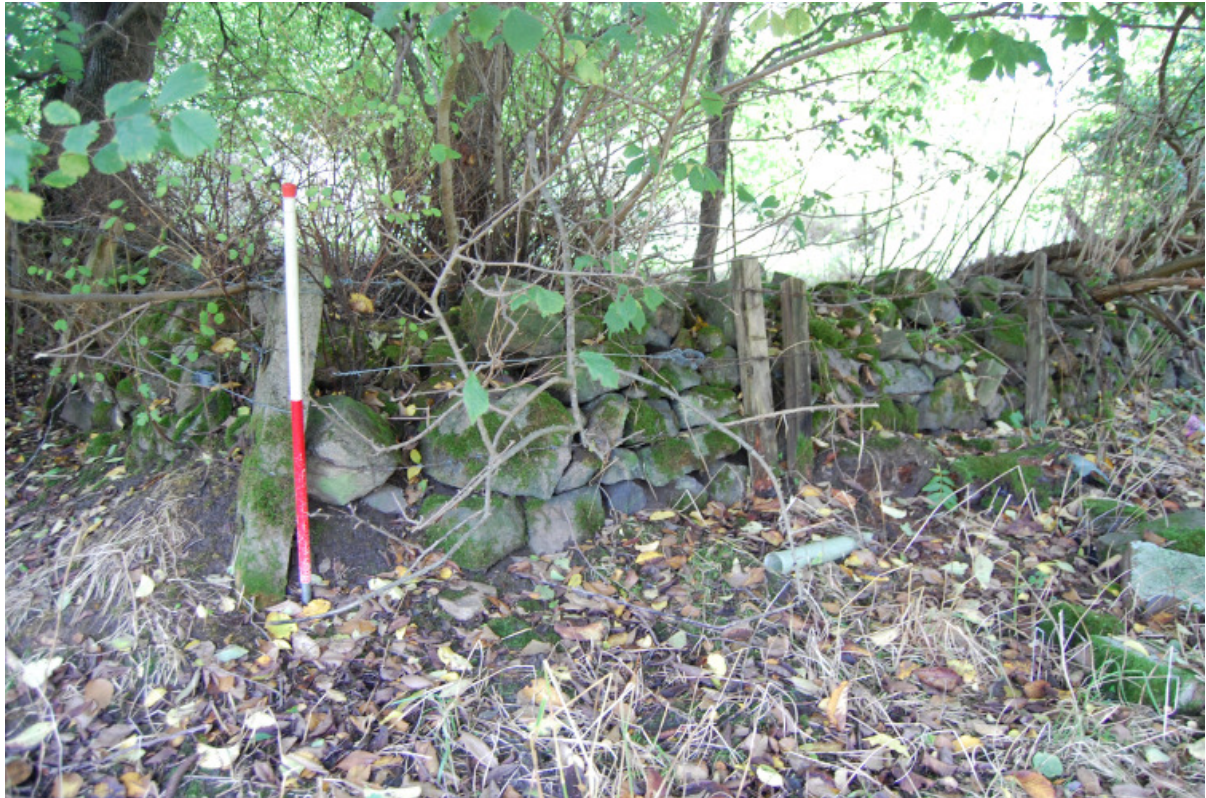
0.7m and a width of up to 0.7m (Plate 5). A small section, c. 2m, has three to four rough courses on the inside face (Plate 6).

Plate 5: View of north-west corner of Cruives Enclosure Wall from enclosure exterior, facing west

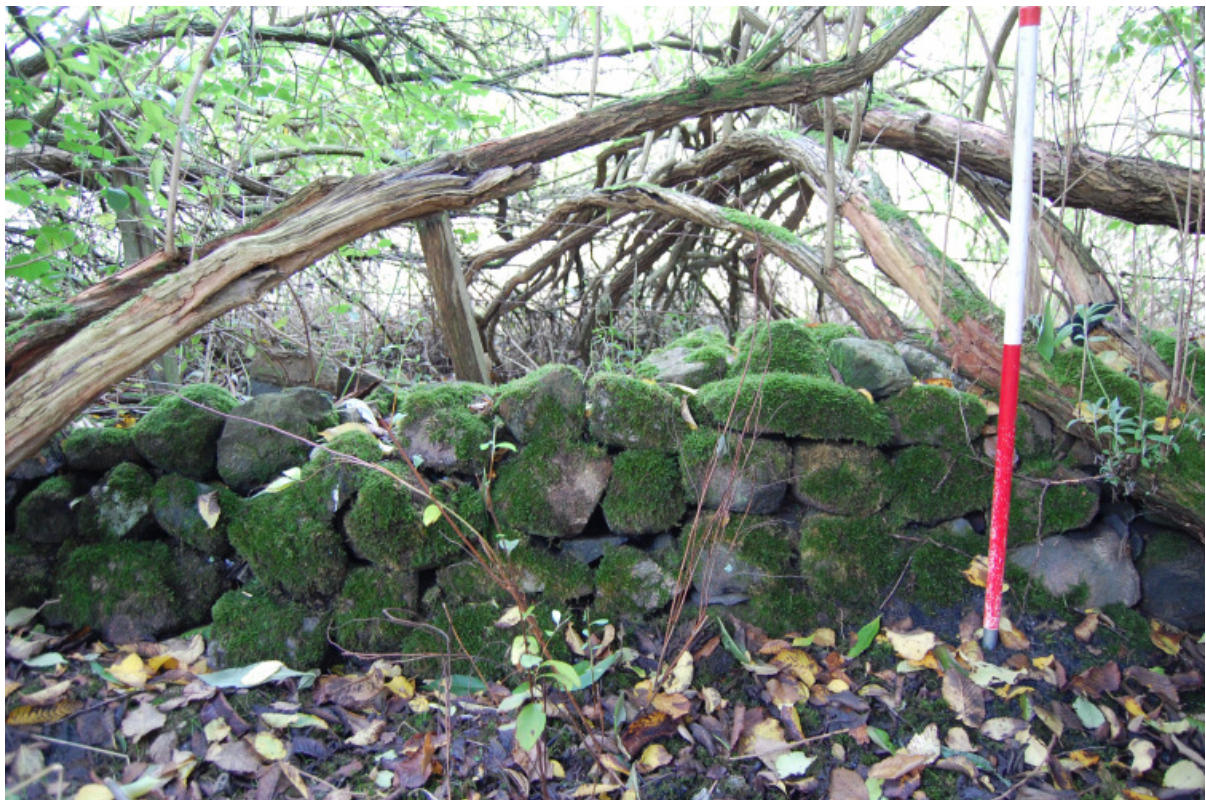
Plate 6: View of west wall of Cruives Enclosure Wall from enclosure interior, facing south-west

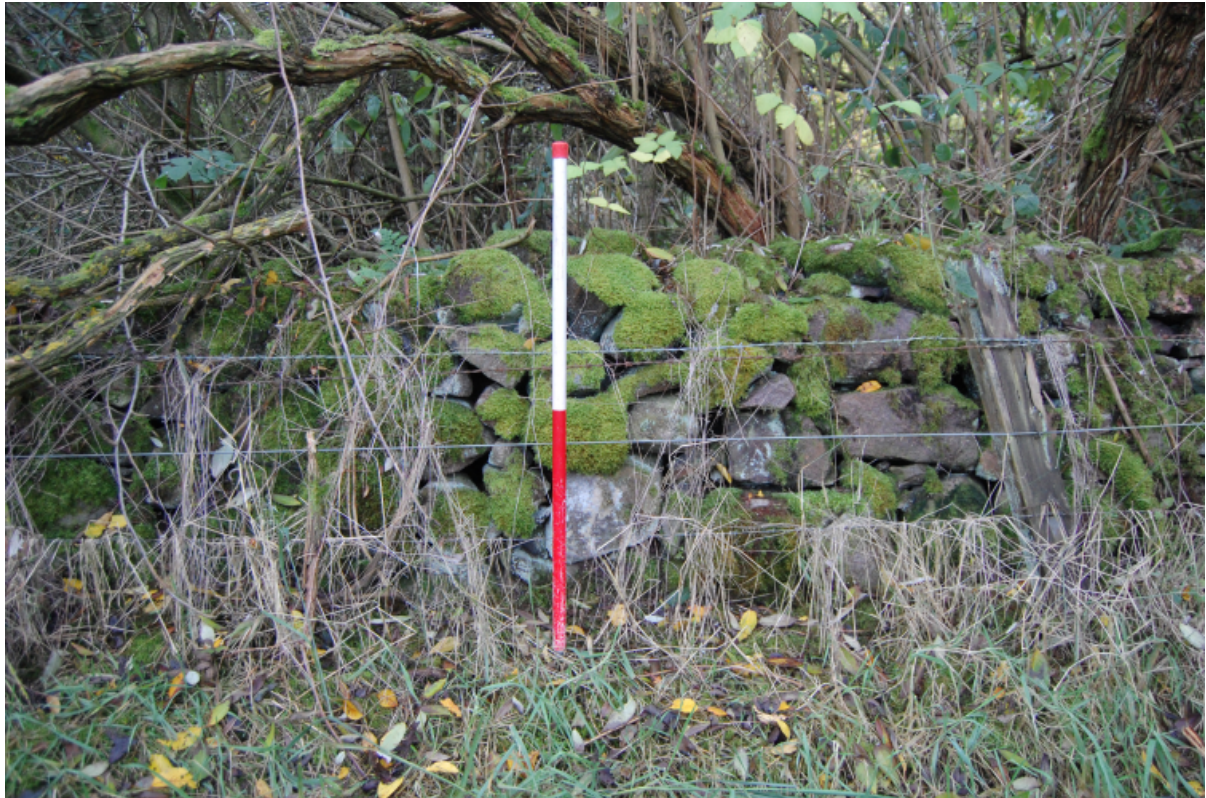
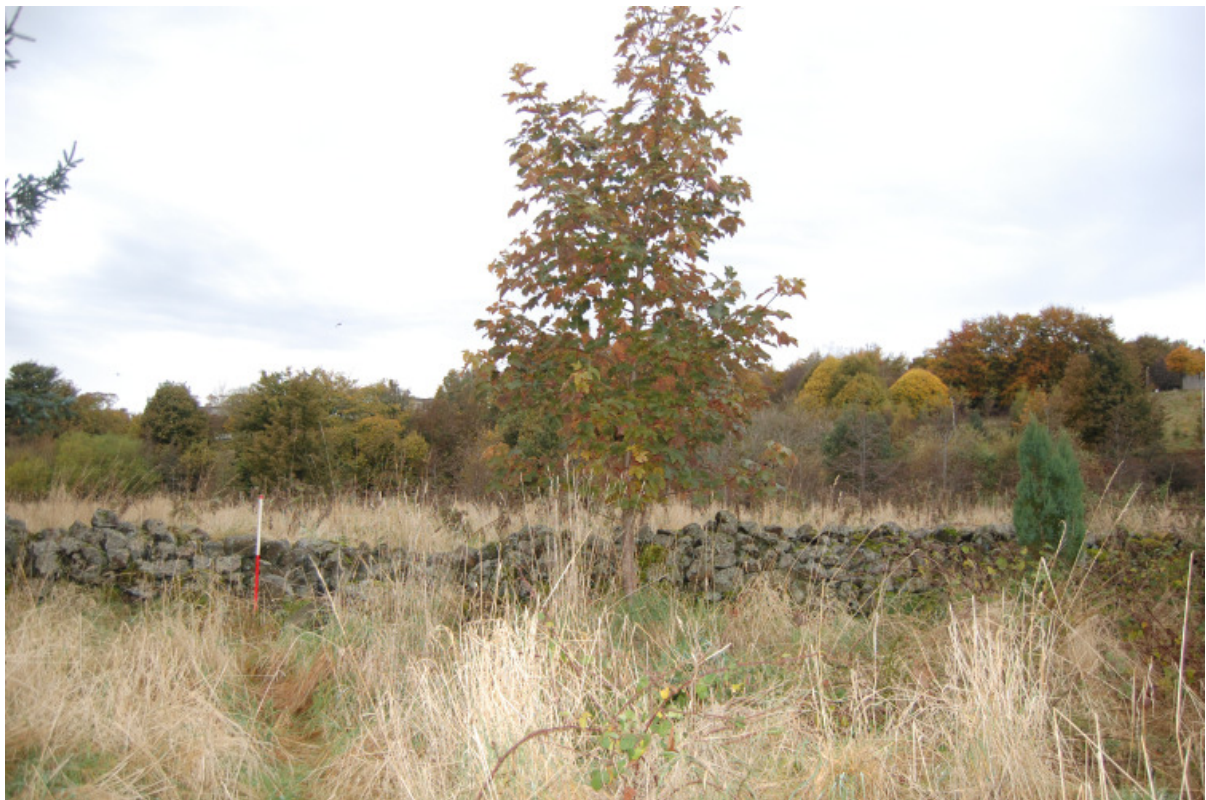
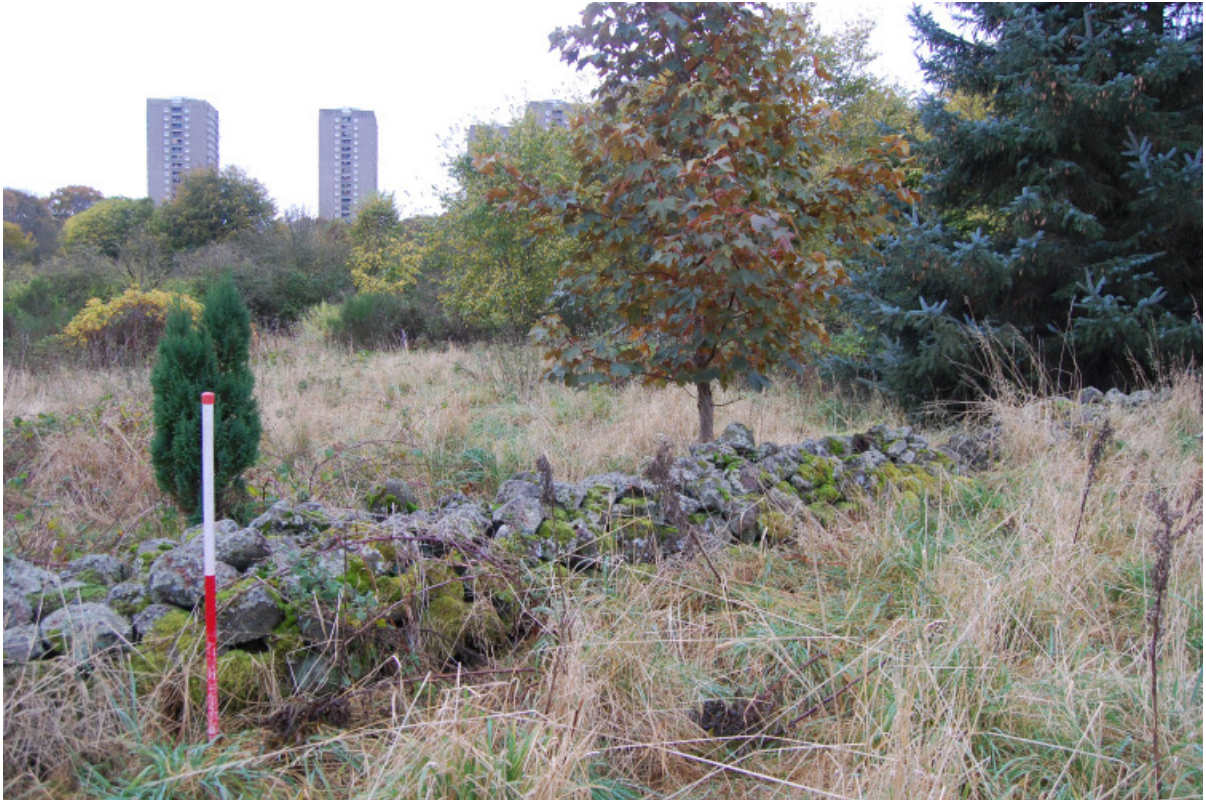
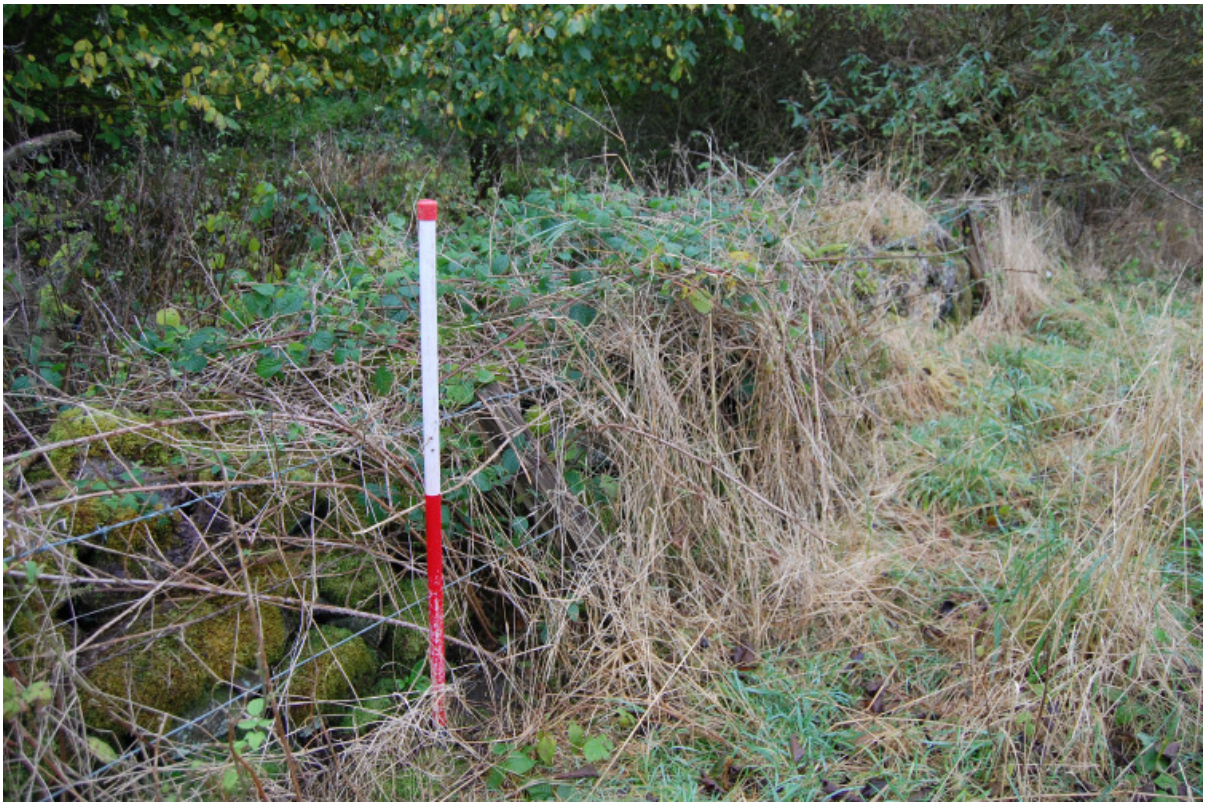
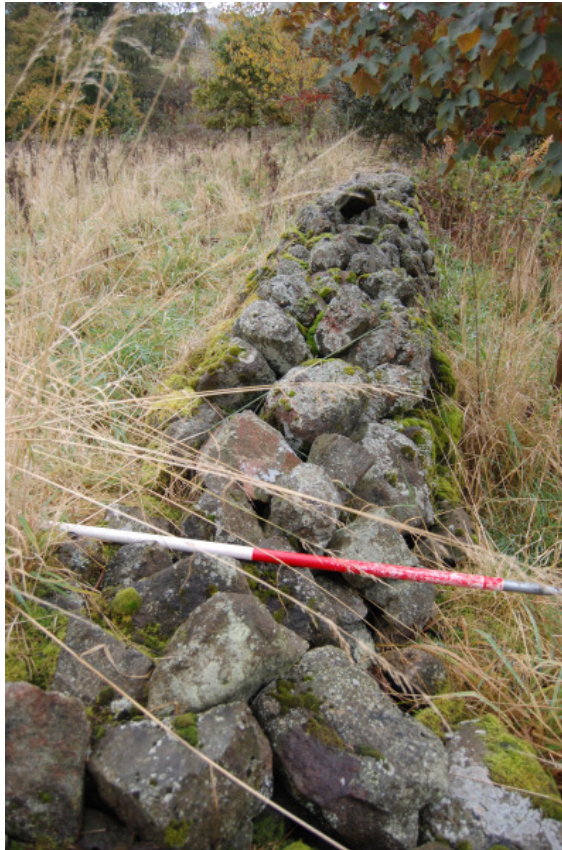
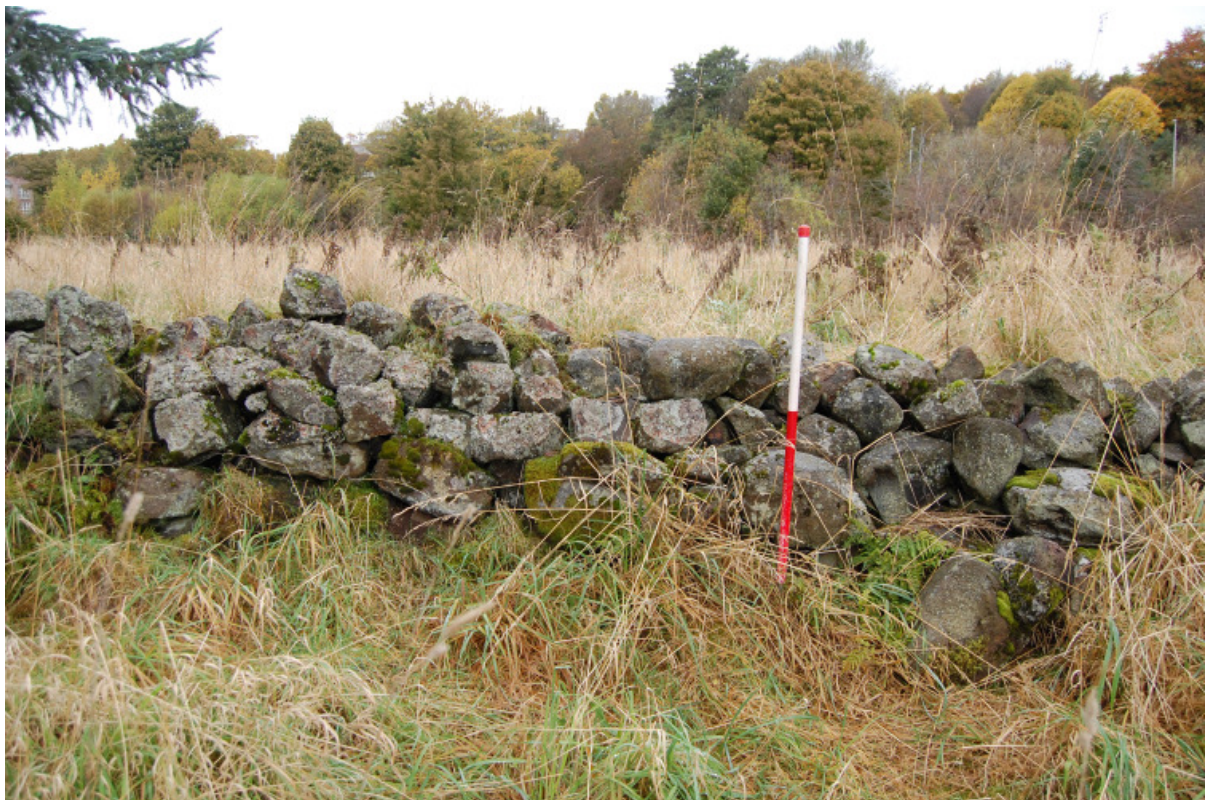
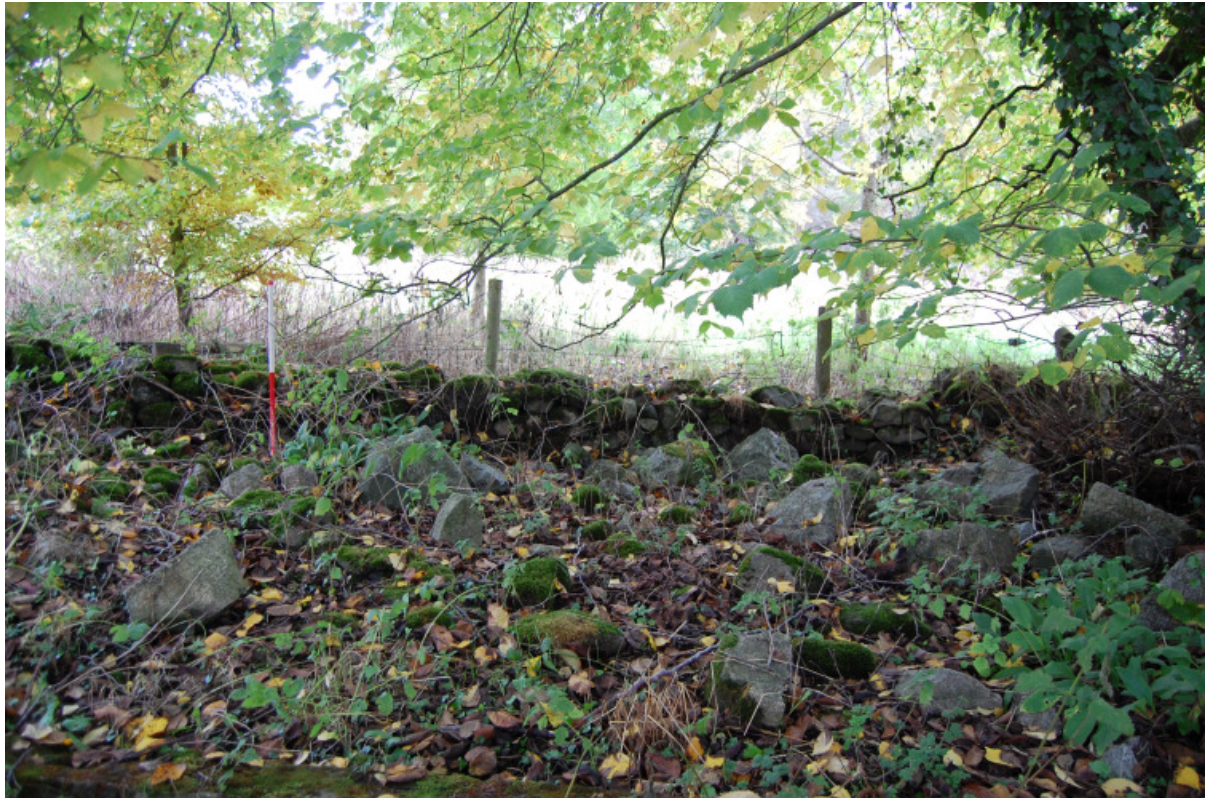
Plate 7: View of north wall of Cruives Enclosure Wall from enclosure exterior, facing south-east

Plate 8: View of north wall of Cruives Enclosure Wall from enclosure interior, facing north-west

Plate 9: View of north wall of Cruives Enclosure Wall from enclosure exterior, facing south-west

Plate 10: View of north wall of Cruives Enclosure Wall from enclosure exterior, facing south-west

Plate 11: View of north wall of Cruives Enclosure Wall, facing south-west

Plate 12: View of north wall of Cruives Enclosure Wall from enclosure interior, facing north-west

Plate 13: View of north wall of Cruives Enclosure Wall from enclosure interior, facing north-west

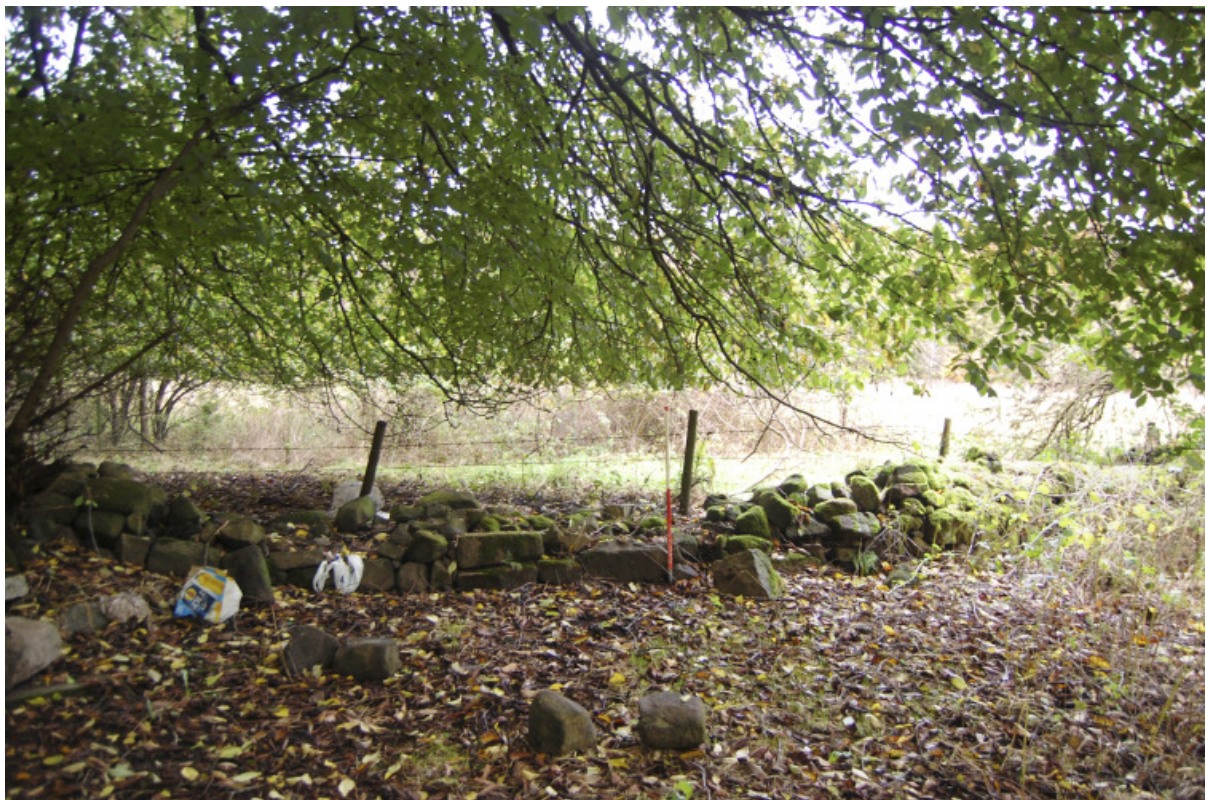
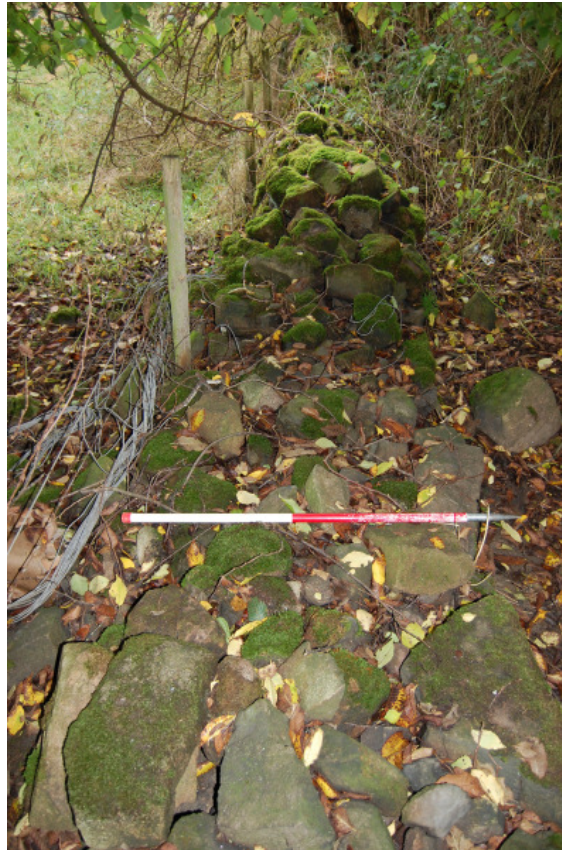
Plate 14: View of north wall of Cruives Enclosure Wall from enclosure interior, facing north

Plate 15: View of north wall of Cruives Enclosure Wall from enclosure interior, facing north-east

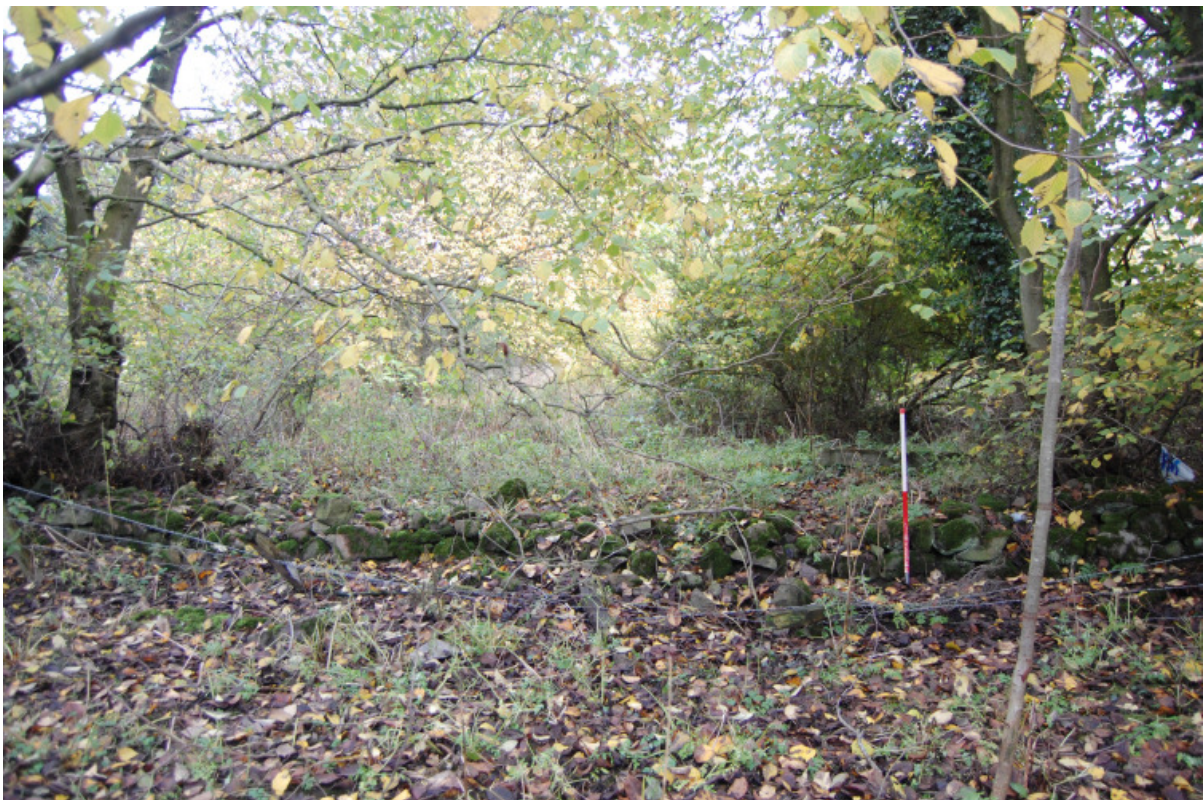
- 3.2.6 The east wall is the least well preserved and stands to a maximum height of 0.5m with an average height of between 0.2m and 0.3m (Plate 16). The wall is up to 0.7m wide. The preservation of the east wall deteriorates from north to south with the southern limit being truncated c. 15m from the north-east corner (Plate 17). The northeast corner has larger stones (up to 0.7m by 0.3m by 0.3m) at the base with smaller stones on top (Plates 18 and 19).

Plate 16: View of east wall of Cruives Enclosure Wall from enclosure exterior, facing south-west

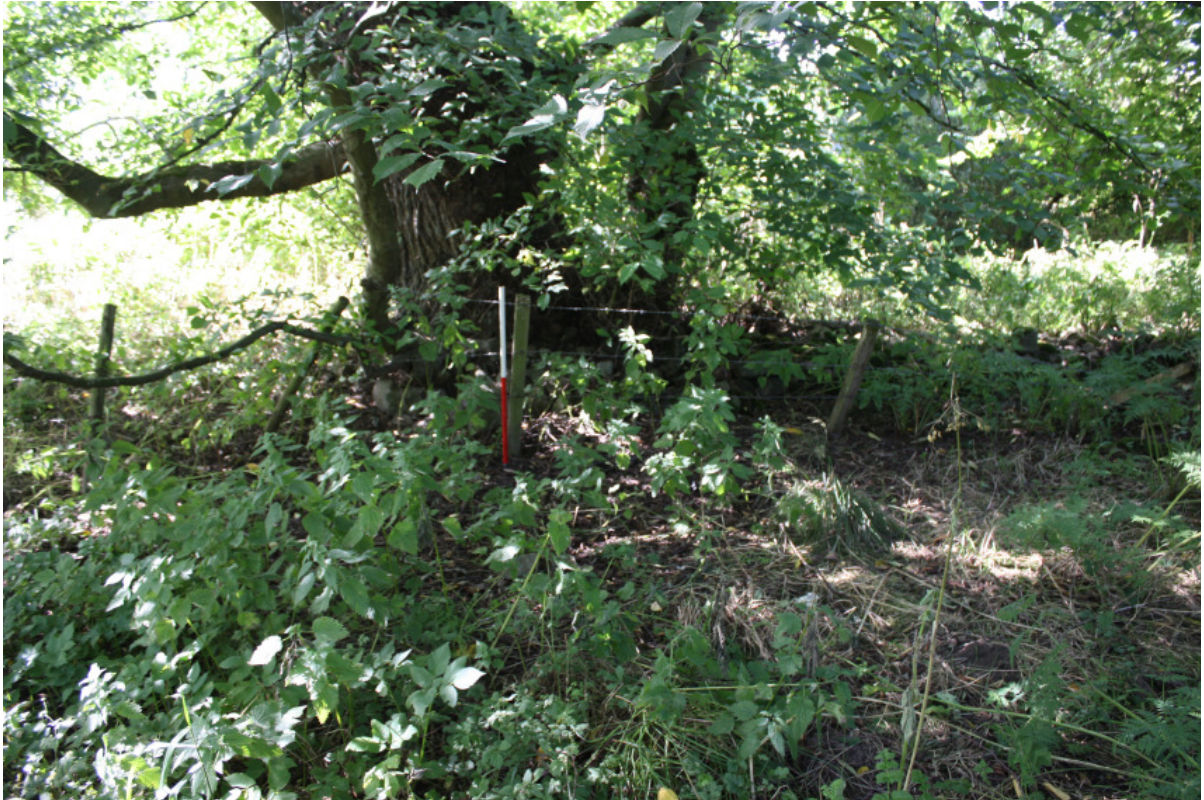
Plate 17: View of terminal of east wall of Cruives Enclosure Wall from enclosure exterior, facing south-west

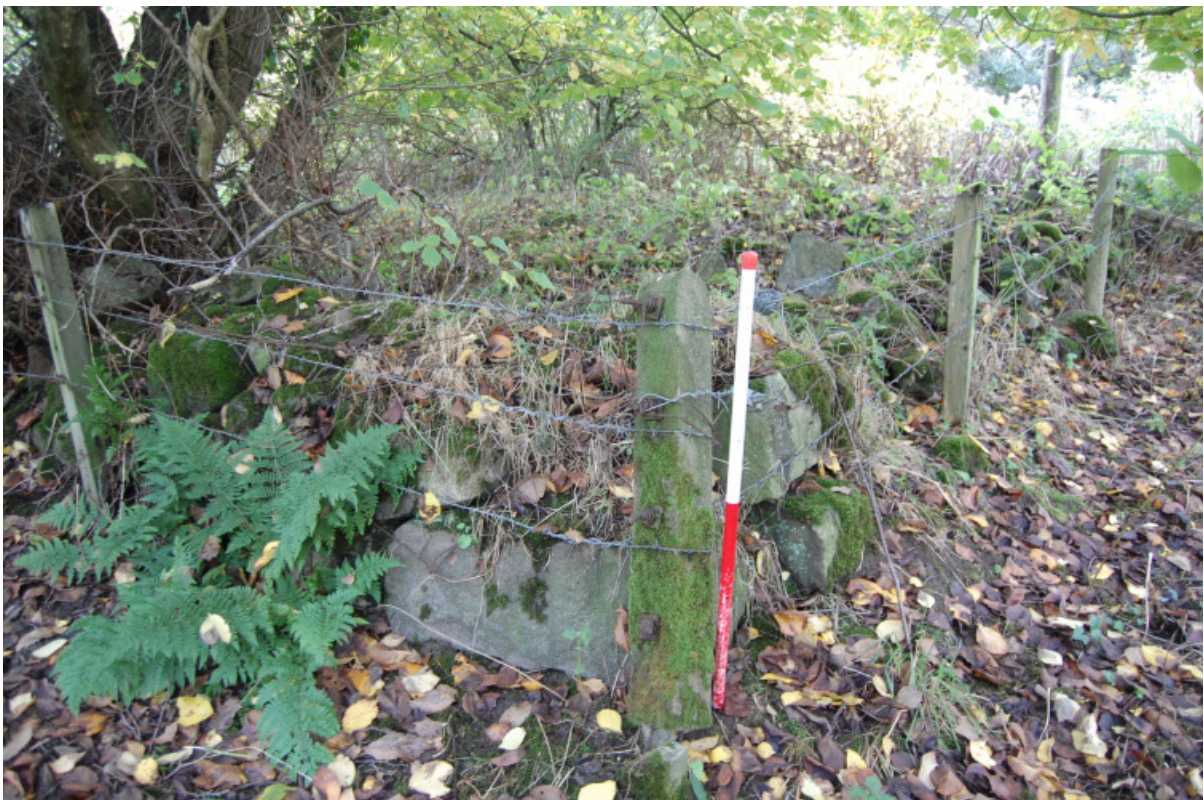
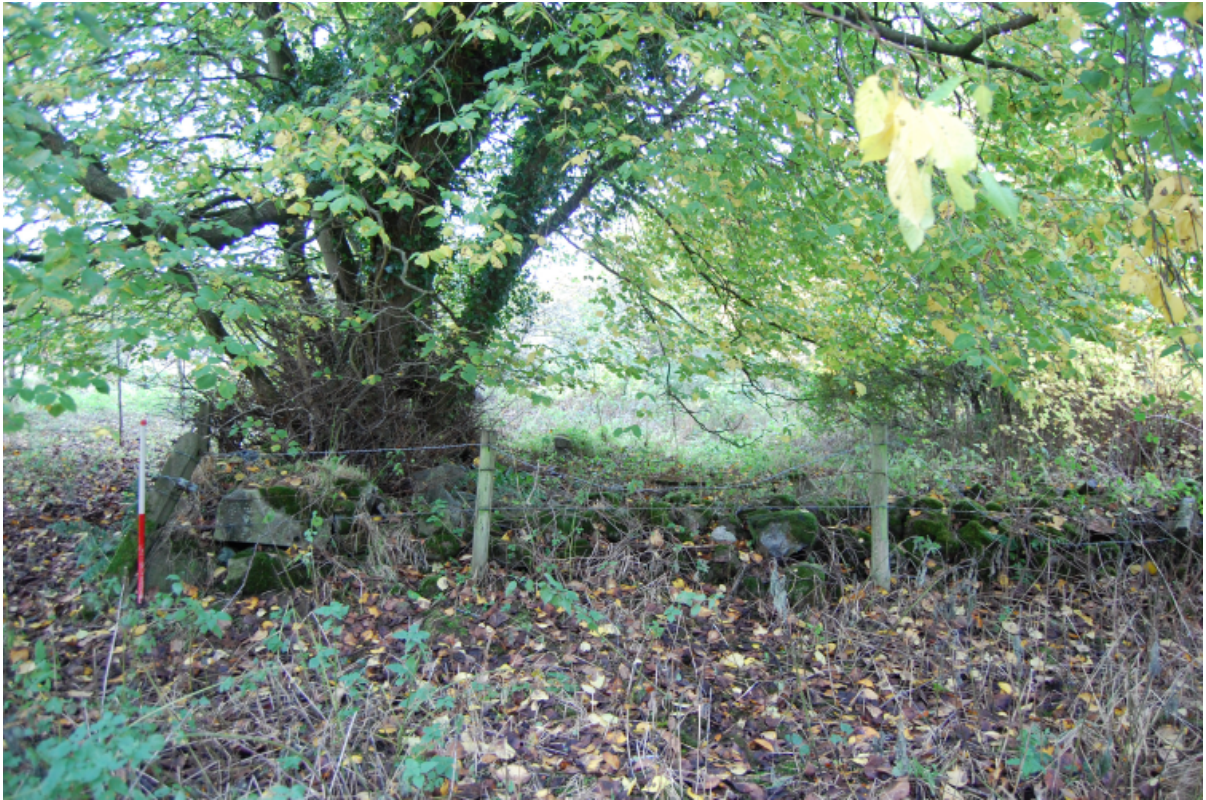
Plate 18: View of north-east corner of Cruives Enclosure Wall from enclosure exterior, facing south-west

Plate 19: View of north-east corner of Cruives Enclosure Wall from enclosure exterior, facing south-east

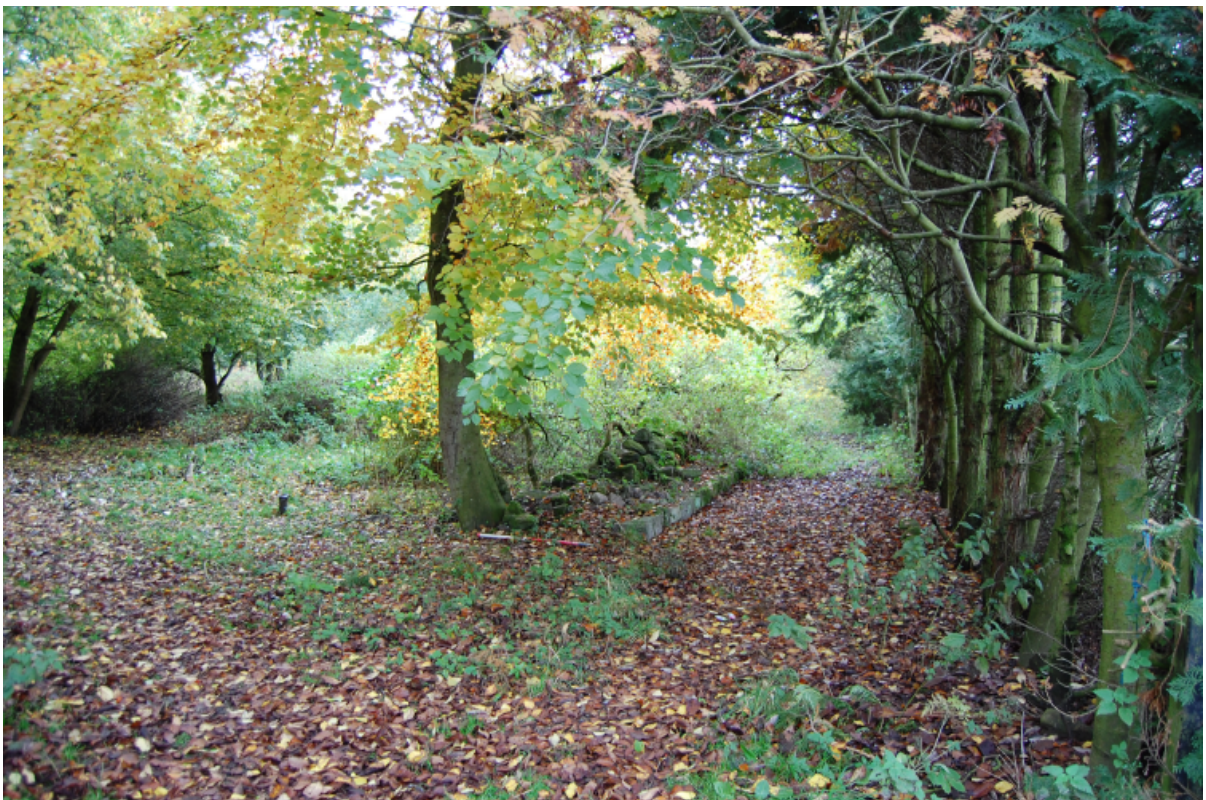
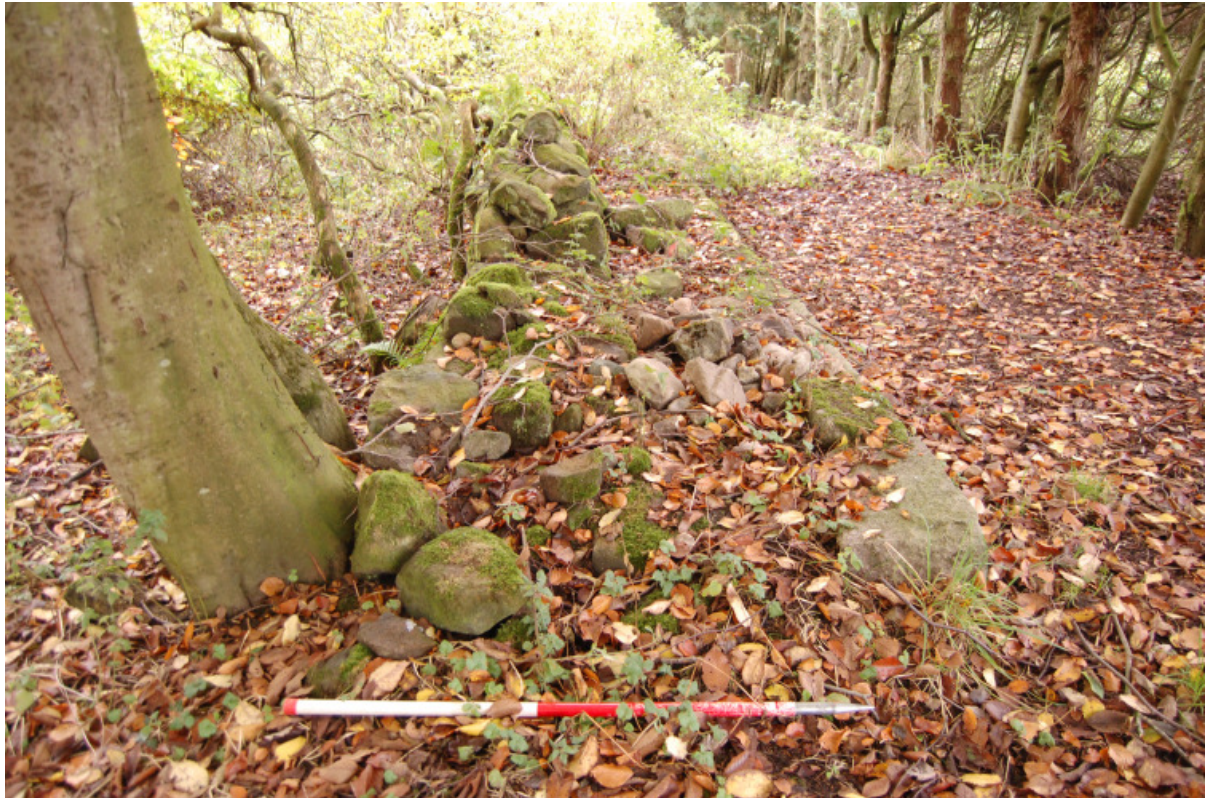
- 3.2.7 Only a short length of the south wall, measuring c.16m, was present though it is well preserved and stands to a maximum height of 0.7m with a width of 0.6-0.7m (Plates 20 and 21). This section of wall has been constructed with a higher proportion of quarried stone to field stones and as a result three to four rough courses were observed (Plate 22). A series of low, roughly dressed cuboid granite stones are present 0.5m to the south of the wall and form one side of a wide path or driveway.

Plate 20: View of remnants of south wall of Cruives Enclosure Wall, facing north-east

Plate 21: View of remnants of south wall of Cruives Enclosure Wall, facing north-east

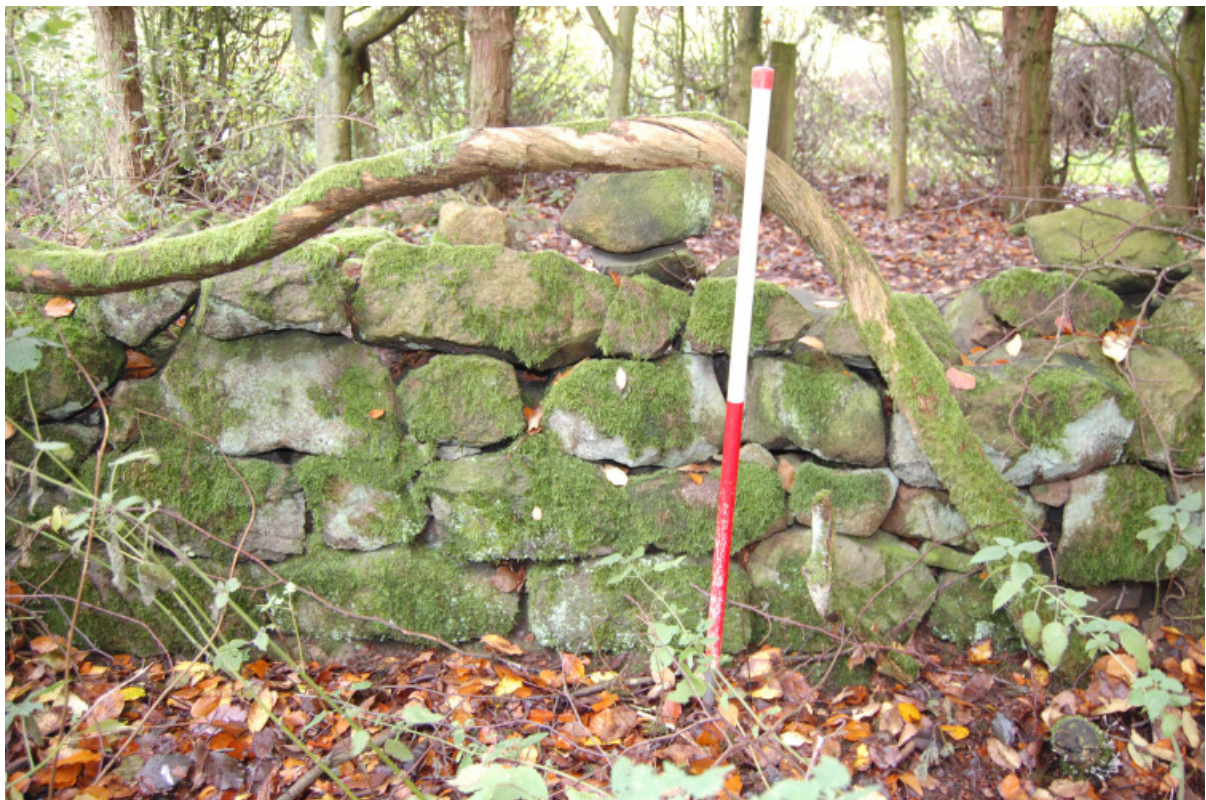
Plate 22: View of remnants of south wall of Cruives Enclosure Wall, facing south-east
