**Non-Invasive Archaeological Investigations for the Aberdeen Western Peripheral Route
(AWPR Package)**

**ACCESS FROM THE NORTH PROPOSAL
(THE THIRD DON CROSSING)**

Cruives Enclosure Wall (Site A29)
Topographic Survey

Report Reference No: AWPR-TDC-002

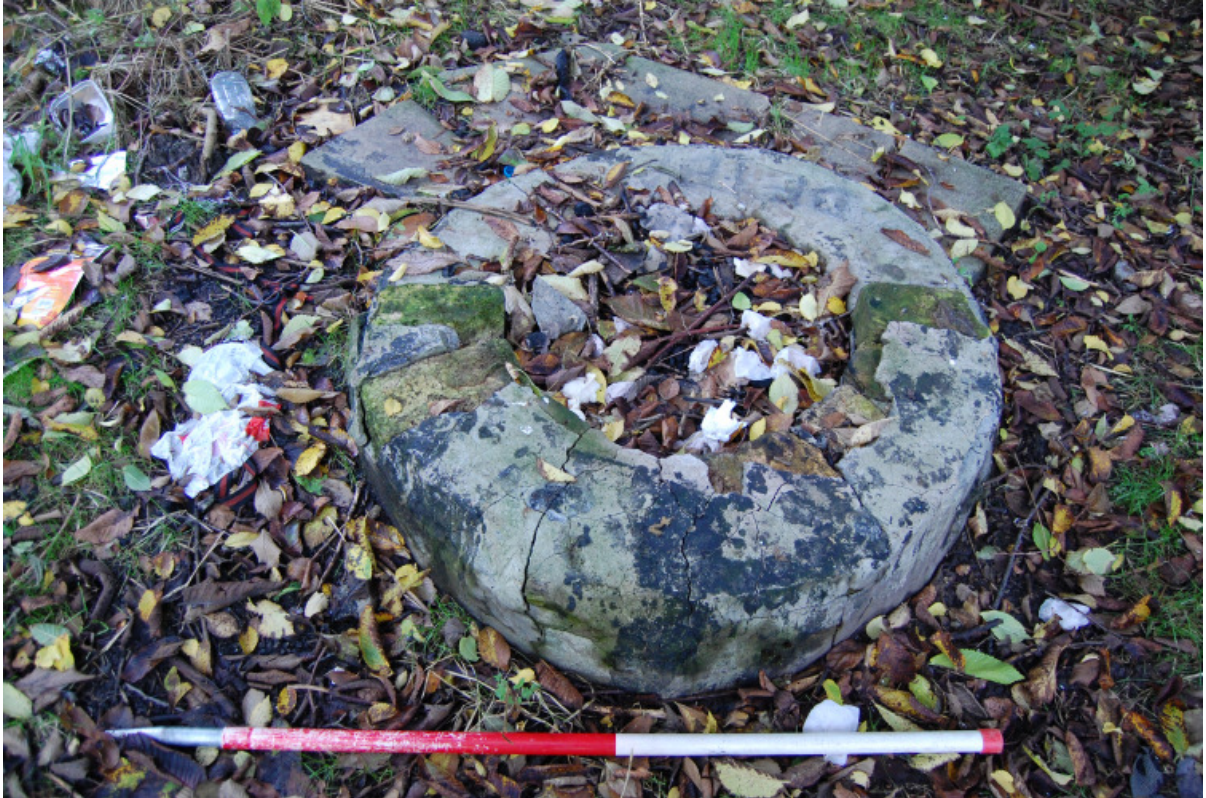
- 3.2.8 There was little evidence of the buildings shown on historic maps in the southern interior of the enclosure although this area was very overgrown. Some stone blocks present in this area have come from the demolished buildings. The survey conducted for the Environmental Statement also found no evidence of the buildings but noted 'a series of garden plots with laid gravel or slab paths between, as well as barbeque / picnic spots' (Aecom, 2006). Since then the area has been neglected and overgrown and as a result no garden features, specifically the gravel paths and plots, were observed apart from a circular stone structure present in the north-west corner of the enclosure that had an external diameter of 0.8m and an internal diameter of 0.45m (Plate 23). It has been used as a fire pit and is located next to an arrangement of ten earth fast stones (c. 0.25m high and 0.25m wide) arranged in a circle approximately 5m in diameter to form a stone circle.

Plate 23: View of possible garden feature re-used as a fire pit, facing north-west
