**ABERDEEN WESTERN PERIPHERAL ROUTE PACKAGE  
(SOUTHERN LEG)**

***Kingcausie Bridge (Site 514) and  
Silverburn Bridge (Site 522)***

***Building Recording Surveys***

**Report Reference No:** AWPR-SL-013

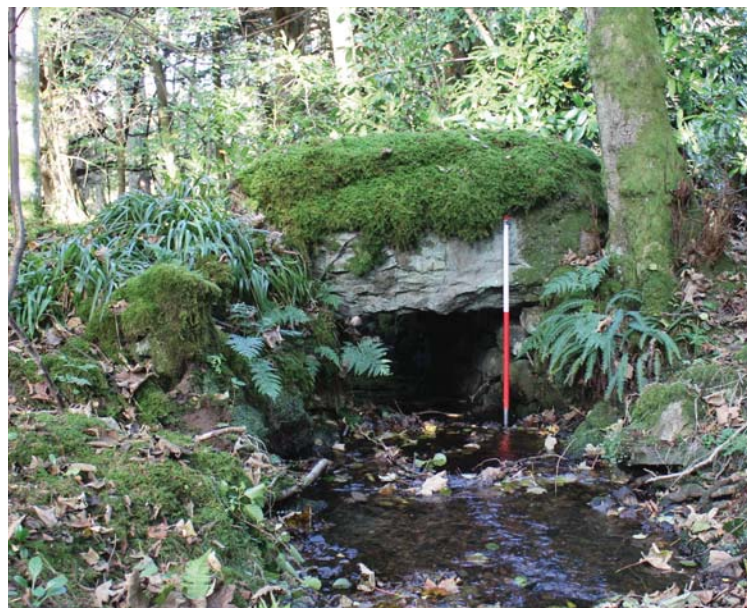
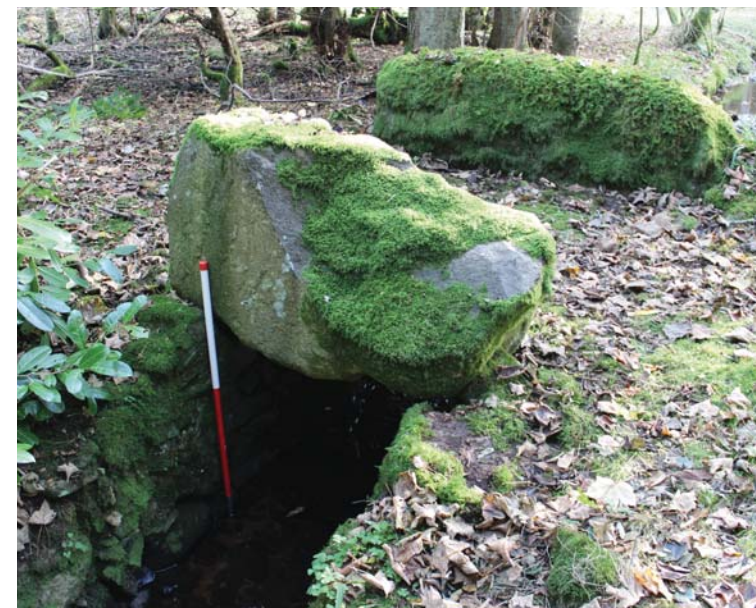
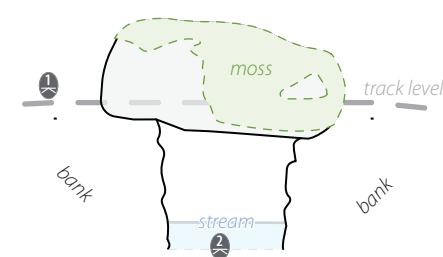
**Illus 6**

SSE elevation

NNW elevation

- 1 46.79m
- 2 45.79m
- 3 45.90m

Plan, elevations and section of Kingcausie bridge

- 3.2.1 Kingcausie Bridge (Site 514) (Plate 4) is oriented east-north-east to west-south-west, carrying a 1.6m wide track over a 1.2m wide stream (Illus 6). The stream flows from the south-south-east under the bridge, then turns gradually to the west. The bridge structure consists of three main elements; the spans, parapets and the revetment walls. Each shall be discussed in turn below.

- 3.2.2 The track is carried on four substantial stones, each of which spans the width of the stream (1.2m). These stones were covered in earth and moss, at the time of the survey. No structural detail of these stones could therefore be seen from above. However, they were photographed from a low angle at either side of the bridge (Plate 5). The stones were irregular but appeared to be quarried. They measured approximately 0.38m wide and 0.25m high; their full length could not be seen. The stones rested directly on the revetment walls.

- 3.2.3 The two stone parapets also spanned the stream but were much more substantial than the other stones. They appeared to be quarried, but were still irregular in shape. The south-south-eastern parapet (Illus 6a) was the largest, measuring 2.18m long, 0.79m wide and 0.89m high. Its upper side was gently curved in profile; it was not possible to see whether it had been worked to this shape due to a heavy covering of moss. The opposite parapet (Illus 6b) was smaller, measuring 1.58m long, 0.47m wide and 0.73m high. It was more angular in profile, with the narrow top of the stone sloping to the west-south-west. Much of the stone was covered in moss.

- 3.2.4 The two revetment walls on which the bridge rested were of random rubble dry stone construction. As well as supporting the bridge for the full width of 2.8m, they extended to either side torevet the stream banks. The eastern wall (Plate 6) extended for 7.3m to the north-north-western side of the bridge, following the bend of the stream to the west. The

western 1.3m of this wall had collapsed and could be seen as a spread of stones at the edge of the stream. The eastern wall extended 1.7m to the south-south-west of the bridge and had been somewhat disturbed by the roots of a large tree growing in the stream bank (Plate 7). The western wall extended for 5.9m to the north-north-west of the bridge, with the western 1.7m in a collapsed state (Plate 8). This wall continues for 0.95m to the south-south-east of the bridge (Plate 9). Under the bridge, the revetments stood 0.83m tall under the south-south-eastern parapet and 0.94m tall under the north-north-western parapet, accounting for an 11cm drop in the basal level of the stream. The thickness of the walls could not be seen. The base of the channel was stony, but it was not clear whether this was a built lining. The stones were slightly more densely packed in the revetted part of the stream.
