**ABERDEEN WESTERN PERIPHERAL ROUTE PACKAGE
(NORTHERN LEG)**

Dyce Airfield – Radio Station (Site 154c)

Building Recording Survey

Report Reference No: AWPR-NL-007

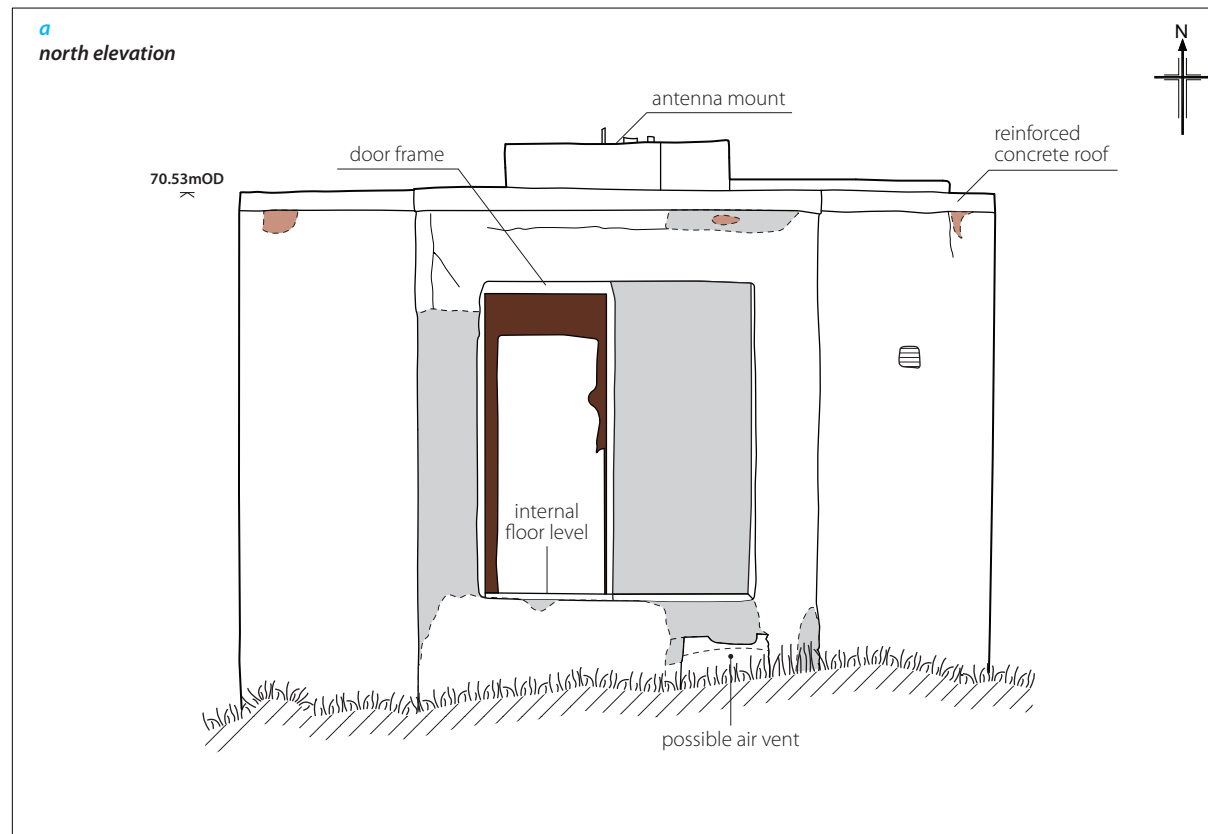
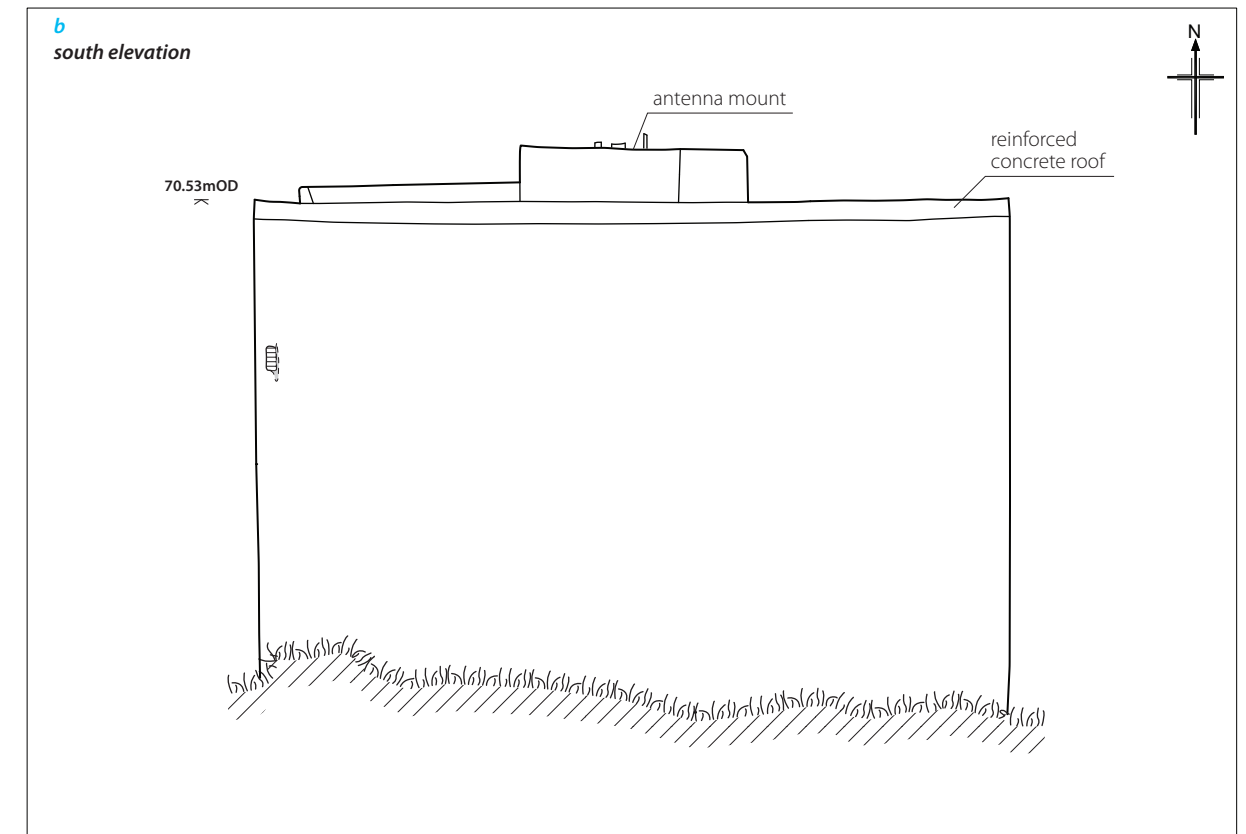
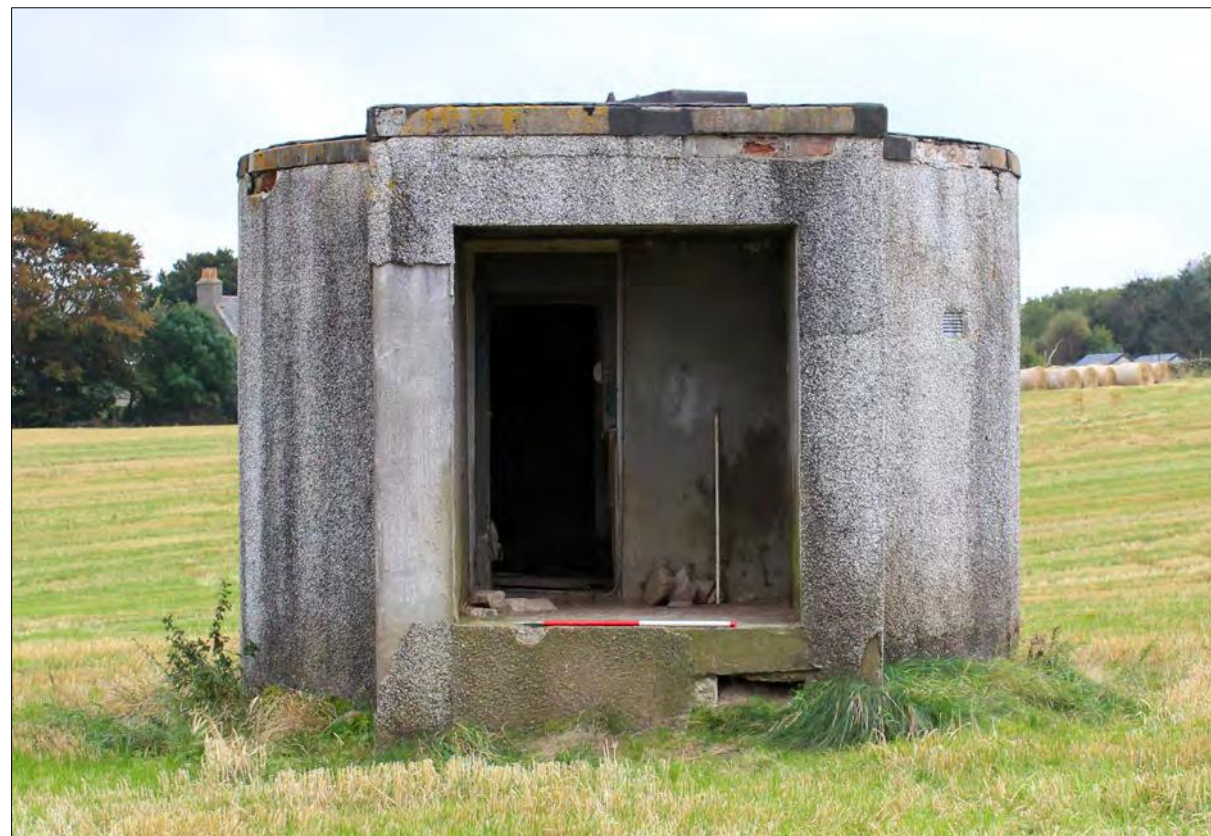
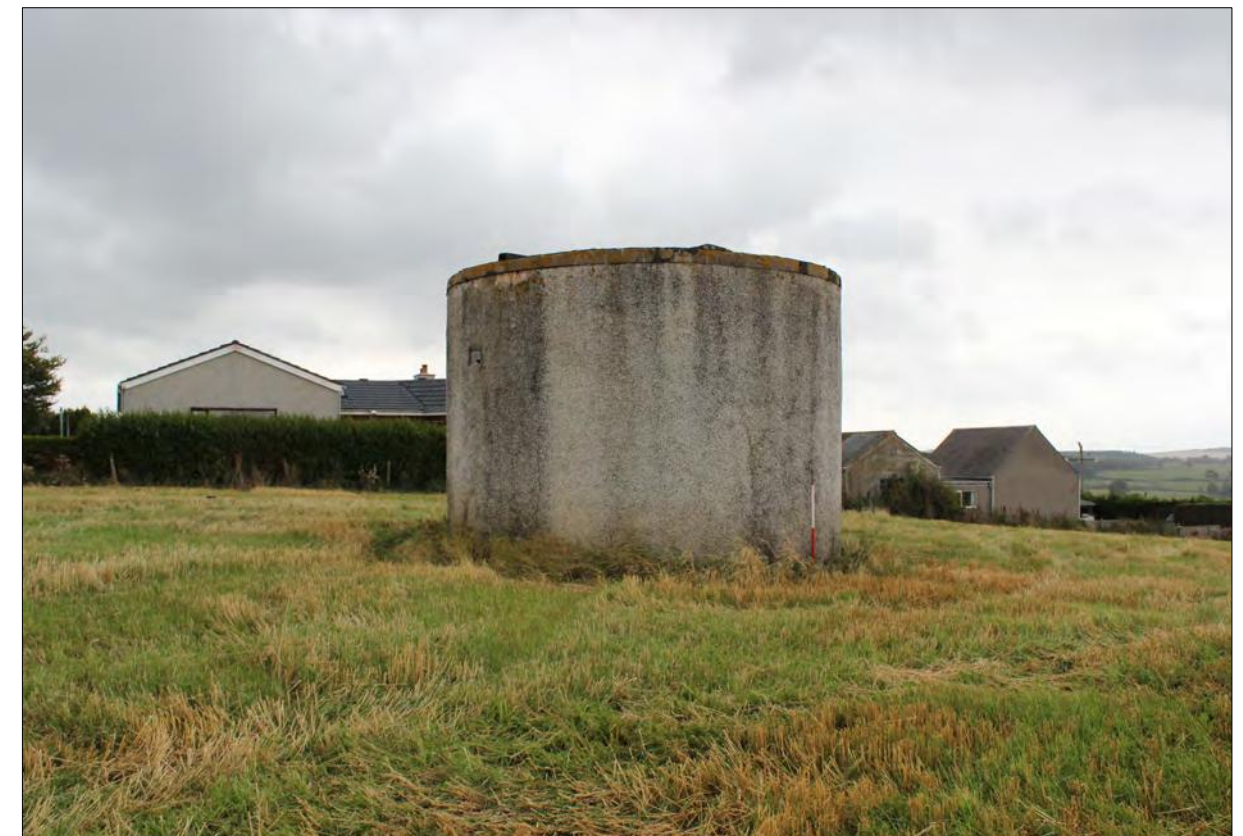
Illus 6
North and south elevation

- 3.2.2 The building is single storey (Illus 6, 7); standing to between 3.15m and 3.4m high to the top of the roof slab. The variance is due to the ground sloping down somewhat to the south-east (Plate 2). A supporting structure for the (now removed) dish/aerial rises a further 0.31m from roof level.

- 3.2.5 The porch is 2.6m wide, 1.8m deep and 3.1-3.4m high externally, and 1.8m wide, 2.1m tall and 1.45m deep internally (Illus 6a). The internal floor level of the porch is raised 0.5m above ground level, a small ladder found inside the building may have assisted in gaining entry. The side walls of the porch are 0.4m thick. The structure of the roof was not visible, but it is likely that the rim of the roof slab (see 3.2.4) is supported directly on the wallheads and the northern edge on a concrete lintel, c. 0.45m thick. The whole has been finished with concrete. A wooden door, measuring 0.7m by 1.95m, on the western side of the south wall gives access to the interior; the door has been mostly removed, with only the stiles, upper rail and parts of the panelling still *in situ* (Illus 6a).

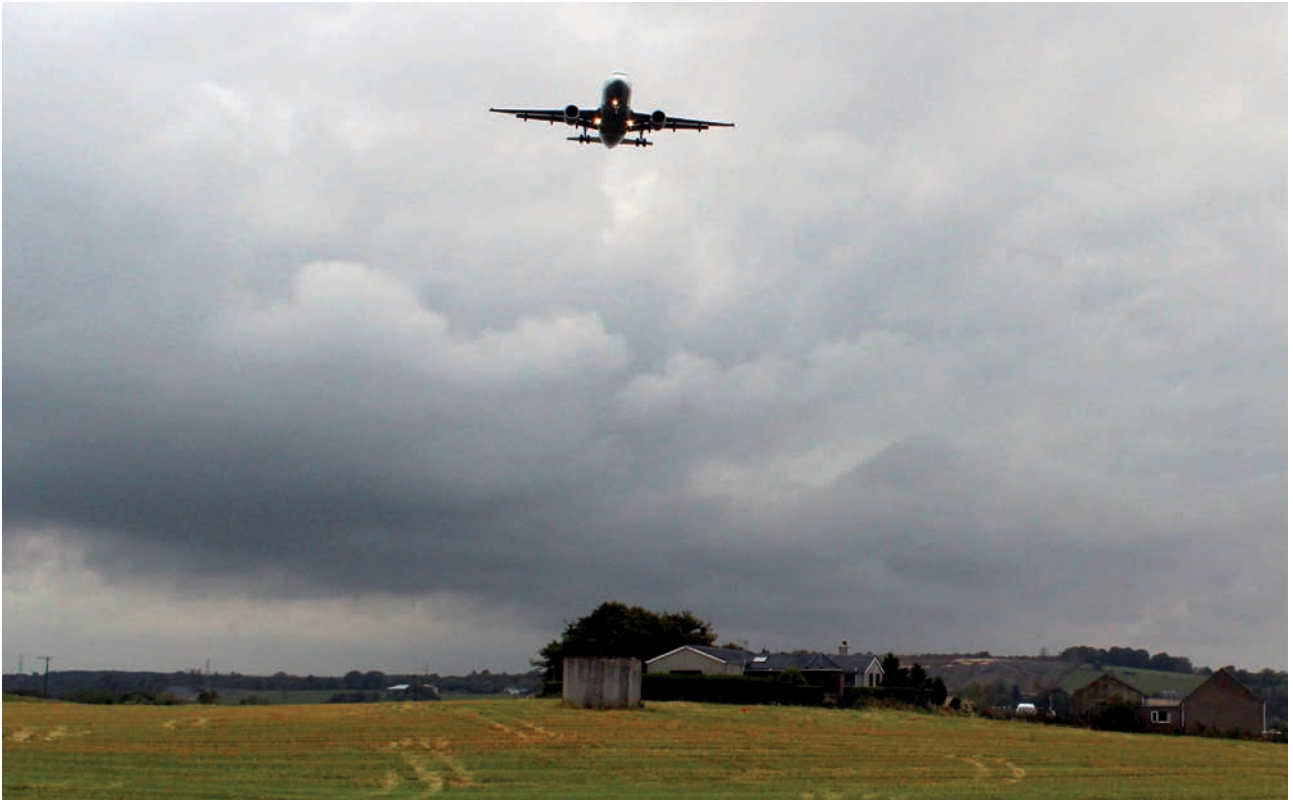
Plate 1

- 1.4.1 The building is located at NGR NJ 87309 14483 in the parish of Dyce (Illus 1). It stands at an elevation of 67.5m OD, around 30m south of Lyndmoor house in an undulating arable field (Plate 1). It is aligned with the main runway at Aberdeen (Dyce) Airport, approximately 1.4km from its northern end.
- 1.4.2 The Radio Station is a small circular building with a substantial porch, built of brick and concrete, with a roof mount for a dish/antenna. The latter has been removed, along with nearly all of the internal fittings. The structure was in generally good condition at the time of the survey.

General view from the south-east with Lyndmoor house in the background

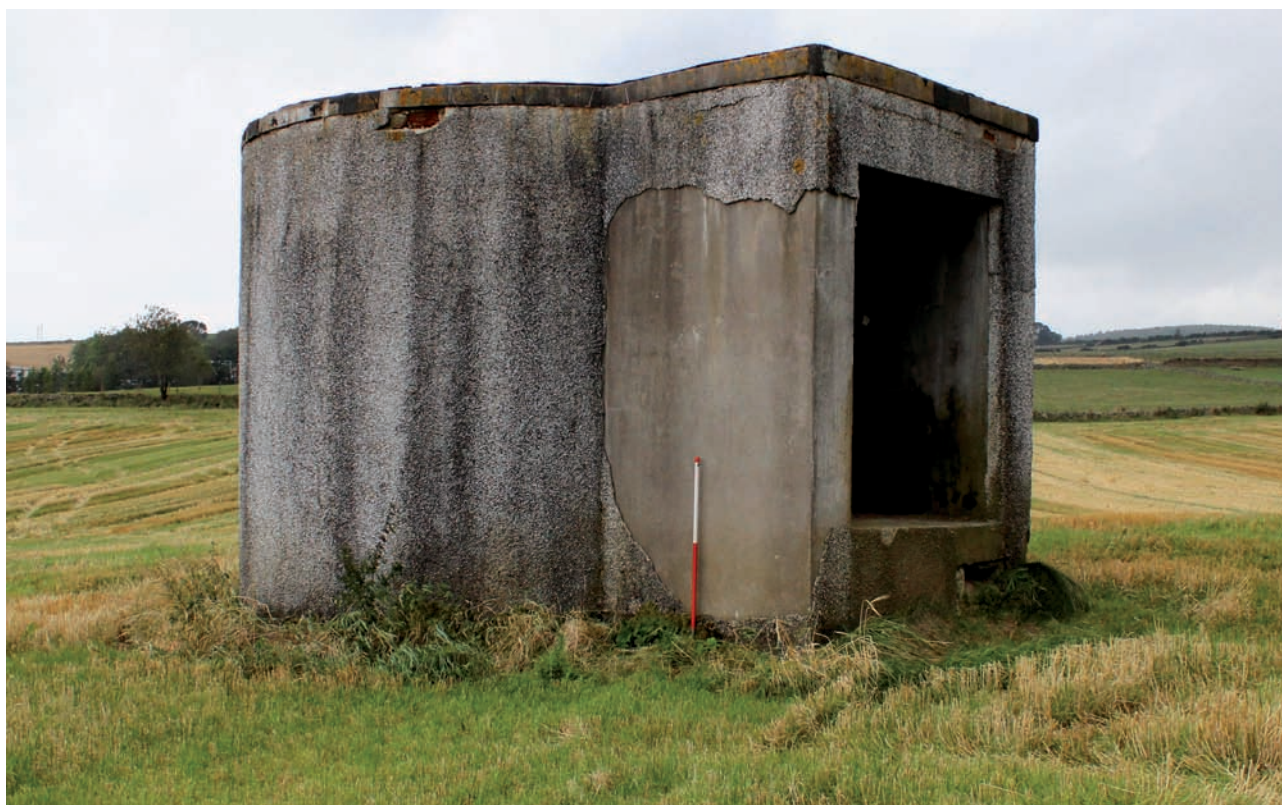
Plate 3

- 3.2.3 The walls are of brick and concrete construction and are 0.47m thick. The exterior is harled, but where this has cracked or fallen off (and on the interior of the porch) the concrete below is exposed (Plate 3). It is possible that this concrete is only a coating; immediately below the roof some of this layer has also broken away to expose brick beneath (Plate 3). Not enough of the brickwork was exposed at any point to assess the bonding or type of brick. Whether brick has been used only in areas requiring extra support (i.e. the wallhead and around the air vents, see below) or if the whole structure is of concrete-coated brick is at this time unclear. No sign of reinforcement was visible within the exposed sections of wall fabric. Two air vents with metal grilles are visible on the western side (Illus 7b). The condition of the exterior is generally good; some of the harling has fallen away, including a large part of the east external elevation of the porch.

General view from the north-east, showing areas of exposed concrete and brick beneath harling

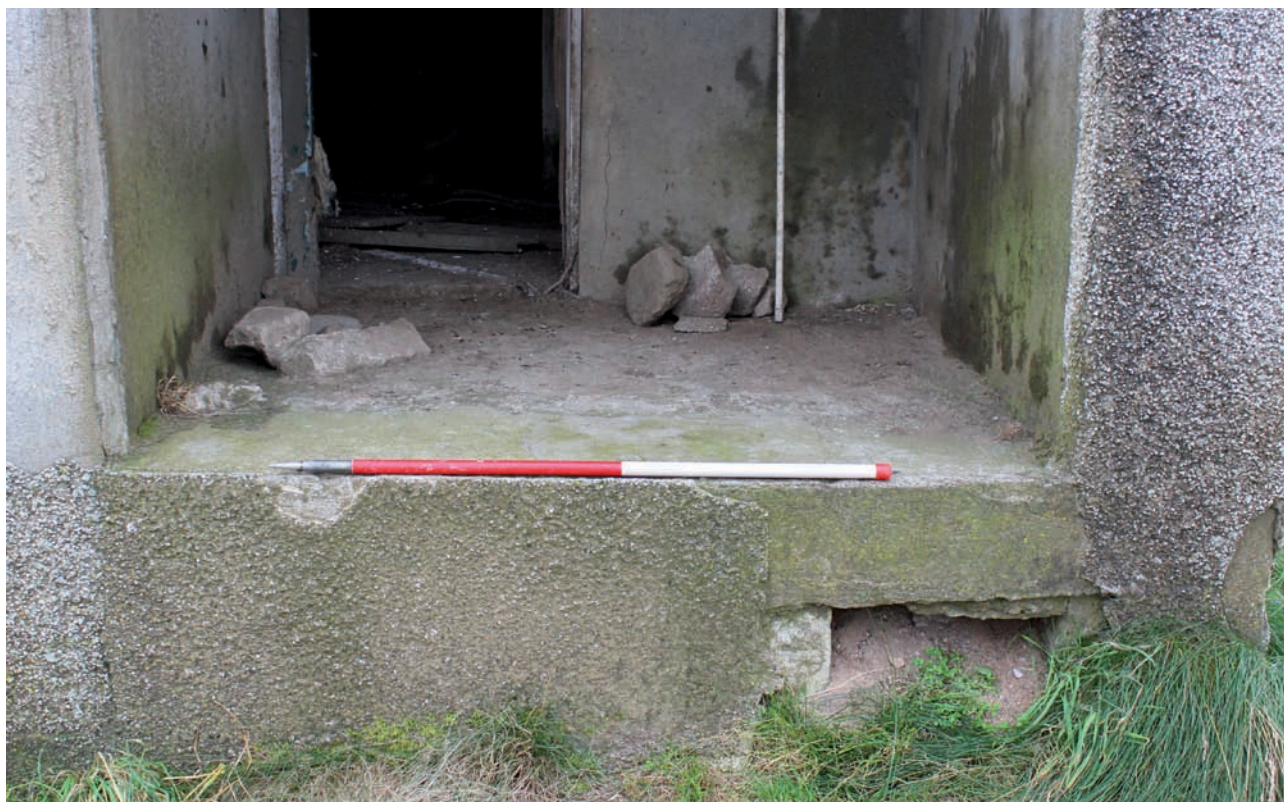
Plate 4

- 3.2.6 The floor of the porch is of poured concrete, although it is not possible to tell if this is solid to ground level or has been built with cavities or using some other method. A void at ground level on the eastern side of the north elevation of the porch, measuring 0.5m wide by 0.3m tall may have acted as some sort of vent; presently it is filled with rubble (Plate 4).

Detail of the floor of the porch, from the north

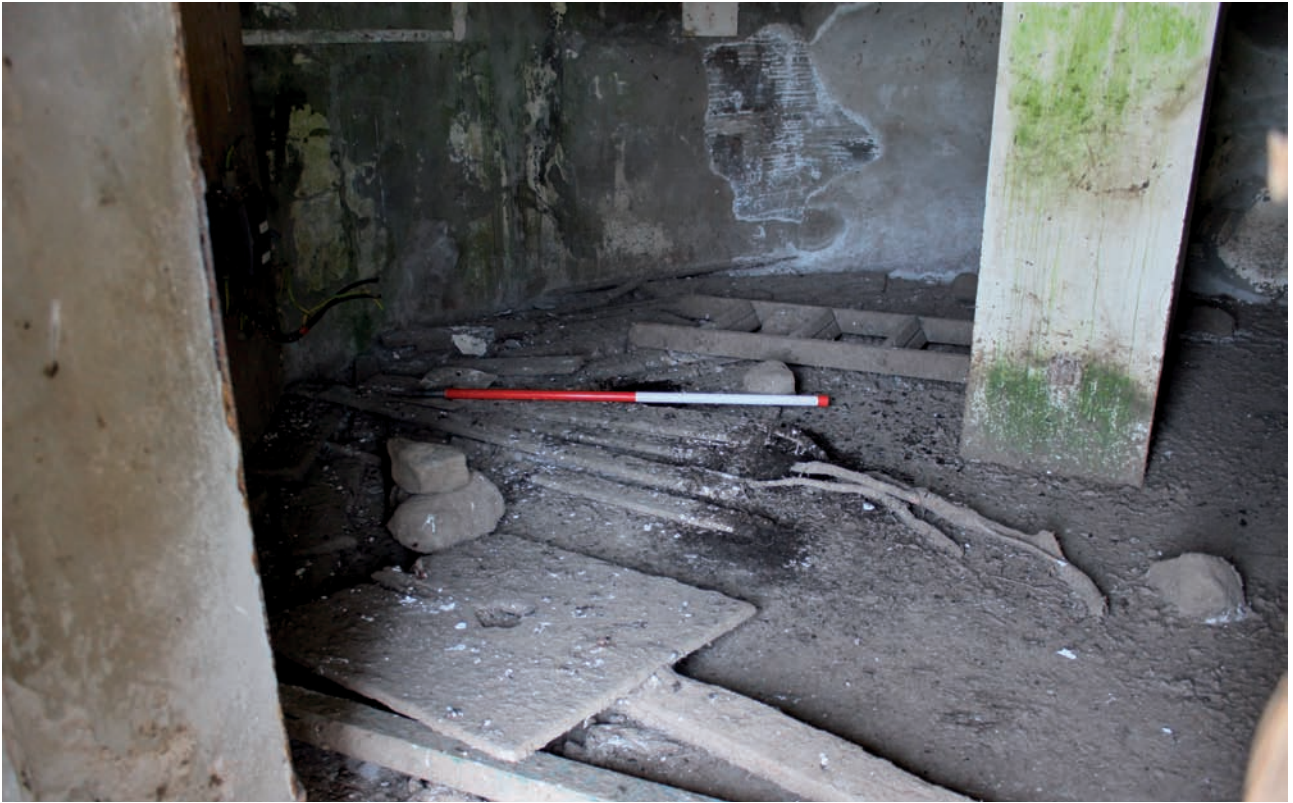
Plate 5

- 3.2.7 The interior of the building measures 4.05m in diameter with a central 0.4m square concrete pillar (Plate 5). This pillar is located directly below the mounting pins on the

Interior from the doorway, facing south-south-east

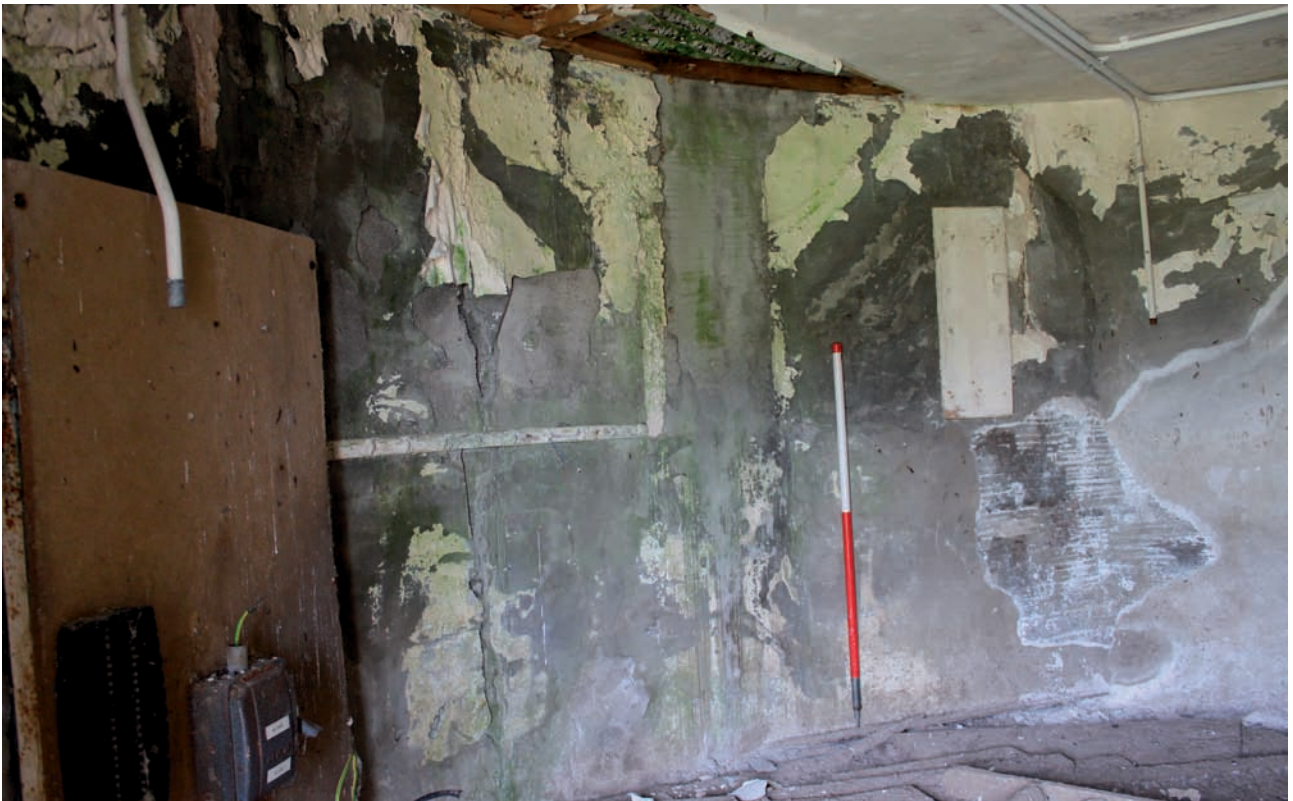
Plate 6

roof, and is likely to have provided direct support for the dish/antenna. The inside face of the circular wall has been finished with a thin layer of plaster, with thin wooden strips set into it in places (Plate 6), possibly for the mounting of electrical equipment. Much of the original white paint has peeled off (Plate 7), as has some of the plaster, exposing the concrete beneath. The air vents noted above link directly to the interior at 1.3m above floor level; these have been formed with brick and also have metal grilles on the west side of the interior wall (Plate 8). On the east side, near the doorway, a flat chipboard panel measuring 0.75m wide and 1.3m tall has been attached to the wall (Plate 9). It presently holds two disconnected pieces of electrical equipment; one that appears to be a fuse box or patch panel, the other is marked '43/17mm-1 Standby Memlok, 20 Amp 600V'.

View of interior showing equipment panel, wooden inserts and peeling paint/plaster, facing south-east

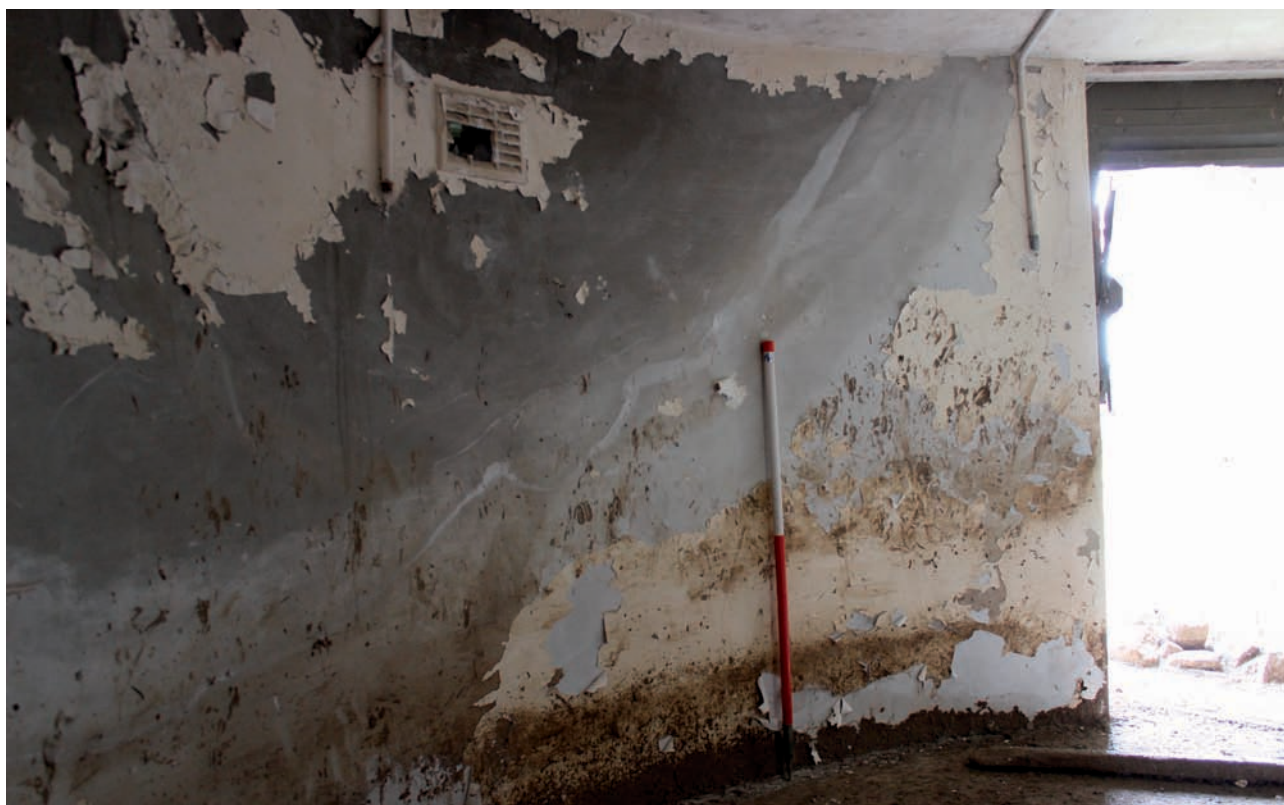
Plate 7

View of interior wall showing peeling paint, northern air-vent and doorway, facing north-north-west

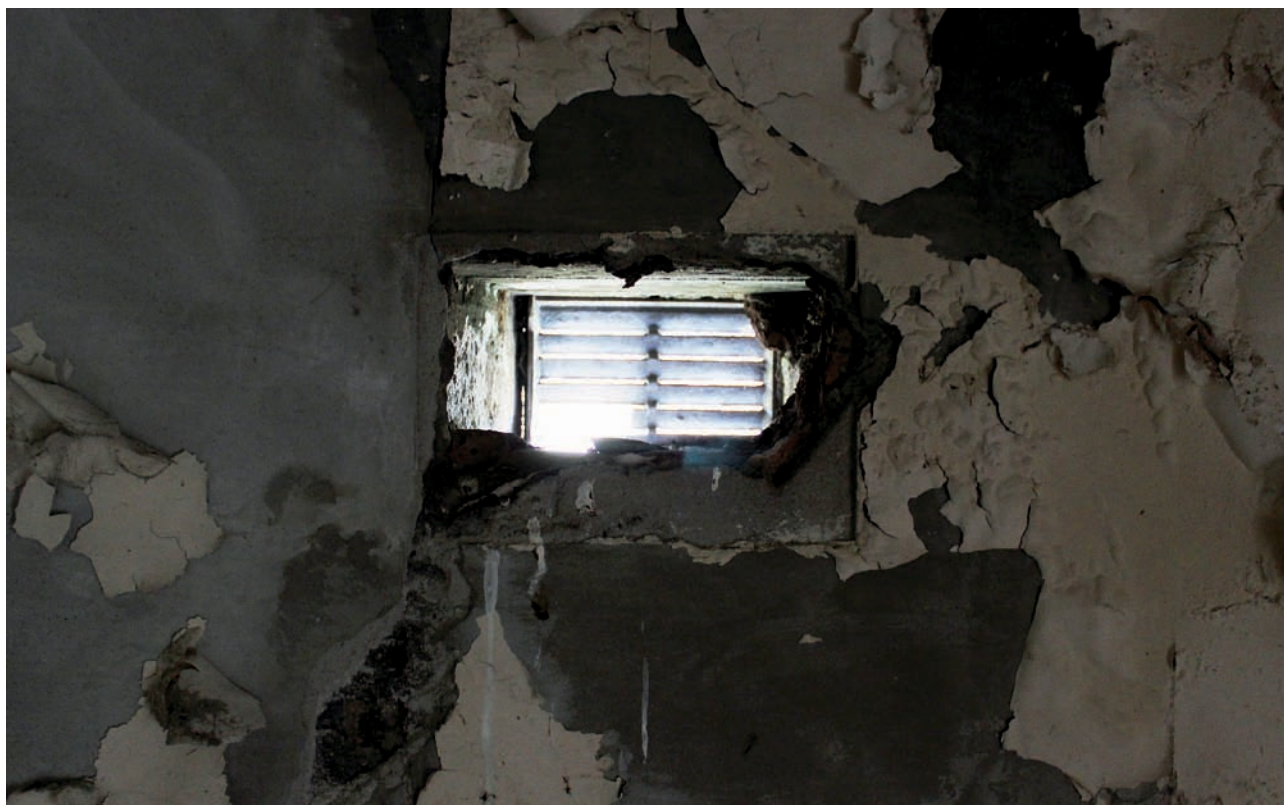
Plate 8

Detail of the southern air-vent, facing west-south-west

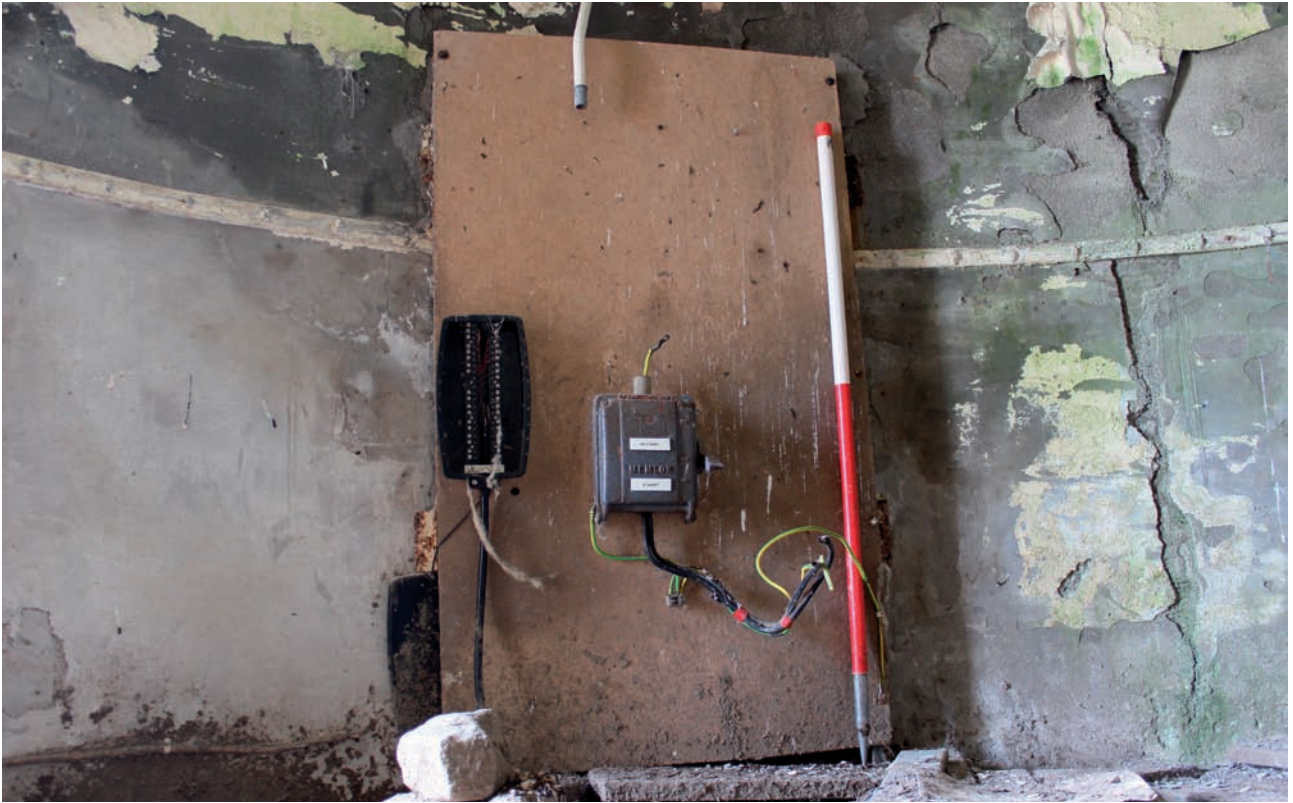
Plate 9

Detail of the equipment panel, facing north-north-east

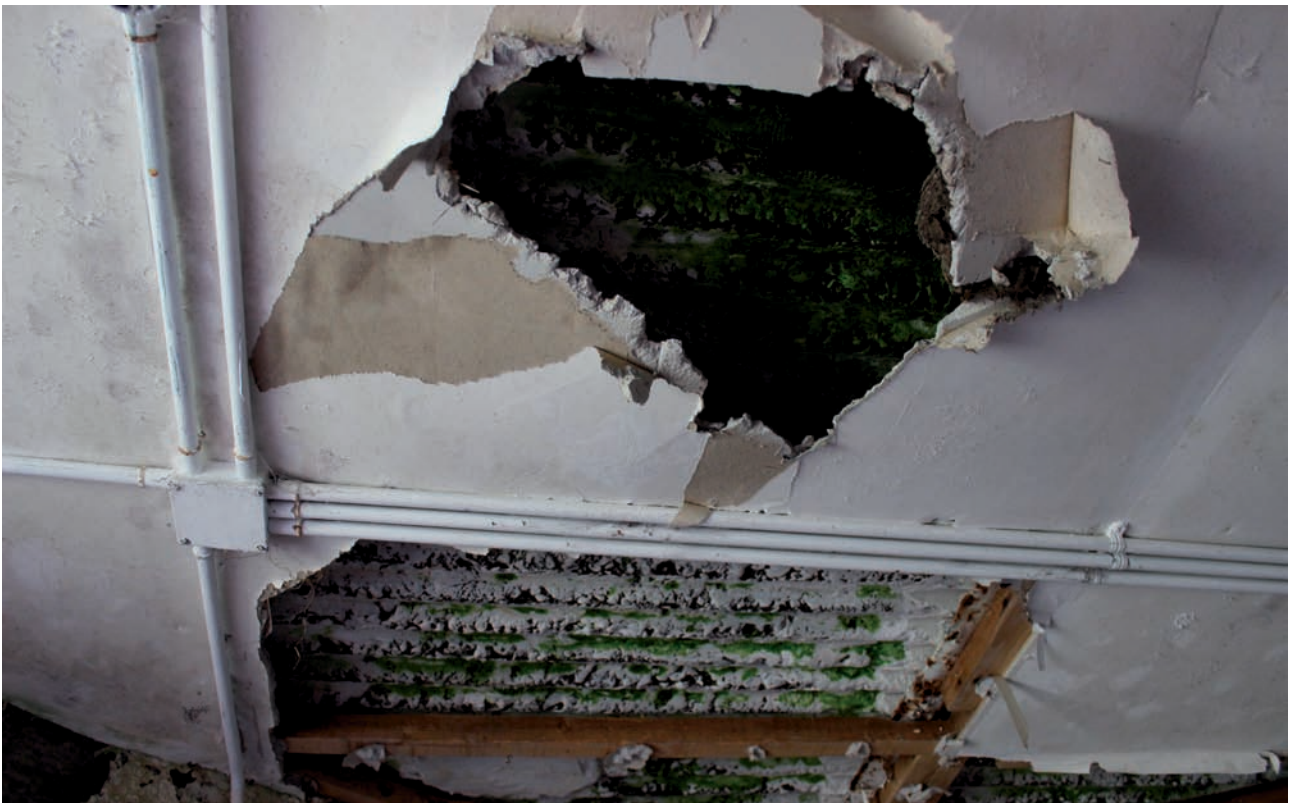
Plate 10

Detail of the ceiling, facing east
