A90 BALMEDIE TO TIPPARTY SCHEME
Topographic and Photographic Surveys:

***Snarleshow (Dambrae) Possible Lade (Site 42),
Kirkhill Upright Stone (Site 51),
Overhill Cattle Rubbing Stones (Site 57) and
Mill of Foveran Lade (Site 72)***

Report Reference No: AWPR-A90-005

Date: 31st October 2012

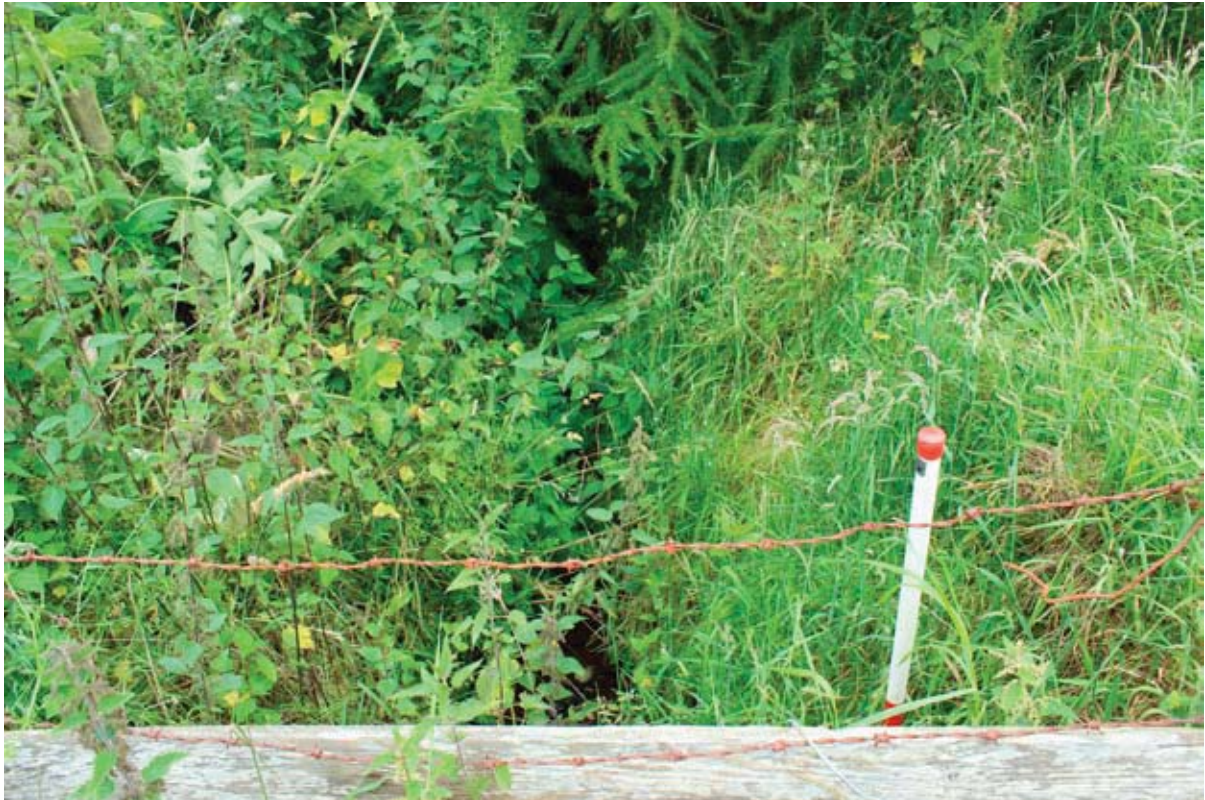
Plate 1

East-facing view of Snarleshow (Dambrae) Possible Lade (Site 42) from eastern crossing. The banks are heavily overgrown; the ranging rod is resting on the base of the channel

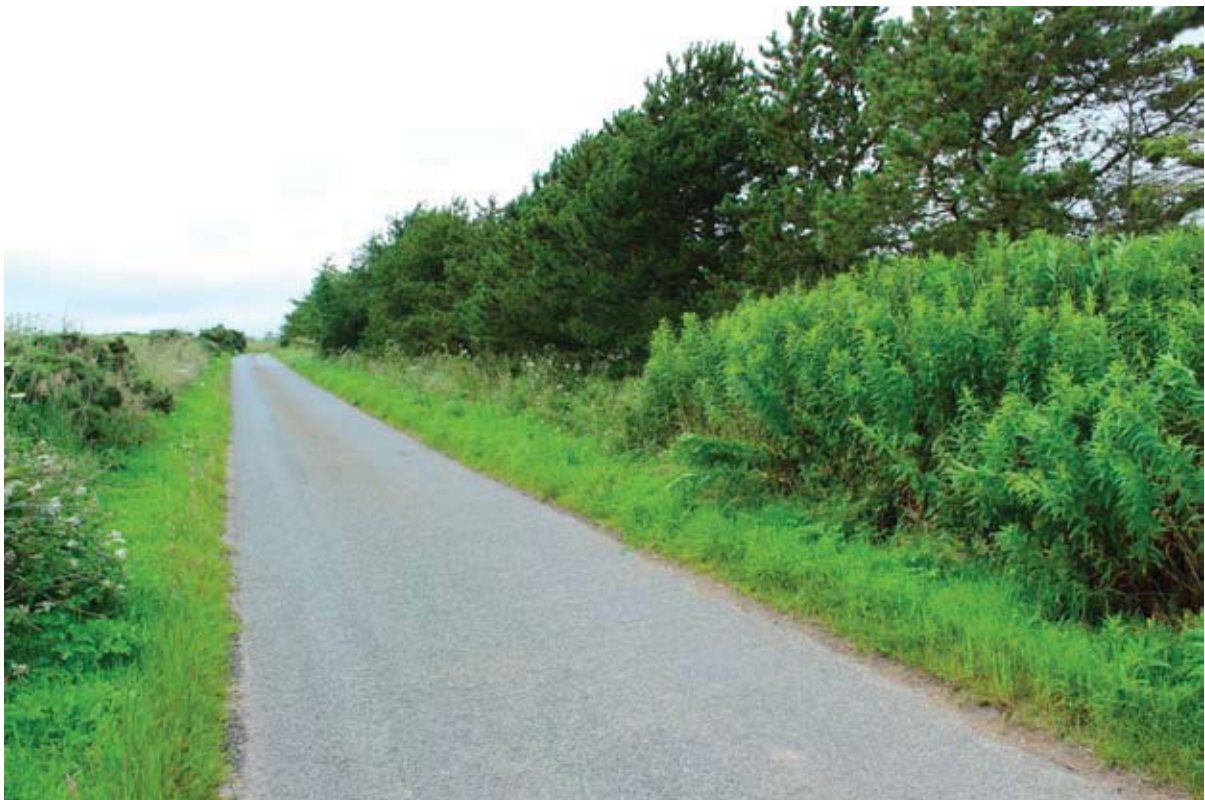
Plate 2

West-north-west facing view of tree-covered section of Snarleshow (Dambrae) Possible Lade (Site 42). The lade runs parallel to the road under the trees

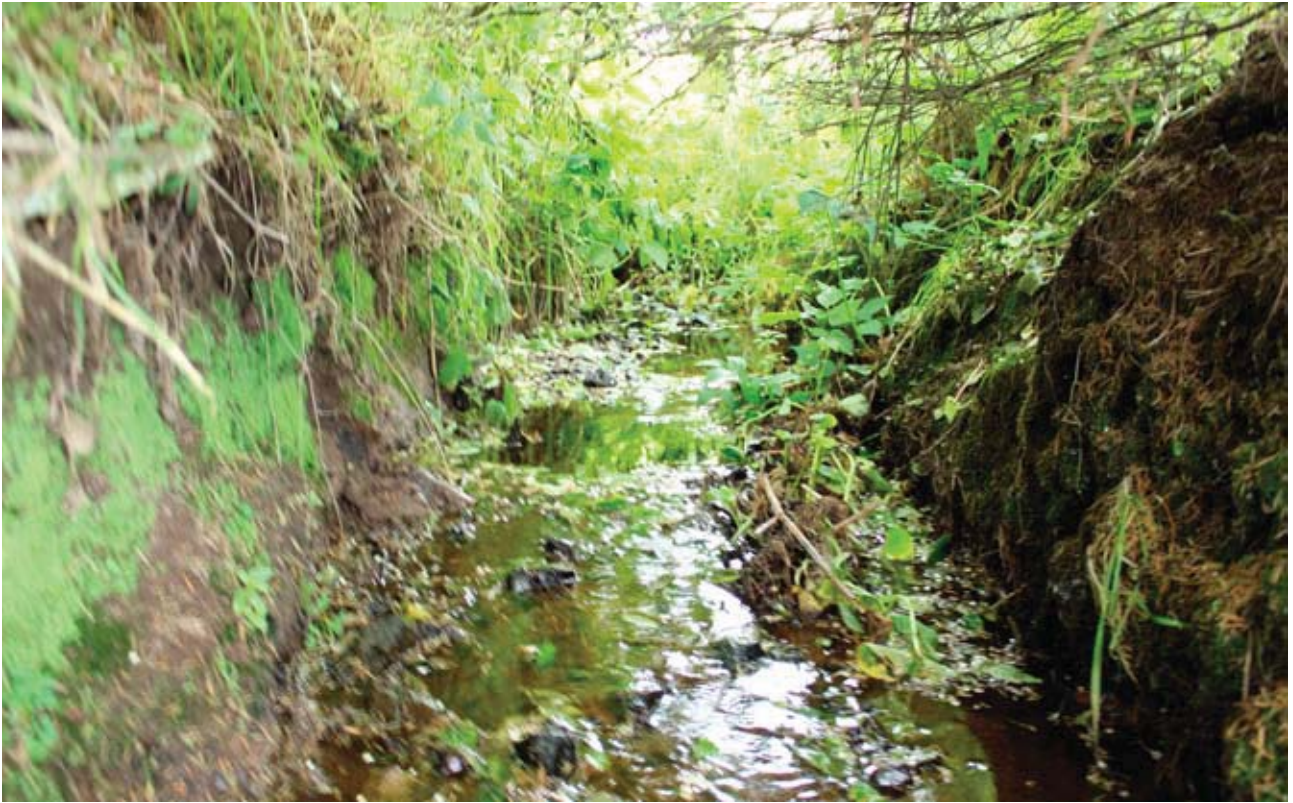
Plate 3

West-facing view near eastern end of Snarleshow (Dambrae) Possible Lade (Site 42) from beneath the undergrowth. The banks are not revetted at this point; the base is not visible beneath moss and leaf matter.

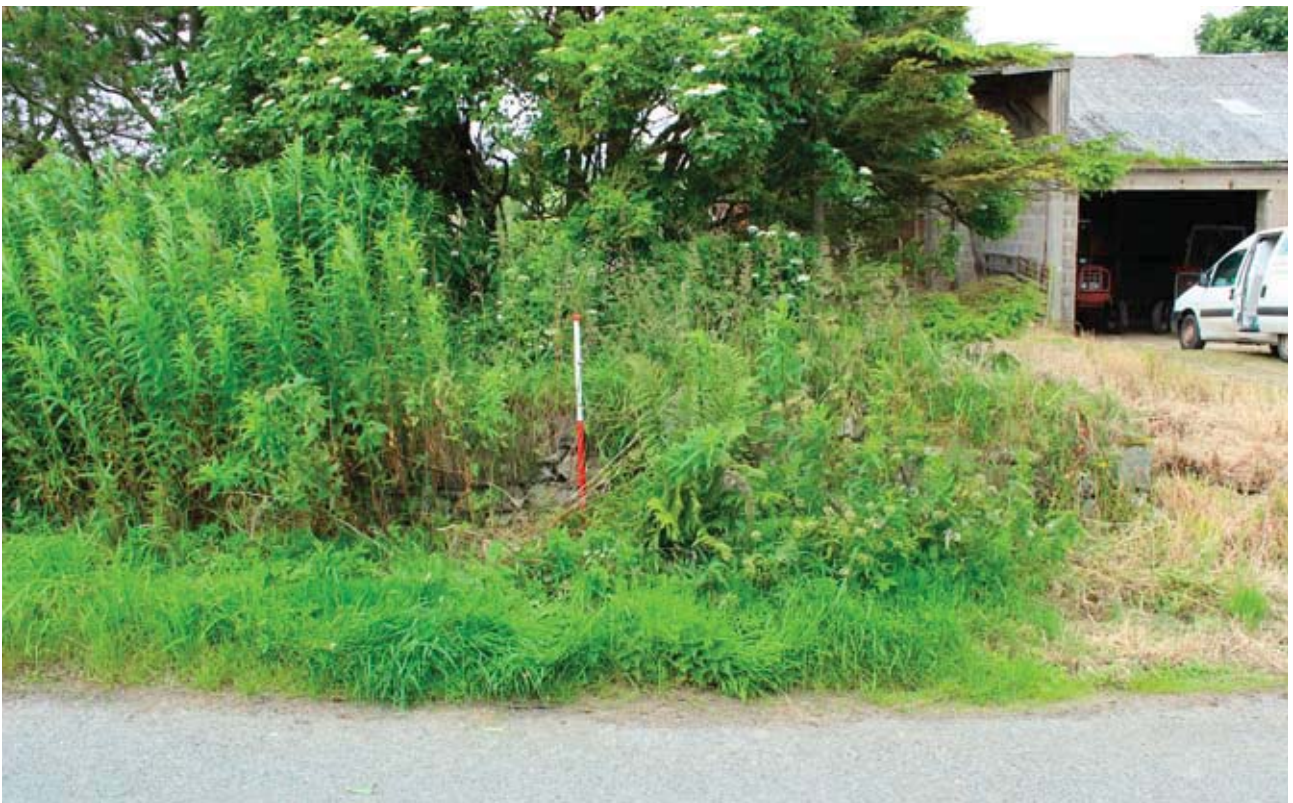
Plate 4

North facing view of overgrown eastern end of L-shaped retaining dyke

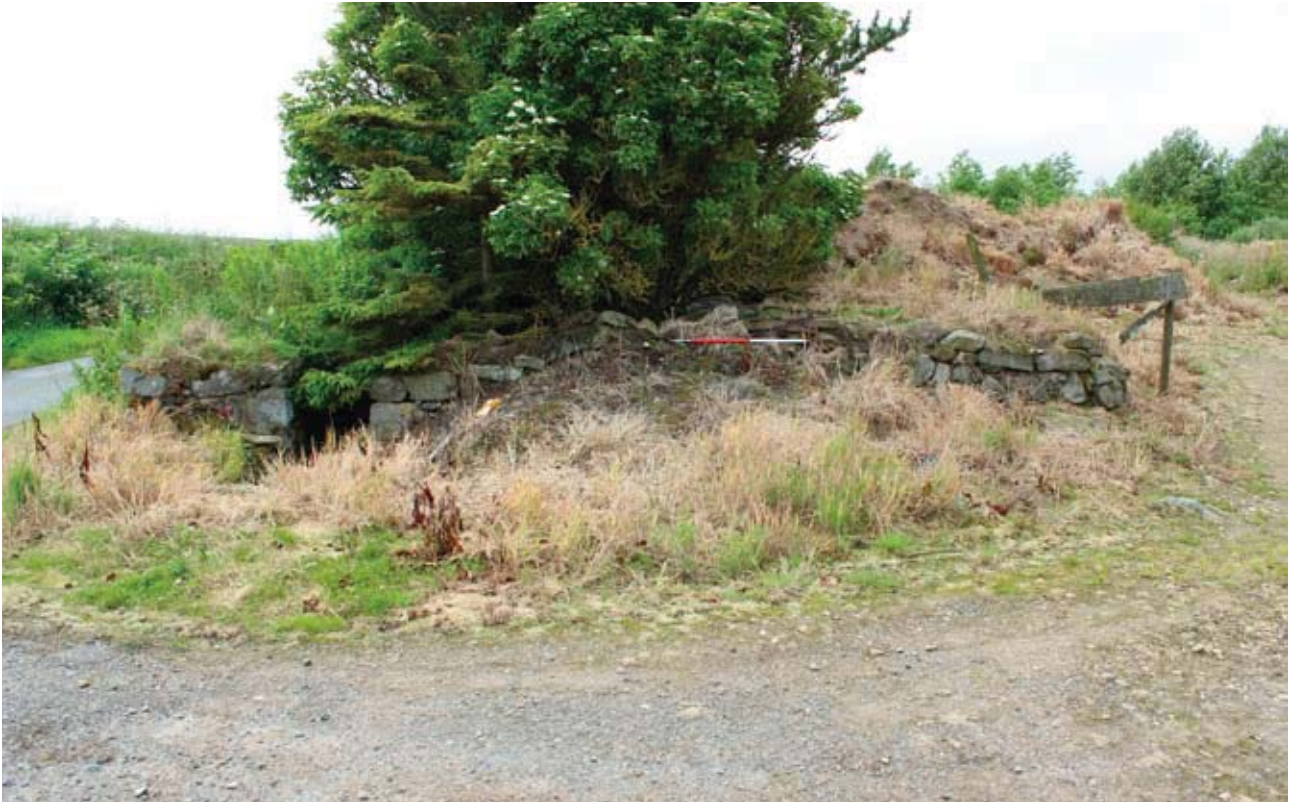
Plate 5

West-facing view of north-south section of L-shaped retaining dyke, showing break for channel to left side of image

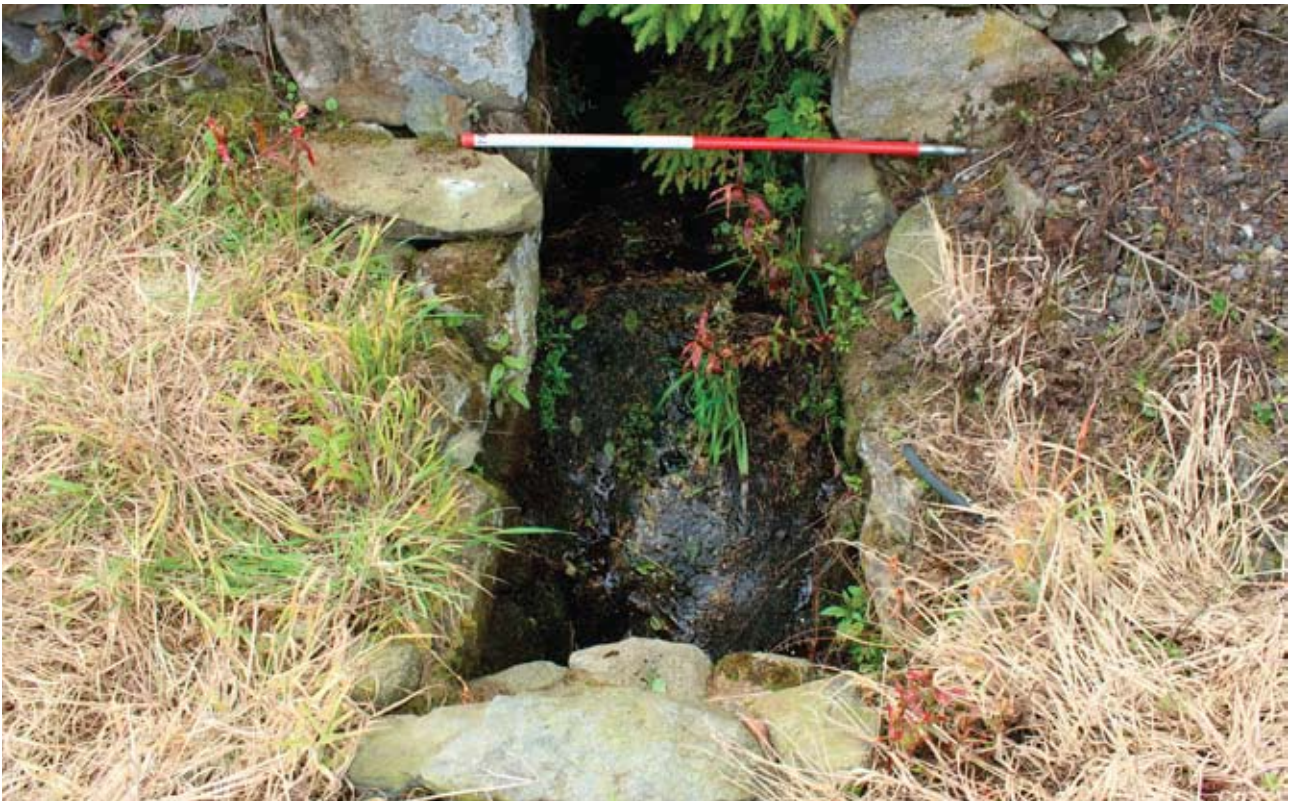
Plate 6

West facing view of sloping stone transition – the ceramic pipe runs underground out of the bottom of the image

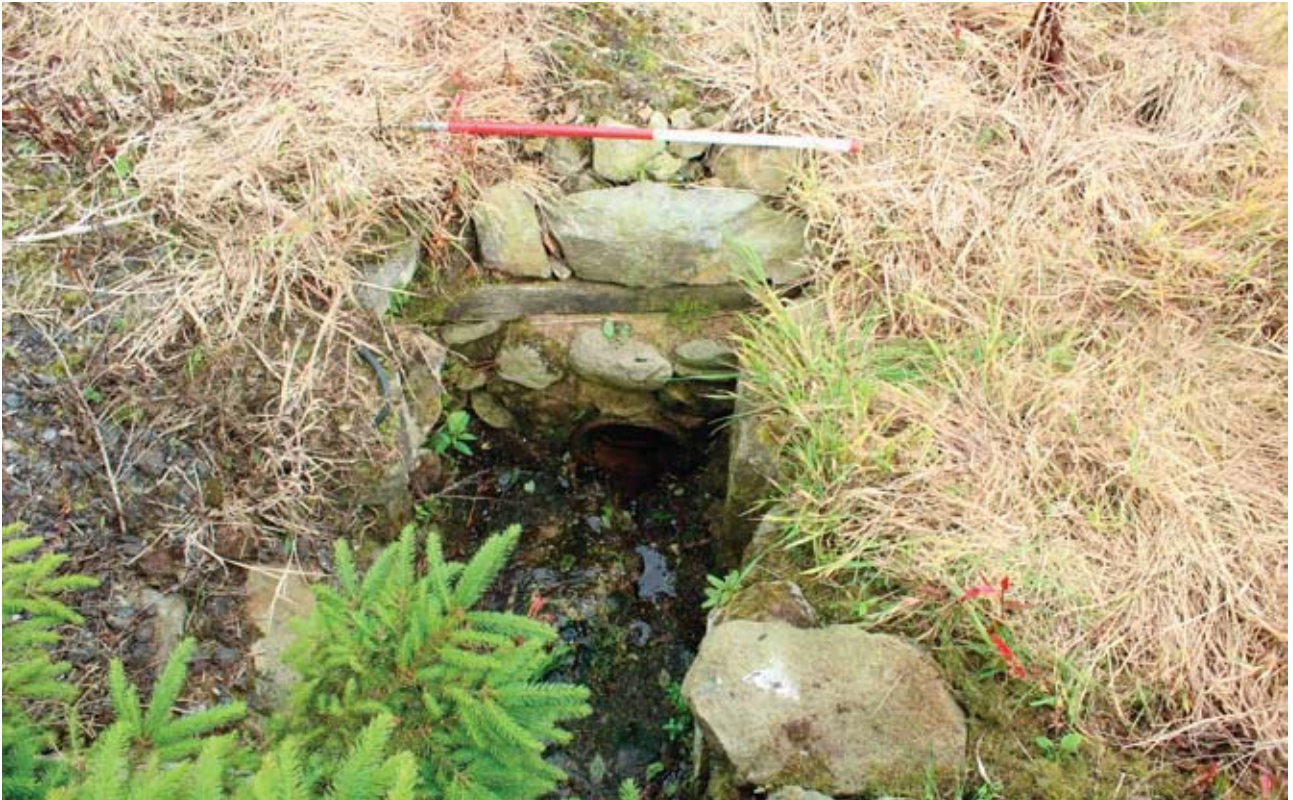
Plate 7

- 3.1.4 At the break in the retaining dyke, the flow of water is transitioned from open channel to buried culvert, in order to allow free access to the farm from the road. This is achieved by way of a sunken stone lined slope (Plate 6), which drops the level of the channel by some 0.3m over a distance of 1.3m into a ceramic pipe (Plate 7). The base of this slope is lined with large, flat stones. The walls are of a combination of mortared rubble and uncoursed dry stone, with a flat lintel over the pipe. The walls are part-buried and so their thickness could not be determined.

East facing view of sloping stone transition – the ceramic pipe runs is visible, with mortared rubble, stone lintel and drystone forming the structure above.

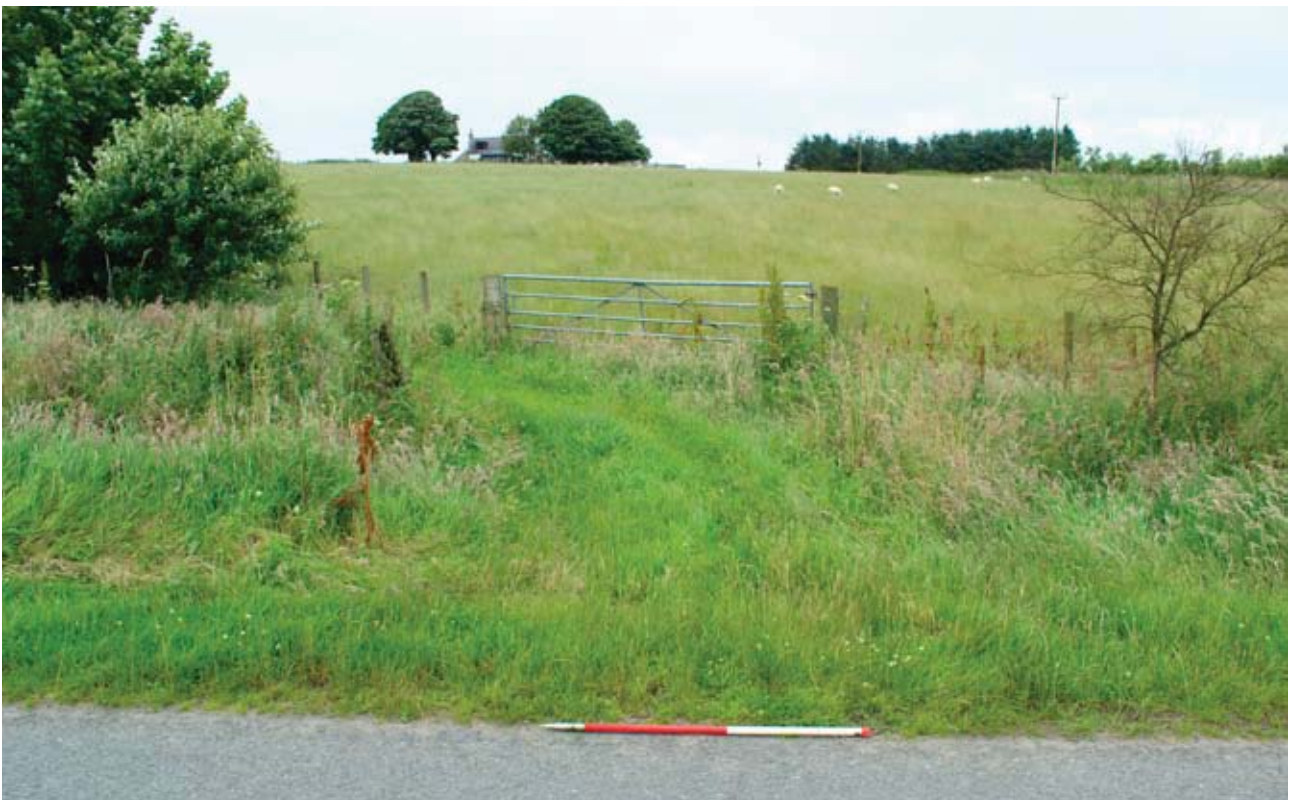
Plate 8

- 3.1.5 The channel is crossed at three points, allowing access from the road to the fields and landscaped ground to the north. The crossings are somewhat overgrown (Plate 8) and their structure obscured; however no abutments or more substantial support are visible, and so it must be assumed that they are simple timber or stone spans resting directly on the channel banks. Two long timbers spanning the channel lie adjacent to the westernmost crossing, lending weight to this hypothesis.

North-north-west facing view of western crossing. The lade runs from left to right across the middle of the image

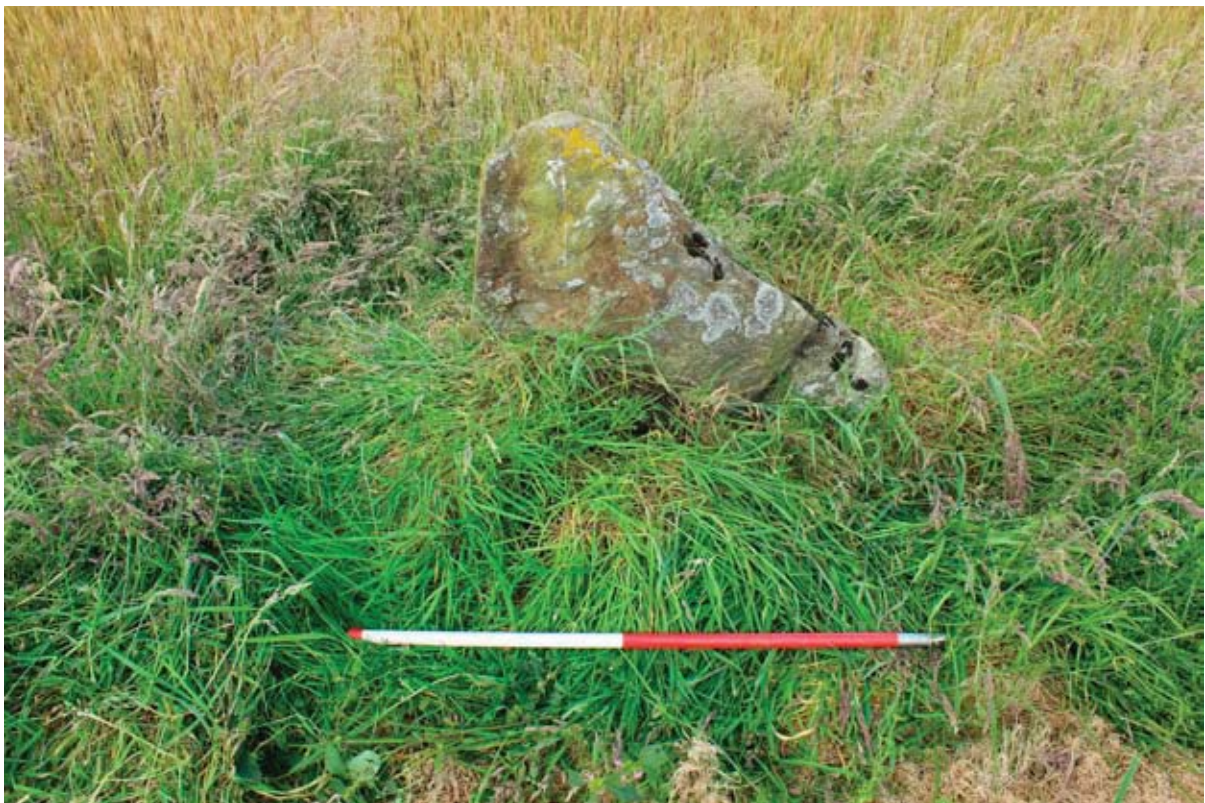
Plate 10

West-south-west facing view of Kirkhill Upright Stone (Site 51), showing earthen mound (in front and to the left of stone)

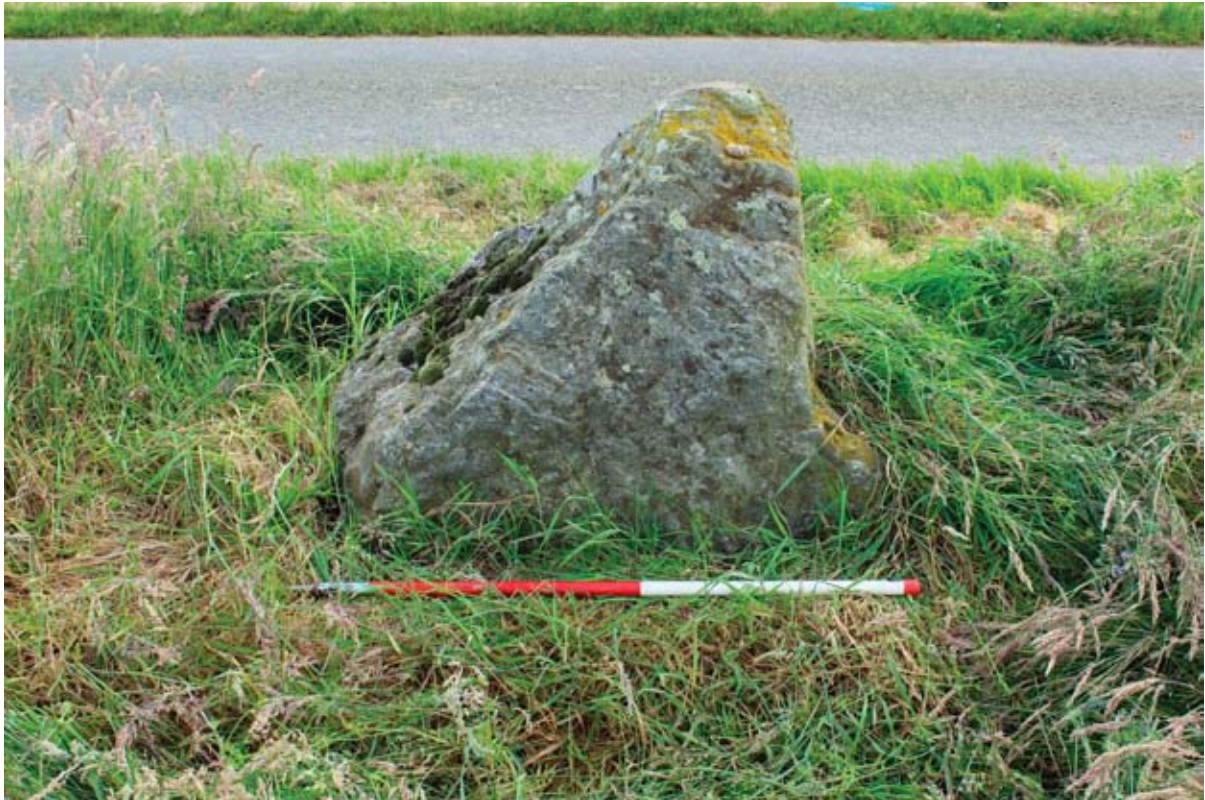
Plate 11

- 3.2.2 The stone is aligned north-north-west to south-south-east, measuring 1m by 0.4-0.5m, and standing between 0.2m and 0.9m high. It is triangular in profile (Plate 11), sloping down to the north-north-west. It appears to be supported to the south-east by a small earthen mound up to 0.3m high. No markings or signs of working are visible.

East-north-east facing view of Kirkhill Upright Stone (Site 51)

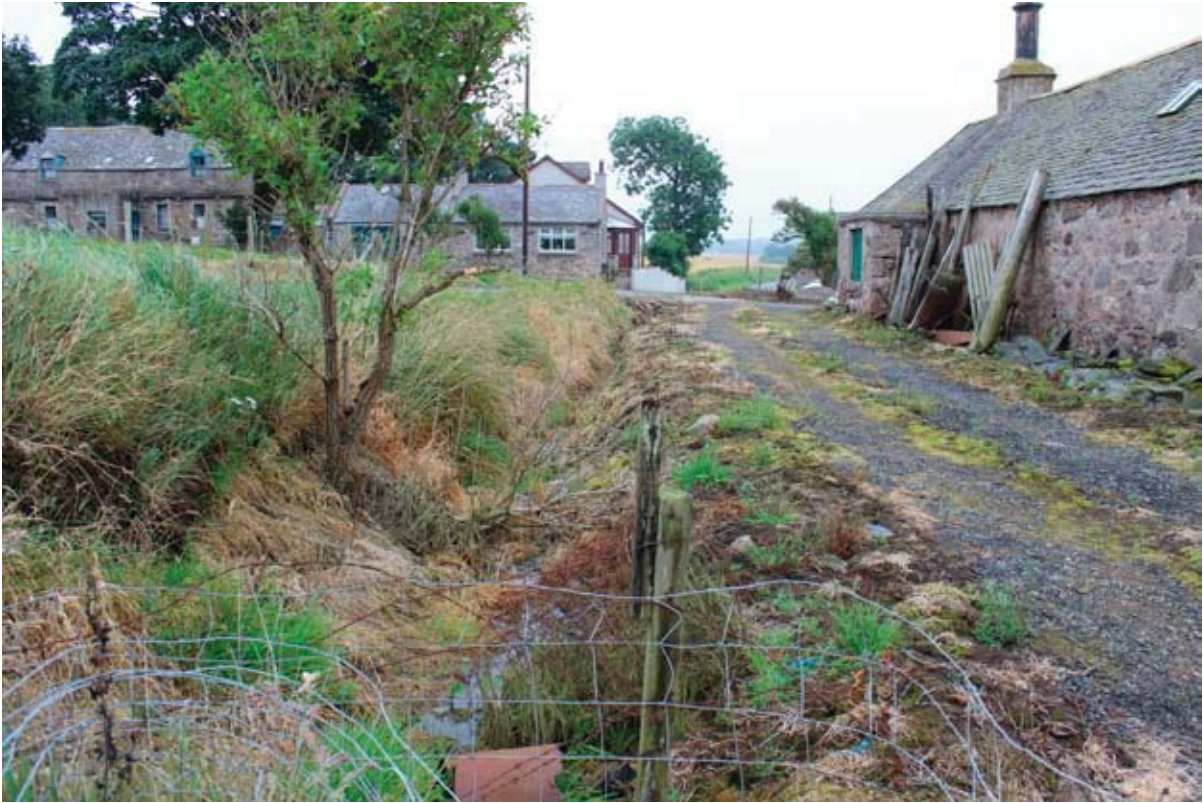
Plate 15

East facing view of Mill of Foveran Lade (Site 72) as it approaches the Mill (just out of view). The crossing is visible at the top of the track

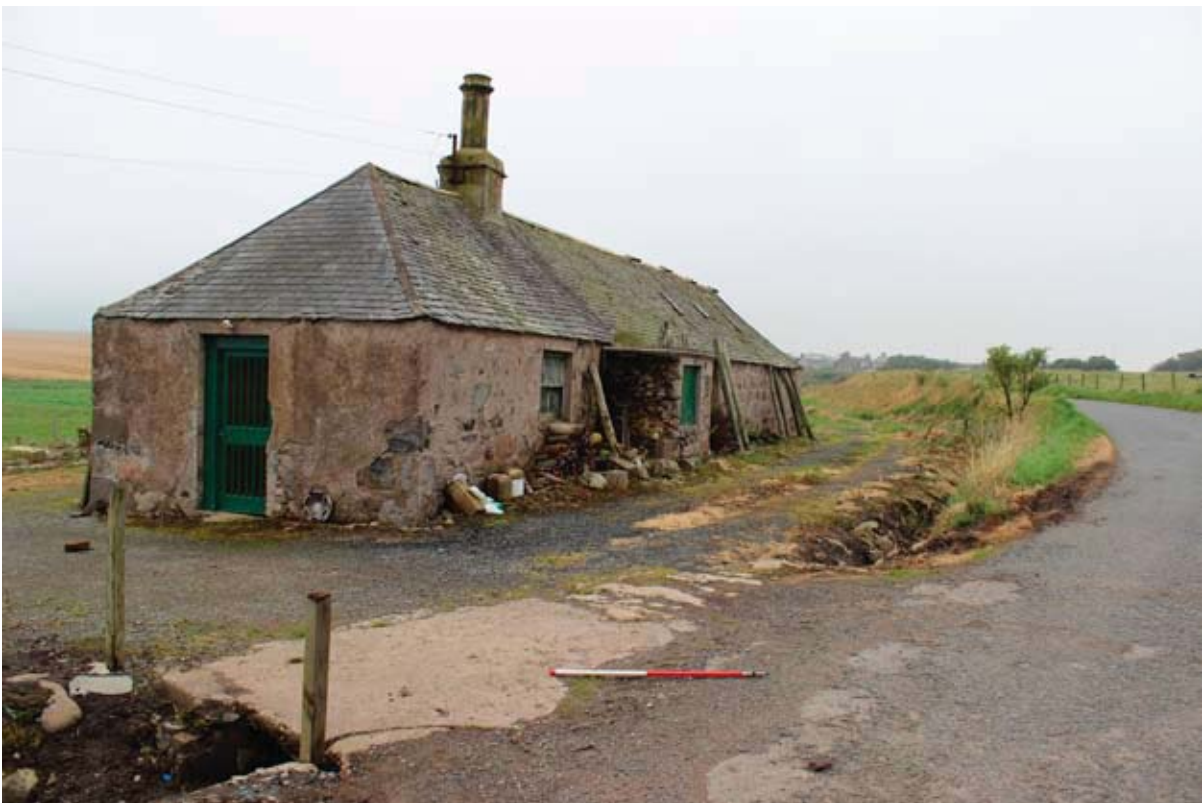
Plate 16

- 4.4.5 There has been a crossing over the lade adjacent to the mill's outbuildings since at least 1870; the present crossing of concrete, stone and timber appears much more recent.
- 4.4.6 The condition of the lade today is relatively poor; it is likely that some lining stone has been removed in the area immediately west of the mill, causing the northern bank to slump into the channel base. The structural condition of the western end of the lade could not be assessed during the survey.

South-west facing view of crossing over Mill of Foveran Lade (Site 72)

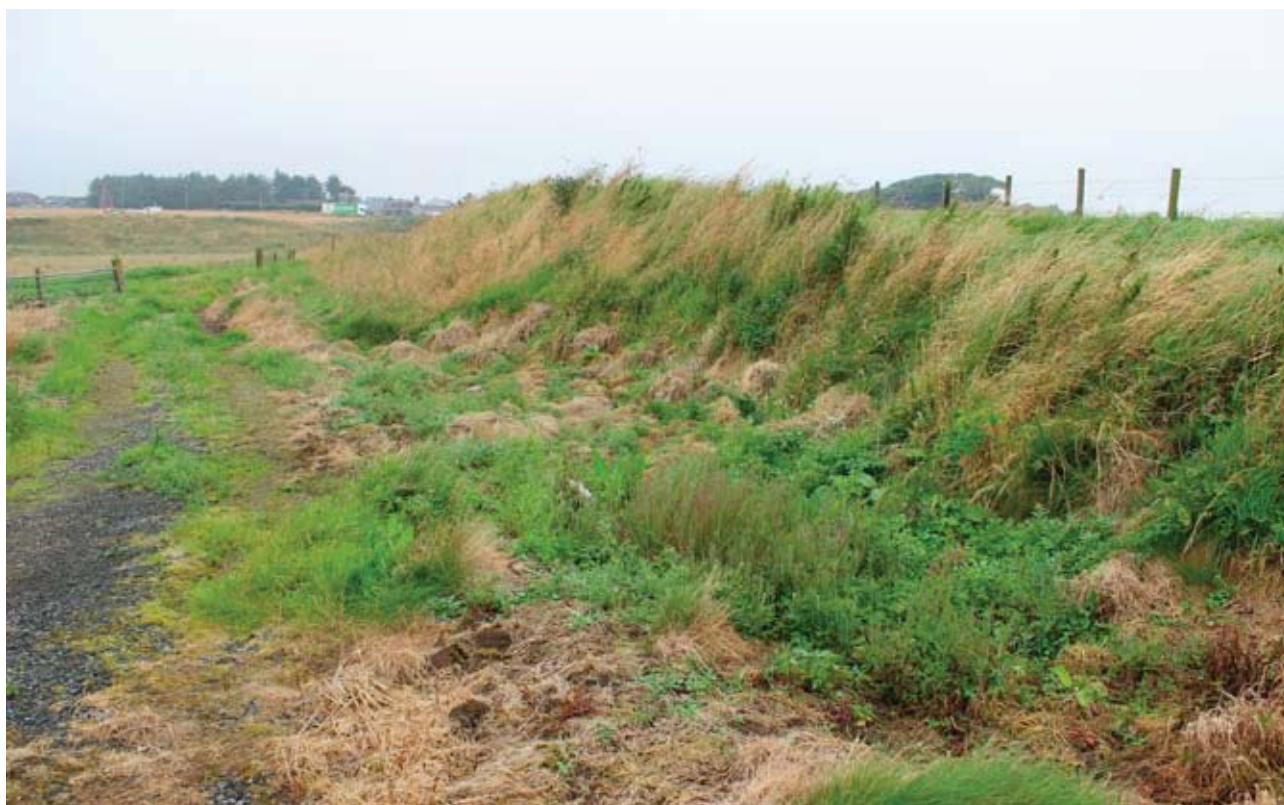
Plate 17

West facing view of Mill of Foveran Lade (Site 72) as it emerges from the overgrown road embankment.

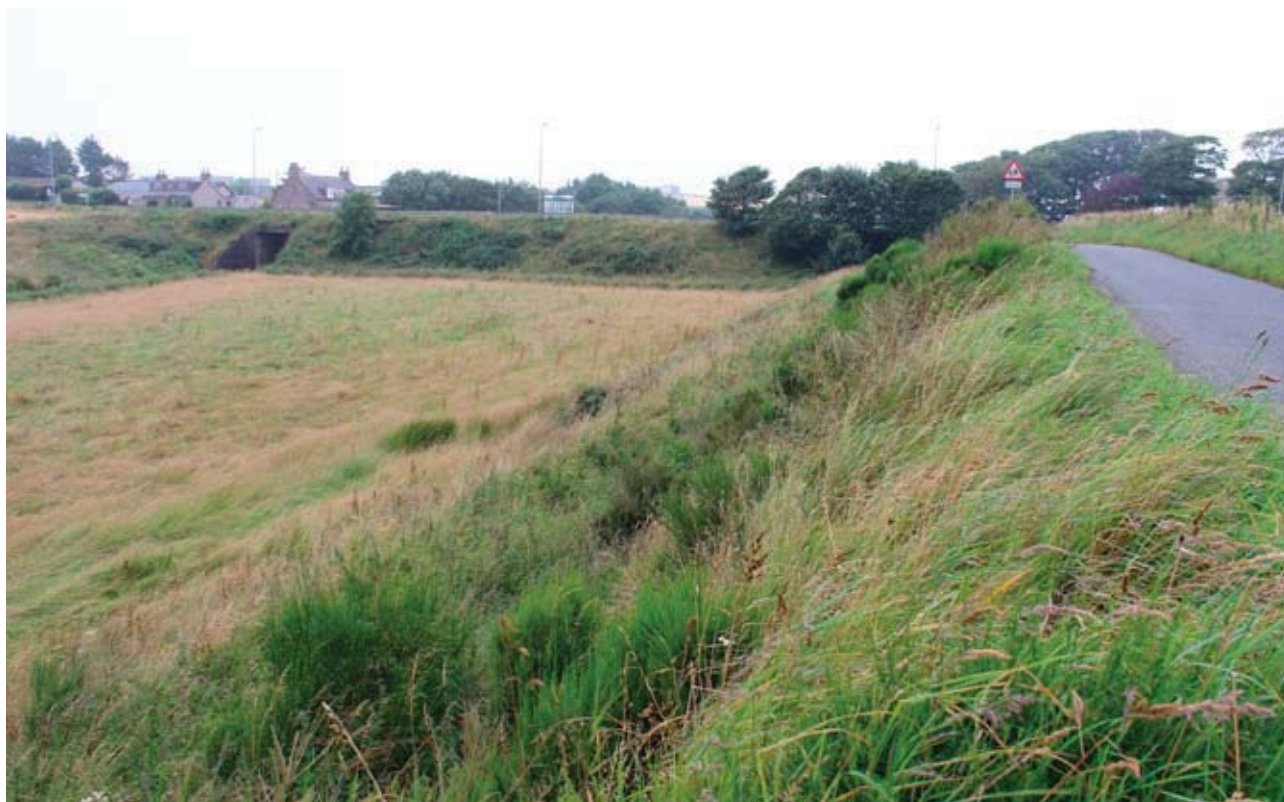
Plate 18

West facing view of an overgrown Mill of Foveran Lade (Site 72). The lade follows the denser line of bushes running from bottom left to top right. Pitgersie Bridge can be seen to the left of the image

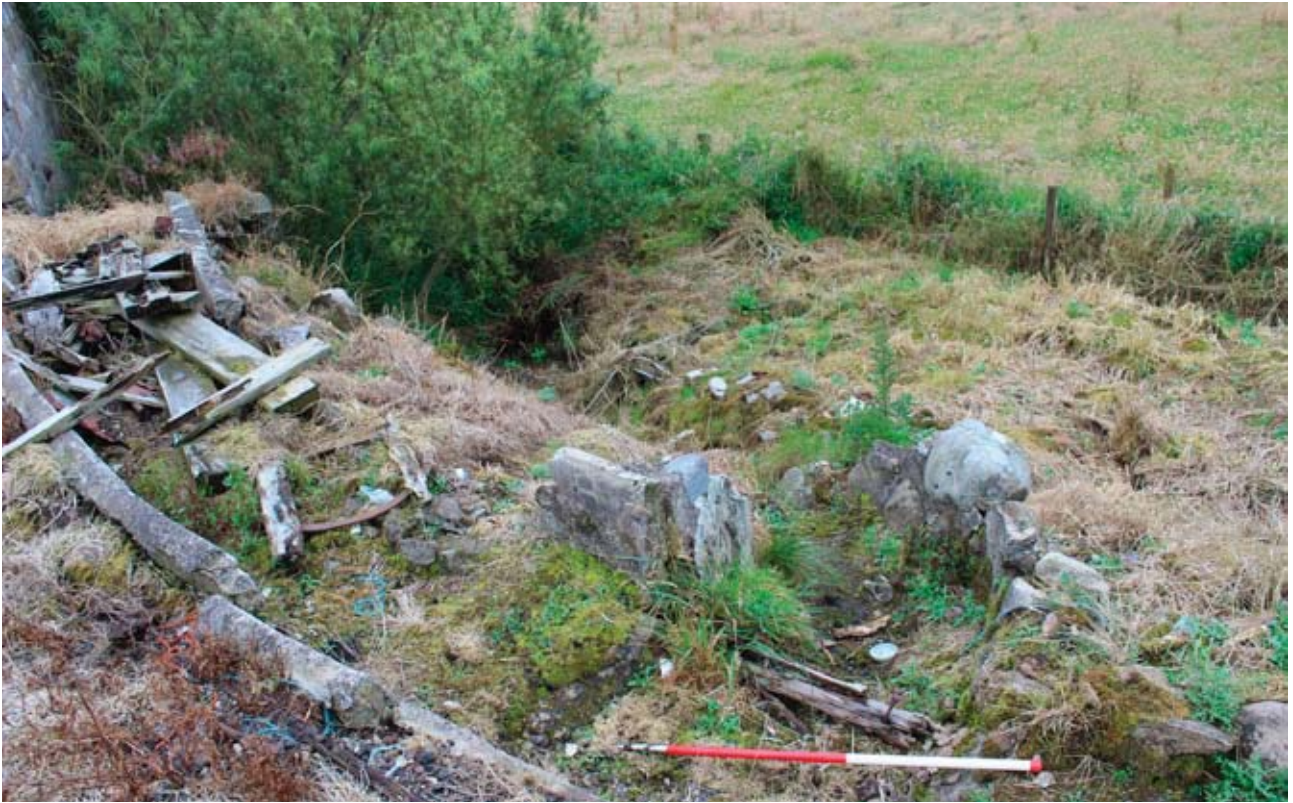
Plate 19

- 3.4.4 Just beyond the eastern limit of the study area, the channel is partly lined with concrete, and split into two with a small sluice gate (Plate 19), with one branch falling some 3m to power the (no longer in-situ) mill wheel, and the other as a diversion past it. Beyond the mill, the channel meets a field drain that subsequently runs back into the Foveran Burn.

South facing view of remains of sluice at Mill of Foveran Lade (Site 72). The branch of the lade to the left of the image runs to the wheel pit for the mill itself; the other branch is the bypass.. This part of the site is immediately outside the proposed road corridor.
