FURNESS ABBEY, CUMBRIA  
ARCHAEOLOGICAL ENABLING WORK FOR MASONRY  
UNDERPINNING TO THE PRESBYTERY

PHASES 5 & 6

*Commissioned by English Heritage*

*March 2014*

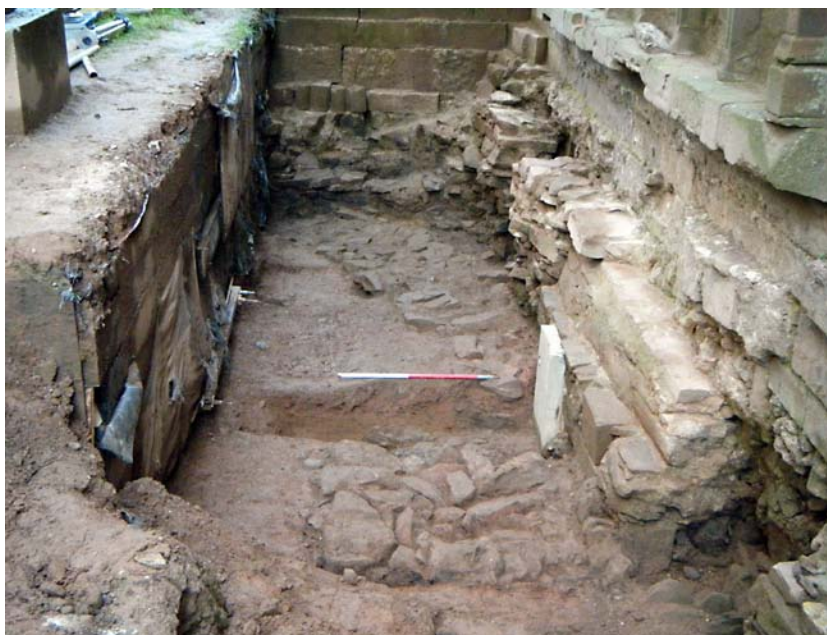
**Plate 1** ▶

*Savigniac apse foundation [12558],  
facing E*

The rubble foundation [12558] for the apsidal east end of the Savigniac church that was recorded in the previous phase of work was uncovered and further investigated (Illus. 3, Plate 1). The foundation was cut [14035] into an alluvial silt deposit [12375] and removal of one or two courses of stone (two courses where more depth was required to allow the underpinning) revealed the continuation of the foundation to a depth of at least 13.20m OD. The foundation was made up of rough courses of large, irregular quarried stone fragments, with similar material packed in between to form the core. The stones were laid in a non-uniform pattern with lenses of pinkish brown silt clay situated between the courses possibly representing a levelling material. At the east end of [12558], one course of the curving east wall [14025] of the apsidal Savigniac Presbytery was partially visible, situated below the 1<sup>st</sup> Cistercian wall [12303], at a height of 13.50m OD (Illus. 3). This was made up of shaped sandstone blocks that formed a regular face which abutted the foundation pad [12558].

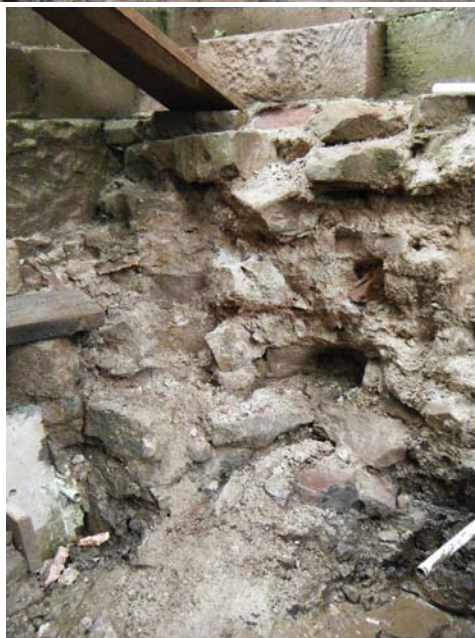
**Plate 2** ▶

*SE corner of Presbytery after early Cistercian  
wall has been removed*

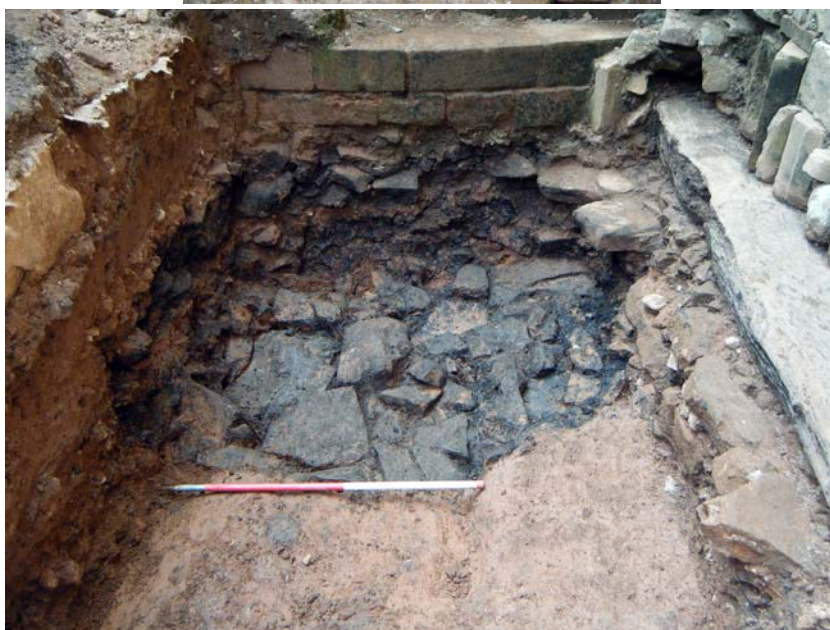
**Plate 3** ▶

*Foundation pad [14009], to E of Savigniac  
chapel wall [12449]*

The rubble foundation [14009] for the apsidal Savigniac chapel was found to continue to a depth of at least 13.16m OD (Illus. 3, Plate 3). It consisted of large irregular stone slabs ([12545] and [14009]) laid in a non-uniform pattern with lenses of dark pink and dark

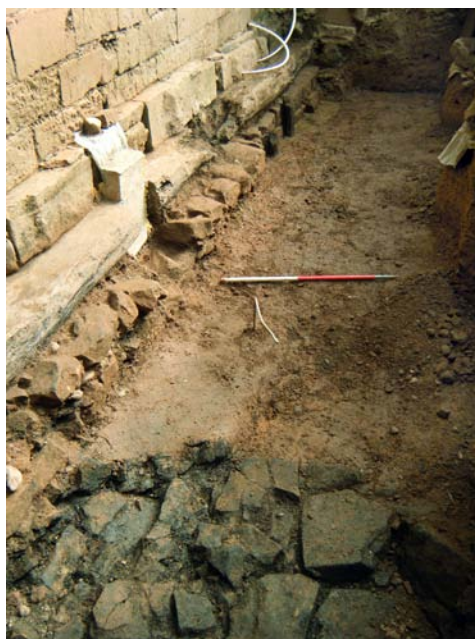
**Plate 4** ▶

*Savigniac apse foundation [14011],  
facing NE*

Adjoining [14009], a similar stone slab foundation [14011] continued to the east below the Presbytery wall, directly below the timber raft, which continued to a depth of between 13.15m and 13.25m OD at least (Illus. 3, Plate 4). The outer edge was roughly faced to form a linear foundation running east to west. This was thought to be representative of the edge of the foundation for the Savigniac Presbytery. At the eastern end, below [14011], a curving, stone paved feature [14023] stepped out 400mm from the foundation base (Illus. 3, Plate 5). The limited extent of excavation of this feature restricted the interpretation, but it was most likely to do with the construction of the Savigniac church.

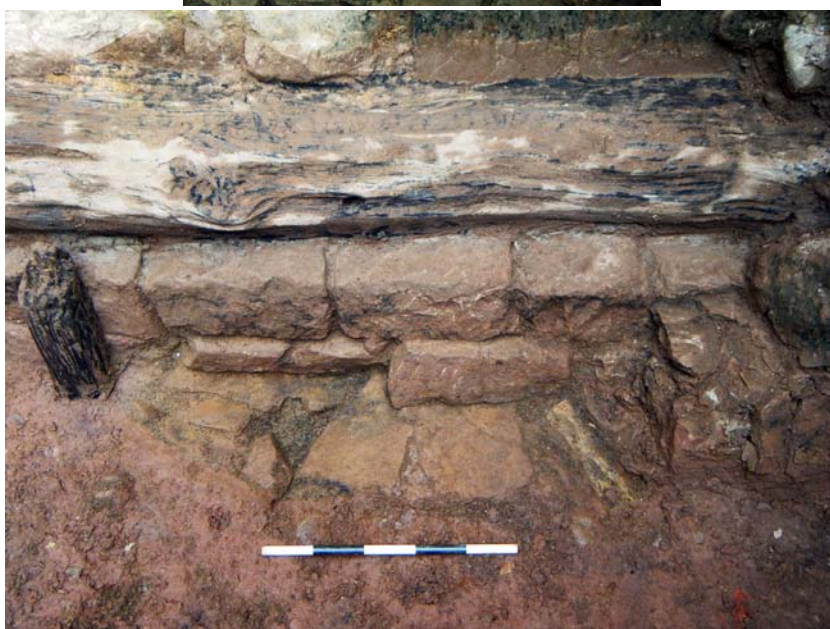
**Plate 5** ▶

*Stone feature [14023], directly below [14011],  
facing N*

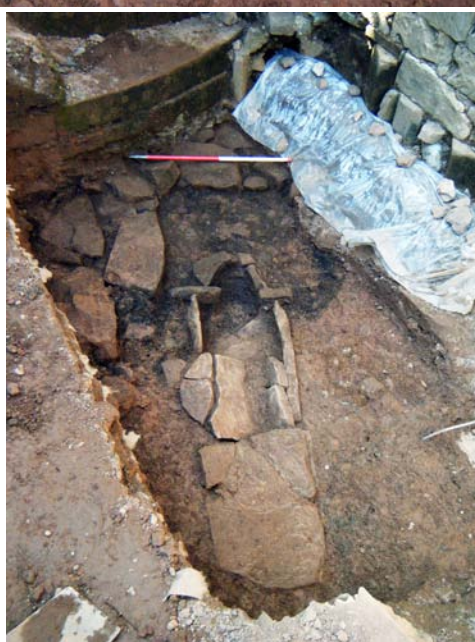
**Plate 6** ▶

*Cist [14000], facing NW*

A cist [14000] with capstones was cut into foundation pad [14009] within the Sacristy at 13.40m OD (Illus. 4 & 5, Plates 6 & 7). Originally interpreted as a drain ([12567]) during the previous phase of work, in the course of removing part of the foundation pad a capstone of the cist was removed, revealing the curved end of the cist. Although no grave cut was discernible, it was established that the cist post-dated the foundation as lower courses of the foundation existed below the cist stones (Plate 3). The cist contained skeleton [14004] which had been slightly disturbed. This was evident as the top half of the skull was positioned at the pelvic area, but the remainder of the skeleton remained un-disturbed. Directly below the skeleton, a thin (0.03m) deposit of reddish brown mixed sandy clay [14006] was present which contained a high percentage of charcoal fragments. Another cist was visible in the north facing section of the sacristy trench (Illus. 10) but remained unexcavated *in-situ*.

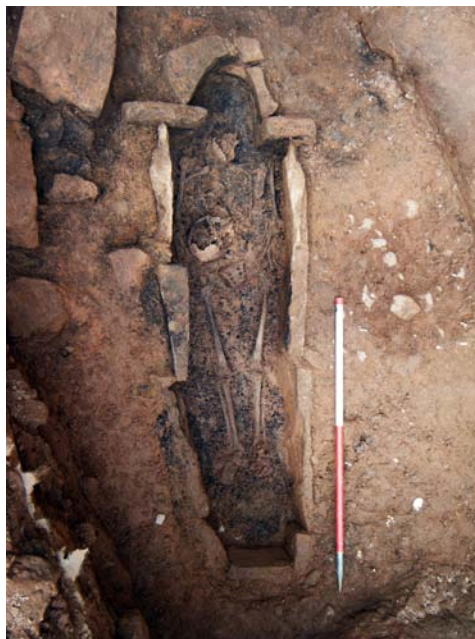
**Plate 7 ▶**

*Skeleton 14004 contained in cist [14000],  
facing NW*

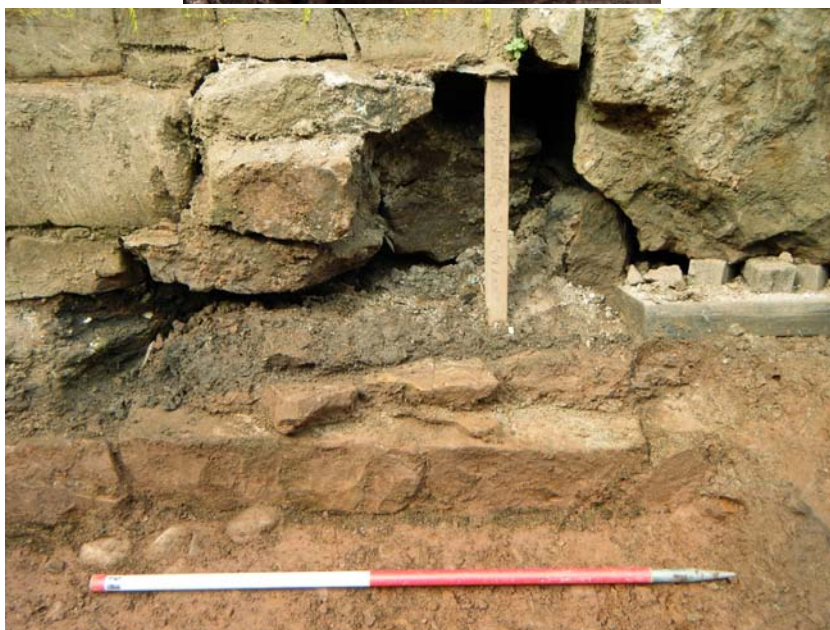
**Plate 8 ▶**

*Potential E end of Savigniac stone foundation  
pad [12445] below timber, facing W*

A similar stone block foundation [12445] to that recorded below the timber within the Sacristy ([14011]) was situated below the timber of the east wall of the Presbytery and continued to a depth of at least 13.25m OD (Illus. 3, Plate 8). It was formed of faced stone blocks to form a foundation running north-south. This was thought perhaps to be representative of the eastern edge of the foundation for the Savigniac Presbytery.

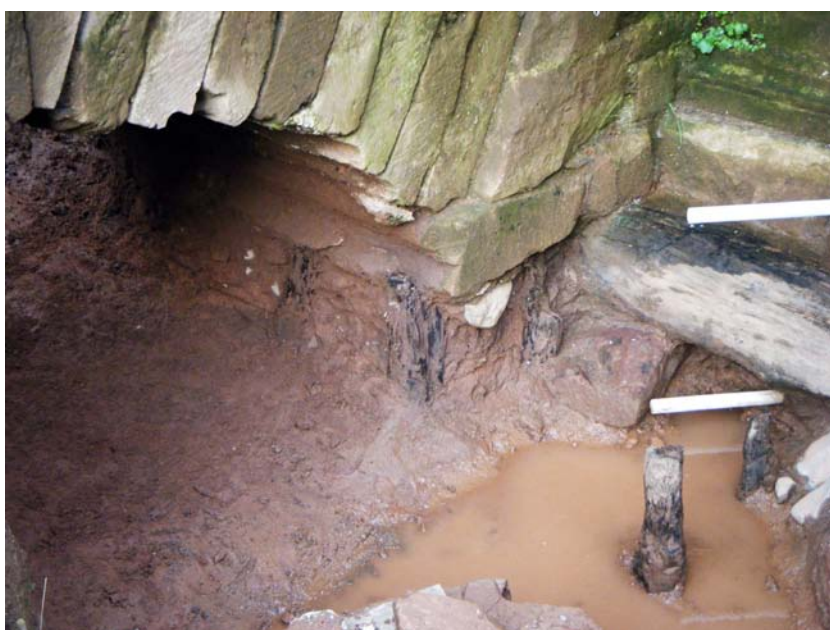
**Plate 9 ▶**

*Timber uprights visible below archway  
[12345]/ [12048], facing NW*

During the underpinning works, further ground reduction below the lowest course of the south-east buttress revealed the presence of a number of oak timber uprights below the stone. Excavation in this area confirmed the presence of the timber raft projecting to a right-angled join beneath the buttress and the foundations resting on a layer of large

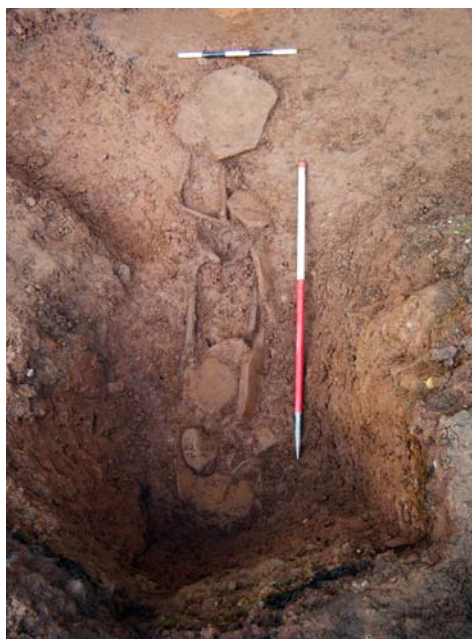
**Plate 10** ▶

*Skeleton [14028], partially covered by cist [14027], facing W*

To the east of the Presbytery, two burials were investigated at a height of 14.10m OD (Illus 4 & 5, Plate 10 & 11). Skeleton [14028] was contained by a disturbed cist [14027]; capstones only partially covered the skeleton, and stones were present on the north-east side of the skeleton but not on the opposing side. Once the capstone was removed from over the skull, a thin sheet of oak [14031], measuring 400x250mm partly covered the skull. No wood was found elsewhere in connection to the skeleton. The stones to the north-east looked to have slumped over the skeleton, but it remained in good condition, apart from the skull which had been affected possibly by pressure and movement of the capstone (Plate 12). Skeleton [14030] was partly excavated and was situated over the sloping cist stone [14027]. The left humerus, radius, pelvis, femur and some vertebrae were exposed, recorded and subsequently left *in-situ* and reburied as there was no requirement for removal. Both burials belong to the burial ground previously recorded in prior phases of work and were thought to date to the phase between the early Cistercian rebuilding in the 12<sup>th</sup>/13<sup>th</sup> century, and the second rebuilding in the 15<sup>th</sup> century.

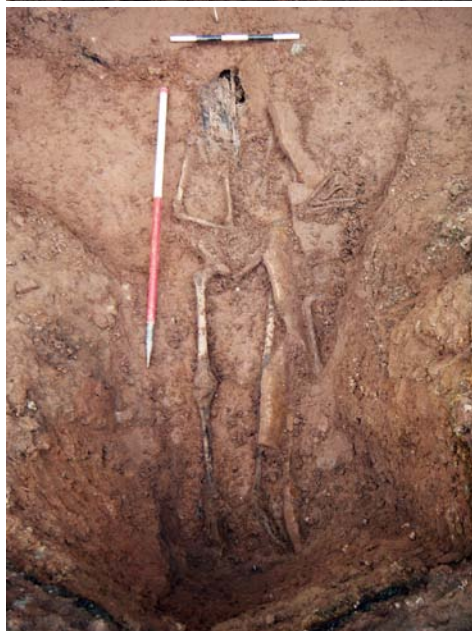
**Plate 11** ▶

*Skeleton [14028] and [14030] side-by-side, facing W*

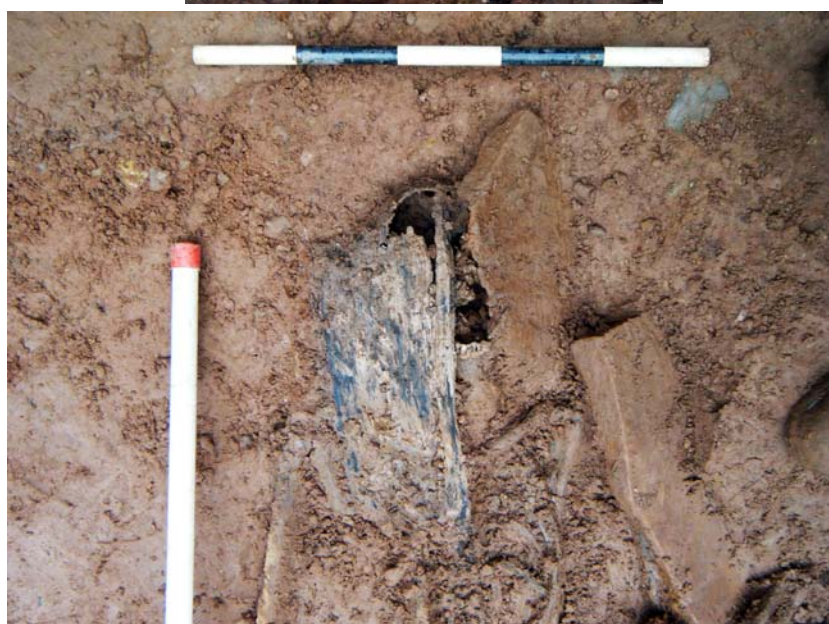
**Plate 12** ▶

*Skull of skeleton [14028] covered by wooden sheet [14031]*

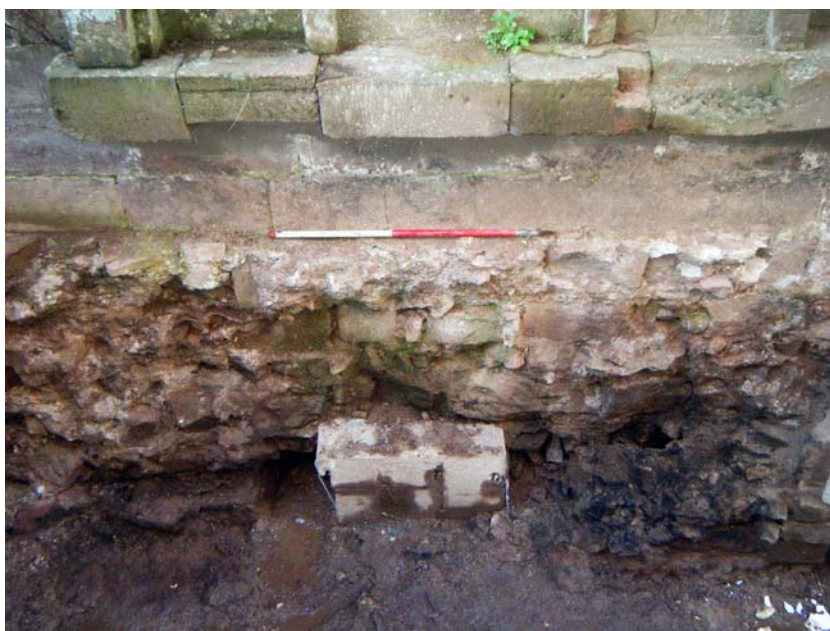
**Plate 13** ▶

*N facing elevation of south Presbytery wall  
after de-construction of [12548]*

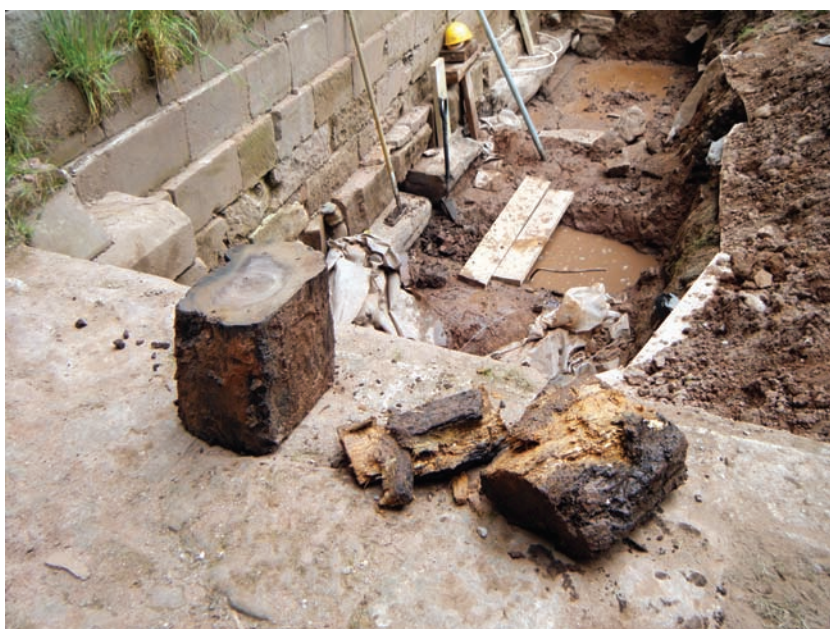
**Plate 14** ▶

*Two sections of timber raft beams [12456]  
extracted during underpinning works from  
outer edge of Presbytery wall  
(cut slot visible in background)*

During the underpinning works, the presence of the oak timber raft below the 15<sup>th</sup> century Cistercian re-build was confirmed. It consisted of three beams running the length of the south wall of the Presbytery; two beams located side-by-side on the external edge, measuring 220x340mm at most in section, and one beam on the inner edge, measuring 250x350mm. This was a similar case along the east wall of the Presbytery, but here two beams were located side-by-side on the inner edge, and one beam on the outer edge. The condition of the timber varied, with preservation of beams along the south wall being moderate to good (Plate 14), to preservation of beams along the east wall being moderate to very degraded. Material extracted, along with the timber beams, from under the abbey walls, included a grey clay deposit [14036] interpreted as packing material around the timber beams, and stone fragments which were presumably the result of either the construction process or fragments of degrading stone.

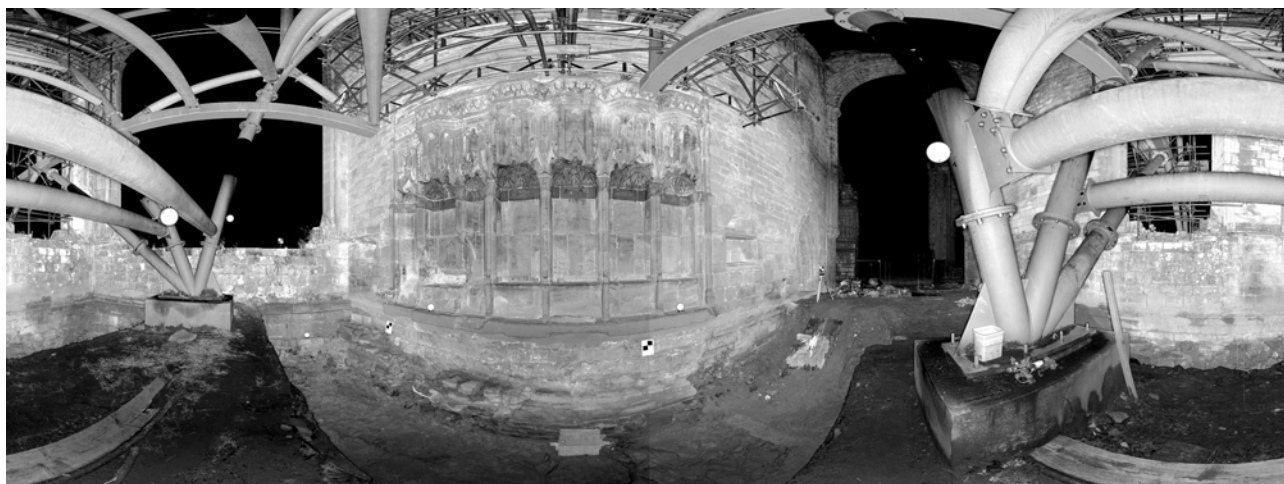
**Plate 15** ▲

The laser scanner's view of the 2013 excavations

A laser scan survey was undertaken to provide a comprehensive metric record of the structures revealed by the 2013 excavations, including the apsidal Savignac foundations and those relating to the early Cistercian phases. Please refer to Appendix 4 for a summary report and results.

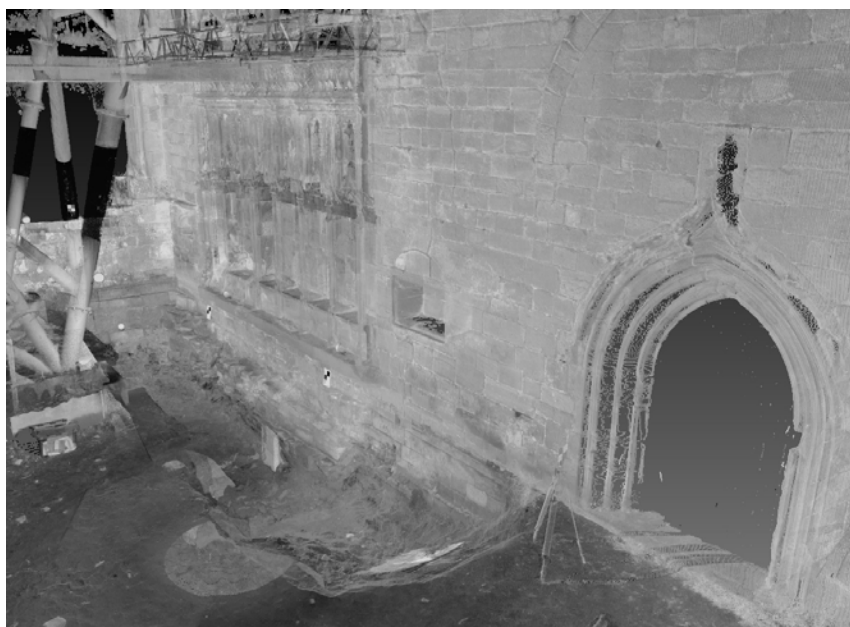
**Plate 16** ▶

A general view of the full point cloud, showing incidental coverage of much of the Presbytery and supporting structures
