NATIONAL MUSEUMS GRANTON, EDINBURGH

A Standing Building Survey

for National Museums Scotland

May 2013

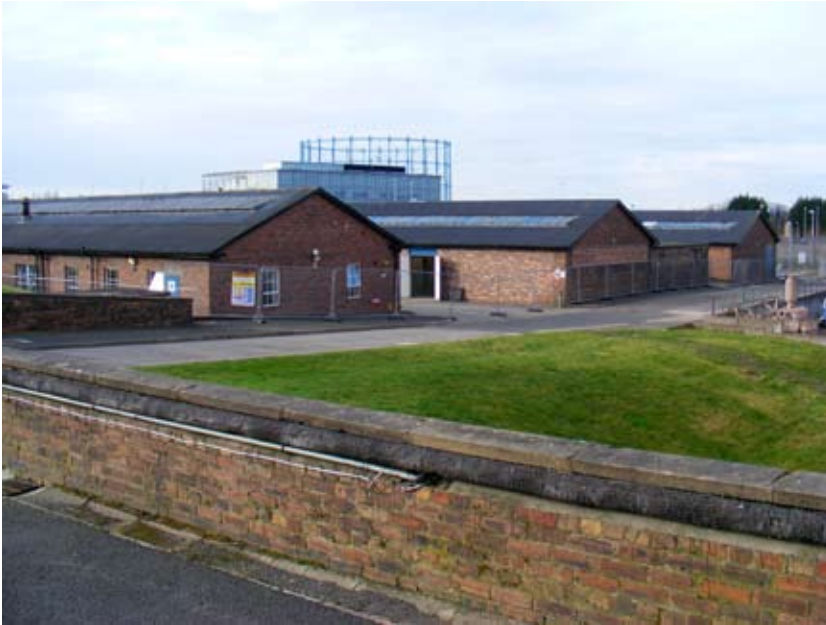
Illus 2

View of the buildings from the SE

The historic building record was centred on three single storey brick constructed buildings (*Illus 2*) to the north end of the group of buildings that form the NMS collection centre. These buildings have been numbered Building 8, 10 and 11 (*Illus 1*) and were all aligned east/west. Building 11 was located to the north side of the development area and Building 8 to the south with Building 10 in the centre. Building 9 had been demolished prior to the planning application for the re-development of this site and was represented by the remains of a concrete floor recorded to the west of Building 8.

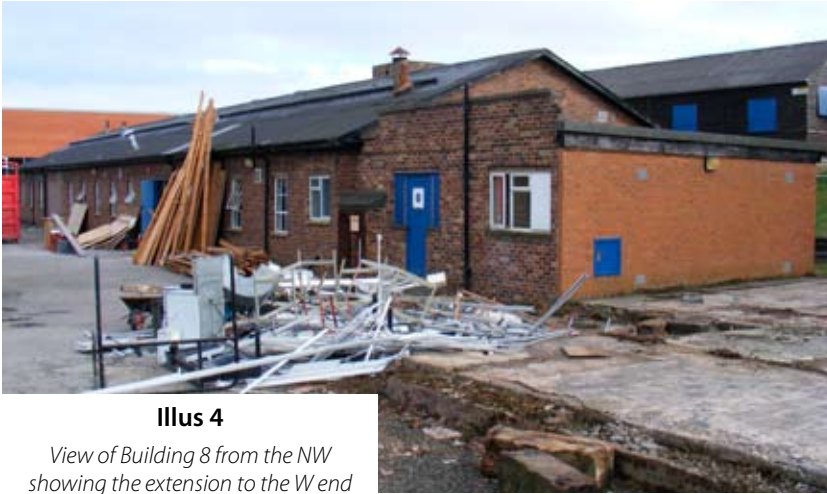
Illus 4

Building 8 was a 49m long single storey brick structure with a short later phase extension abutting the west end (*Illus 4*). The main building included gabled ends and corrugated iron sheeting across the roof. The wall head was capped with painted timber eaves and the roof capped by timber skewes on the gables. All the main wall faces were of stretcher brickwork bonded with cement. The small brick extension to the west end was only half the width of the main building and included an even later phase modern brick end wall, presumably constructed after Building 9 had been demolished.

View of Building 8 from the NW showing the extension to the W end

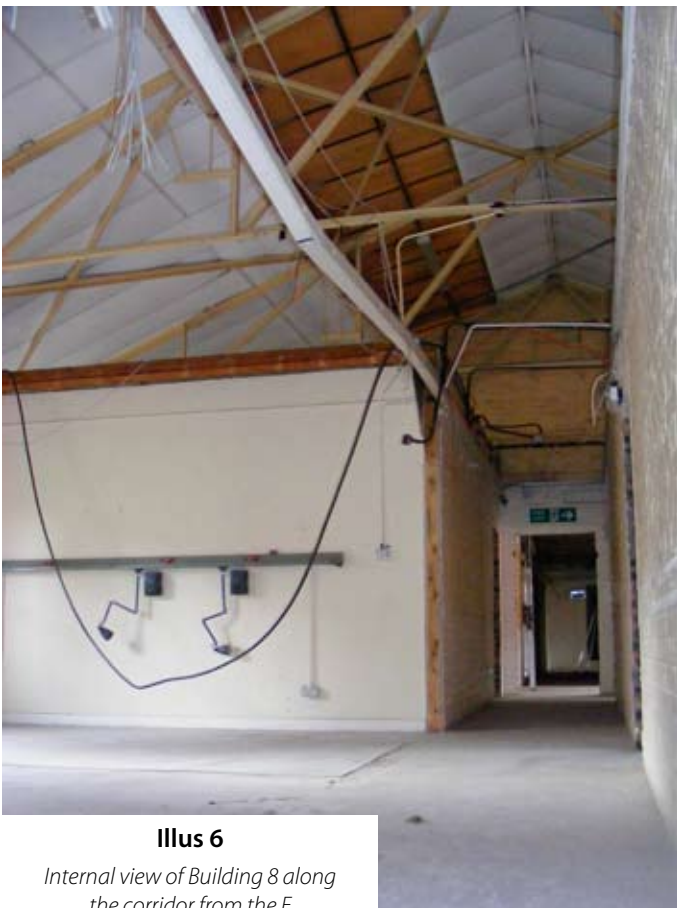
Illus 6

Internal view of Building 8 along the corridor from the E

The internal configuration comprised a series of small rooms leading off a central corridor (*Illus 6*). The floor was concrete throughout and the steel roof support frame was exposed across the whole length of the building. A number of steel support pillars for the roof frame were exposed within the main brick walls of the building.

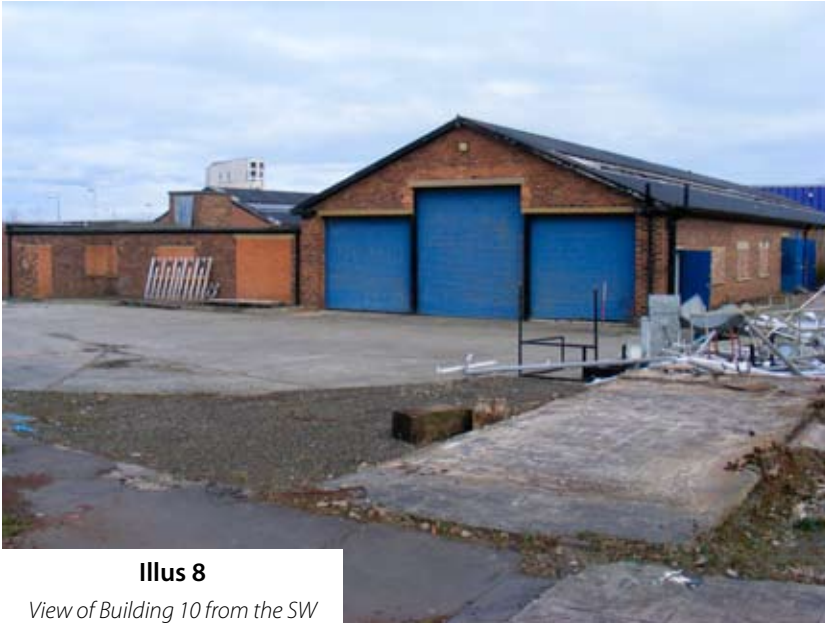
Illus 8

View of Building 10 from the SW

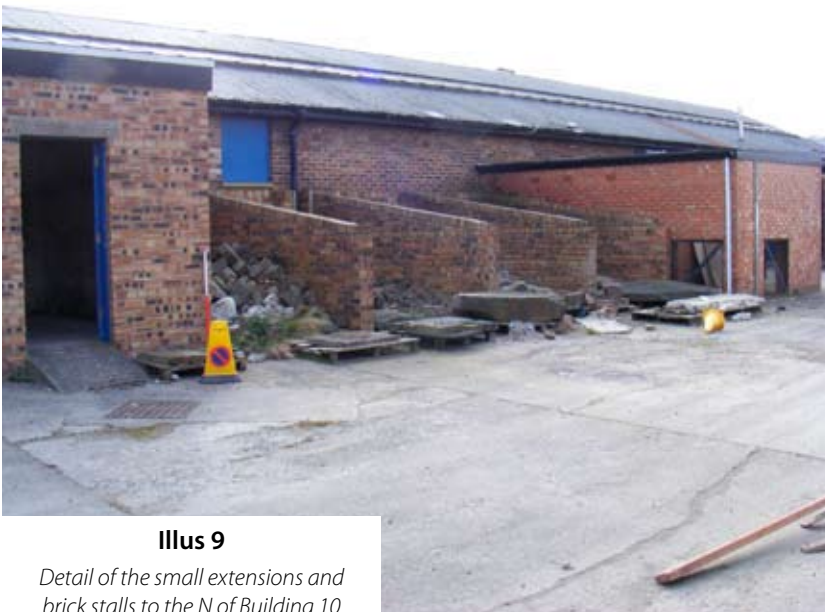
Illus 9

Detail of the small extensions and brick stalls to the N of Building 10

Two smaller extensions were also recorded on the north wall of Building 10. These were both brick built with flat roofs and were clearly later phase additions. The extension to the east had an English-garden-bond construction and the one to the west a stretcher bond construction. These two extensions bounded a series of low brick walls that formed a series of small bays along the north elevation of Building 10 (see *Illus 9*).

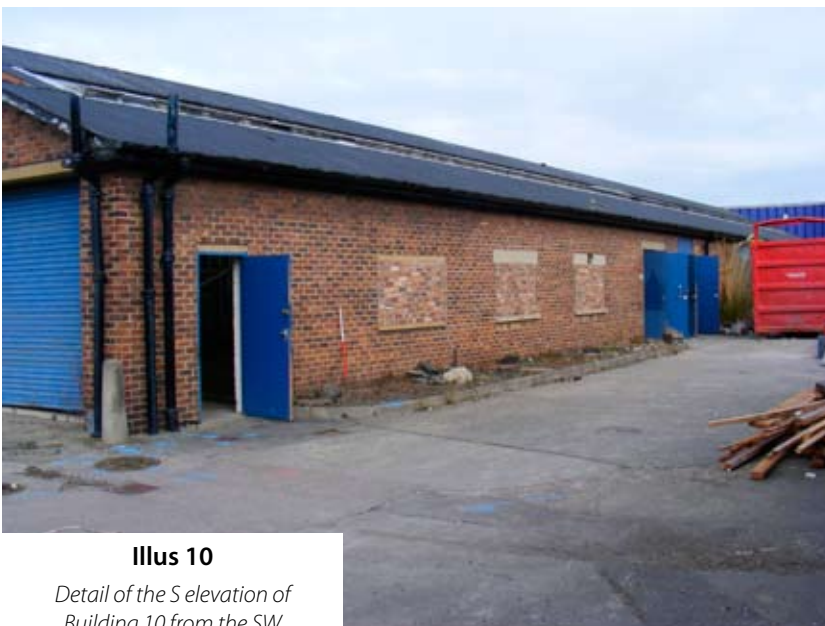
Illus 10

The south elevation of the building included four large timber doors and four brick-blocked windows, three of which are located to the west end of the wall (*Illus 10*). A construction line was also recorded at the east end of the elevation. To the north side of the building a number of the features had been masked by the later

Detail of the S elevation of Building 10 from the SW

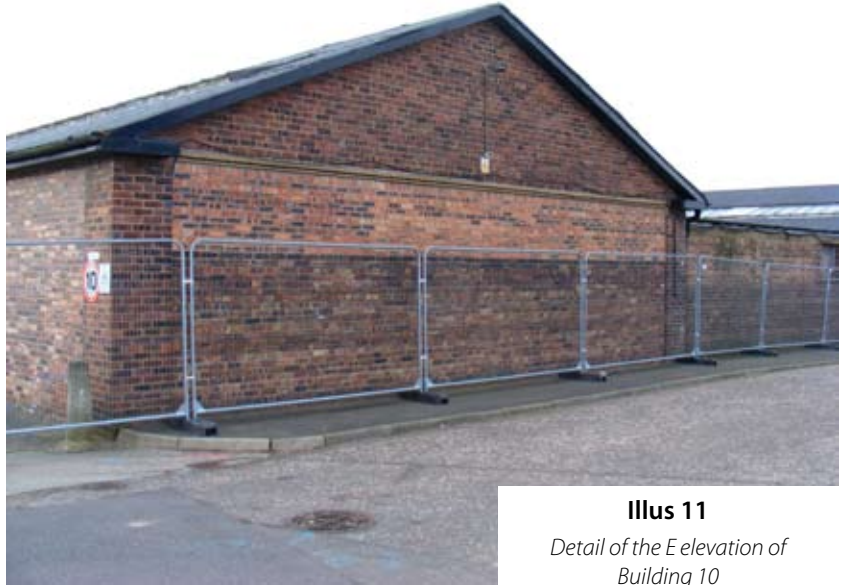
extensions; although two sets of large double doors and three brick-blocked windows were recorded. The east elevation comprised a brick wall constructed of two different types of brick (*Illus 11*). The upper gable comprised a stretcher bond while the lower part of the wall had an English-garden-bond capped with stone. The wall has a slight recess suggesting it may have originally had a large opening at this end. The west elevation included a modern roller-door.

Illus 11
 Detail of the E elevation of
 Building 10

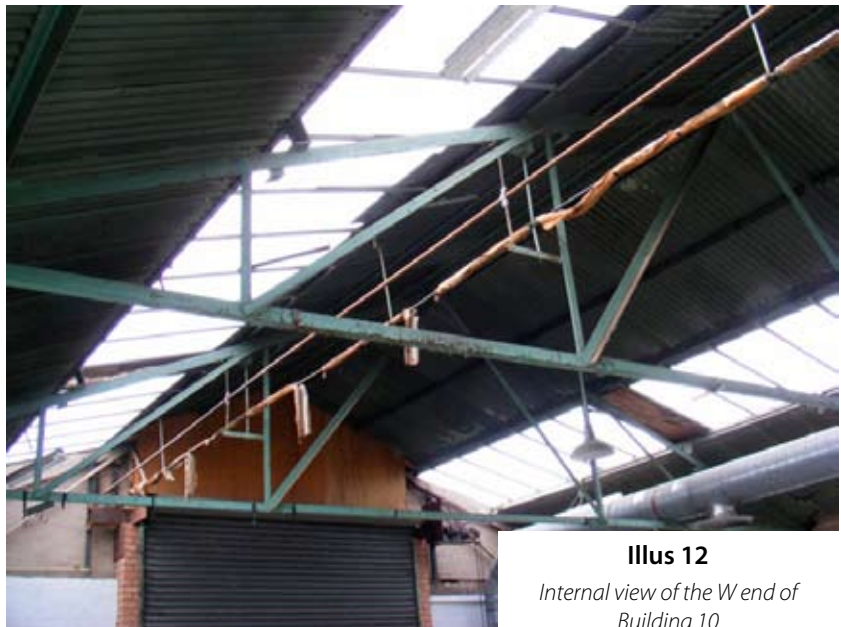
The internal configuration of the building comprised of seven separate rooms divided by painted brick walls. The outer walls included raised brick buttresses and integral steel roof support pillars. The ceiling was open to the basic steel frame of the roof (*Illus 12*) and the floor was concrete throughout. The central brick partition wall was constructed of English-garden-bond brickwork.

Illus 12
 Internal view of the W end of
 Building 10

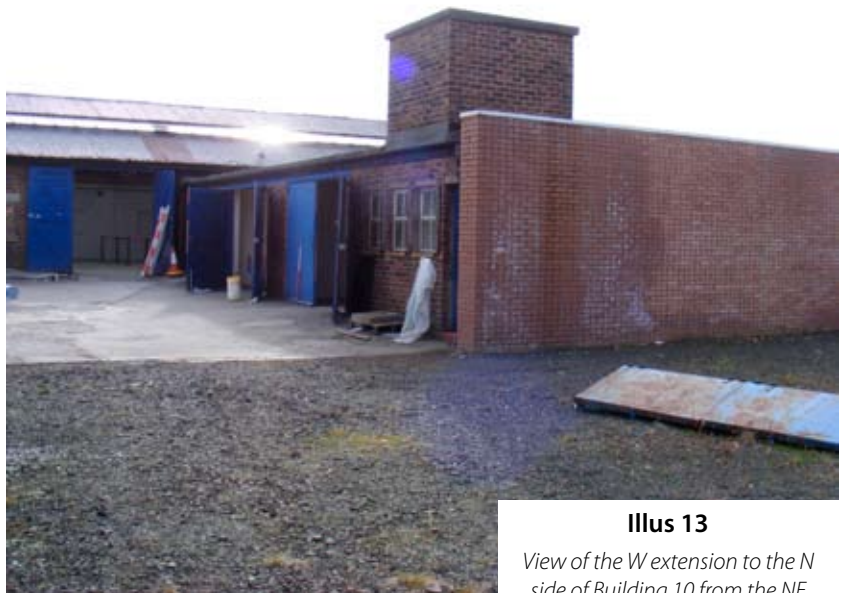
The brick extension to the west side of the north elevation included a flat roof and a small raised area to the north end (*Illus 13*). This extension formed four separate storage rooms with large double timber doors to the east side and brick-blocked windows to the west side (see *Illus 8*). The north end wall was clearly a later phase modern brick wall that had

Illus 13
 View of the W extension to the N
 side of Building 10 from the NE

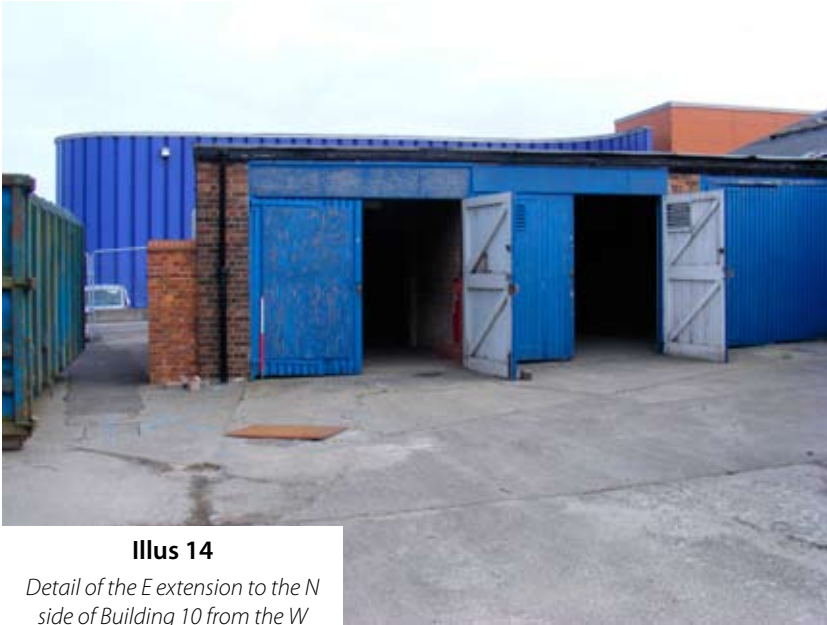
Illus 14

The east extension on the north side of Building 10 comprised a two room brick building with an English-garden-bond construction and a flat concrete roof (*Illus 14*). It included three large timber double doors to the west side and two timber vents high up on the north side of the east wall. The internal construction included a concrete floor and walls that included raised brick buttresses. The roof was supported on steel pillars and beams and the internal brick partition wall was thought to be a later phase as it was not keyed into the main walls. A large double door on the south internal wall (also the north wall of Building 10) led into the main building (*Illus 15*).

Detail of the E extension to the N side of Building 10 from the W

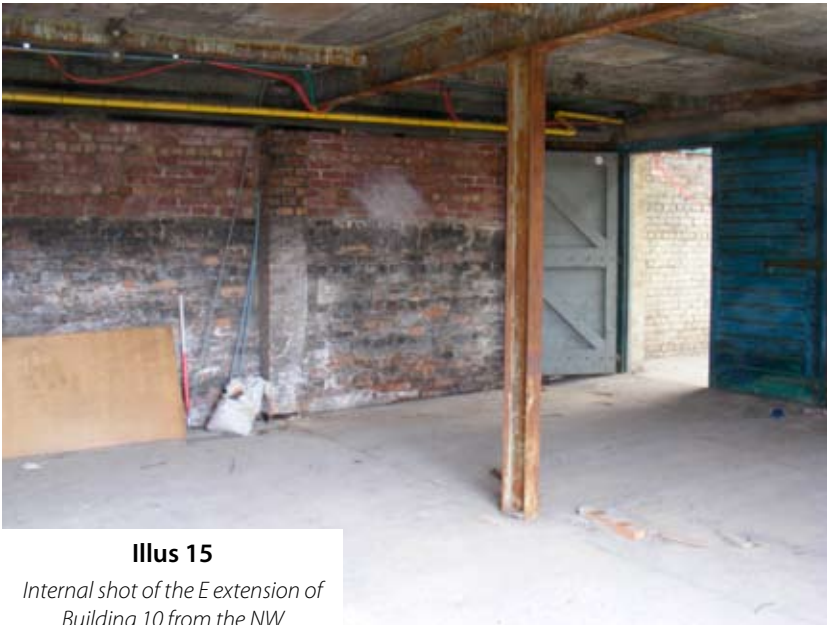
Illus 15

Internal shot of the E extension of Building 10 from the NW

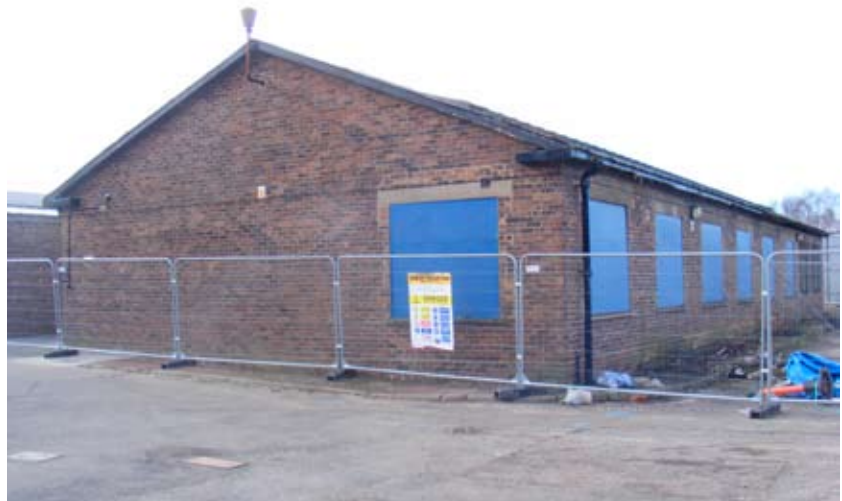
Illus 16

The final building at the north end of the development area was approximately 29m long forming a single storey gable ended brick building (Illus 16). It had a corrugated iron roof incorporating glass skylights along both pitches and timber skews along with painted timber eaves at the wall head. The brick walls were constructed in a stretcher bond on all four sides although a change in the type of brick used was recorded on both the north and south elevations with a clear construction line visible (Illus 17). It was unclear what this change in brick work represented.

General view of Building 11 from the NE

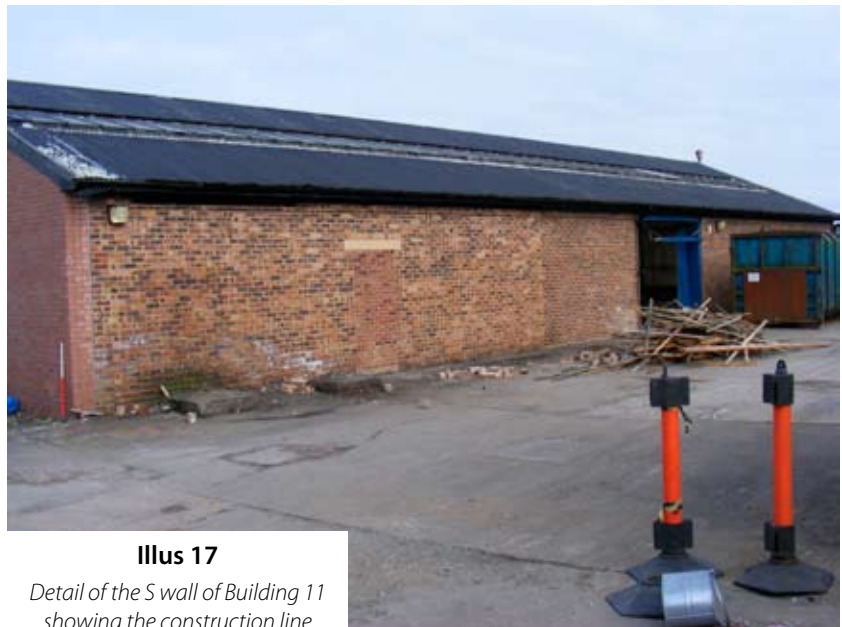
Illus 17

Detail of the S wall of Building 11 showing the construction line

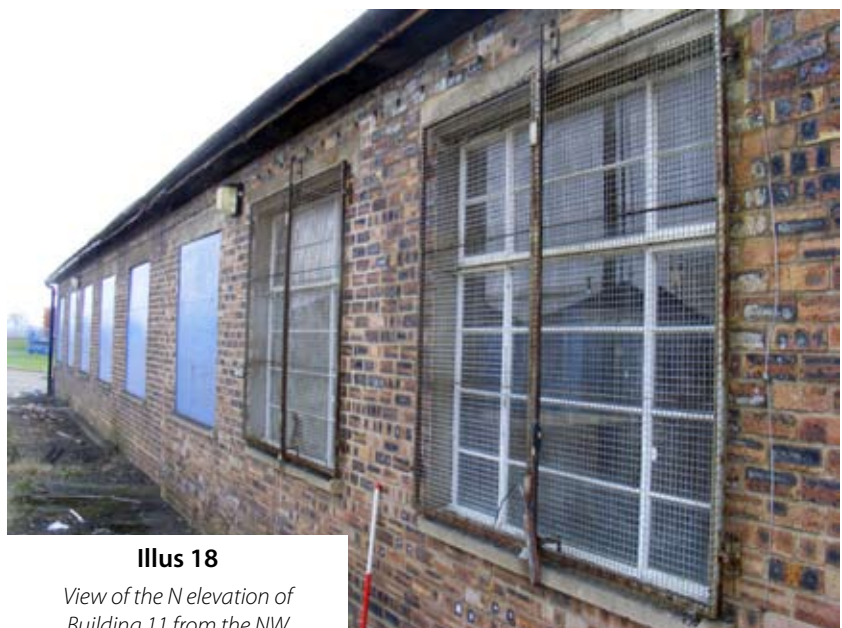
Illus 18

The north elevation included a series of eight casement windows although the windows only survived in the final two openings at the west end of the elevation (Illus 18), the remainder having been brick-blocked on the internal elevation. The south elevation included a large modern concertina door and a single timber door close to the east end. A second door at the west end of the elevation had been brick-blocked (see Illus 17). As with the north elevation a construction line was clearly visible showing two distinct brick styles. The east elevation included a single casement window that had subsequently been boarded-up (see Illus 16). The bricks in the window surround were a slightly different colour and suggest the window was a later phase insertion. The west elevation was a plain brick wall using modern bricks. The construction was the same as that found on the north elevation of the west extension to Building 10 and clearly represented a modern support wall constructed after the demolition of the original west end of Building 11.

View of the N elevation of Building 11 from the NW

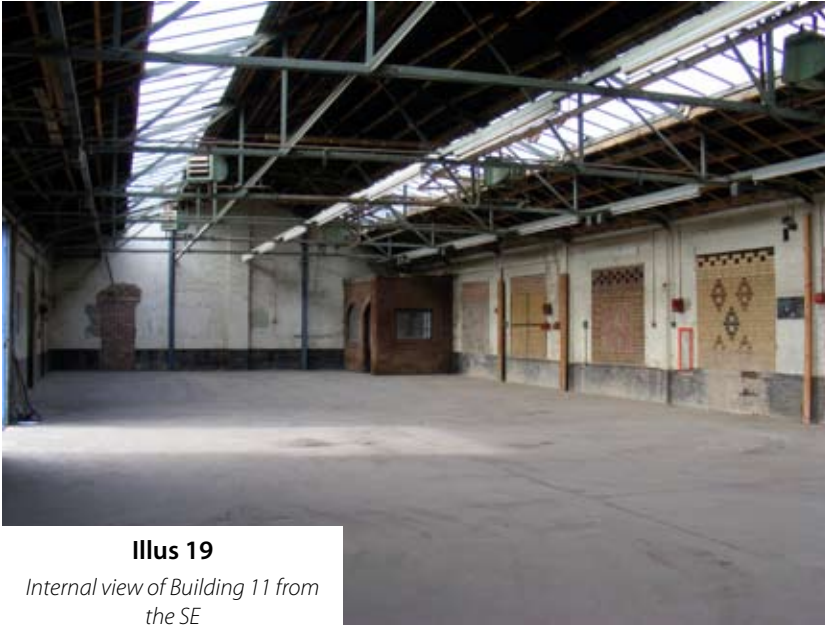
Illus 19

Building 11 had no internal dividing walls and formed a large warehouse space (Illus 19). It had a concrete floor and was open to the steel framed roof supported at the wall head by steel pillars embedded in the walls. All the windows on the north wall had been brick blocked with the blocking used to create a series of individual patterned brickwork forming a mosaic style decoration on the wall (Illus 20). The only internal structure was a small brick built office without a roof. This included a number of stylistic features that may represent a model blueprint that others could copy/learn. It is possible that the windows had been used as learning tools.

Internal view of Building 11 from the SE

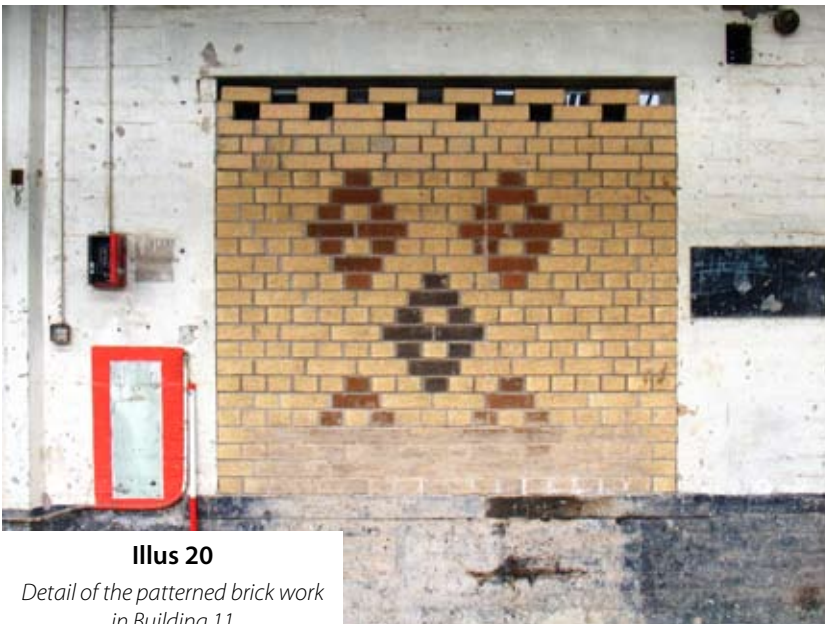
Illus 20

Detail of the patterned brick work in Building 11
