# HOPETOUN HOUSE BIOMASS

*Archaeological Monitoring  
for Hopetoun Renewables Ltd*

*0169/FUL/12*

*March 2013*

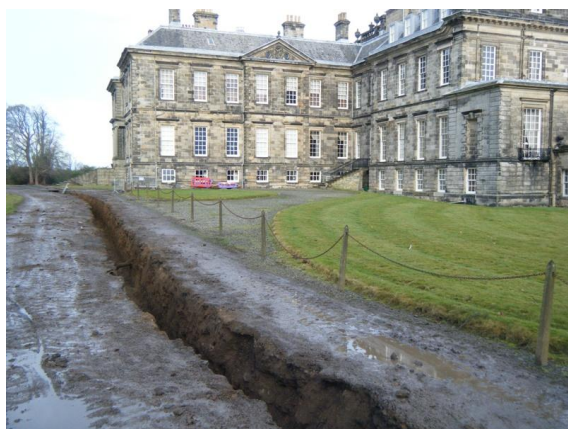
Illus 2: View of Trench 2 to the rear of Hopetoun House, facing north

The trenches ran from the north wing of the main house (the location of the existing boiler house) across the lawn to the rear (west) of the

house before continuing south along the gravel track to the rear of the house (Illus 2). As the trench reached the south end of the track it turned to the east running through the tree-lined gardens up to the buildings that form the farm complex, to the south-east of Hopetoun House. Immediately beyond the cottage that forms part of the farm the trench drops in level to the lower ground of the Silo, workshop and steading. The pipe trench ran to the north side of these buildings before turning to the south continuing along the line of the road leading to Byre loan cottage at the Hopetoun estate's south entrance. A number of smaller pipe trenches led off from the main line leading to the various occupied buildings on the estate.

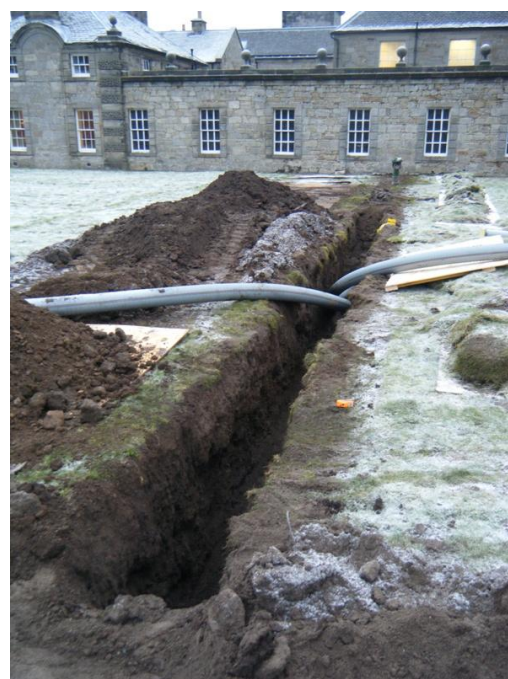
The initial trench (Trench 1) was aligned east/west running from the rear wall of the north wing of Hopetoun House across the lawn to the gravel road where it joined trench 2 (Illus 3).

The stratigraphy of this trench revealed up to 1m of topsoil over the geological subsoil. In this instance the topsoil comprised dark brown stoney sand and the subsoil was mid orange brown gravel. At the east end of the trench a stone-lined drainage feature (006) was encountered abutting the main rear wall of the north wing. This comprised a rectangular rubble stone constructed feature capped with squared worked stone. The drain

### Illus 3: View of Trench 1 from the west

was 1.3m wide and 1m deep projecting 0.4m from the wall face. At the base of the drain a channel ran through the wall leading to a short length of culvert on the east side of the wall (this was exposed in Trench 3).

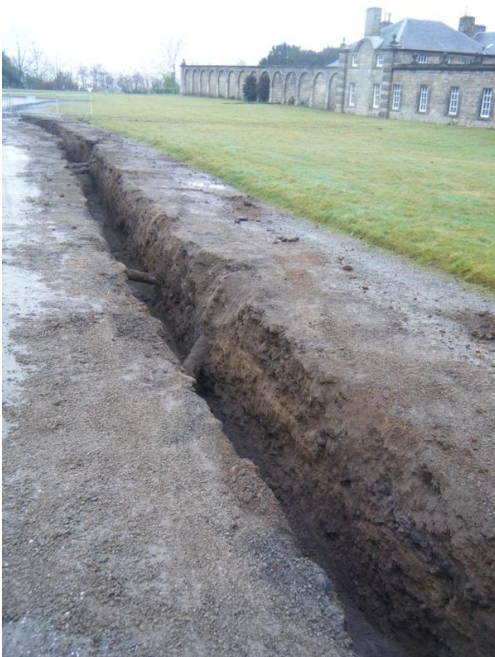
Trench 2 located to the north of Trench 1 ran from the west side of the north wing continuing across the lawn up to the gravel road gradually turning to the south and continuing along the line of the road (Illus 4). A slightly larger area was excavated where this trench linked up to Trench 1 for the insertion of a pipe joint. The stratigraphy of this trench was compatible with the results of Trench 1 with a 1m deep layer of topsoil overlying the geological subsoil.

Illus 4: View of Trench2 facing north

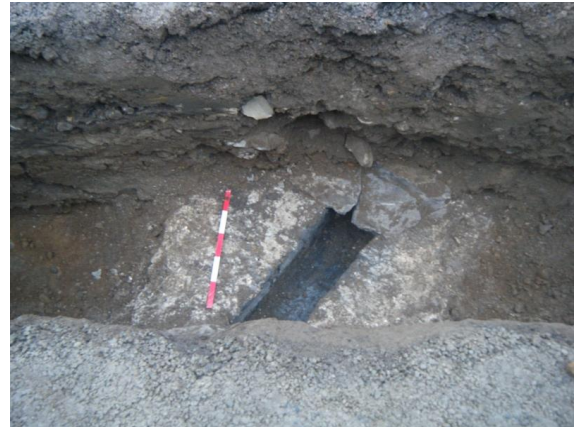
As Trench 2 reached the steps leading up to the rear entrance of the main house a stone-lined culvert (017) (Illus 5) aligned north-west/south-east was recorded 0.9m below the surface. The culvert had large stone caps covering a 0.2m wide stone-lined channel that cut into the geological subsoil.

Illus 5: View of culvert (017) from the west

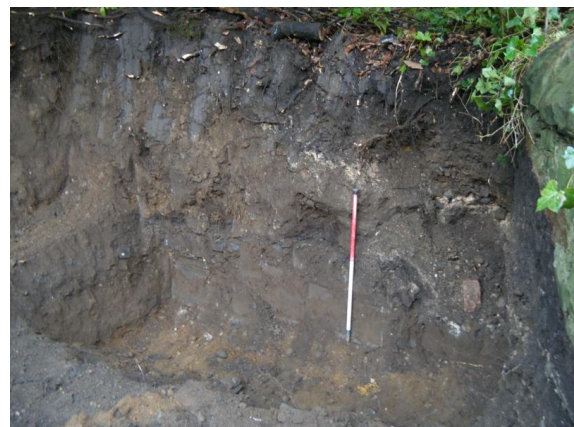
The trench ran north from a wall immediately east of the cottage turning sharply to the west across the front of the building. The ground to the east side of the cottage rose steeply resulting in the west facing trench section of Trench 4 being over 2m high exposing over 0.5m of topsoil (007) overlying 1.2m of made ground (008) (Illus 6).

Illus 6: View of the W facing section at the E end of Trench 4.

Within this layer were shallow lenses of lime mortar and small stones (009) suggesting this was re-deposited material. Below the made ground (008) a shallow layer of loose shale fragments (010) up to 0.1m thick was recorded. This material was only identified in the initial 5 m of the trench and was only seen in section.

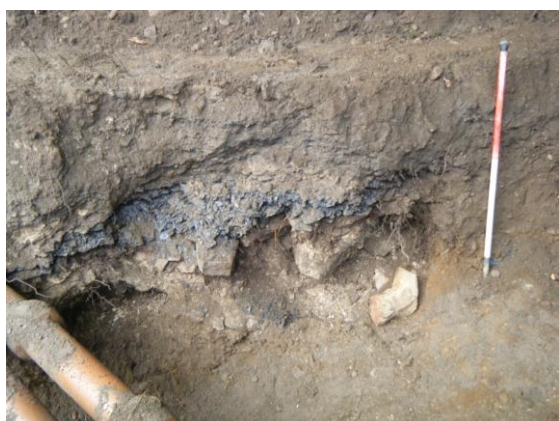
One of the most significant features recorded at east end of Trench 4 was a large amount of rubble stone (011) that may have formed part of a wall foundation (Illus 7).

Illus 7: View of foundation wall (011) from the south

Unfortunately this feature was predominantly exposed below a series of modern services so was difficult to record and interpret. The stones were bonded with a course of white lime mortar but very little structure was visible. The stones were mainly recorded in the south facing section of the trench forming a feature 2.8m wide and 0.5m tall, although the base of these stones was not exposed. The cut for these stones (012) cut through a layer of sandy garden soil (013) up to 0.6m thick recorded above the geological subsoil. The layer of shale (010) was particularly predominant above this stone feature and may represent a demolition phase.

The only enigmatic feature was the stone wall foundations recorded in Trench 4 to the north of the cottage. Unfortunately no dating evidence was recovered from this feature and its location below a number of service pipes made its identification difficult. The stone was only recorded in the south facing section of the trench suggesting whatever the stones represented they may survive in-situ to the north of the trench location.

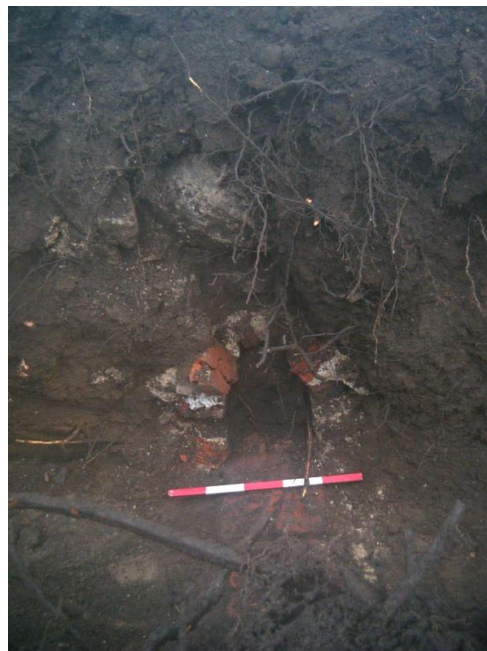
west end of the trench a small brick-lined drain (020) was recorded 0.7m below the surface cutting through geological subsoil (Illus 8). The drain was 0.5m wide and 0.6m high with a brick arched cover and brick base.

Illus 8: Detail of the brick-lined drain in Trench 4

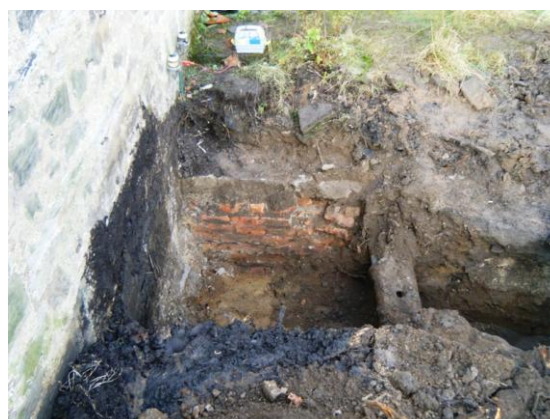
Trench 5 ran from a boiler house located on the south wing of the main house continuing south to link up with Trench 4. At the north end of the trench, as it abutted the east wall of the boiler house, the outer wall of a brick-lined culvert (021) was exposed in the south facing section (Illus 9). The culvert was capped with stone slabs.

Illus 9: View of south facing section at the north end of Trench 5 showing culvert 021.

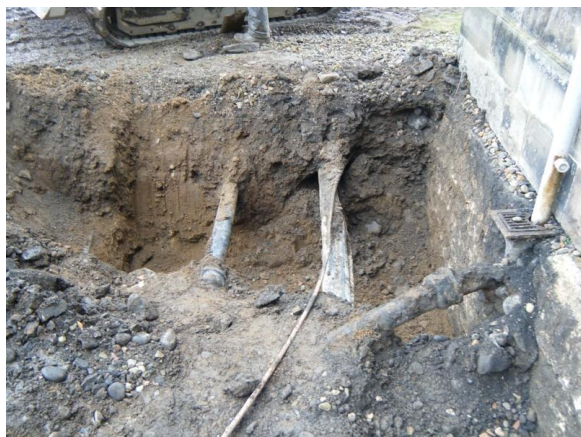
A very short trench (Trench 6; Illus 10) was monitored to the south of the rear entrance to Hopetoun House. This exposed a number of service pipes backfilled with sand.

Illus 10: East facing section of Trench 6
