FENROTHER WIND FARM, MORPETH, NORTHUMBERLAND

archaeological evaluation

for CgMs on behalf of EnergieKontor UK Ltd

May 2013

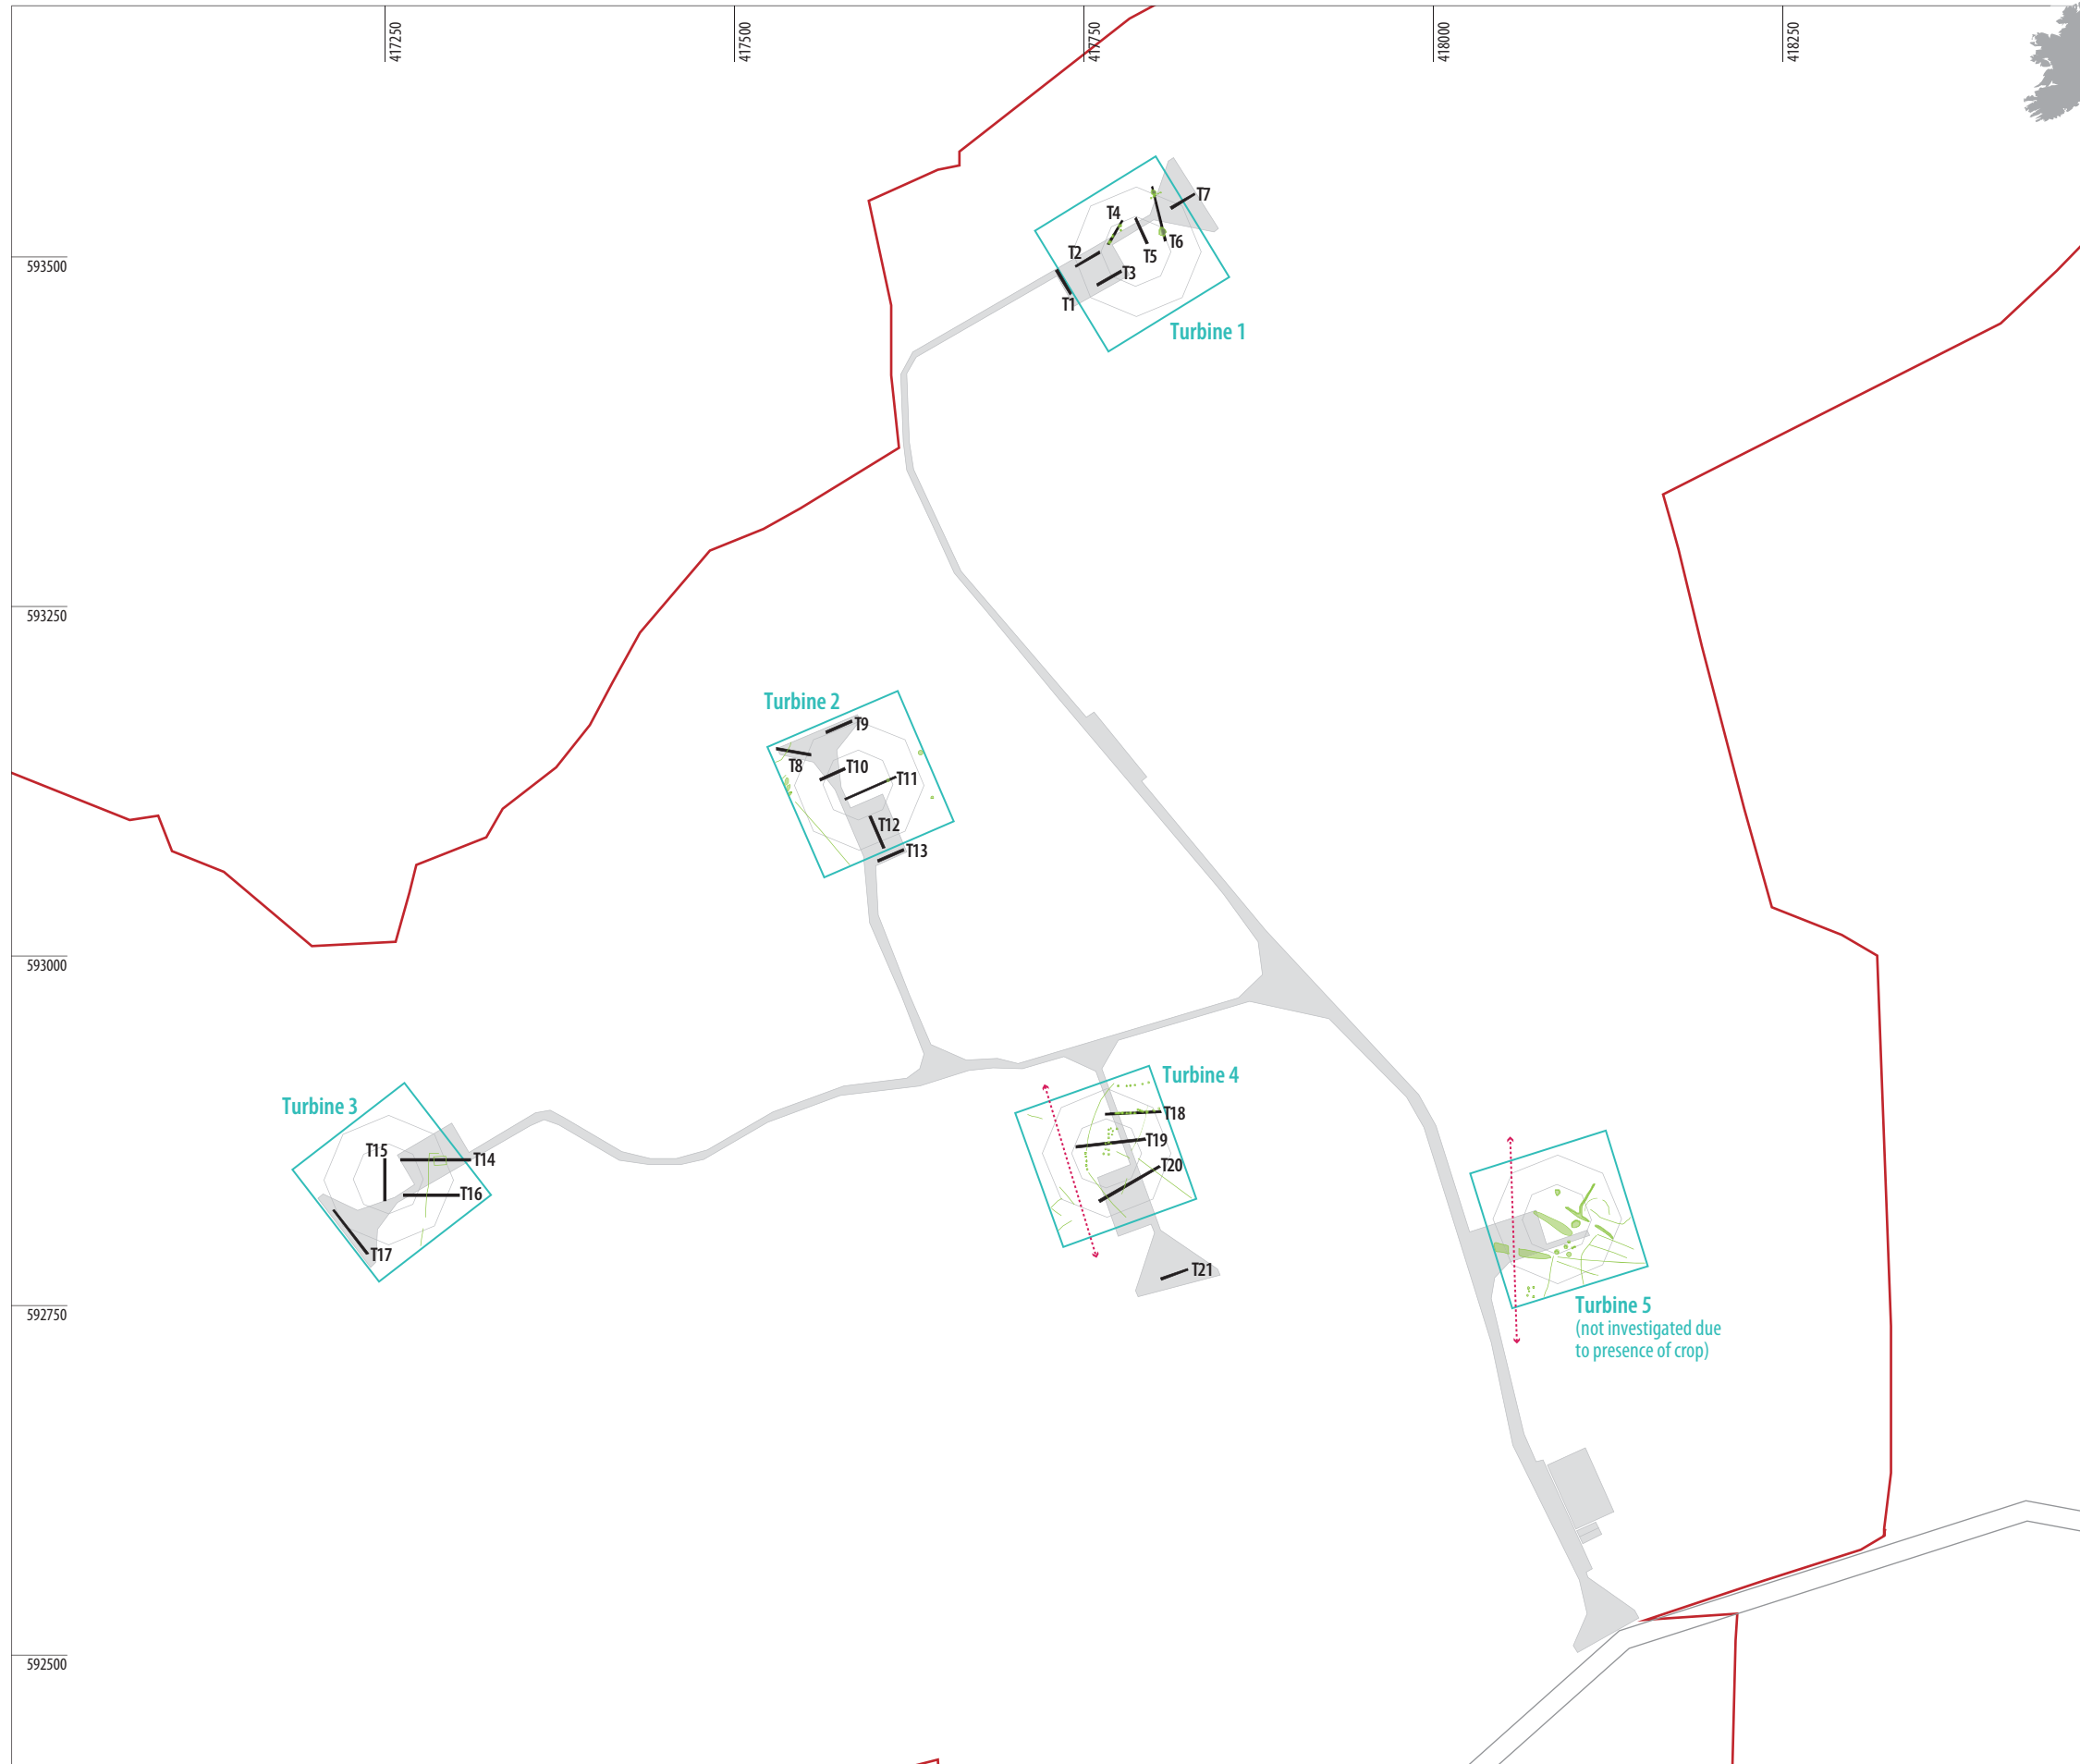
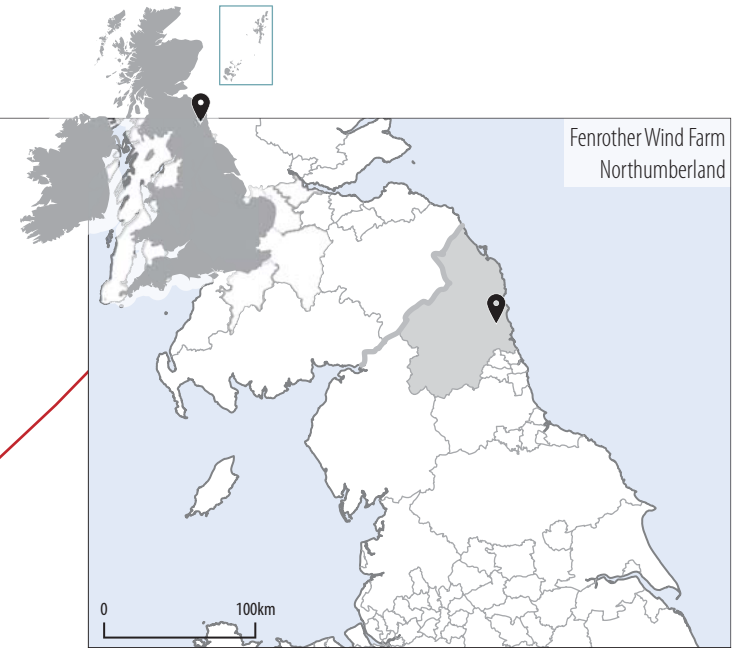
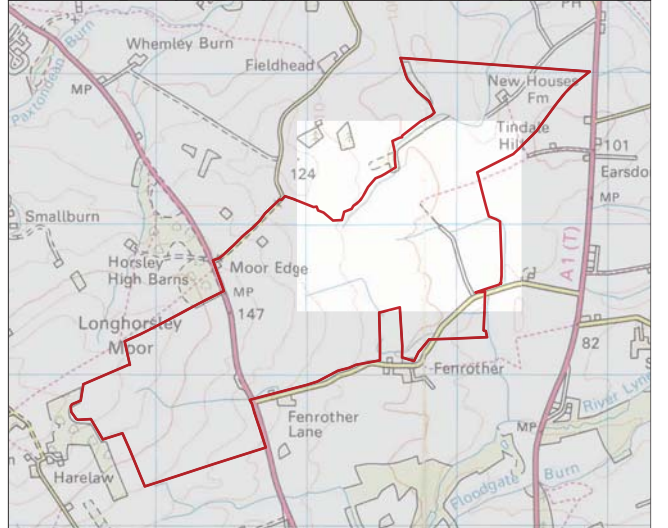
Illus 1
 Site location

A total of twenty-one trenches were excavated, over four turbine locations (Illus 1).

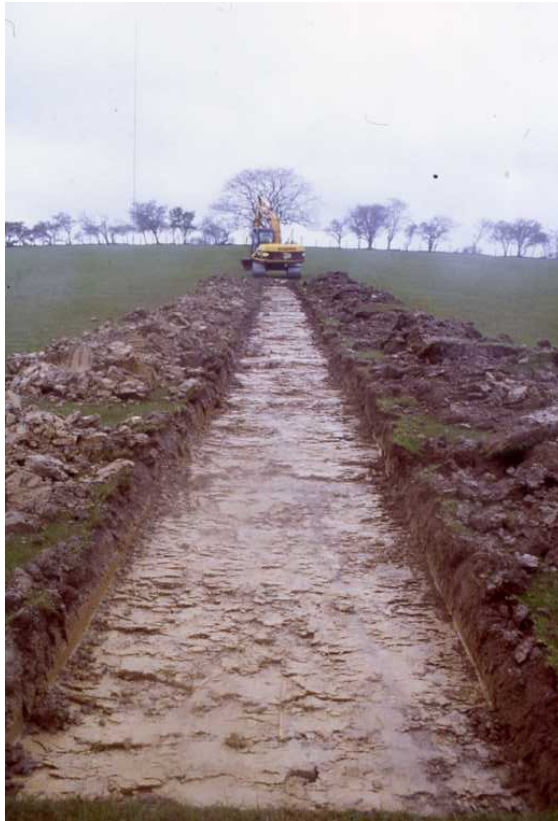
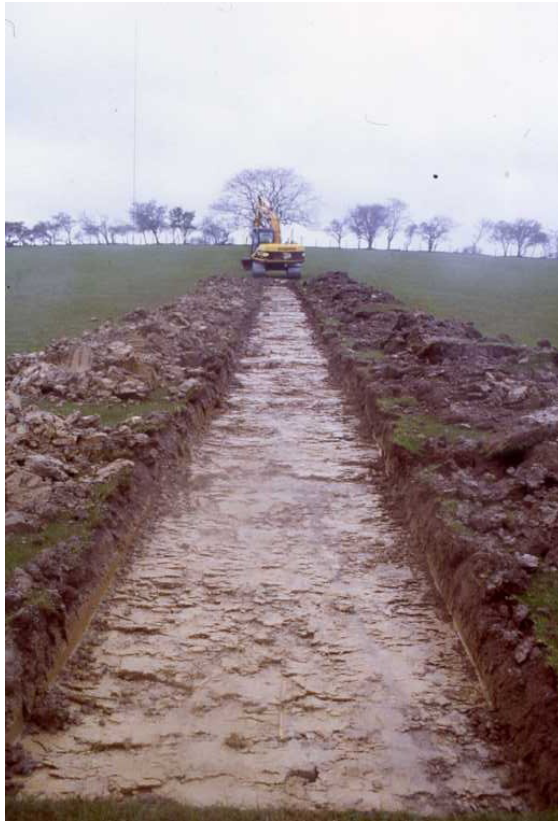
Illus 2

Turbine 2 was located in a field of pasture, on a slight east-facing slope. Two trenches (Trench 8 and Trench 11) were located over geophysical anomalies with the remainder spread across the extent of proposed construction. Across the field the topsoil was 0.3m deep and comprised a mid-light greyish brown clayey silt with occasional small stones. The natural subsoil was a yellow boulder clay (Illus 2).

View of Trench 11 at Turbine 2, looking south-west

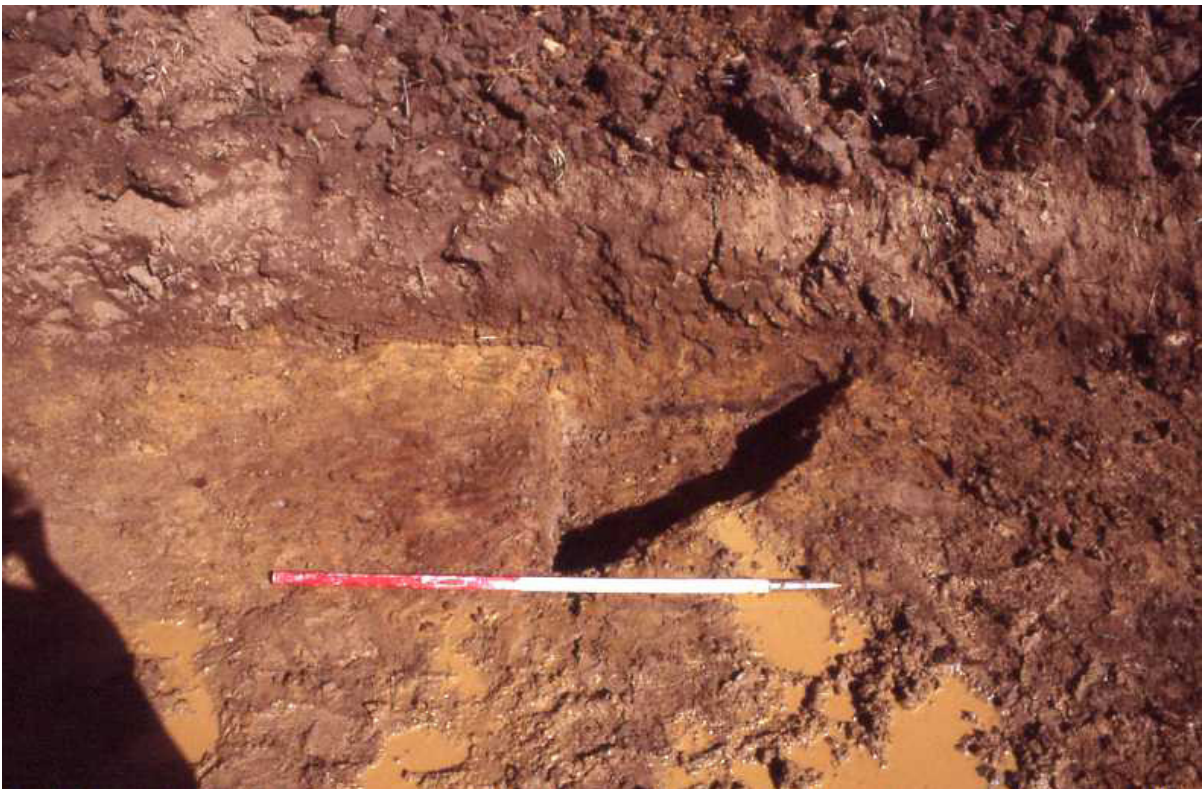
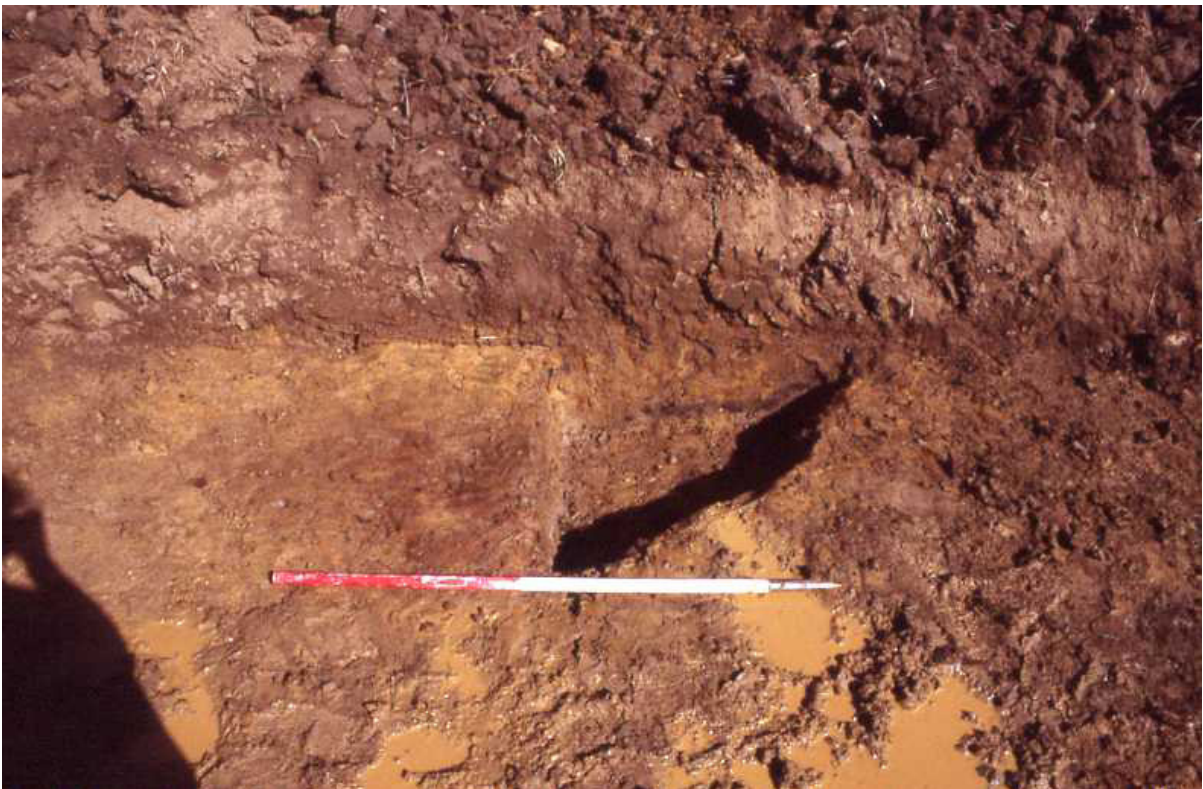
Illus 3

A number of possible features were identified during trenching and investigated. The majority of these possible features were found to be shallow pockets of topsoil in the natural subsoil. Some were shown to be field drains. One wide linear feature was identified at the west end of Trench 19, which matched up with a geophysical anomaly from the survey. A slot through the feature revealed it was a large field drain, running across the lowest part of the field which the other smaller drains presumably ran into. In Trench 21, a possible pit was investigated and proved to be a tree bole (Illus 3). No features or deposits of archaeological origin were identified at Turbine 4.

Shot of tree bole excavated in Trench 21, Turbine 4
