THIRD DON CROSSING

Archaeological Trial Trenching

commissioned by Aberdeen City Council

October 2013

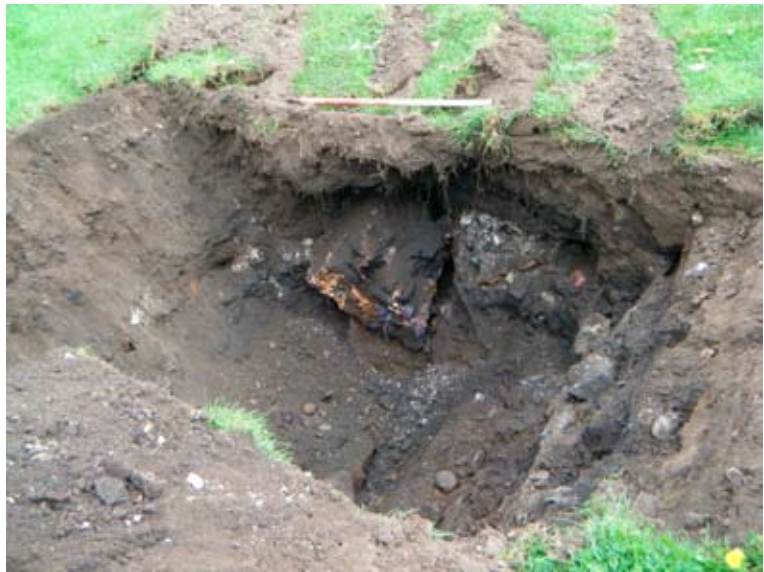
Illus 3

Made ground seen in Trench 24S. From the S

A total of 29 trenches were excavated (**Illus 1**). The three trenches on the south side of the river could not be fully excavated due to deep deposits of unstable made ground. These trenches were replaced by six trial pits located at each end of the trenches (**Illus 1**). The topsoil comprised grey brown sandy silts generally 0.2m to 0.3m thick. The underlying geological deposit on the north side of the river comprised mainly orange-brown gravels except for Trenches 19 to 21 on the flood plain next to the river which were located on alluvial sand. The area on the south side of the river contained dumped deposits over 2.2m deep in places (**Illus 3**).

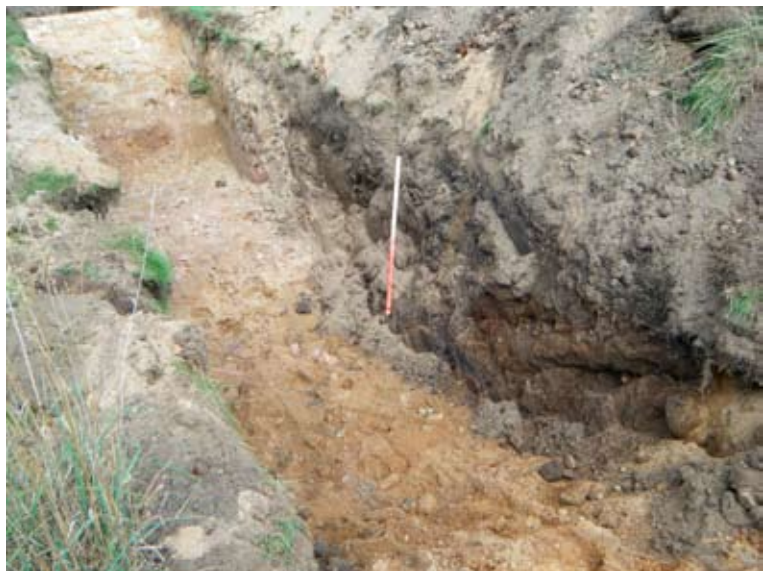
Illus 4

Section across ditch [01] in Trench 16. From the S-W

Ditch [01] was located in the northern half of Trench 16. It was aligned east to west and running along the edge of and parallel with a terrace along the south side of Balgownie Drive (**Illus 2**). The fill comprised loose dark gritty sand containing bands of clinker, bricks and other building debris indicating rapid backfill (**Illus 4**). The nature of the fill indicated that the ditch had been backfilled sometimes during the last two centuries.

The large ditch seen in Trenches 14 and 16, ([01]/[06]) had loose un-compacted fill containing industrial waste suggesting a fairly recent date. The shape and fill strongly indicates that the are both part of the same ditch running east to west along the front edge of a terrace before tuning down slope towards the south-west. The feature is not depicted on the early OS maps.

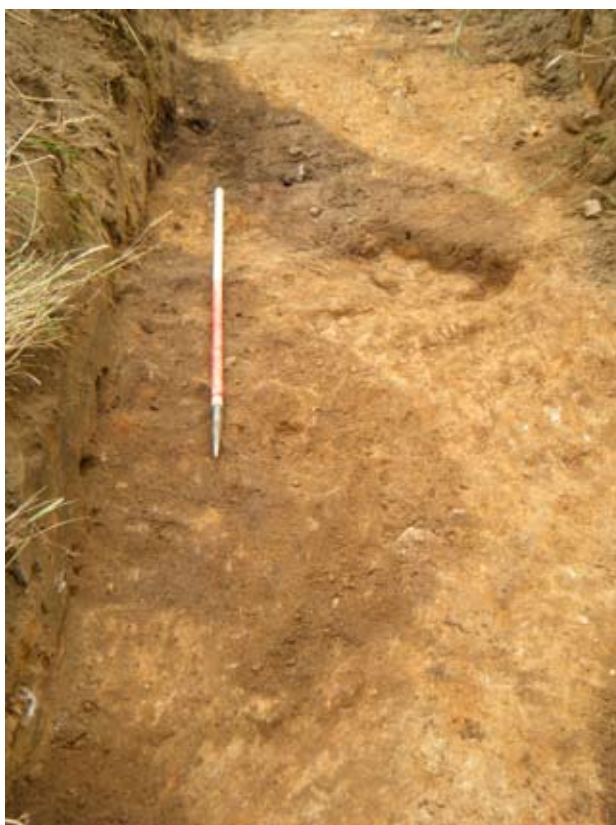
Illus 5

Gullies [13] and [15] in Trench 10. From the S-E

The eastern terminals of two shallow gullies [13] and [15] were exposed towards the north-western end of Trench 10 (**Illus 2, 5**). They were both aligned east to west and terminated at the same point. [13] to the north was 0.55m wide by 0.08m deep and extended 2m into the trench. Gully [15] to the south was 0.72m wide, only 0.02m deep and extended 1.6m into the trench. The alignment and position of the two gullies indicates that they are contemporary and probably linked.

The two gullies [13] and [15] in Trench 10 were both less than 0.08m deep. Although very shallow, the gully terminals were well defined indicating that they are the base of cut features and not a result of undulating sub-soil. The fill of the features was very similar to the overlying soil, which may indicate that the features are recent; possibly related to the nearby orchard.

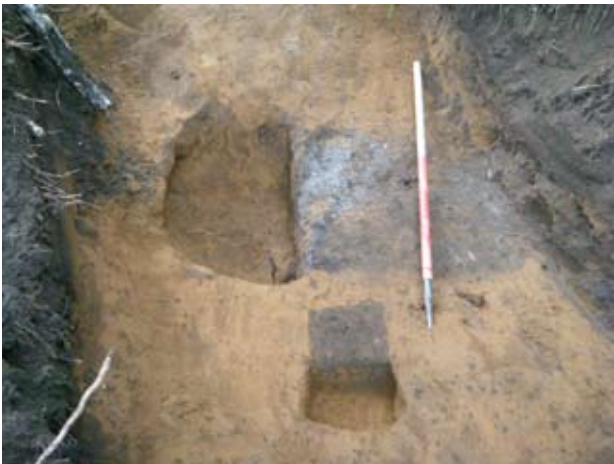
Illus 6

Pits [18] and [20] in Trench 19. From the S-E

Two pits [18] and [20] were uncovered in the north-western part of Trench 19 (**Illus 1, Inset 4**). [18] was an oval pit aligned north-east to south-west, 0.6m wide by 1.2m long and 0.25m deep. Immediately to the south-east edge of [18], [20] was a smaller rectangular pit located 0.2m to the southeast measuring 0.4m long by 0.2m wide and 0.12m deep (**Illus 6**). This pit was aligned north-west to south-east at right angles to the larger pit. Both pits were filled with dark grey gritty sand containing black clinker, mortar and coal fragments, very similar to the overlying made ground that covered the north western part of Trench 19. The fill indicates that the pits are likely to date to the 19th or early 20th century.

The two pits uncovered in Trench 19, were both filled with similar material: Soft grey brown gritty sand containing black clinker,

fragments of mortar, coal and slag. The fill is similar to a layer of made ground that cover the feature and the north-west end of the trench. It is likely to represent demolition debris or waste from industrial complex in the vicinity.

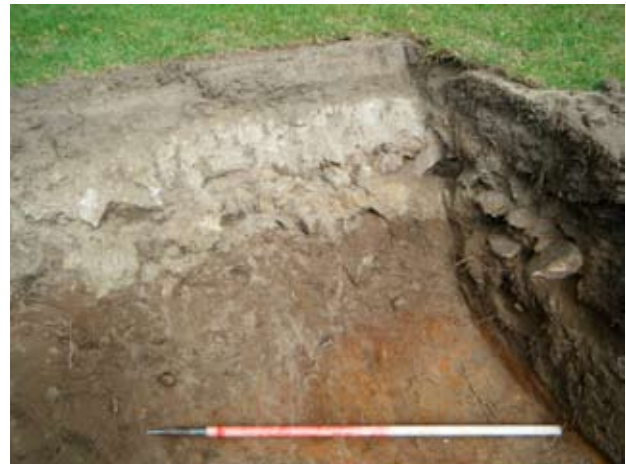
Illus 7

Path foundations [17] at northwest end of Trench 6. From the S-W

The edge of stony foundations for a garden path, [17], was uncovered at the northern end of Trench 6 (**Illus 1, Inset 2**). The foundations were up to 0.4m thick and comprised sub-angular stones, 0.05m to 0.3m across, in a matrix of pale orange clay (**Illus 7**). The foundations extended 0.9m into the north end of the trench.

The foundation of a garden path, [17] was uncovered at the north end of Trench 6 inside the 18th century walled garden at Danestone. The line of the path had been recoded as a linear anomaly during a geophysical survey of the corridor in 2012 (Bartlett & Boucher 2012). The landowner Alexander Gordon remembered seeing the path before it was covered over to create a lawn in the western half of the walled garden.
