# FORMER HEXHAM SWIMMING POOL, GILESGATE, HEXHAM, NORTHUMBERLAND

*Archaeological Evaluation*

*commissioned by CgMs on behalf of McCarthy and Stone*

November 2013

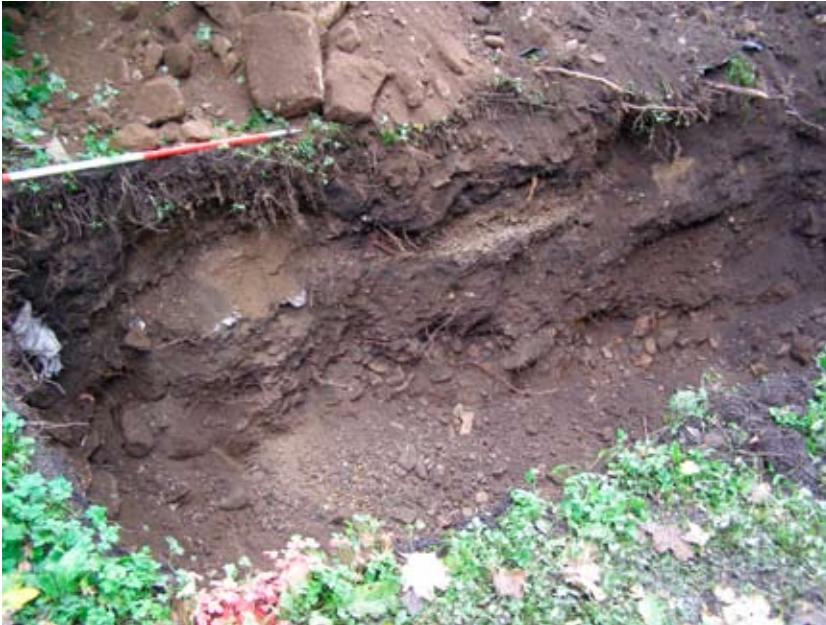
**Illus 2**

*SE-facing section of Trench 1*

Trench 1 (Illus 2) contained a 0.2m thick deposit of topsoil (101), overlying a 0.8m thick, loose loam (102) containing ash and gravel. Inclusions of modern pot, glass, plastic, indicate that it has been disturbed relatively recently and it is interpreted as a garden soil.

A 0.3m thick deposit of silty clay (103) interpreted as colluvium underlay the loam (102) and contained a small amount of animal bone (not retained). Geological sands and gravels were encountered at a depth of 39.7m OD.

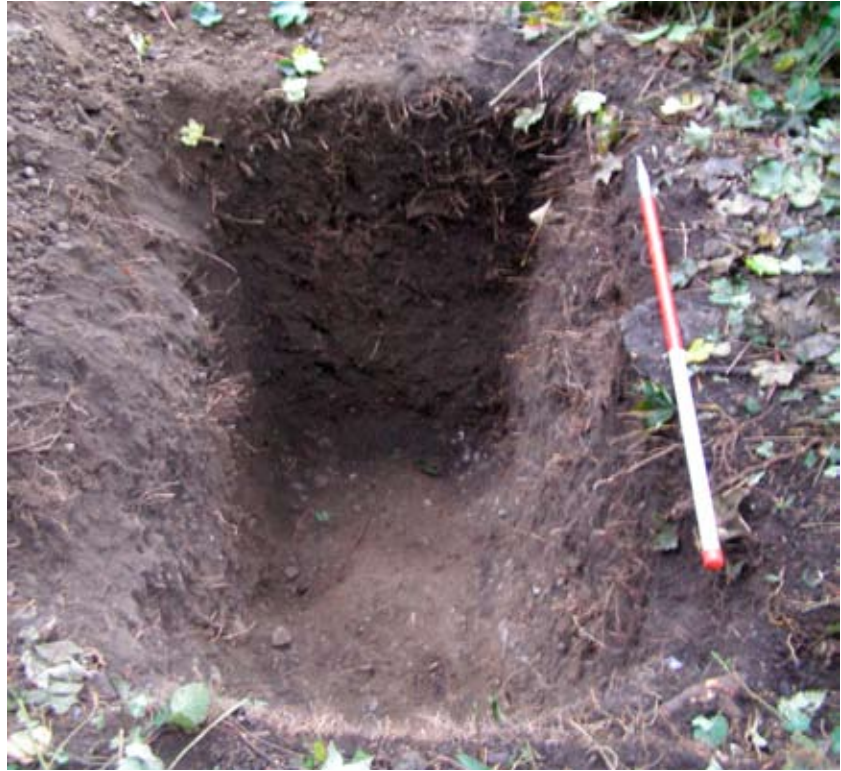
**Illus 3**

Trench 2 (Illus 3) contained a 0.9m thick deposit of dark grey brown sandy silt (201) containing inclusions of pottery, glass and animal bone, which was interpreted as garden soil. This overlay a 0.2m thick deposit of sandy silt (202) containing fragments of mortar, pottery and brick. Underlying these deposits was light brown silt clay (203). The full thickness of this deposit was not established as excavation was terminated at 43.3m OD when the trench reached a maximum safe working depth of 1.2m.

*SW-facing section of Trench 2 at limit of excavation*

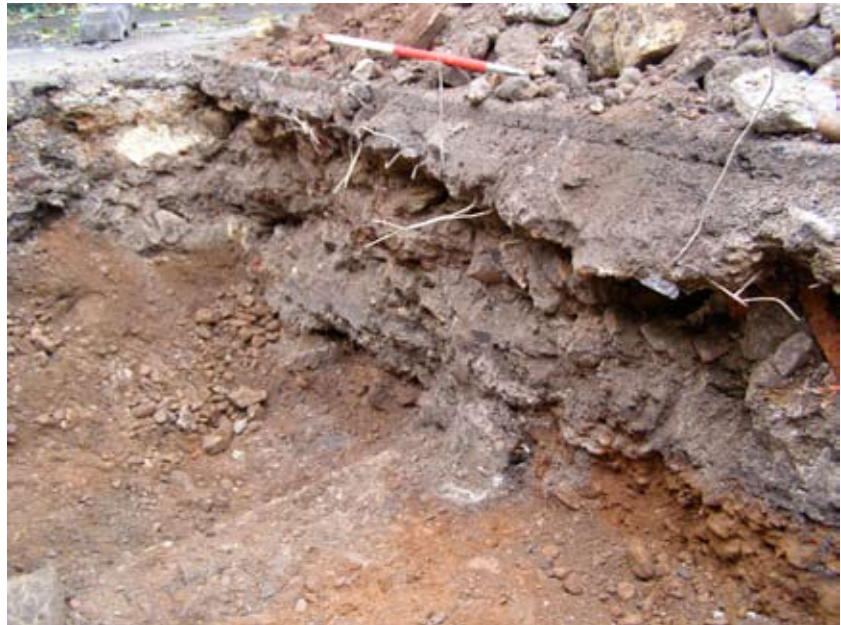
**Illus 4**

Trench 3 (Illus 4) had upper deposits of tarmac (300) and concrete (301) which were 0.05m and 0.07m thick respectively. These overlay a 0.4m thick deposit of sand and gravel (302) with frequent inclusions of red and yellow brick; this was interpreted as a deliberate dump or 'made ground'. This overlay a mixed deposit containing ash, brown sand, white/grey chalk sand clay (303) 0.4m thick, also interpreted as a deliberate dump of made ground.

A sandstone foundation [305], aligned north-west to south-east and 0.45m in width, was revealed in the north-east end of Trench 3.

It was cut into geological sand and gravel (304) (at 48.5m OD) to the south-west (Illus 4). To the north-east of the foundation, mixed mid brown orange gravels (307) containing modern pottery sherds was present. This deposit is interpreted as relating to either the backfilling or levelling of a potential cellar.

*NW-facing section of Trench 3 and wall foundation [305]*

Cartographic evidence shows the DA was occupied by buildings from at least the mid 19th century onwards (Wood 1862 in CgMs 2013). The foundation found in Trench 3 [305] is presumed to relate to one of the buildings on the site at this time as its position and orientation is consistent with those shown on Wood's map. These buildings (still on the same alignment) are apparent on the Ordnance Survey Map of 1896 but by the Ordnance Survey Map of 1963 had been cleared. This indicates that the levelling of the area now occupied by the car park took place between these dates.

A foundation, dating to at least the early 19th century, was the only feature recorded during the evaluation that is regarded as having archaeological significance. The wall is assessed as having local importance and low sensitivity.
