## 3-9 DUFF STREET, ABERDEEN

*Archaeological Evaluation*

*commissioned by Tulloch Homes*

March 2008

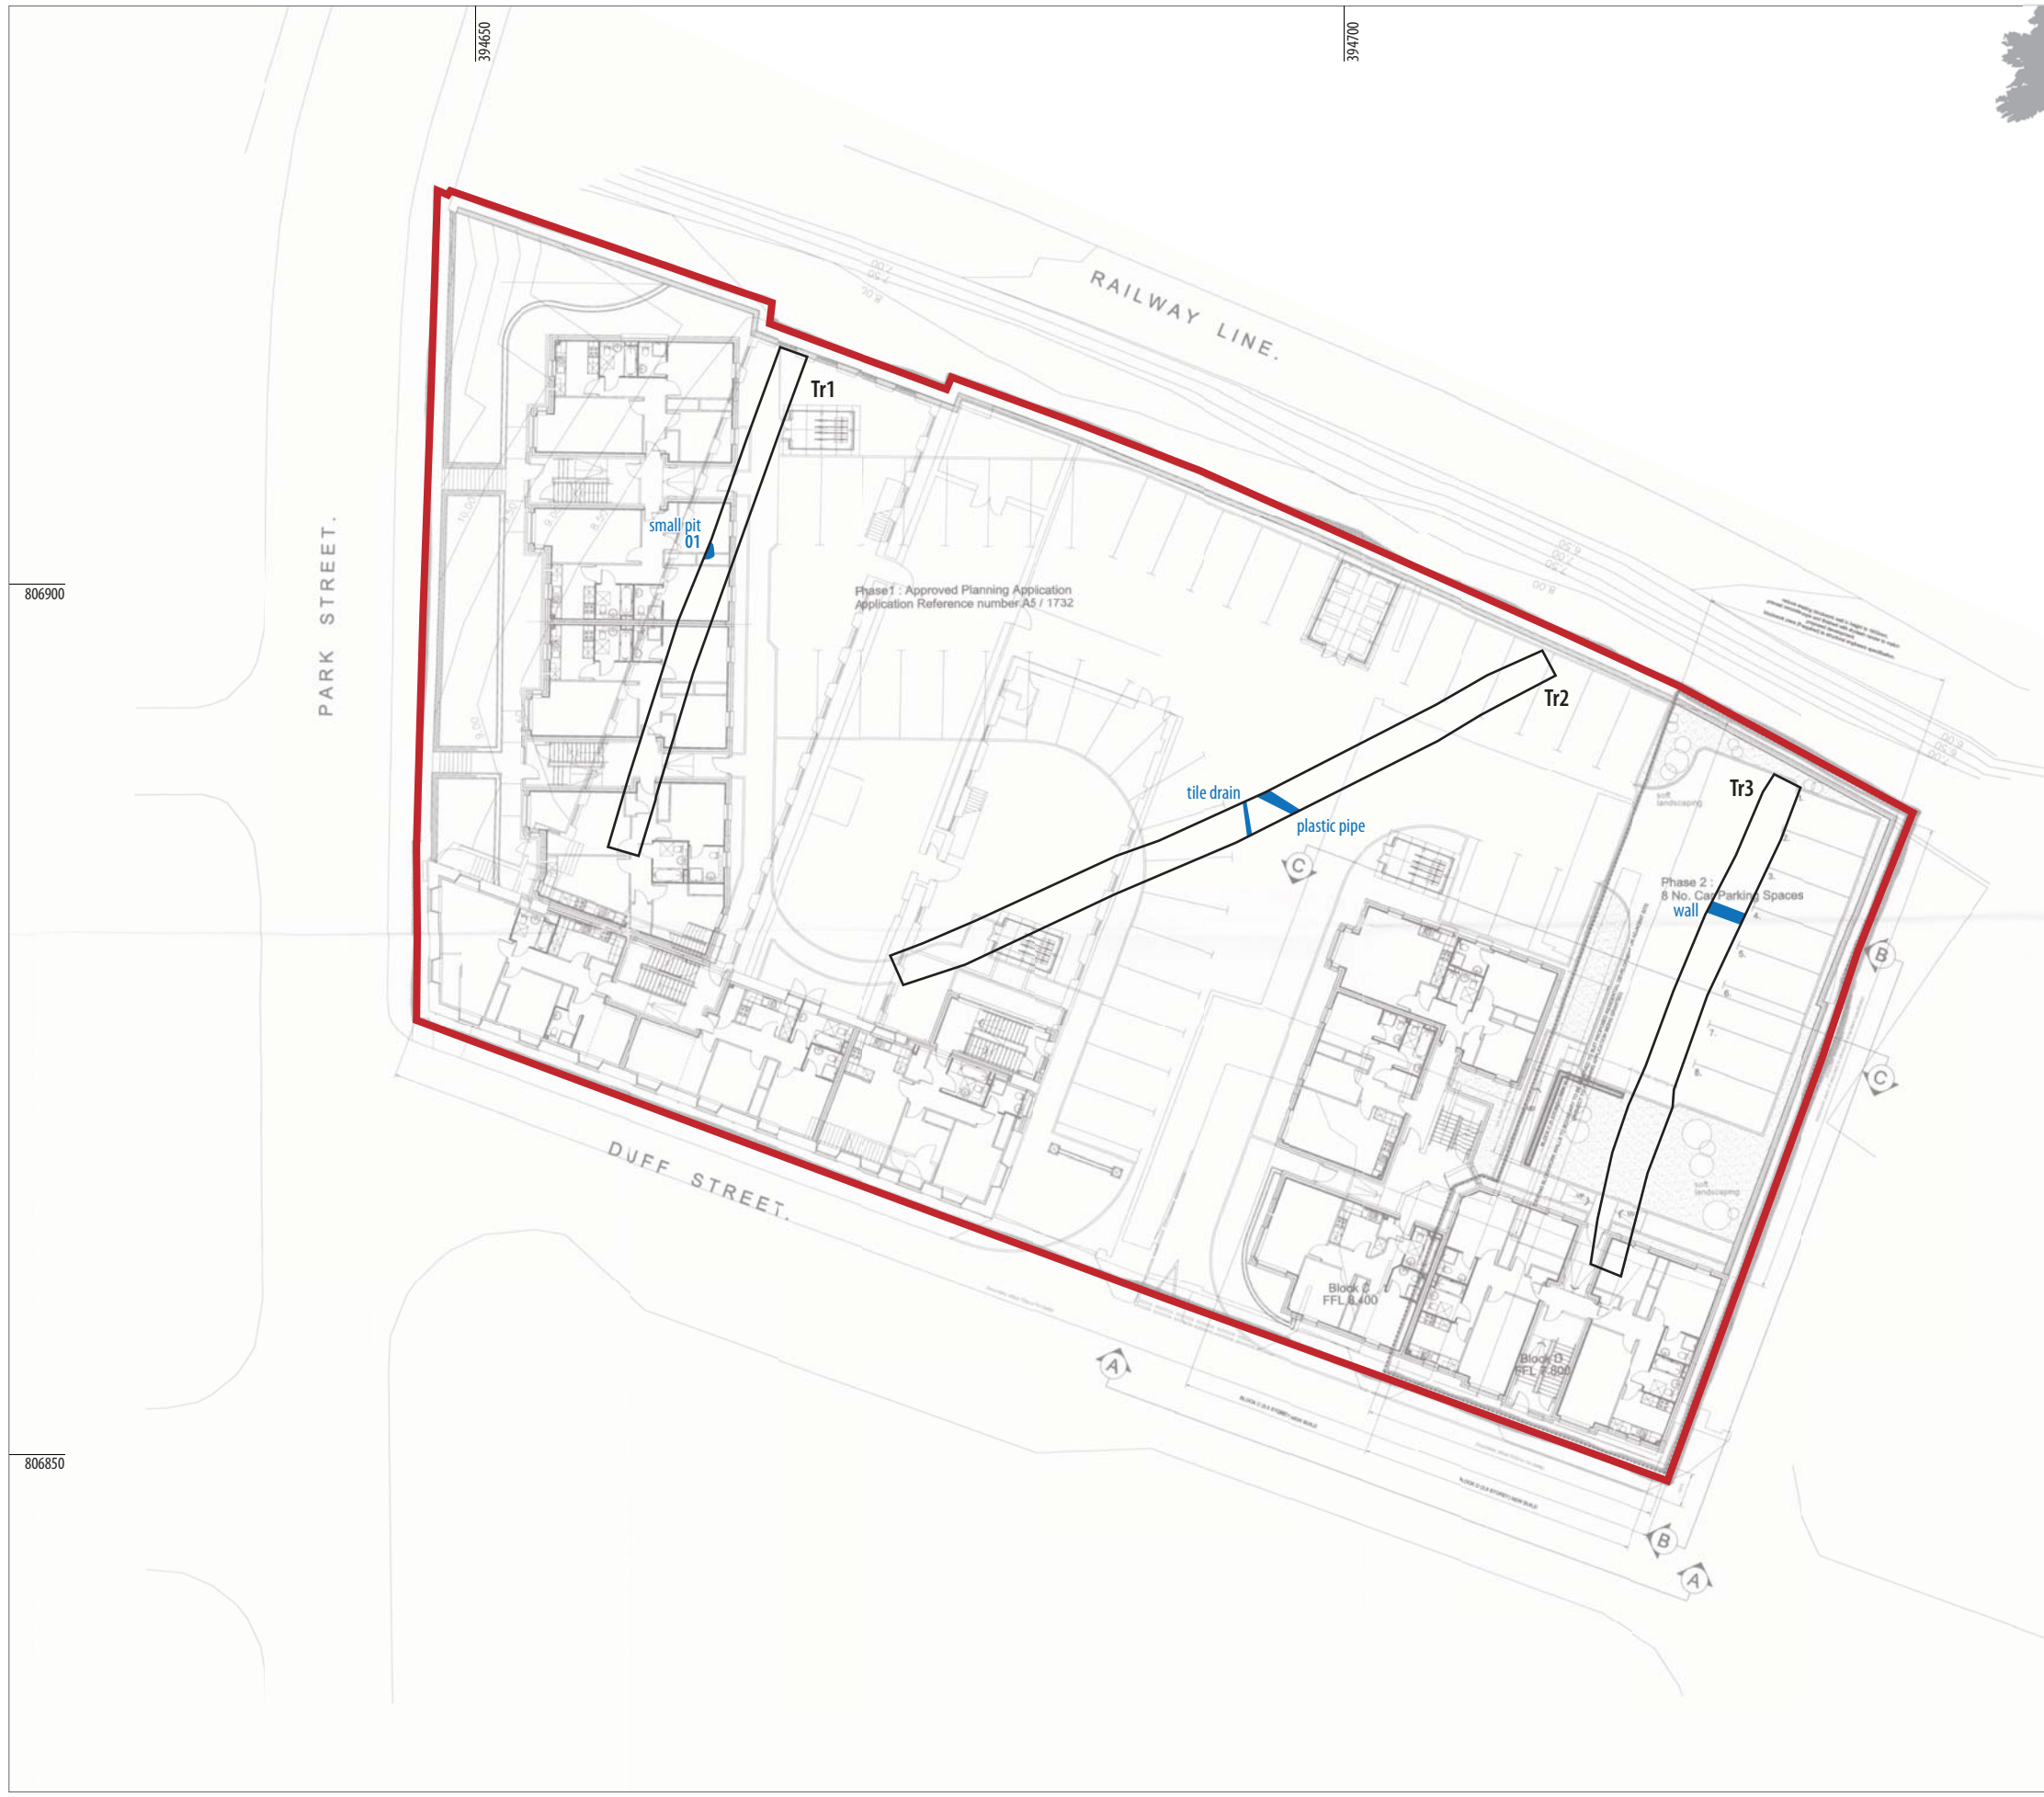
**Illus 1**  
Site location

The proposed development covers an area of approximately 0.37ha. It is bounded to the north by a railway line leading south to the Regent Quay at the harbour, to the west by Park Street and to the south by Duff Street (**Illus 1**).

Three trenches were excavated (**Illus 1**). Prior to the works all buildings on the site had been demolished and the ground levelled. In Trench 1 a deposit of dark brown humic soil (03) 0.5m to 0.9m thick was encountered. The deposit was largely undisturbed by the construction and demolition of buildings in the area, with the exception of the south end where it was covered by a demolition deposit up to 0.4m thick (04).

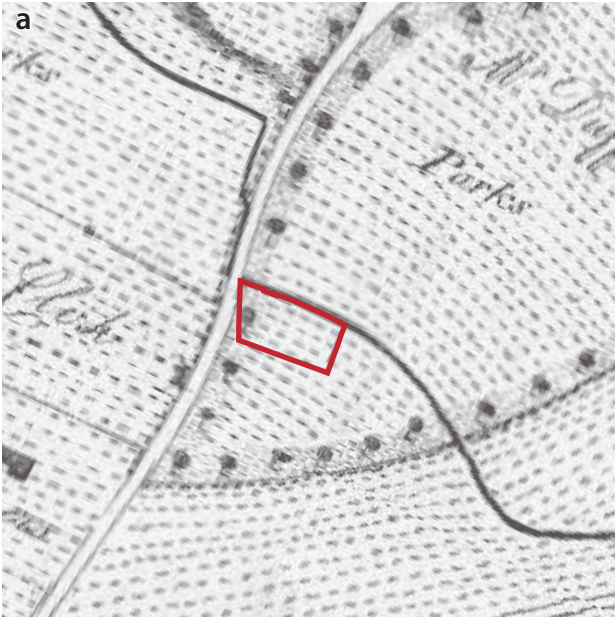
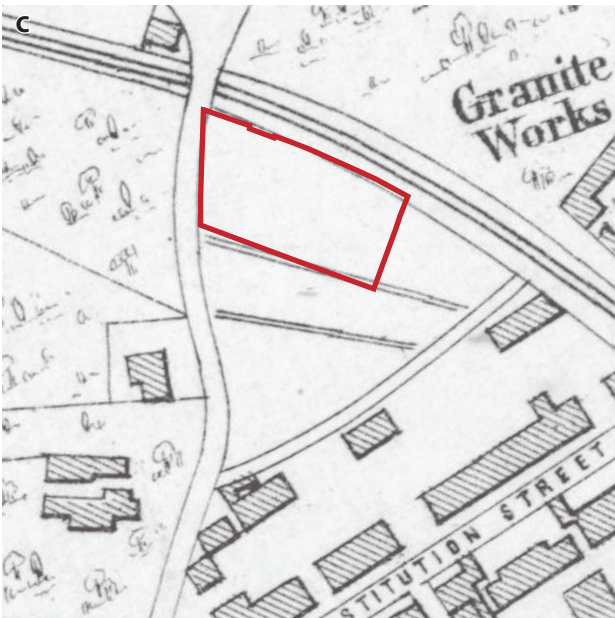
**Illus 2**

On Keith and Gibb's map published in 1862 (**Illus 2c**) the canal has been replaced by a railway line. The map shows two parallel lines cutting across the area probably depicting narrow paths within the *allotment* area. The southern path is roughly in line with the future Duff Street.

The first edition OS map surveyed in 1866 shows the area in great detail (**Illus 2d**). A narrow path along the line of the future Duff Street leads into the area from Park Street to the west with regular

Old maps of the area

The development of the site is illustrated through a series of historical maps of this area (**Illus 2**). On Milne's map from 1789 (**Illus 2a**) the site lies at the south end of a triangular field bounded by a line of trees and labelled *Mr Duffs Parks*. The Park Road runs up along the west side of the field and the *Fow Creek* cut across the southern end of the field. Constitution Street lies to the south-east of the site. It runs towards the north-east parallel with the eastern boundary of Mr Duffs land.

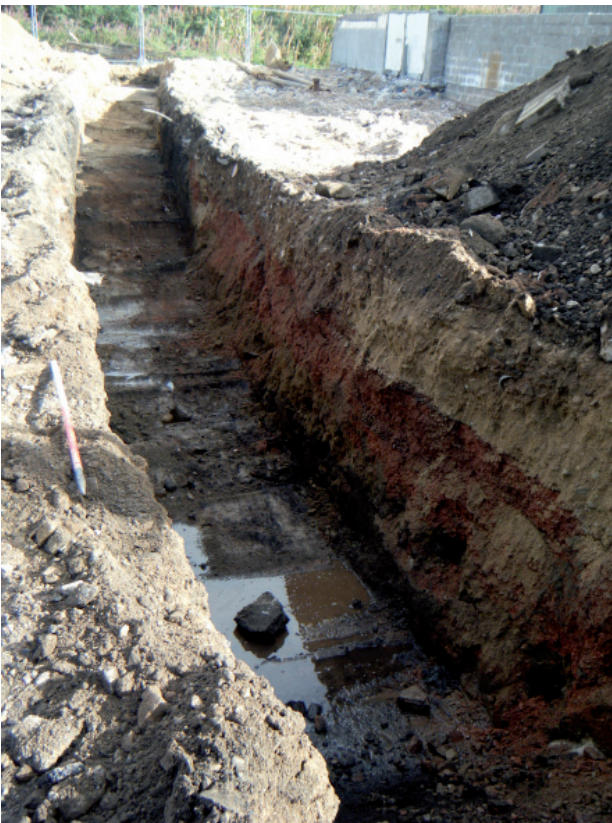
**Illus 4**  
*Deep demolition deposits in W-facing section at the south end of the Trench 3. From SW*

The deposits in the two trenches to the east (Trenches 2 and 3) comprised demolition rubble (04) mixed with gravels and sand generally 0.2m to 1m thick, with a deeper area 1.8m thick located at the south end of Trench 3 (**Illus 4**). A modern concrete wall foundation 0.8m wide and 0.25m deep, aligned parallel with Duff Street cut across the north half of Trench 3 (**Illus 5**).

The results of the evaluation suggest that most of the eastern half of the site has been heavily disturbed by the construction and demolition of buildings on site over the last 130 years. The deep disturbance seen at the south end of Trench 3 might indicate that there had been cellars or possibly a buried tank in this area.

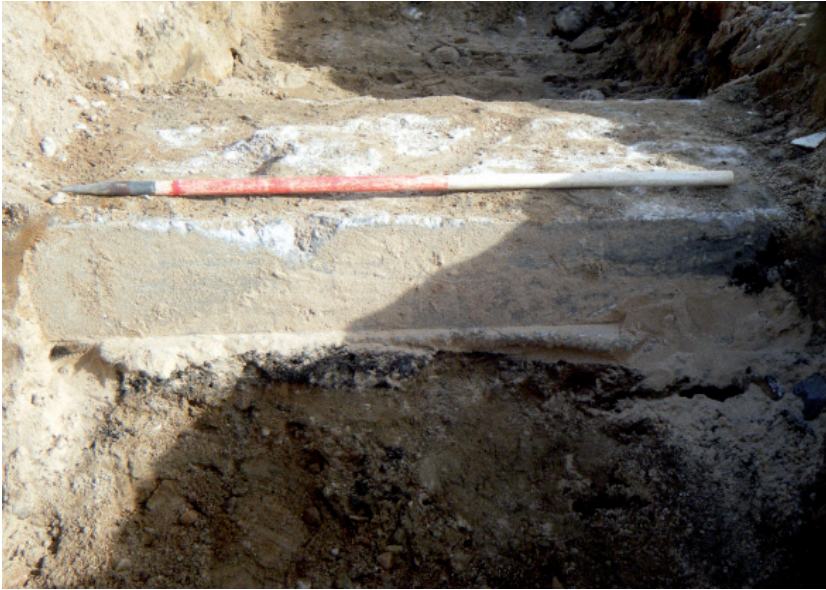
**Illus 5**

*Concrete wall foundation in north half of Trench 3. From NE*
