## SOUTHBANK ROAD KIRKINTILLOCH

*Historic Building Recording and Archaeological Monitoring  
for Ogilvie Homes Ltd*

*January 2014*

HA Job no.:	SKED12
HAS no.:	002
NGR:	NS 6544 7367
Parish:	Kirkintilloch
Council:	East Dunbartonshire
OASIS ref.:	headland1-165618
SMR no.:	N/A.
Archive will be deposited with:	RCAHMS

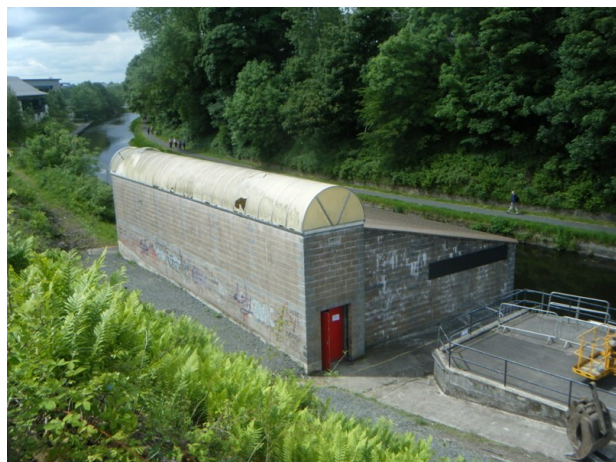
The construction of the brick built boatshed was typical of the period with a corrugated plastic curved roof head. The shed covered a small dry dock that was left in-situ and was not affected by the development.

Illus 3: View of the boatshed from the SW

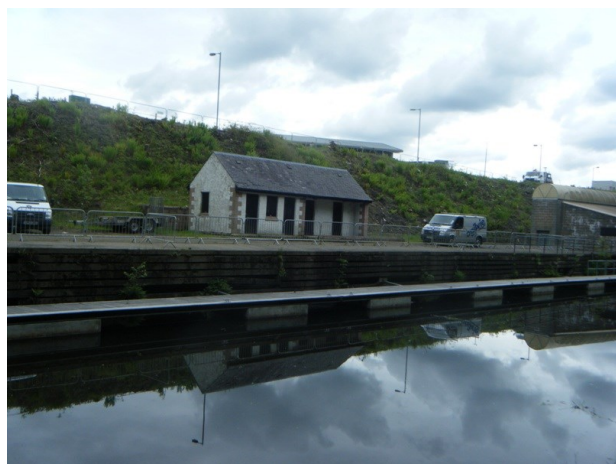
Immediately to the south of the boatshed was a modern pontoon. A small brick constructed utility building was located further to the south. This single storey building had been constructed in the 1990's for the use of the canal boaters. Its demolition provided an opportunity to see if any features of the earlier boatyard survived below its foundations. Unfortunately no earlier features were recorded during the monitoring of this work.

Illus 4: View of the amenities building from the opposite canal bank.

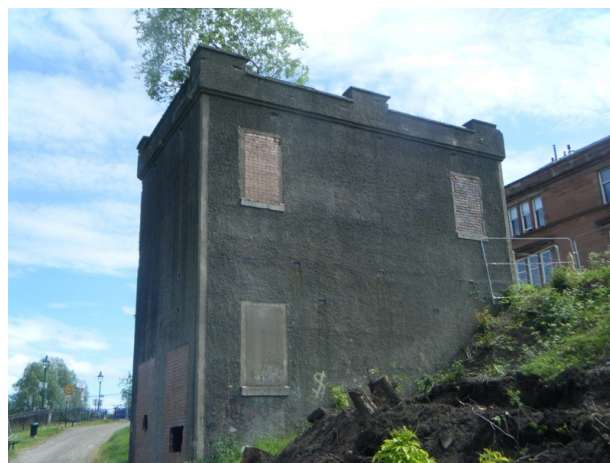
The utilities building recorded comprised a large brick built structure that had been marked as a substation on the 1938 OS. The building was cut into the bank providing two levels with an upper floor servicing the street level and a lower floor servicing the canal side towpath. The building had clearly been constructed to form an interesting structure along the canal side with its raised castellated pediment. The demolition of this

building failed to provide any clues as to its original purpose. What it did show was that the brick foundations cut into the bank to the level of the canal towpath.

Illus 5: View of the utilities substation from the NE

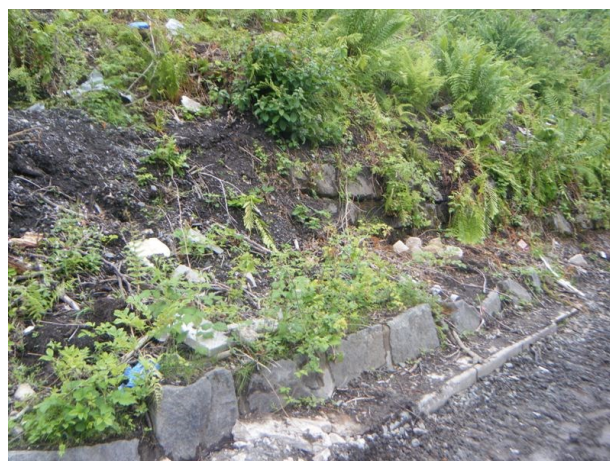
A substantial earthen bank formed the boundary between the street level and the canal basin. Removal of the vegetation across the bank was monitored in order to identify any features of interest. The main feature evident was the stone revetment wall at the base of the bank. This comprised of several courses of large un-bonded granite stones. An earlier inspection of the site had initially identified these stones as representing the foundations to an earlier boathouse, but they were clearly just supporting the bank.

Illus 6: View of the revetment stones at the base of the bank.

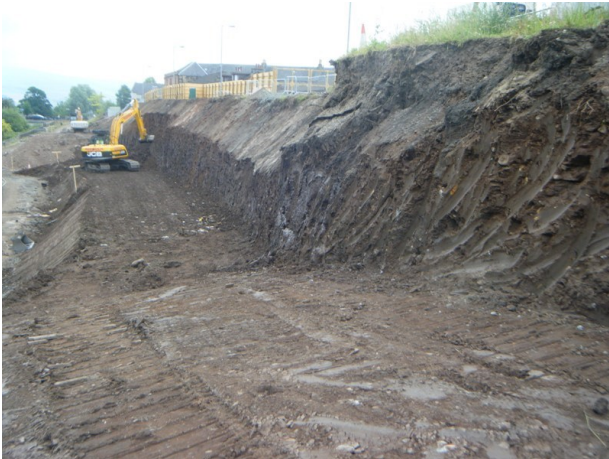
The exposed sections through the embankment indicated that the material at the southern end of the bank was re-deposited. Towards the north end of the site the exposed compact reddish brown fine clayey is thought to be natural geological sediments.

Illus 7: A view of the section through the embankment, facing south.

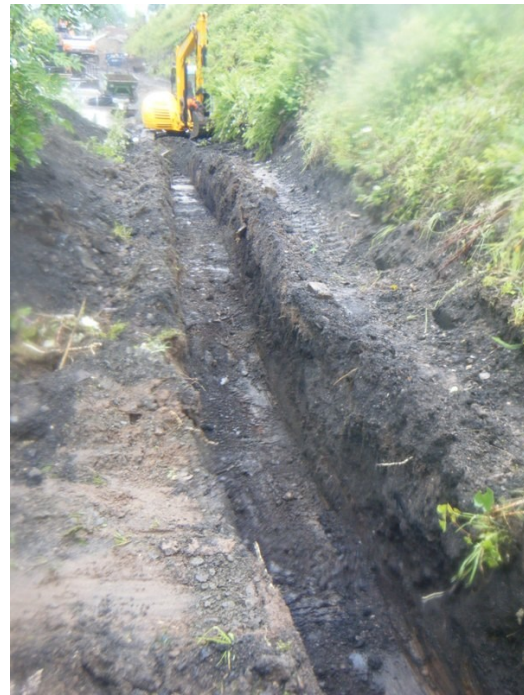
Monitoring of the ground works across the existing towpath was also undertaken. The main focus of these ground works were the excavation a drainage trench running from the north end of the site down to the canal side just south of the dry dock area.

This drainage trench was only 0.5m wide and excavated to a maximum depth of 0.5m but was generally only 0.35m deep. Although this trench was excavated through the existing ground level along the canal basin no features relating to earlier canal structures were encountered.

Illus 8: View of the drainage trench across the bank at the N end of site

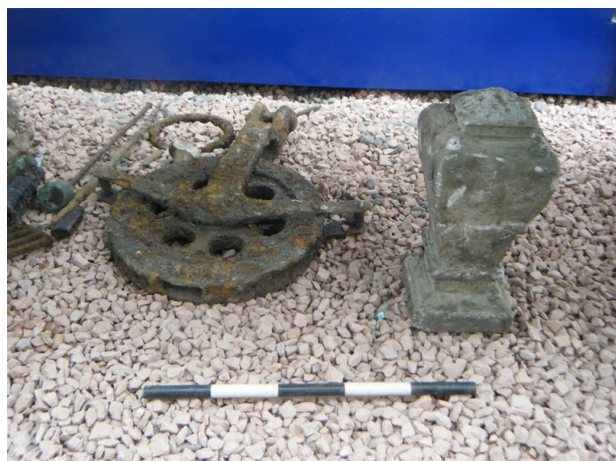
A selection of finds recovered from the removal of topsoil from the embankment provided evidence of the sites industrial past. The most interesting finds were a large cast-iron pulley wheel and a stone ornament. The finds were recorded on site and left in the site compound. They were offered to the local authority museum service who declined.

Illus 9: Detail of some of the finds recovered from the bank topsoil
