HARVESTER'S WAY, WESTER HAILES, EDINBURGH

Archaeological Evaluation

commissioned by Coopar Cromar on behalf of Places for People

January 2014

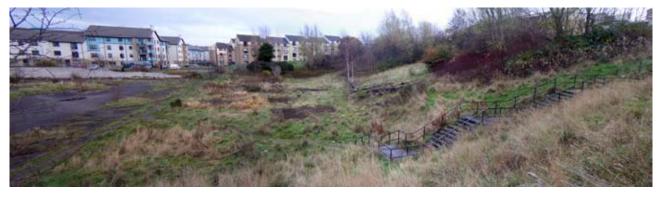
Illus 4

Panoramic view of the site, looking east. The quarry face is to the right, with the former carpark to the left

A quick topographical and photographic survey was undertaken of the area. It found that the area of excavation was situated within a large rectangular cut made into a north-facing slope. The levelled area measured 57m (north east to south west) by 20m. A series of steps entered the area from the south-west corner, with paths crossing through its western extent and along the northern border. An outcrop of sandstone was visible on the south western periphery of the area. Approximately 110m² of this outcrop was visible, 13m (north east to south west) by 12m. There was no face to the quarry as such, the outcrop rising approximately 3m in a series of unevenly-spaced steps. Although there was no evidence that the quarry had been worked

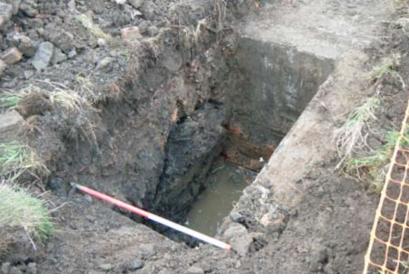
Illus 8 *Trench 01, north-facing section*

This trench was 5.6m (ENE to WSW) by 1.6m and up to 2.2m deep. The trench was stopped due to water ingress. Brownish grey clay with no inclusions 0.7 to 1m thick was encountered at the trench's base. This had been cut by the foundation trench for concrete and brick footings, which extended from 0.4m below the ground surface, to at least 2.2m and ran north to south. The poured concrete foundations were at least 0.9m wide and had been placed upon a splayed footing formed from machine-made bricks. The trench cut was backfilled with a redeposited clay mixture. Another concrete footing, at least 0.9m wide, but only 0.5m thick, abutted the first set of footings, running east to west.

Overlying the clay was a mottled dark grey silty clay containing clay lenses, stones, bricks and inclusions, this layer abutting the

foundations and up to 0.6m thick. This was situated below very mottled brown and grey silty clay containing a high level of brick, stone and modern inclusions (pipework, metal), 0.2 to 0.6m thick. The whole was overlain by 0.3 to 0.4m of a grey silty clay with stones, bricks and modern artefact inclusions.

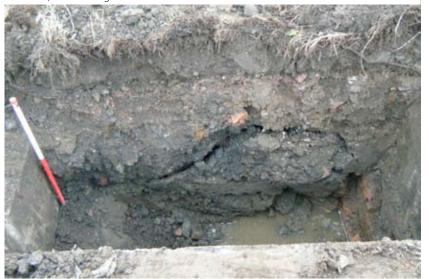
Illus 9 *Trench 10, looking west*

Trench 10 was 4.2m (ENE to WSW) by 1.6m and up to 2.2m deep. Excavation stopped at the ingress of water. At the base of the trench was mottled grey and blue clay with no inclusions was encountered, at least 0.3m thick. This was overlain by mottled brown and grey clay with large standstone inclusions throughout. A single fragment of clear-glazed stoneware was noted in the deposit, but could not be recovered. This clay had been truncated by a foundation cut for a poured concrete footing, extending from 1.1m below the ground surface to at least 2.2m and 0.9m wide. The footing was overlain by a mottled brown/grey silty clay containing a high level of brick, stone and modern artefact inclusions, 0.8m thick. This was overlain by 0.3m of a grey silty clay with stones, bricks, and modern artefact inclusions.
