# HAYMARKET RAILWAY STATION CAPACITY PROJECT

*Archaeological Monitoring and Historic Building Recording*

*commissioned by Morgan Sindall*

May 2014

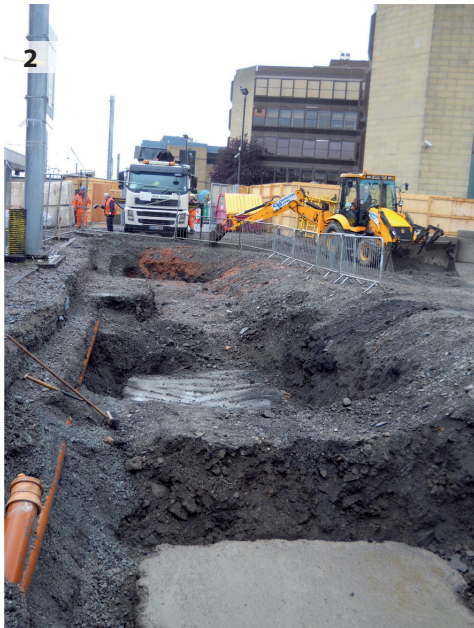
### **Illus 2**

*General view of trenches G3–G6, facing west. The concrete bases have already been poured*

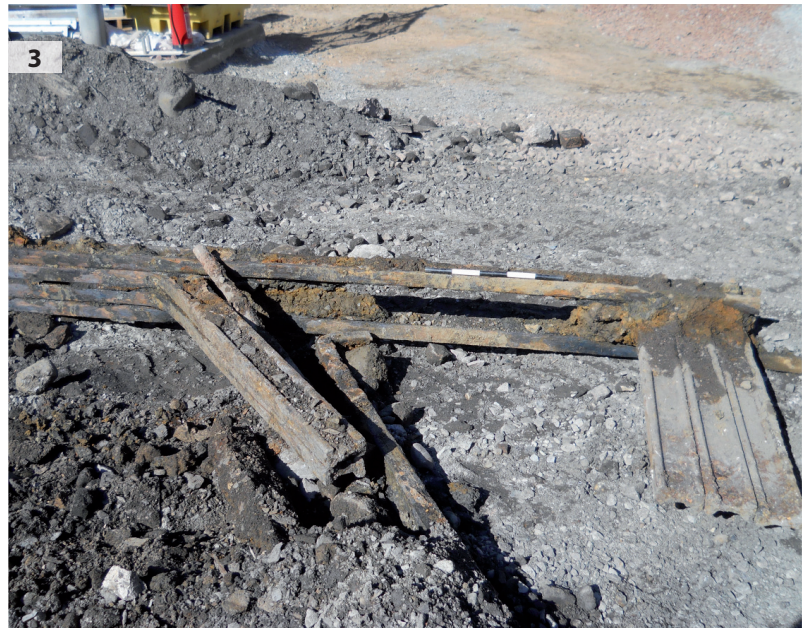
### **Illus 3**

*Remains of possible buffer stop, shortly after removal from Trench G5*

Trenches G3–G8 were located immediately to the north of the railway line serving platform 0, which had been temporarily infilled to facilitate construction work. An area c. 1.5 m around the trenches was reduced in level by up to 0.7m to allow safe access where necessary (**Illus 2**). Excavation revealed a deep (up to 2.4m) layer of made ground overlying geological subsoil comprising boulder clay. The made ground consisted of very mixed dumped deposits, including gravel, stones, masonry fragments, timber and wood. The possible remains of an iron buffer stop were encountered in this layer towards the north-western corner of Trench G5 (**Illus 3**). The item did not appear to be in situ but was very heavy and may not have been moved far from its original location.

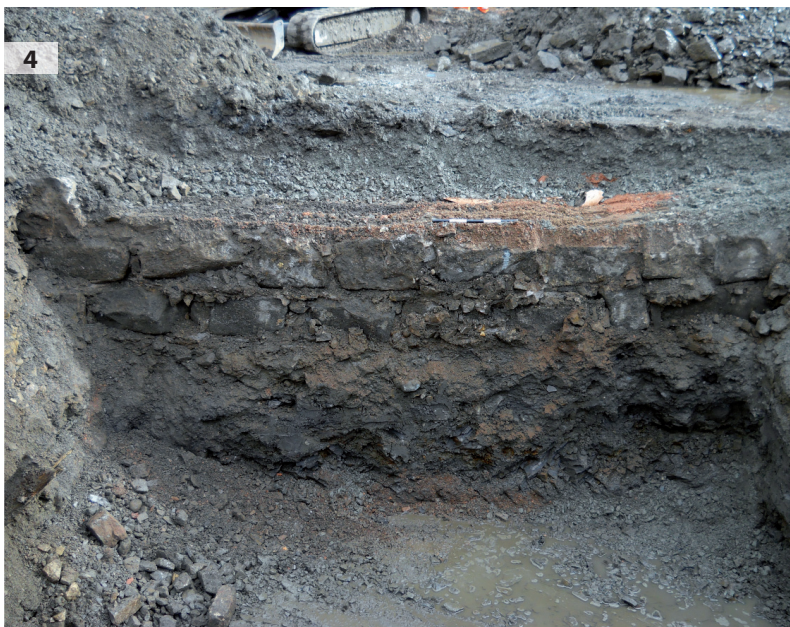
### **Illus 4**

*Sandstone wall at the east side of Trench G7, facing west*

A sandstone wall was encountered in the eastern edge of Trench G7 (**Illus 4**). This wall was aligned perpendicular to the existing railway lines and may represent the eastern limit of an earlier, infilled railway line. The level of undisturbed geological deposits to the east of this wall was also c. 1m higher, suggesting that the railway line had been cut deeper into the natural clay.

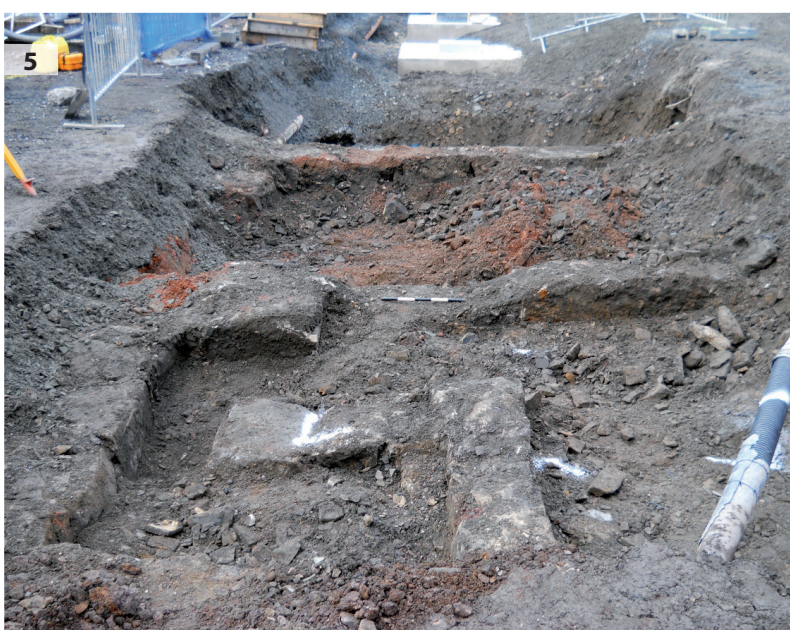
### **Illus 5**

*Sandstone structures in Trench G8, facing west. The wall in the background is that on the eastern side of Trench G7*

Further sandstone structures were encountered in Trench G8 (**Illus 5**). Three sides of a rectangular foundation structure were exposed, as well as a further, small, L-shaped wall. These were truncated in two places by

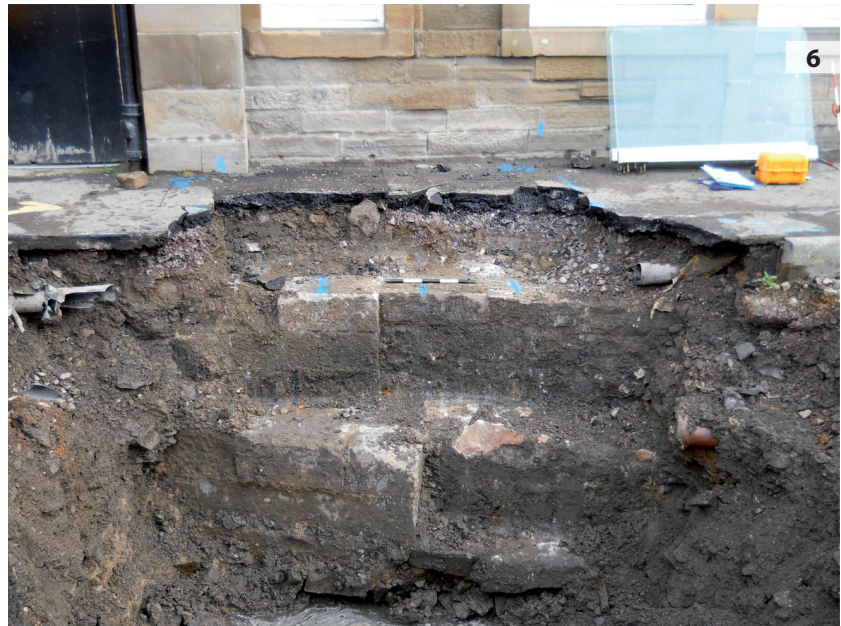
### Illus 6

*Stepped sandstone foundation in Trench X20,  
facing east*

At the eastern side of Trench X20, a stepped sandstone foundation was exposed. This was aligned approximately north-south and

stood 1.64m high (Illus 6). A sandstone wall on a similar alignment was found at the western side of Trench Y20 (Illus 7). These may represent part of the foundations for a two-storey building that joined the original station building to the train shed and pedestrian overbridge; which dates to the end of the 19th century. The stonework in Trench X20 was removed entirely to make way for a foundation pile, while that in Trench Y20 remained in situ, with only the upper stone removed to allow a drainage pipe to cross.

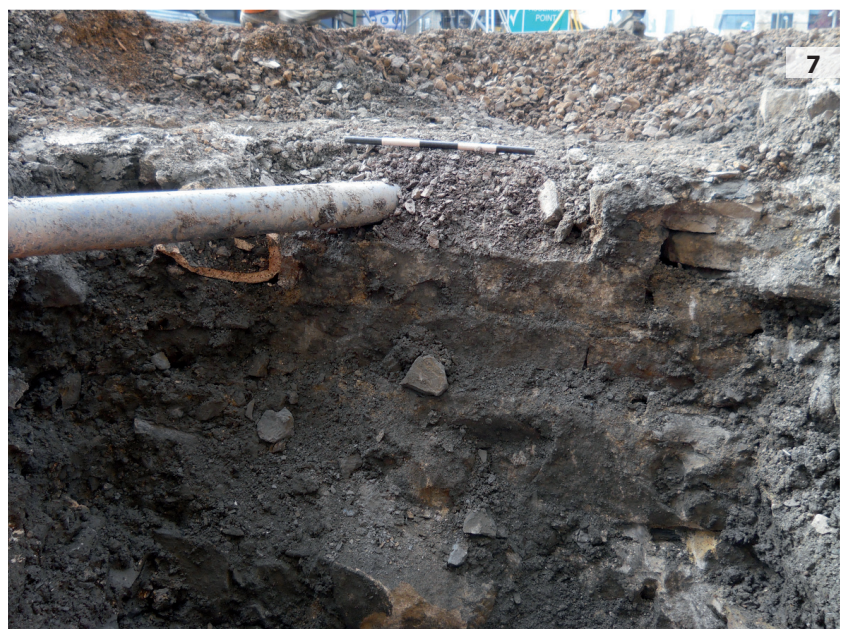
### Illus 7

*Sandstone wall at western side of Trench Y20,  
facing west*

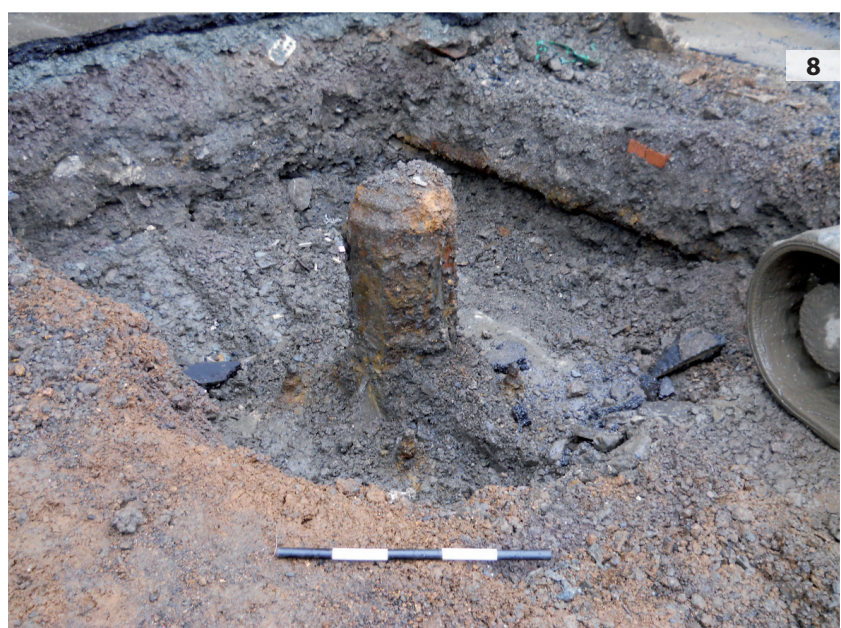
### Illus 8

*Iron column base in Trench Z20,  
facing south-east*

A cast iron column base set in a concrete foundation was found in Trench Z20 (Illus 8). It was not clear whether this was part of the 19th century train shed or a later structure. The corner of a sandstone structure was also revealed at the eastern side of this trench, which was most likely part of the foundations for the main station building.

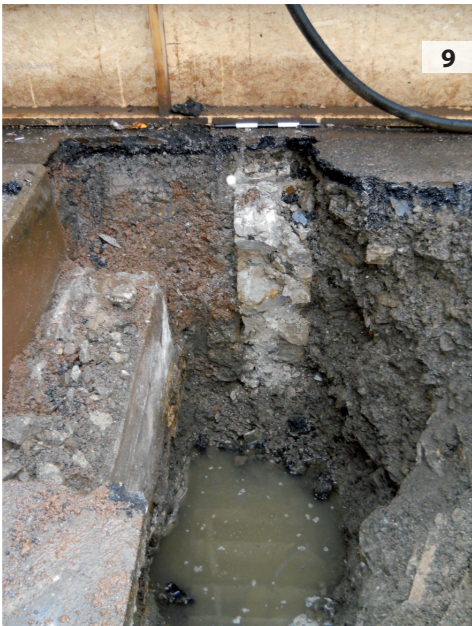
**Illus 9**

*Wall stub in southern side of Trench 19, facing south*

These trenches were excavated through the structure that makes up Platforms 0 and 1. Trench I4 had been previously excavated and backfilled with gravel and mixed rubble. Similar material was found in Trench I9, to a depth of 0.9m, overlying mudstone. The northern end of a sandstone wall standing 0.8m high was found at the southern end of this trench (Illus 9); a substantial concrete foundation slab lay to the east.

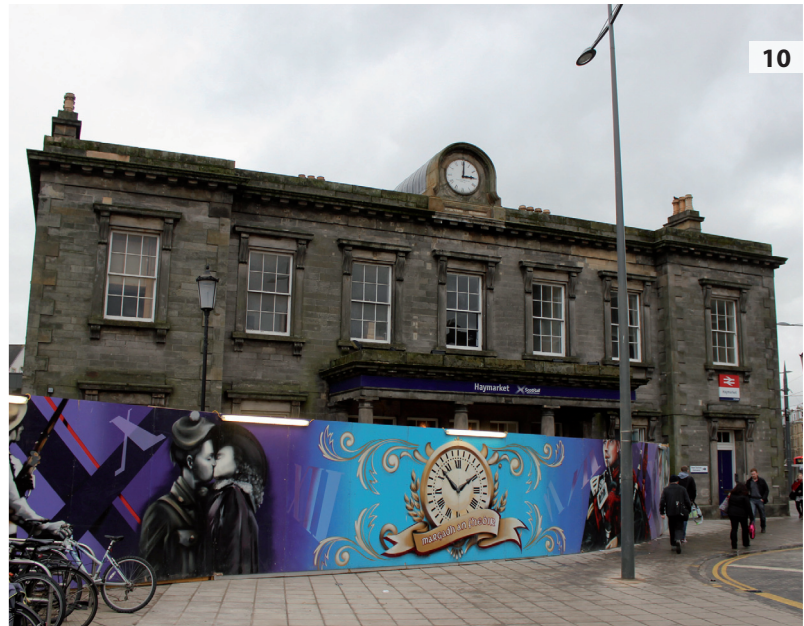
**Illus 10**

*General view of north-east facing façade. Unfortunately the view was blocked by hoarding at the time of fieldwork*

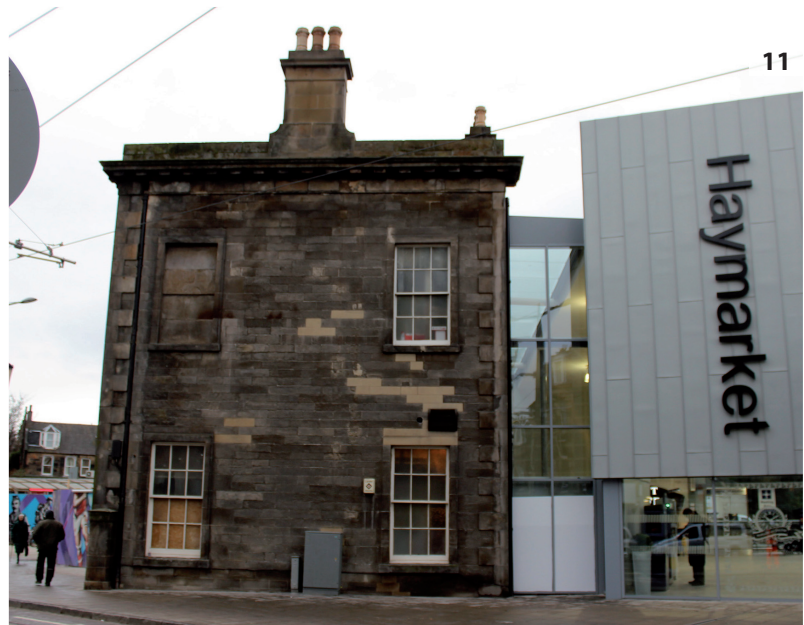
**Illus 11**

*General view of north-west facing elevation. The new building can be seen to the right*

The north-west elevation (Illus 11) is largely as built but for a blocked window on the first floor, an inserted service vent and some areas of stone replacement. An external stair leading to platform level behind the building has been removed during construction of the adjacent tram stop.

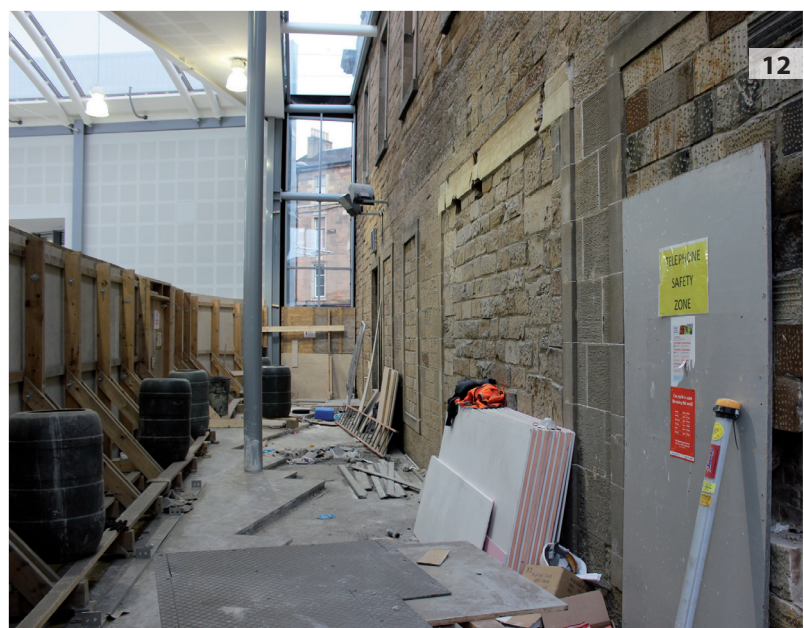
### Illus 13

*General view of the basement level of the south-west facing elevation from within the undercroft of the new station building*

The three-storey south-west elevation (Illus 12 and 13) consists of six bays at first floor level, with a more functional arrangement at ground and basement (platform) level. At the time of fieldwork, the new building had advanced to the point where the basement floor was no longer visible to the public, being hidden in the undercroft. Several alterations to windows, doors and connecting openings are visible. A small gabled dormer has been added, most likely relating to the 1894 modifications, when some of the roof space was opened up for use as accommodation. One window at first floor level has been sealed at the same time as the result of a new fireplace being inserted behind. Several changes have been made at ground floor level, relating to the removal of a raised wooden structure that provided a connection between the booking hall and the train sheds, which were on a different orientation. The structure led to the stairs and footbridge and also contained an agent's room. It was removed as part of the 1984 renovation, leaving two windows, a doorway and a large opening unused. These were sealed sympathetically with matching sandstone. A replacement opening was made closer to the southern corner to connect with stairs to Platform 1; this in turn will be sealed up as part of the present renovations. Two new openings will be made to connect the old building with the new. The basement

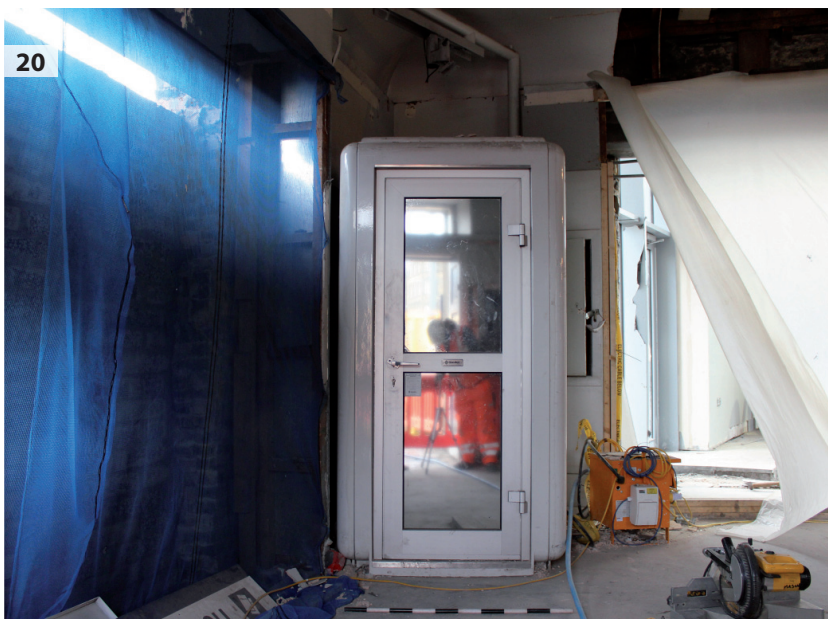
**Illus 20**

*Security box in southern corner of G01*

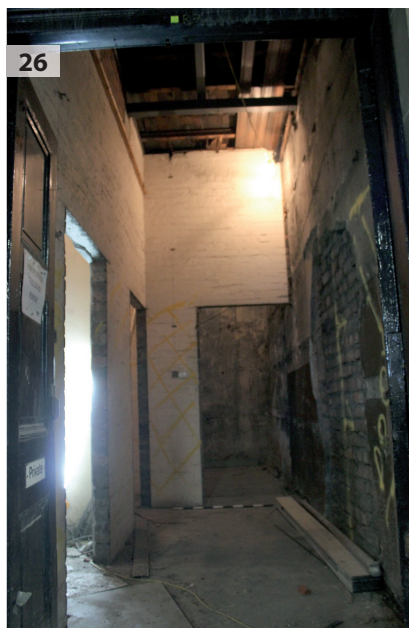
**Illus 25**

*South-east facing elevation of B04 showing B01 through hole in wall and a blocked-up doorway of the former sub-basement*

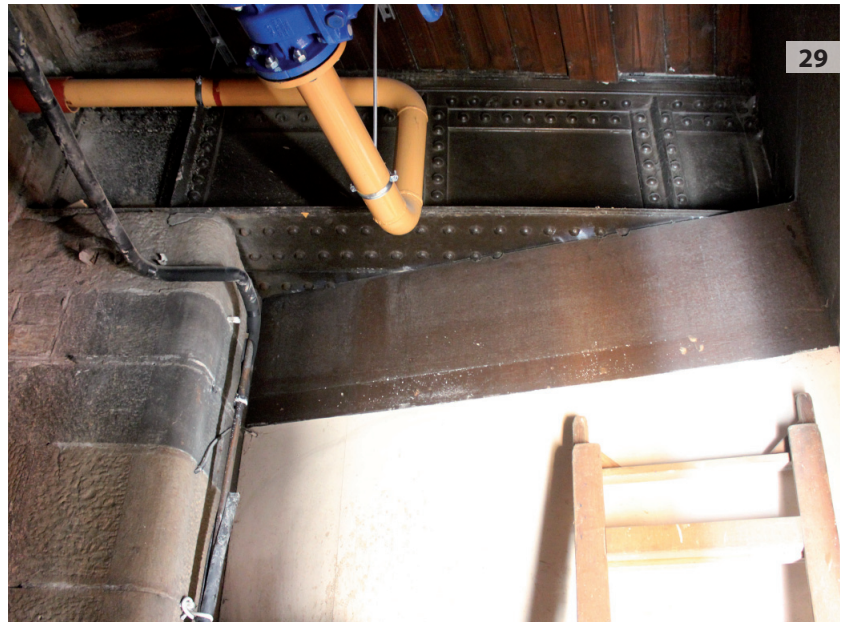
*Retaining wall visible in B14, facing south-east*

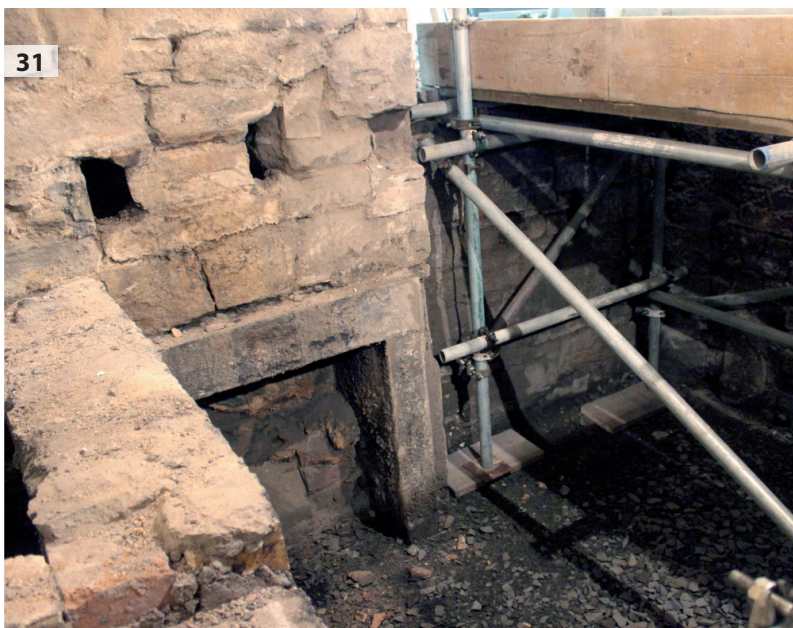
**Illus 31**

*North-east facing elevation of SB01, after the basement floor was removed*

The north-west facing elevation of Room SB01 (Illus 31) featured a blocked opening presumed to be a window, although it is not clear in what manner light was transmitted to it from platform level. Adjacent to this is a small stone fireplace, somewhat masked by a brick support for the new hearth slab in the B03 above. A bricked-up doorway in the south-east facing elevation would have provided access to Room SB05, which was found to have been filled in with concrete, most likely in the 1980s. The brick partition between SB01 and SB02 was inserted when the rooms went out of use, presumably to provide support for the new floor. The purpose of Room SB03 was unclear. Beneath the staircase to B01 was a small boiler room SB04 which remained in use some way beyond 1894.

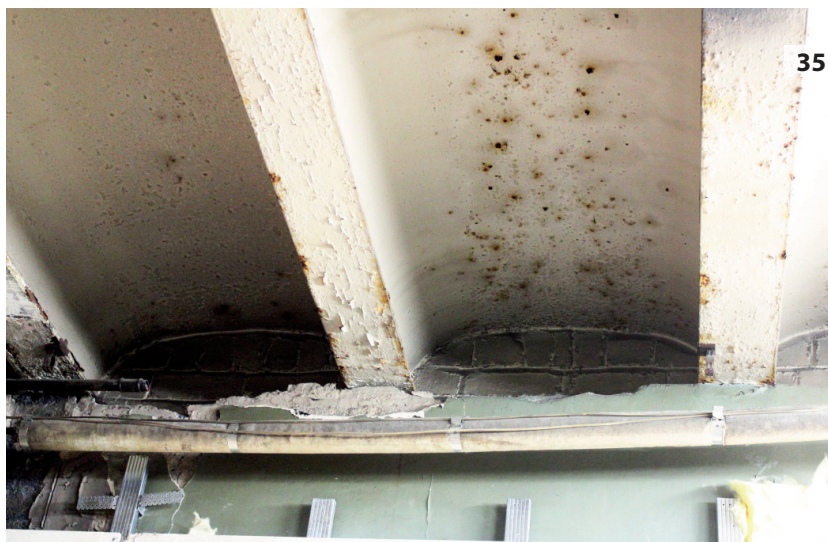
**Illus 35**

*Cast-iron barrel vaults in rooms adjacent to Platform 4*
