# NIDDRIE MILL PRIMARY SCHOOL, EDINBURGH

Archaeological Evaluation  
Historic Building Recording

commissioned by CCG (Scotland) Ltd

January 2015

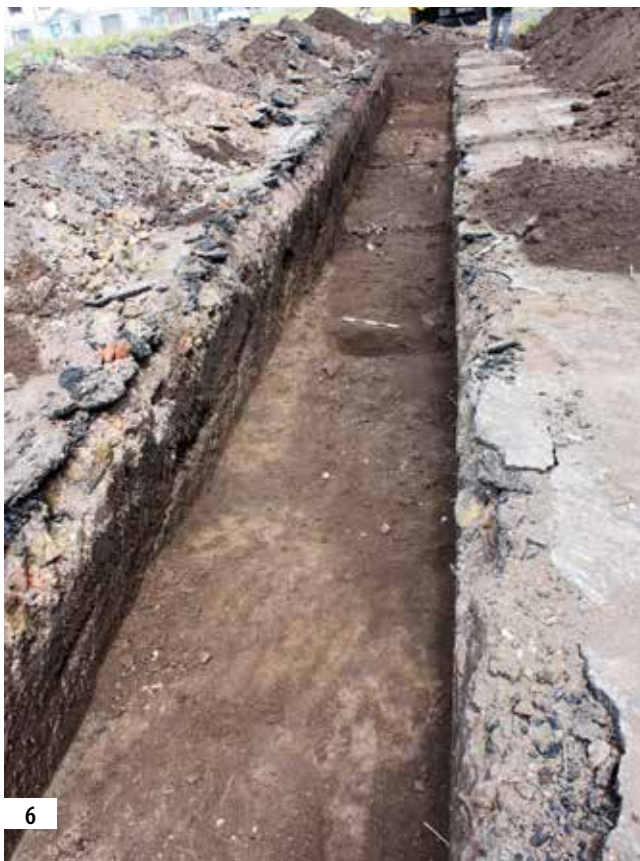
ILLUS 6

N facing view of ditch cut [016] in Trench 4

Only one archaeological feature was recorded within the trenches. This feature, identified in Trench 4, comprised a linear ditch cut [016] aligned NNW/SSE turning to the south-east at its south end (Illus 6). The ditch had steep sloping sides 0.5m deep and a flat base 1.5m wide and contained three distinct fills (Illus 7). The basal fill (019)

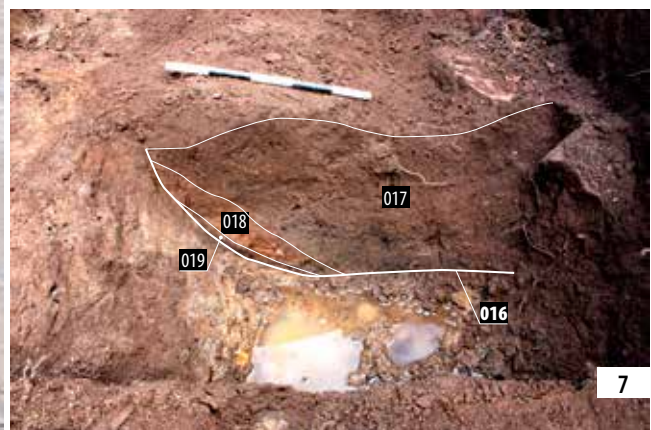
ILLUS 7

Detail of the S facing section through ditch cut [016]

comprised a very shallow layer of mid-grey silty sand no more than 0.04m thick. Above this was a further shallow layer of soft orange clayey sand (018) that appeared quite organic in nature. This layer mainly formed at the edges of the cut. This was overlain by a more substantial layer of soft orange brown loam (017) that included occasional animal bone fragments and charcoal flecks. The makeup of this material was similar to the overlying subsoil (012) that was recorded across trenches 2 to 5.

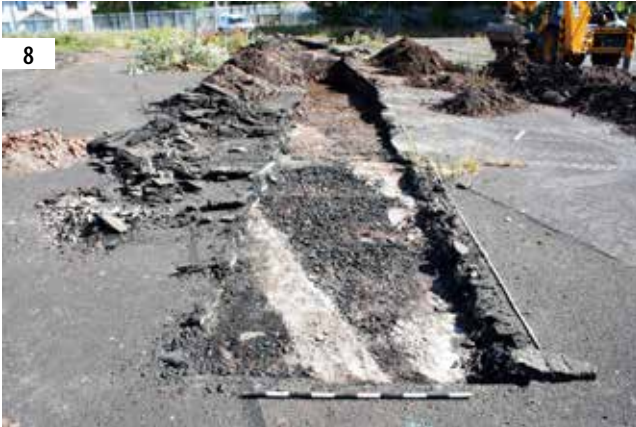
**ILLUS 8**

Trench 2 from the SW end showing the foundation walls

The subsoil recorded in trenches 2 to 5 comprised a dark greyish brown sandy loam with frequent small stone inclusions. This layer was between 0.2m and 1m thick and recorded 0.35m below the present surface. It was mainly overlain by modern levelling layers of brick rubble (002) and tarmac (001). In trenches 1 to 4 a series of brick walls (009), (010) and (015) set in concrete foundations were recorded either cutting the subsoil (012) or overlaying it (Illus 8). The walls only survived to a maximum height of 0.3m and formed the foundations to a large 21st century building. A number of the bricks were stamped 'SHOTTS'.

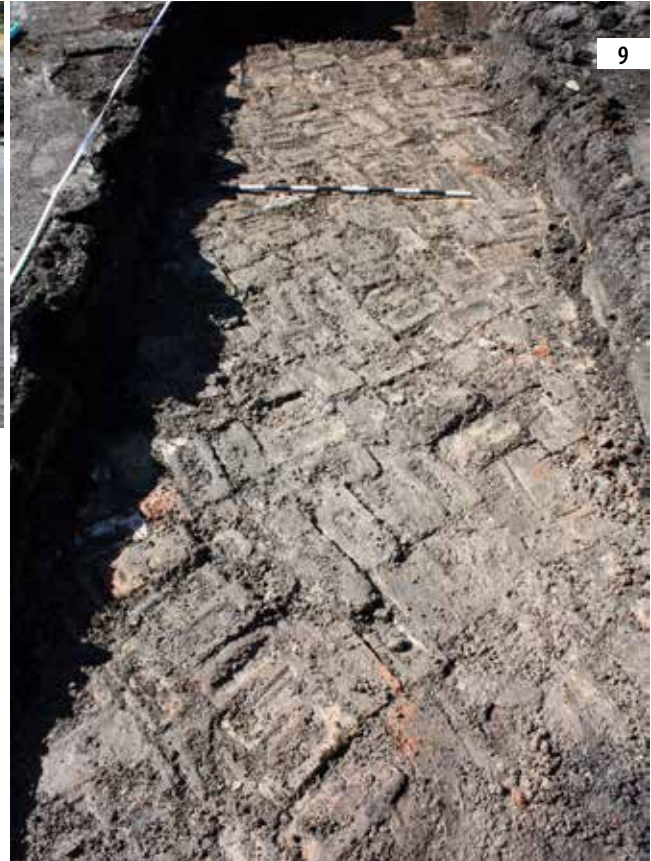
**ILLUS 9**

Brick floor at NE end of Trench 2

Associated with the walls was an uneven brick floor recorded at the north end of Trench 2 (Illus 9). This comprised frogged bricks set in a zigzag pattern and bonded with a sandy mortar. Again this was recorded 0.3m below the tarmac surface. In Trench 3 a further brick wall and two cement bonded square brick pillar foundations, both 0.65m<sup>2</sup>, formed further evidence of the same structure.

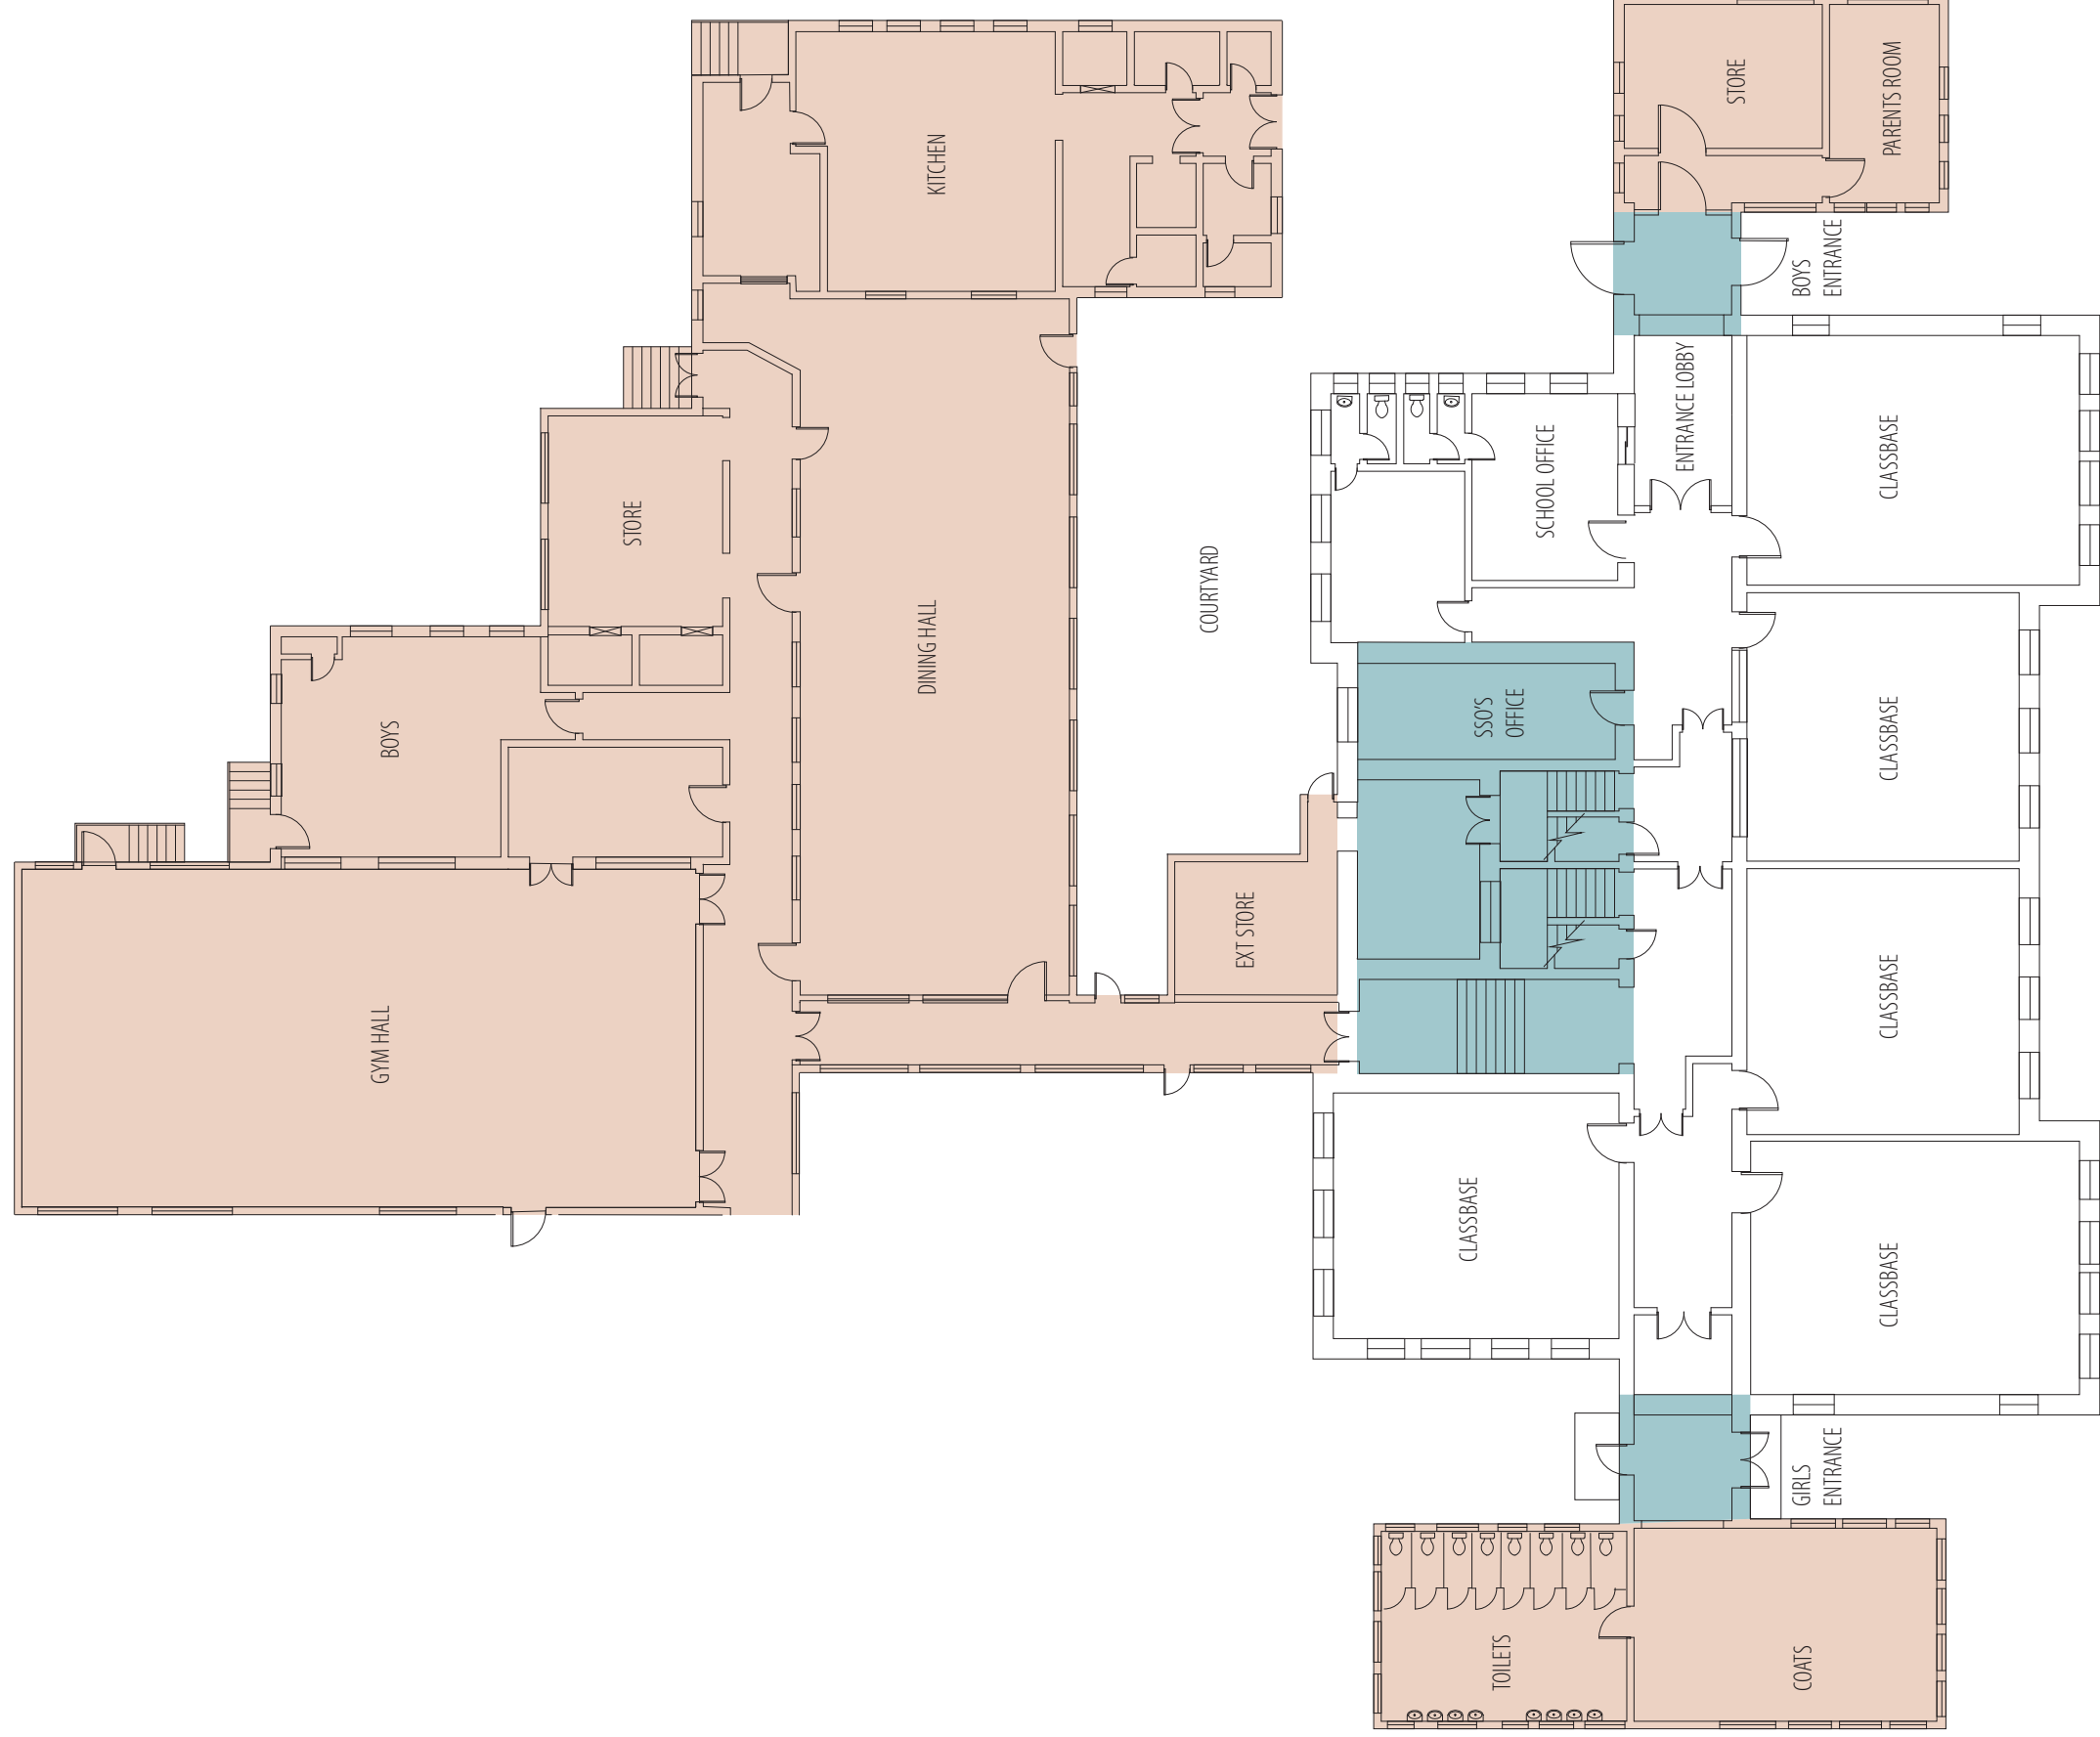
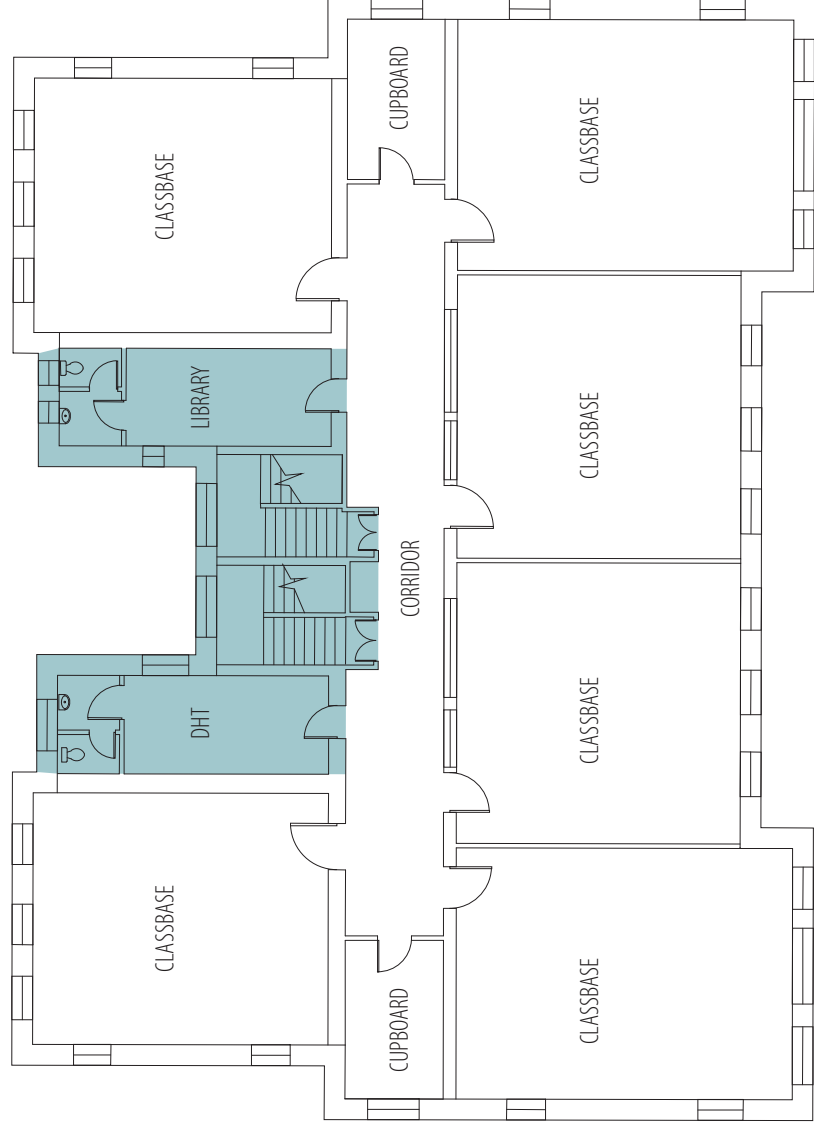
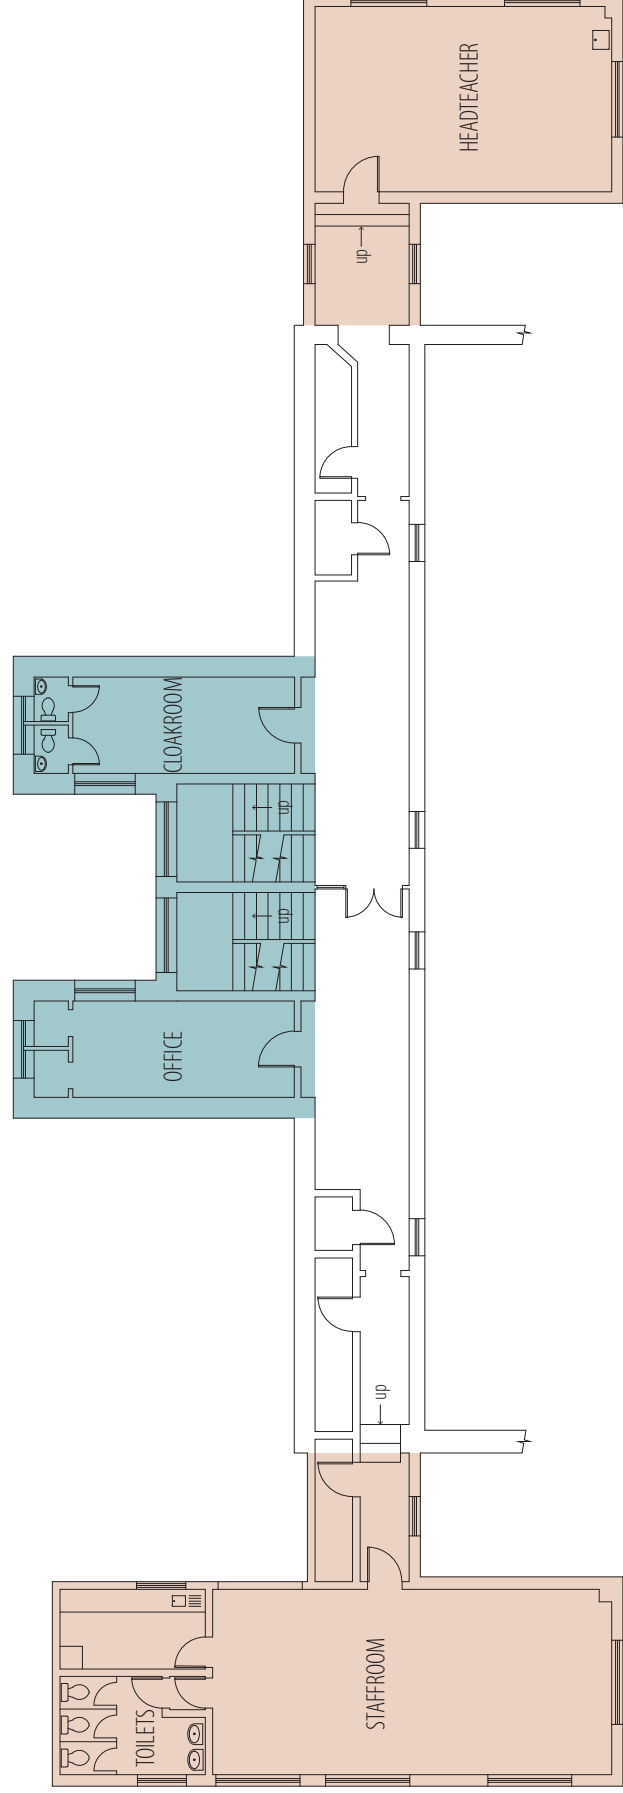
FIRST FLOOR

MEZZANINE FLOOR

A total of four buildings were present within the study area. This comprised the original brick constructed school building plus a number of later modifications and three later 20th century buildings that formed a further expansion of the school (Illus 10 & 11).

The interior of the main school building was in a poor condition at the time of the site visit. All the windows had been blocked up and most of the internal door windows had been broken or damaged. The general plan of the building comprised five large classrooms and two smaller rooms including an office on the ground floor, a long corridor on the mezzanine level and six classrooms on the upper floor (see **Illus 10 & 11**).

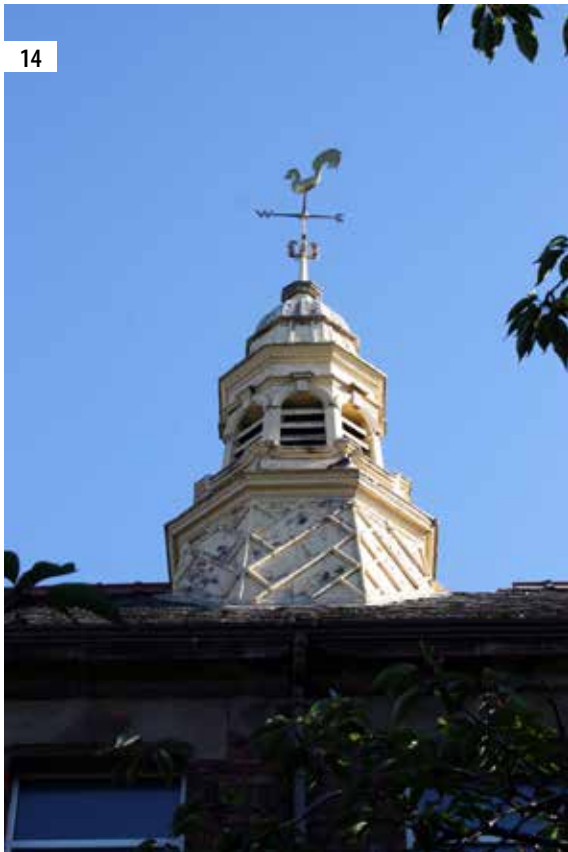
ILLUS 14

N facing view of bell copula

The original school building formed a large H-shaped structure over two storeys with a slate roof that included a slatted wooden bell tower (Illus 14). The brick built school was constructed in the Renaissance style with stone lintels at the windows and doors and moulded pediments adding a degree of decoration to the front facia of the building (Illus 12). The building was flanked on both sides by a later phase single storey brick constructed entrances that linked the school (see Illus 25) building to two later 20th century ancillary buildings.

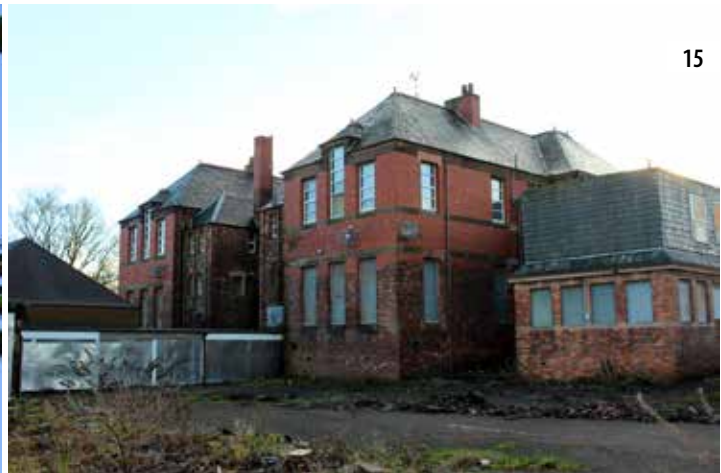
ILLUS 15

SE facing view of the rear of the school building

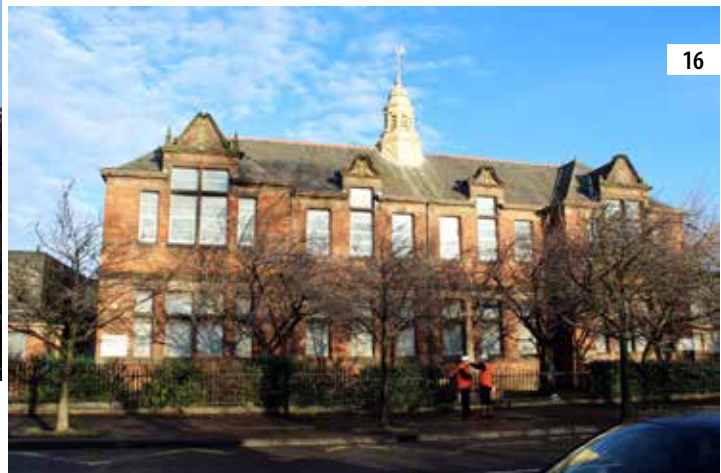
ILLUS 16

N facing view of the front of the S elevation

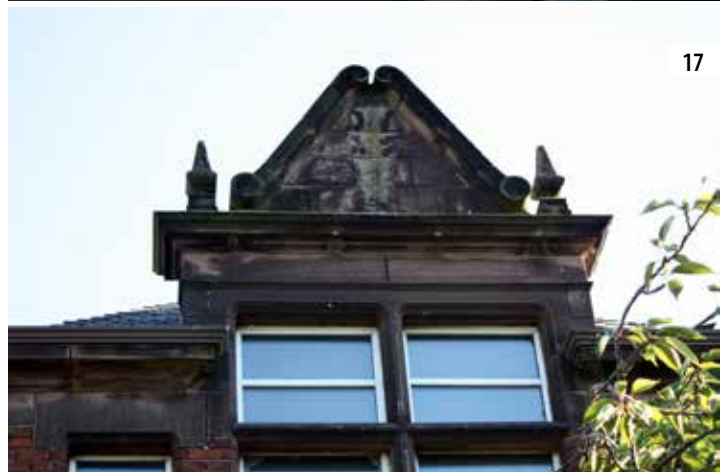
ILLUS 17

Detail of the pediment above the first floor window

The south facing elevation provided the only original elevation of the building that had not been altered or added to. The H-shaped plan of the building was not immediately obvious on this elevation as the end projections were only very slight. The south elevation presented four window bays with two slightly forward projecting wing bays (forming the H shaped plan) flanking two central bays (Illus 16). The two wing bays were identical both displaying two narrow casement windows flanking two wider central windows to each floor. The two larger windows on the upper floor were raised slightly above the level of the roofline cornice and were topped with a decorated curved pediment (Illus 17). The two central bays also

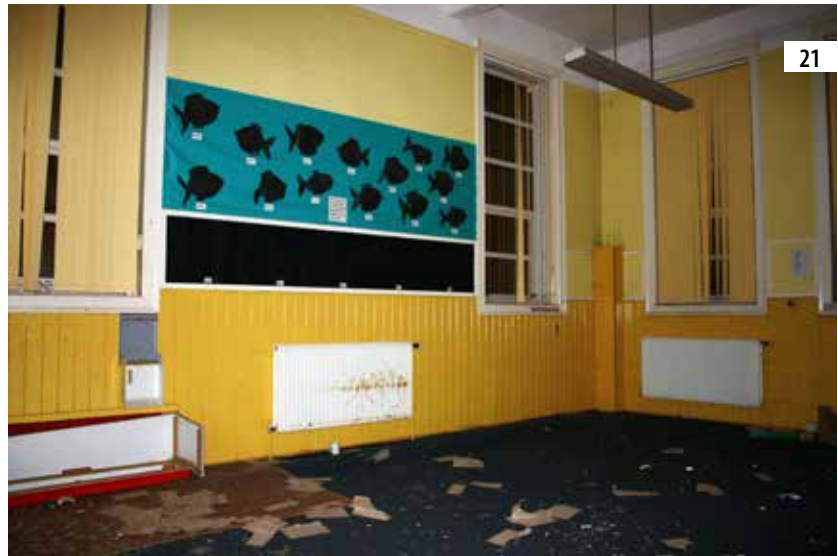
**ILLUS 21**

General view of ground floor classroom showing wainscott panelling

Very little architectural detail was present within the school buildings. Most of the classrooms included wainscott panelling (**Illus 21**), painted brick partition walls and high ceilings. Some of the internal walls facing into the corridor included glass panel windows above the wainscoting. The entrances into the stairwells included large arched timber surrounds that had been boarded with single

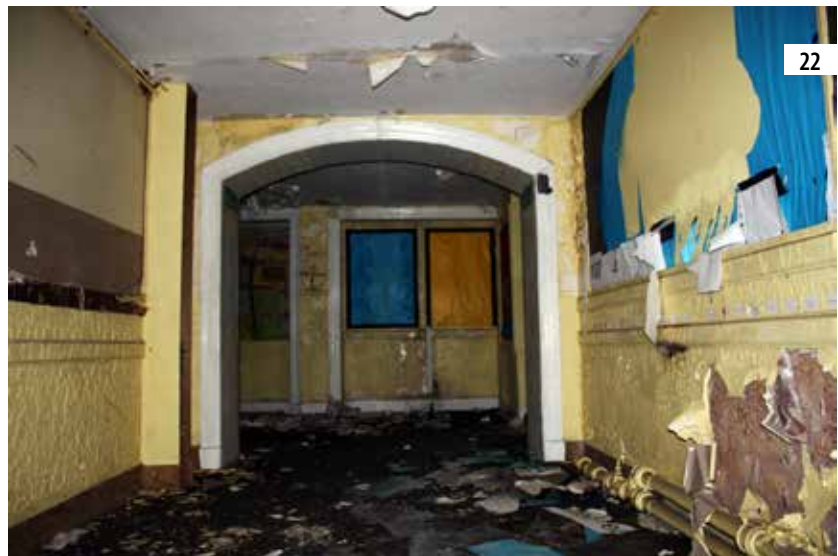
**ILLUS 22**

View of central corridor of ground floor showing the arched openings

timber doors inserted. The timber arch surrounds were also seen on the upper floor level both along the corridor and at the entrances to the classrooms to the south side of the building (Illus 22).

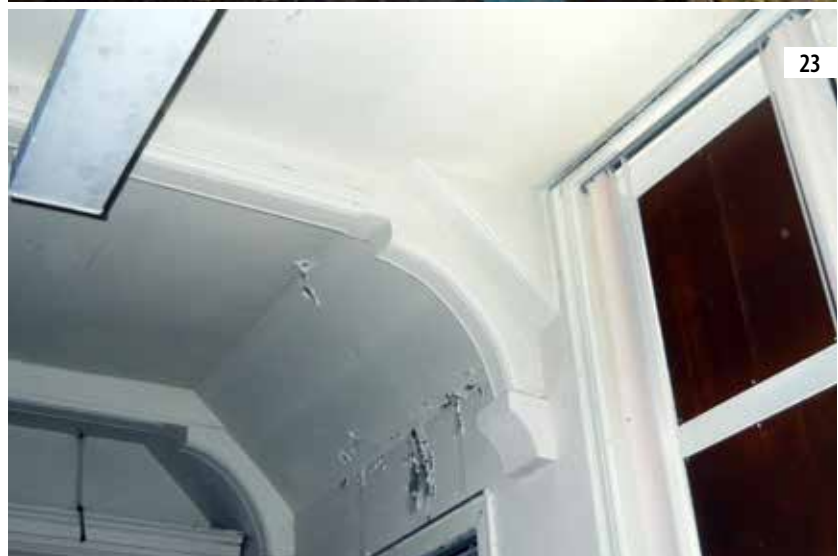
**ILLUS 23**

Detail of the supports for the bell tower

The first floor had a very similar layout to that found on the ground floor with four large classrooms on the south side of a central corridor and two further classrooms on the north side flanking two smaller rooms (a library and office) located either side of the staircase. The only features of note were the timber supports for the bell tower. (Illus 23) These were visible in the ceiling of the two central classrooms on south side of the building. The corridor included a skylight and a hatch/skylight located in the library for access to the roof and bell tower.

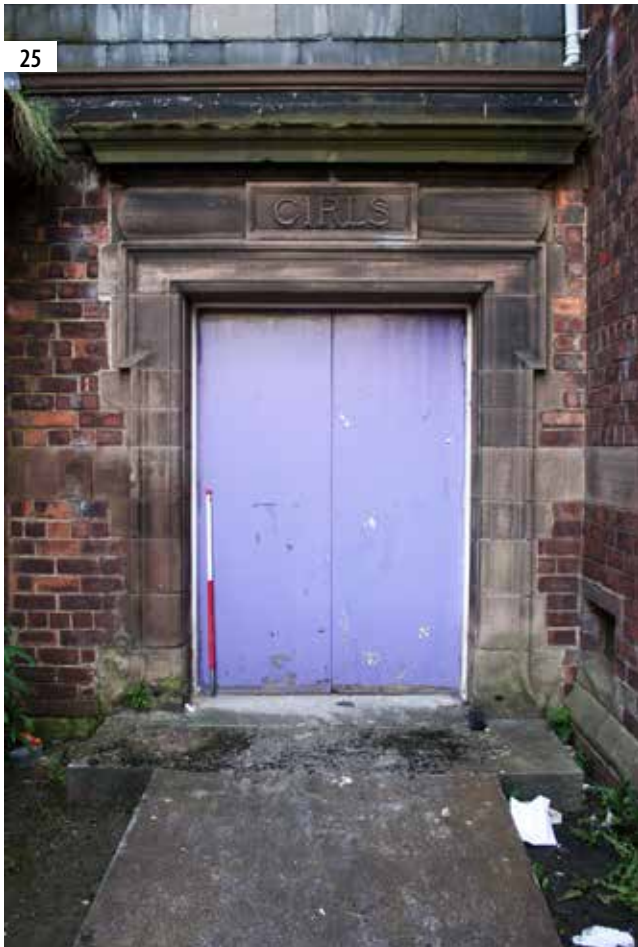
ILLUS 25

Detail of stone surround of the early 20th century phase girls entrance

The 1908 ordnance survey (Illus 24) depicts a small number of changes to the site. These include the addition of the two entrances to the sides of the building. These comprised of single storey brick constructed rooms with decorated stone door surrounds with the west entrance marked 'GIRLS' (Illus 25) and the east entrance marked 'BOYS' above the doors (Illus 26).

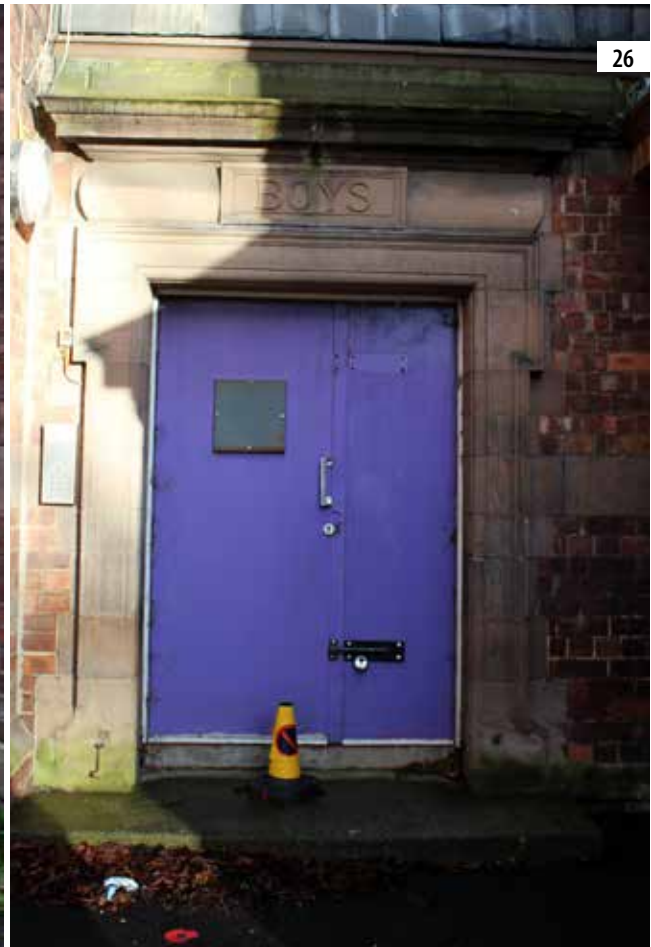
ILLUS 26

Detail of stone surround of the early 20th century phase boys entrance

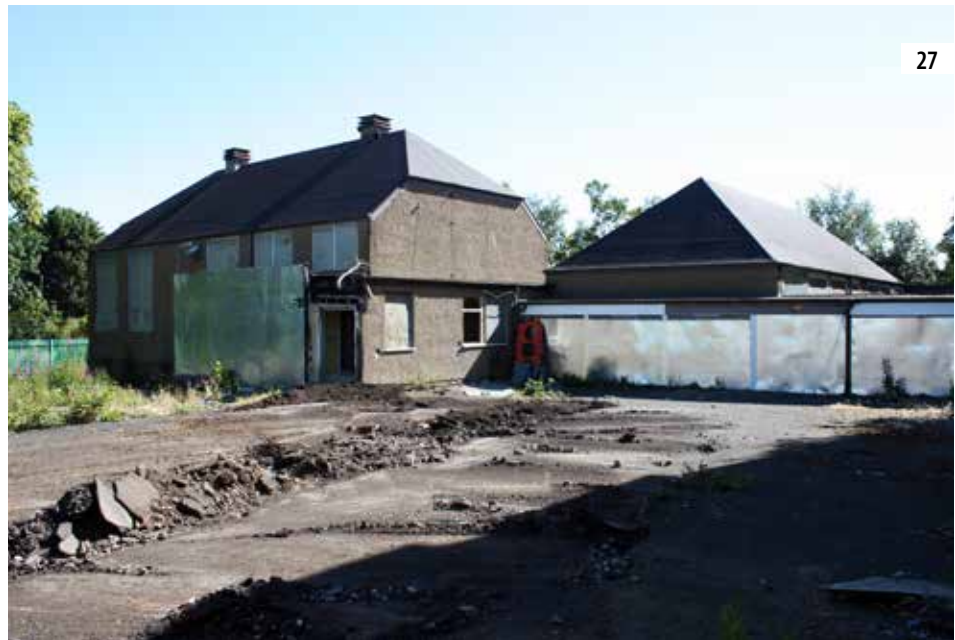
ILLUS 27

View of the modern mid 20th century school buildings to the north of the main school

Further buildings had been added to the rear of the school. These were all brick built buildings that had been covered in a painted render. These formed a gymnasium, kitchen and dining hall along with a number of ancillary rooms (Illus 27).
