# LANGLOCH FARM, LANARK

Archaeological Desk-Based Assessment,  
Historic Building Recording and Evaluation

commissioned by Clydesdale Community Initiatives

December 2014

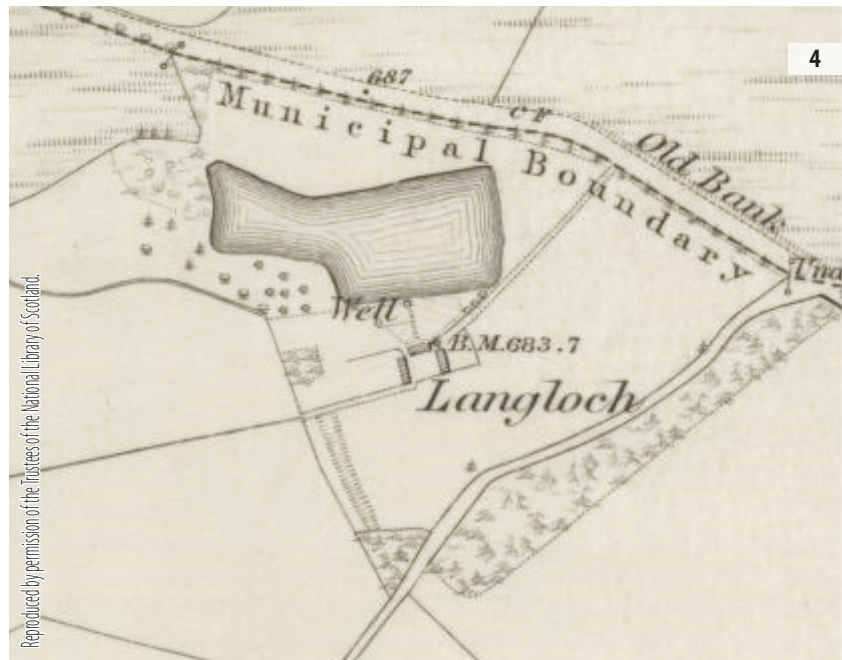
ILLUS 4

The 1864 Ordnance Survey (Lanarkshire: Sheet XXXII) is the first to depict a detailed plan of the farm. This map shows the farm comprising three separate buildings forming a U-shape steading around a central courtyard (Illus 4). This probably represents the farmhouse to the north of the site flanked by two ranges to the east and west. By the revised 1897 Ordnance Survey (Lanarkshire Sheet 032.04) the steading had been modified with a third long range attached to the south ends of the two existing ranges (Illus 5). In addition to this the map depicts a small extension (probably a porch) to the south side of the farmhouse, two small buildings and a enclosure to the north-west of the steading along with enclosure walls abutting the east side of the east range. From this date onwards no changes to the steading are noted.

Extract from 1864 Ordnance Survey map

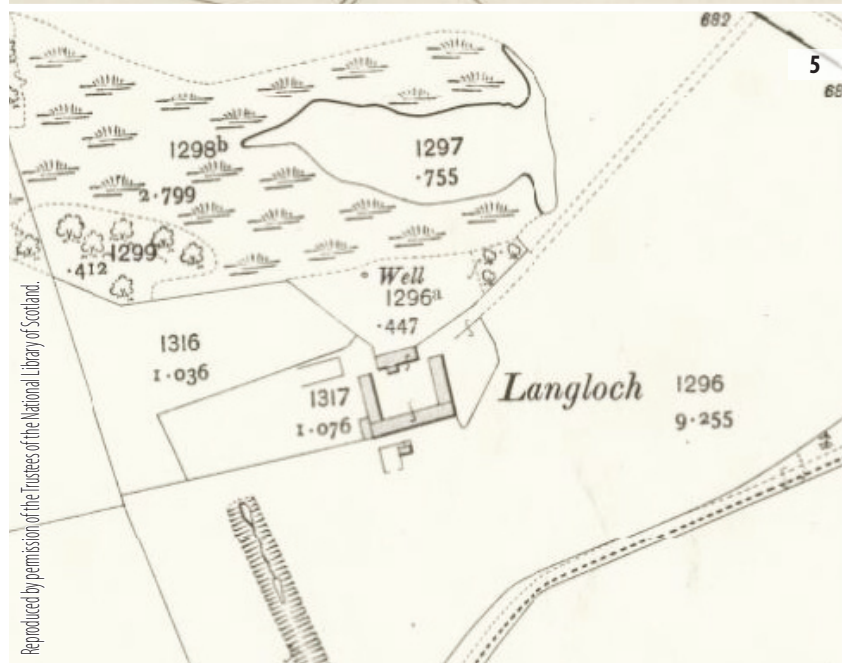
ILLUS 5

Extract from 1911 Ordnance Survey map

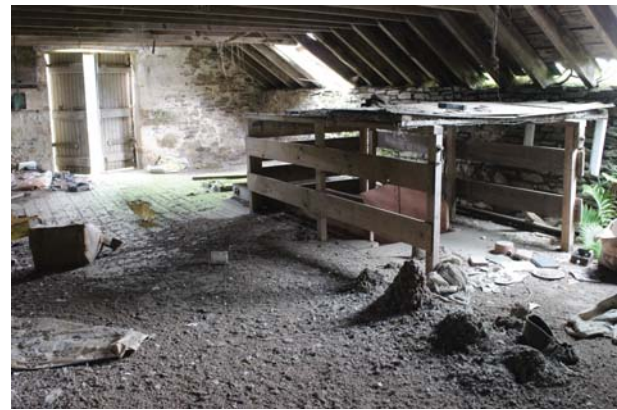
ILLUS 7A  
East range, first floor, R16, machine chute (024)

The upper floor (Room 16) had partially collapsed, therefore the room was only recorded from a position at the top of the stairs. The room extended across the full length of the east range. The threshing machine from Room 2 emerged in the north-east corner of the room, with a chute and surrounding wooden superstructure (**Illus 7A**). In the southern part of the room along the east wall there was a collapsed long table. At the location of the dividing wall between Room 1 and Room 2 on the floor below the height of the timber floor changed, with the floor to the north half of the room being 10cm higher.

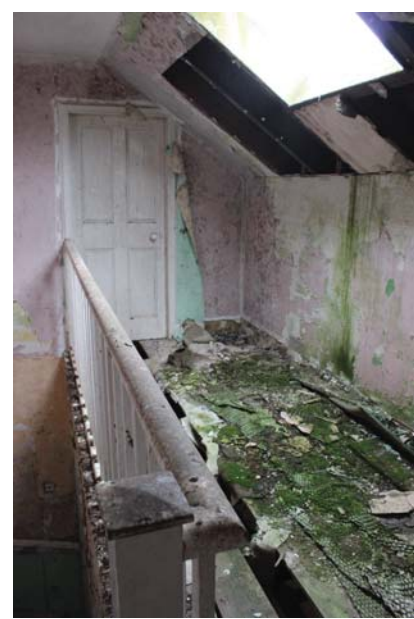
ILLUS 7B  
North range, first floor, hallway, general shot (044)

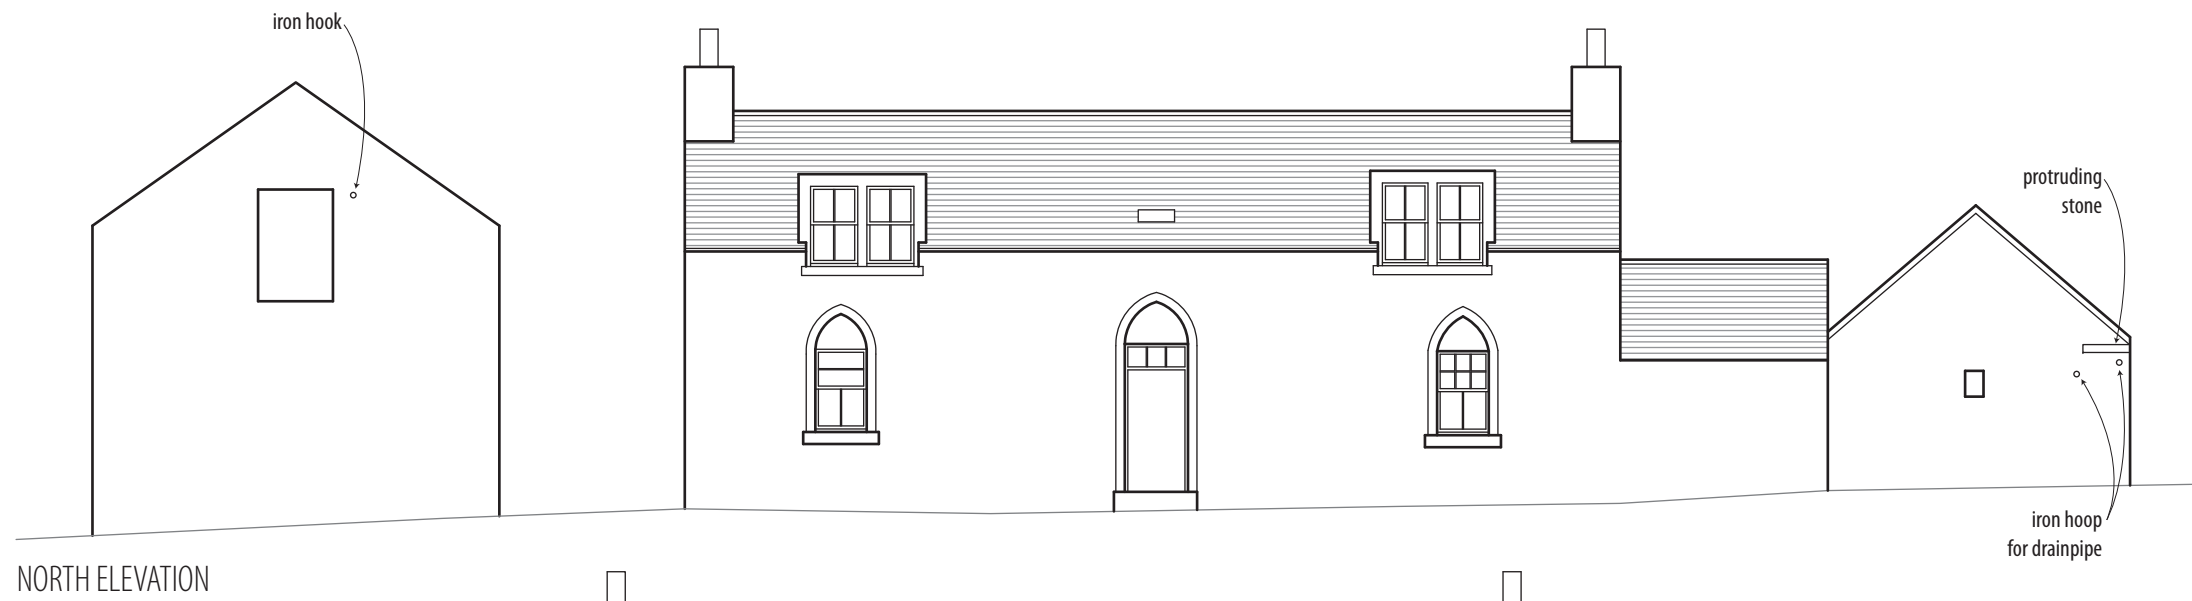
NORTH ELEVATION

The Farmhouse comprised of a detached 1 ½ storey building with the upper floor built into the roof space. The building was covered in a painted render masking the rubble stone construction. The building had gabled ends with a pitched slate roof that included two dormer windows facing north (F5 and F7) and one facing south (F3). To the west side a single storey extension had been added along with a small porch to the south side. The main elevation faced north and presented a central door (G28) flanked by a window to each side (Illus 8A). Both the door and windows included pointed arched stone surrounds. The upper part of the door or window, within the pointed arch, was made of decorated wooden panelling (Illus 8C).

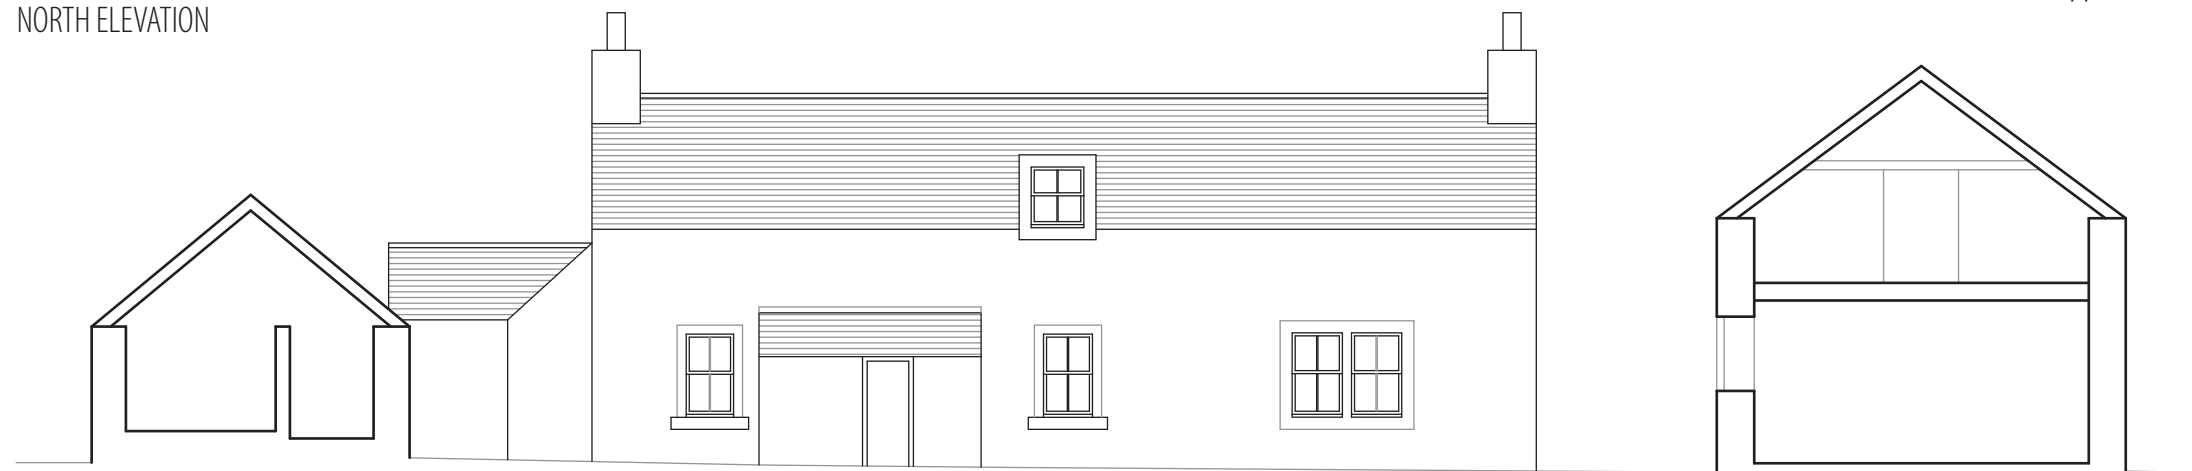
SOUTH ELEVATION

The south elevation faced into the courtyard (Illus 8B). A large double window (G26) was located on the east side of the elevation and two single windows flanked a door (G24) on the western side of the elevation. The door was masked by the later brick-built porch. The windows on the south side of the building did not display the pointed arch surrounds recorded on the north elevation. The single dormer window on this elevation was located above the east window flanking the door.

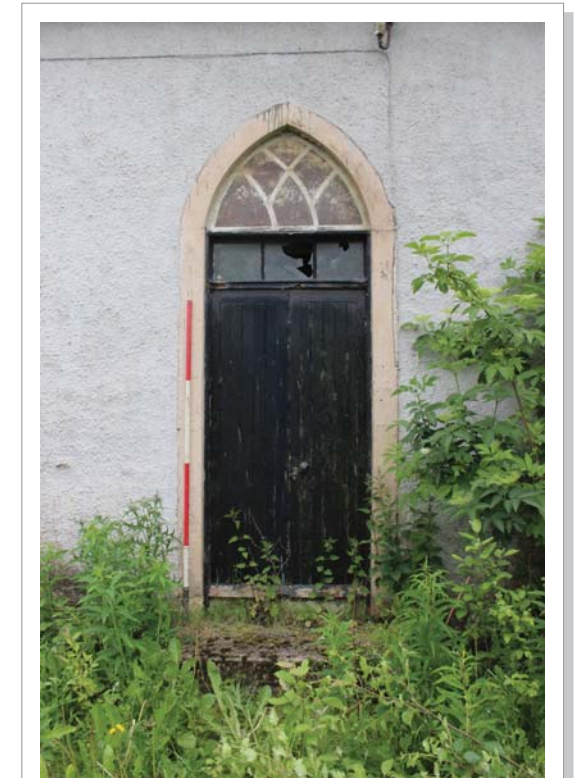
ILLUS 8C  
North range, north elevation, detail of door G28 (032)

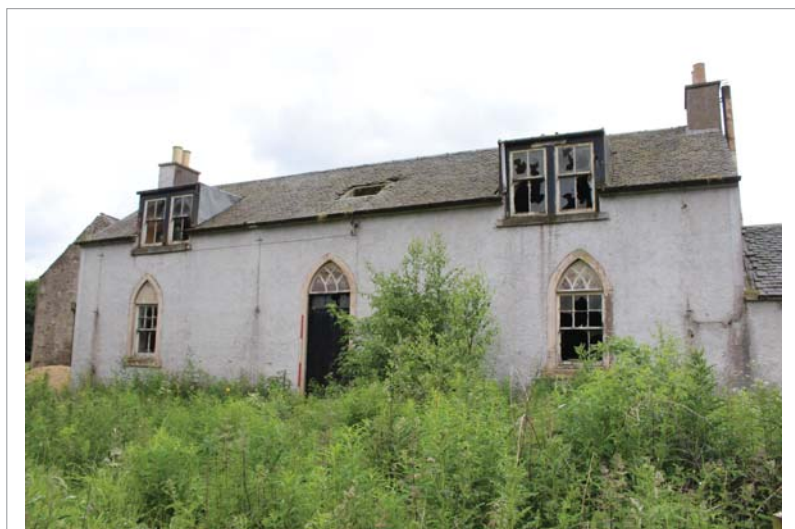
ILLUS 8A  
North range, north elevation, general shot (031)

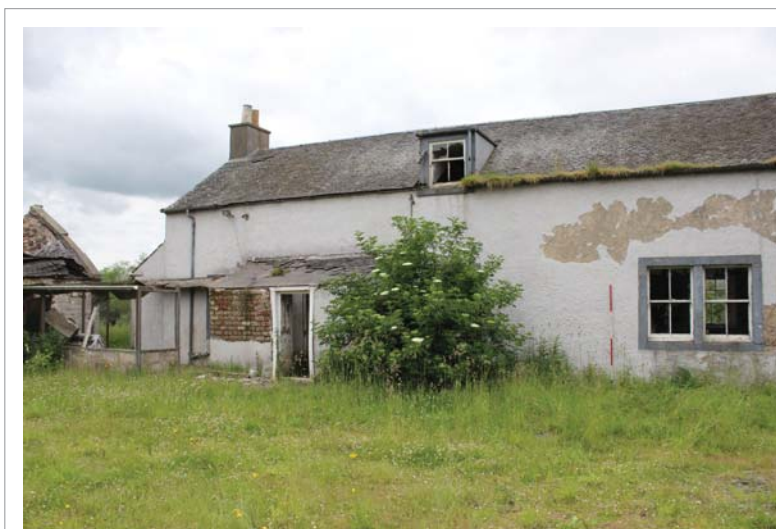
ILLUS 8B  
North range, south elevation, general shot (027)

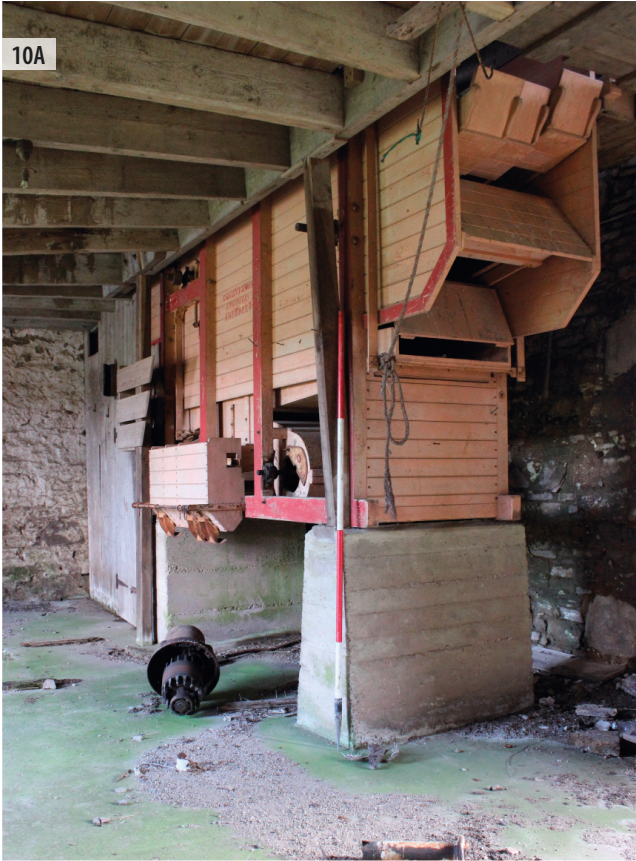
Room 2 was dominated by a modern threshing machine located in the north-east corner supported on concrete plinths (**Illus 10A**). The threshing machine extended through the ceiling of Room 2 into Room 16. It was engraved with 'R. G. Garvie & Sons. Engineers. Aberdeen'. To the north of the machine was a wooden partition which related to the thresher. The interior walls were mostly without render, although some survived on the north wall. Two construction lines indicating the location of a stone-blocked window were recorded on the centre of the north wall, with a wooden lintel still in situ (**Illus 10C**). The blocked window was not apparent on the north exterior elevation. In the south-west corner of the room, a wooden staircase gave access to R16 above. The line of the staircase cut across the window at the south end of the west wall indicating that it was likely to have been inserted at a later date.

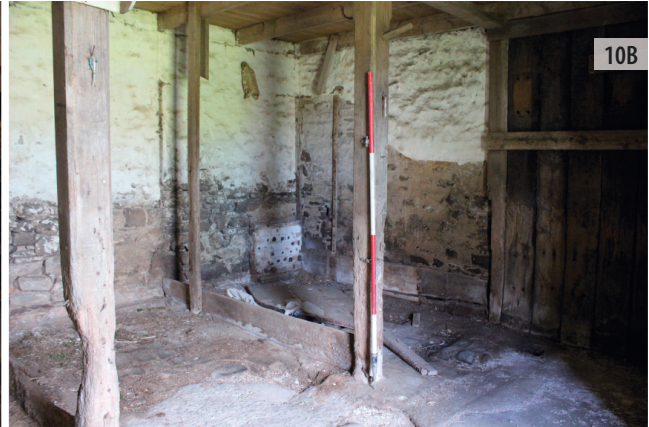
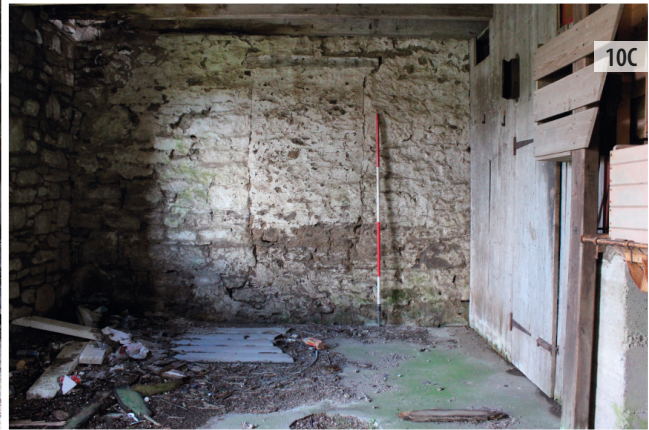
## ILLUS 10

The East Range comprised a two storey, stone built farm building with a gable-ended pitched slate roof. The east face of the roof included four skylights. The building had two internal rooms at ground floor level (R1 and R2) and a single room to the first floor (R16), running the full length of the building. Some evidence of alterations and rebuilding was noted on the external walls.

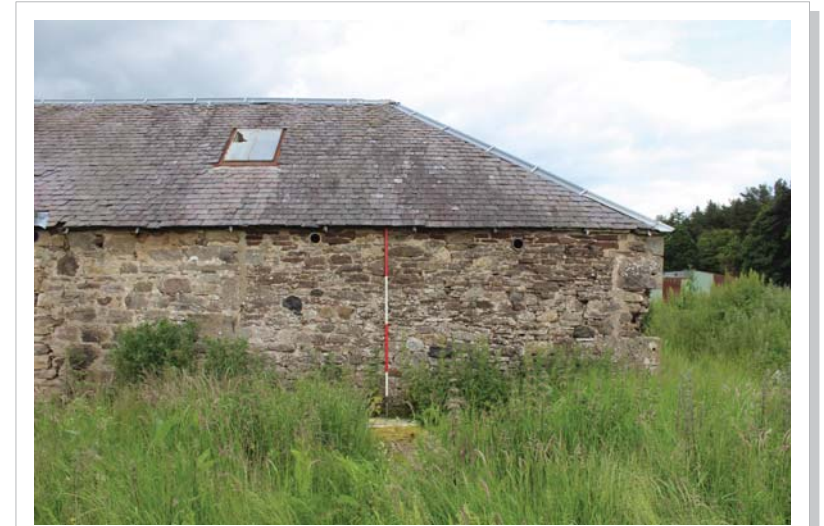
ILLUS 12D  
West range, west elevation, detail of different construction at south end (070)

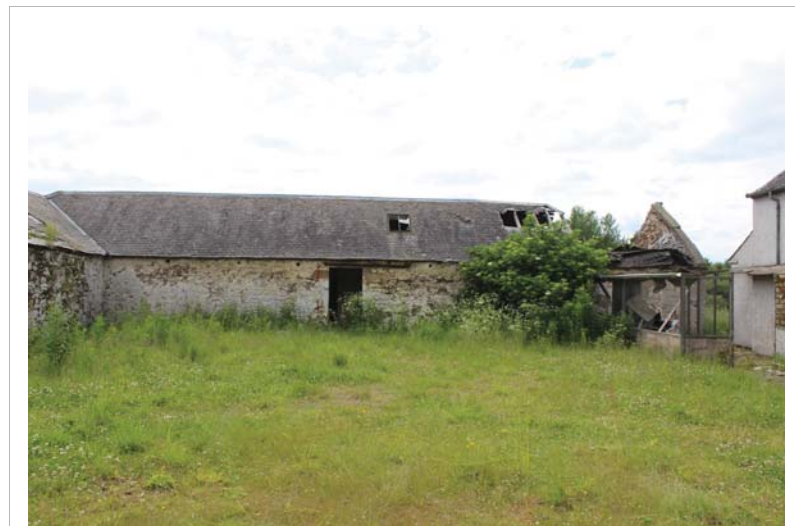
ILLUS 12A  
West range, east elevation, general shot (065)

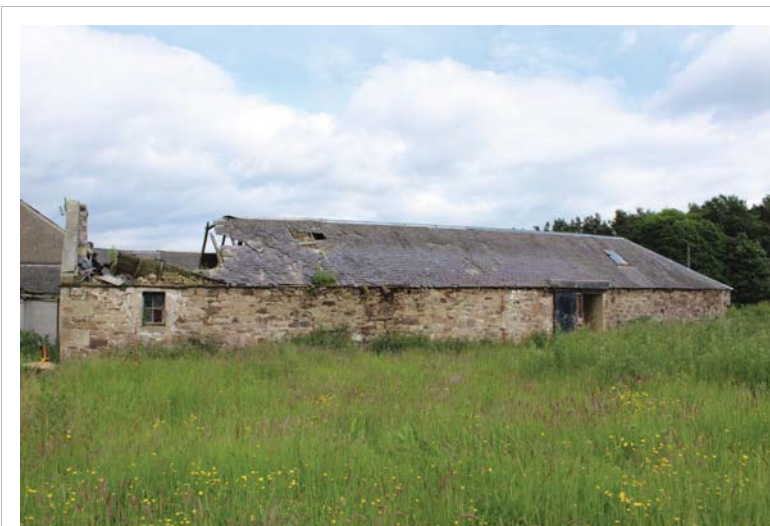
ILLUS 12B  
West range, west elevation, general shot (068)

A timber sliding door (G17) close to the south end and a single window (G21) at the north end were the main features recorded on the west elevation. A possible blocked door was noted in the northern part of the west elevation between door G17 and window G21 (**Illus 12C**). At the south end of the elevation the stonework differed with a larger amount of smaller stones within the construction and a clear line visible between the two construction types (**Illus 12D**). This likely represents the change in plan of the farmstead with the addition of a south range as depicted by the 1897 OS map. A small brick-blocked ventilation slot was also visible immediately to the south of this. The east elevation facing into the courtyard included three doors (G18 – G20) although two of these, close to the north end, were masked by foliage and the collapsed roof. The central door was missing but the iron runner above indicated the position of a sliding door. A central window (G22) was recorded on the north gable elevation with raised skew stones along the roof line.

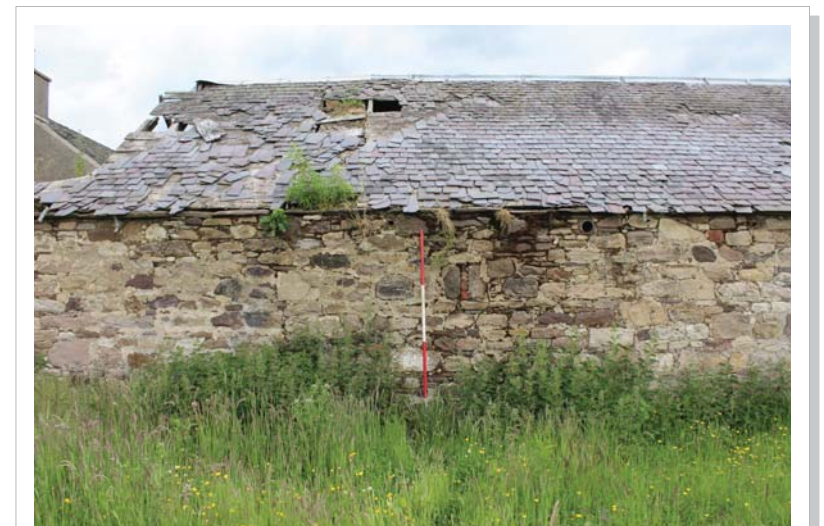
ILLUS 12C  
West range, west elevation, possible blocking (072)

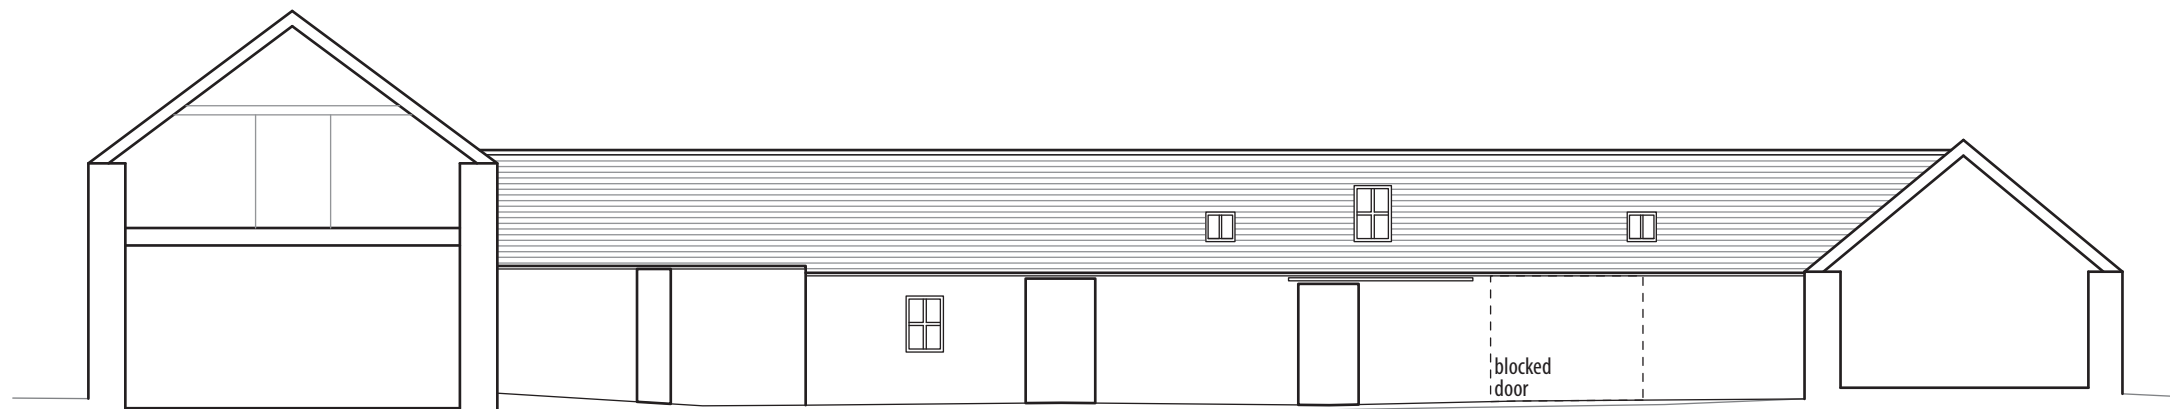
NORTH ELEVATION

The north elevation, facing into the courtyard, provided further evidence for the phasing of the steading. A construction line immediately west of a large double barn door opening (G11) mirrored the construction line on the south elevation. The barn door to the east side of the elevation included a central stone pillar. This open

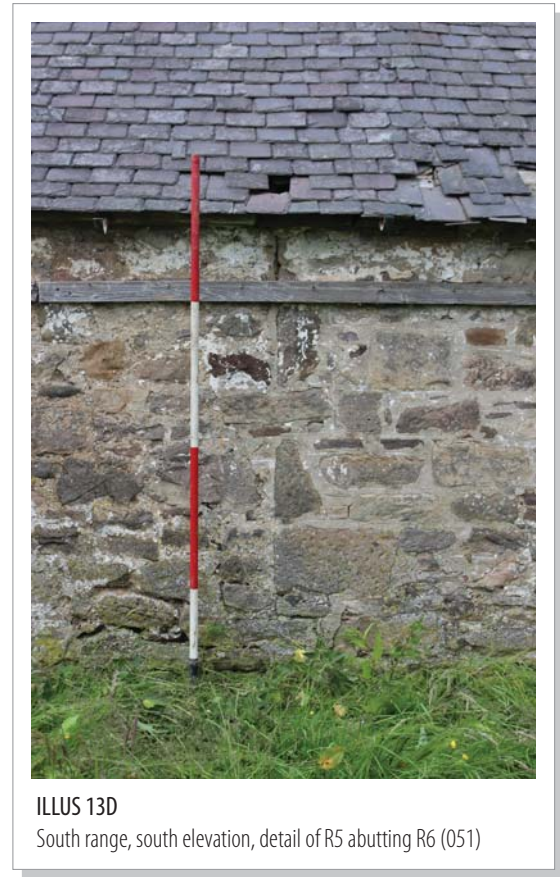
ILLUS 13D  
South range, south elevation, detail of R5 abutting R6 (051)

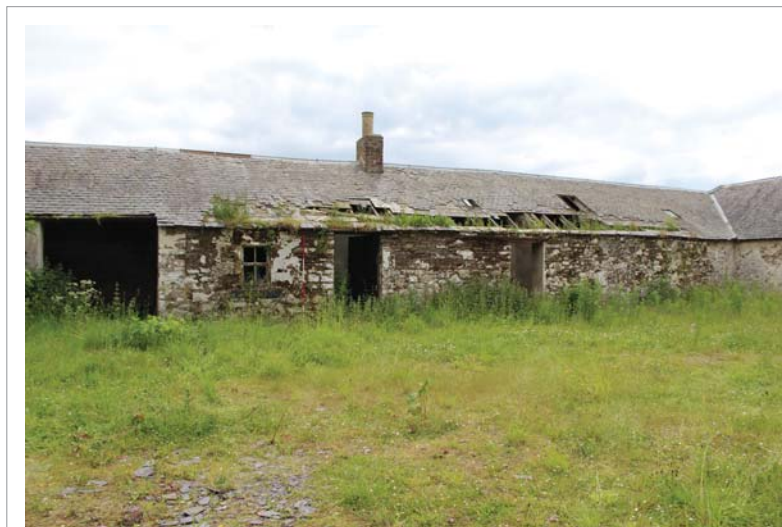
ILLUS 13A  
South range, north elevation, general shot (045)

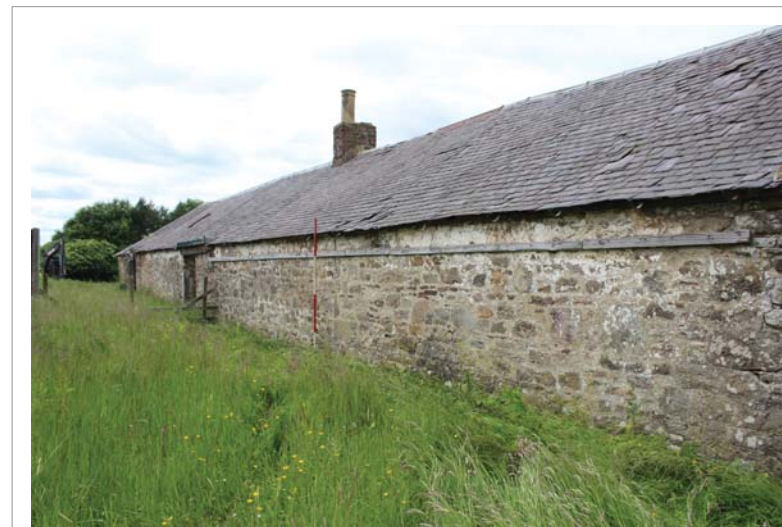
ILLUS 13B  
South range, south elevation, general shot of east end (049)

The south elevation included two doors (G16 and G15) located to the west side of the building. The door and window (G10 and G9) at the east end of the elevation form part of the south end of the East Range and are described above as such. A construction line was recorded approximately 5m from the east end of the range (**Illus 13D**). From the construction lines seen in the south-west corner of the buildings it is clear that the South Range was the last to be built and it may be that originally it was shorter in length, with a gap existing between it and the East Range. At a later date, the gap was filled in and the current horseshoe layout created.

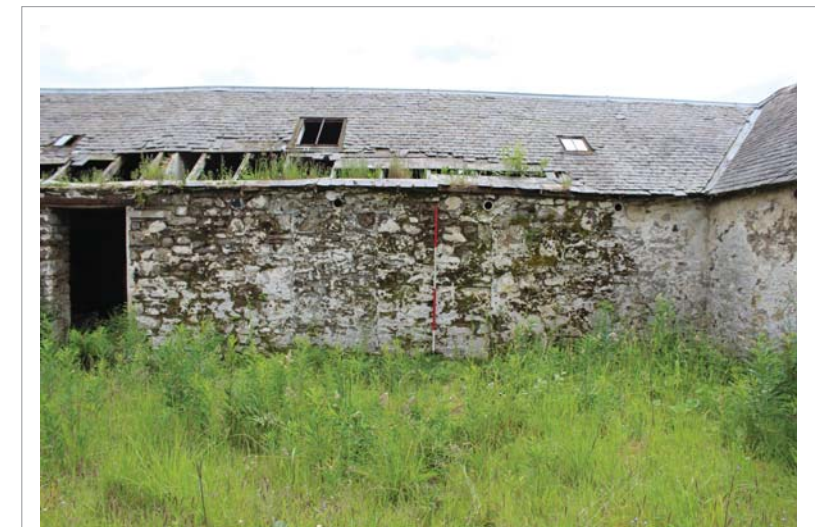
ILLUS 13C  
South range, north elevation, detail of blocked doors to west of G14 (046)

To the west of the construction line the elevation displayed a window and door (G13 and G12) accessing a central room (Room 6) of the range and a second door (G14) leading to Room 7. This second door included an iron railing above indicating the opening was a sliding door. To the west of G14, three construction lines were evident in the elevation. These lines appeared to indicate the part blocking of the opening leaving a narrow door that was subsequently also stone-blocked (Illus 13C).

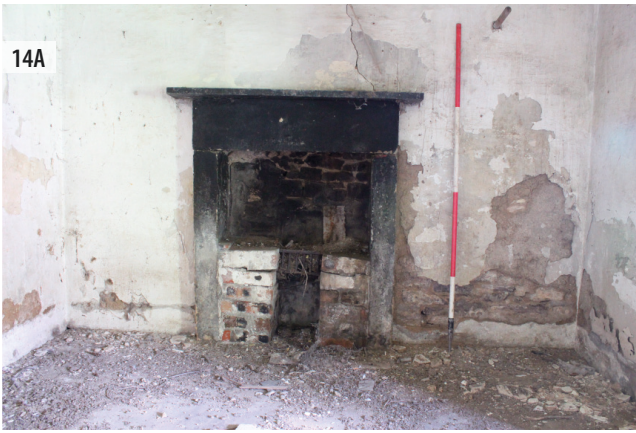
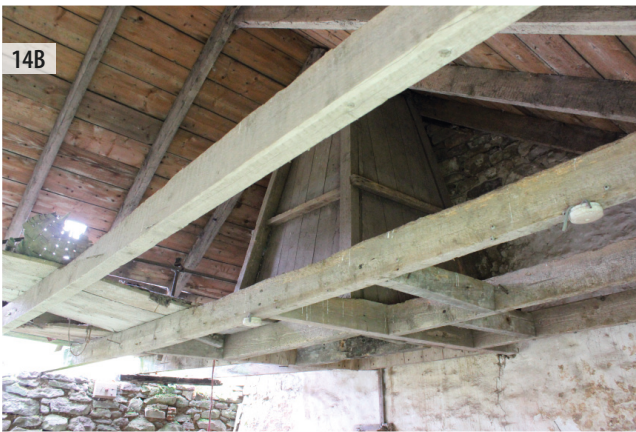
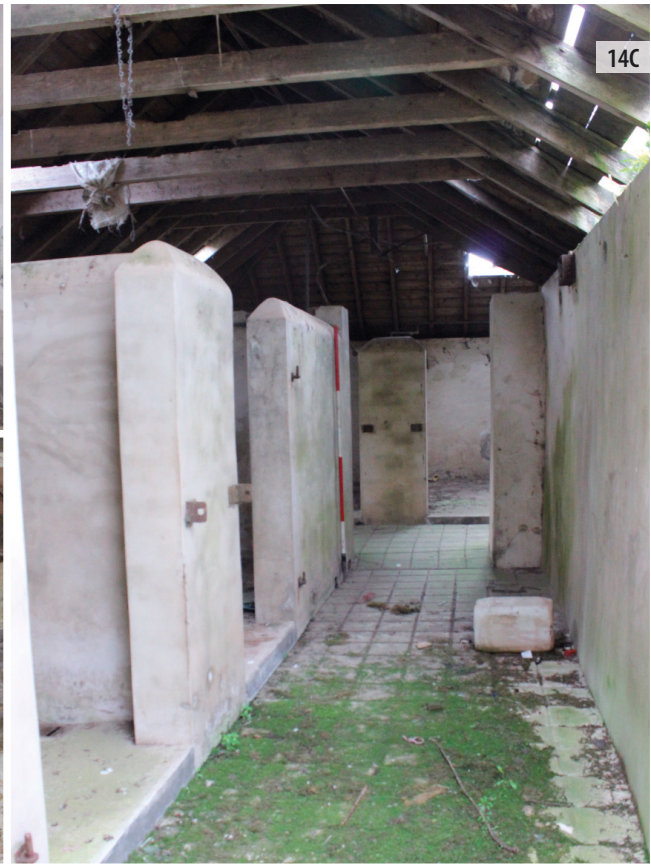
## ILLUS 14

Room 7 contained remains of a raised brick footing along the base of the east wall of the room. This probably represented the foundation for a trough or feeding rack. A chimney-like wooden structure was located in the roof space above the centre of the room, although it was blocked at the top (Illus 14B).

concrete floors and iron tethering rings. The uniformity and good condition of the walls suggest that Room 8 had been converted to this use relatively recently (Illus 14C).

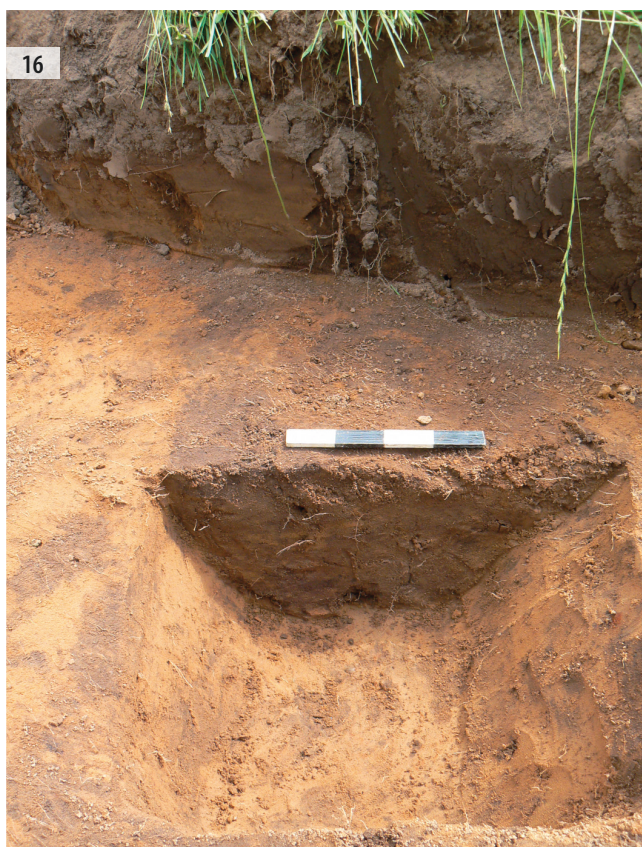
ILLUS 16

West facing section through gully [015]

The majority of the linear features appeared to be heavily truncated and were less than 0.1m deep. There were two exceptions with features [015] and [019] in the north half of Trench 2 significantly deeper. Gully [015] was 0.4m to 0.5m wide and 0.22m deep with sloping sides and a flat base (Illus 12). Gully [019] was located some 3m to the south. It was 0.4m wide and 0.33m deep with sloping sides and a rounded base (Illus 13).

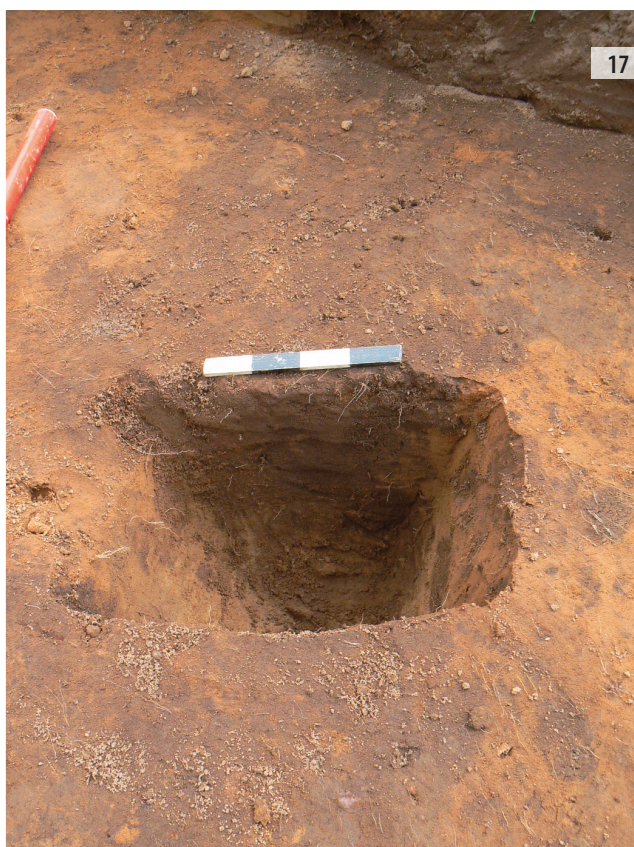
ILLUS 17

West facing section through gully [019]
