# PRIMARY SCHOOL, HOWATSHAWS ROAD, DUMBARTON

## ARCHAEOLOGICAL EVALUATION

commissioned by Morgan Sindall  
on behalf of HUB West Scotland

DC14/193

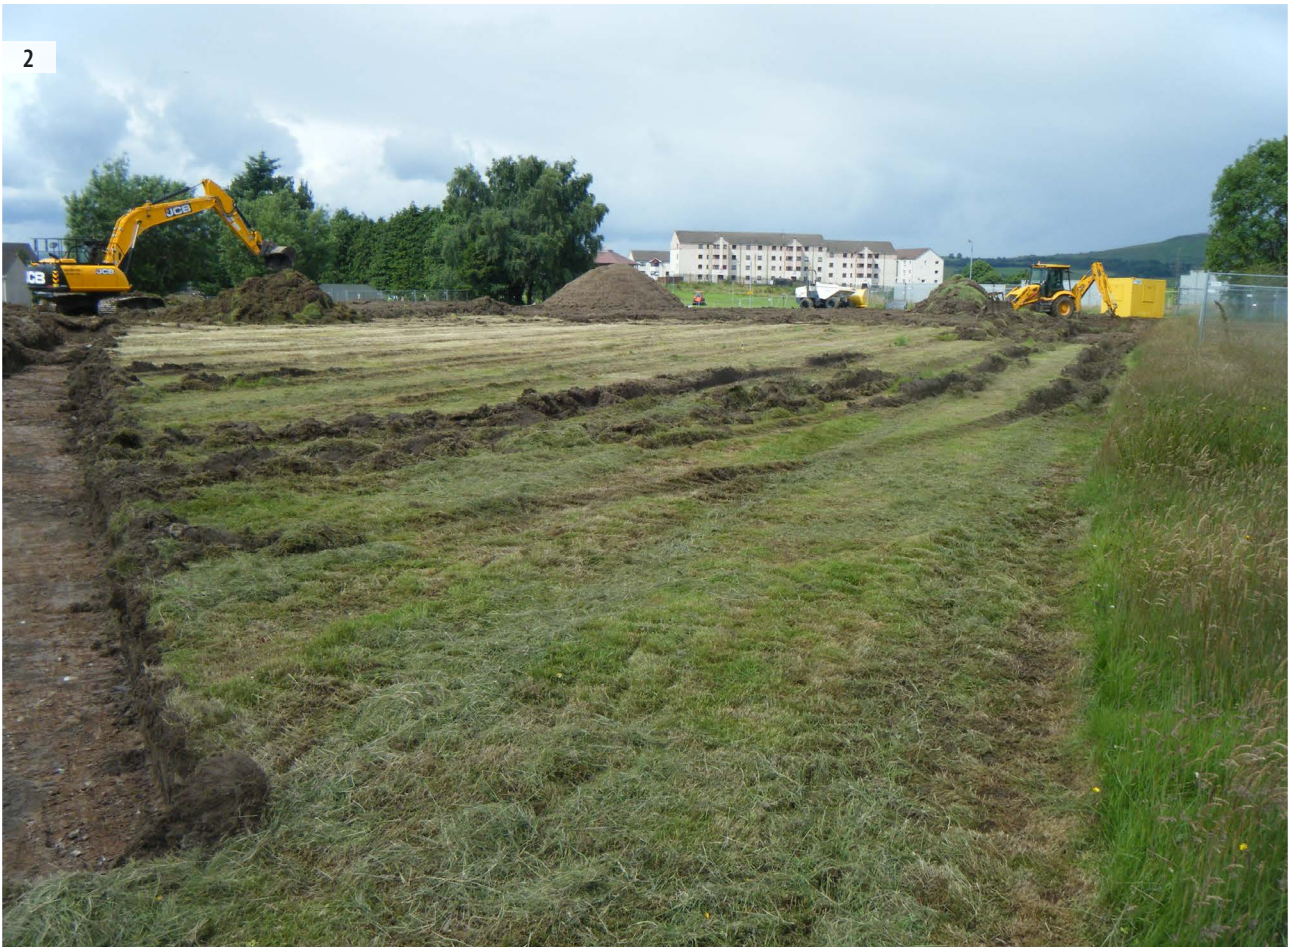
ILLUS 2 W facing view of site    ILLUS 3 Trench 1, NE facing view    ILLUS 4 Trench 6, SE facing view    ILLUS 5 Trench 7, SE facing view

The evaluation did not reveal any deposits of archaeological significance. It seems likely that the area was subjected to levelling at the time of the construction of the Primary School in order to provide a flat surface for a playing field. The presence of a large number of modern drains indicates that the area was susceptible to water retention, most likely as a result of the levelling itself

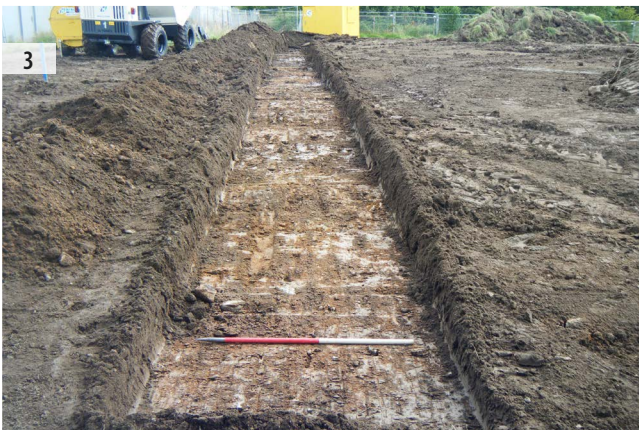
The topsoil (001) comprised mid brownish grey silty sand 0.25m – 0.40m thick overlying mid pink silty clay natural subsoil (003). Occasional patches of mid yellow sandy clay natural subsoil were exposed in trenches one, four and six – the western part of the site. A make-up deposit (002) of compact grey clay 0.35m thick containing brick fragments and planks of wood was identified at the northern end of the trench one, underlying the topsoil. This make-up deposit also occurred in patches in the northern half of trench six where it was observed to be between 0.10 and 0.20m deep.

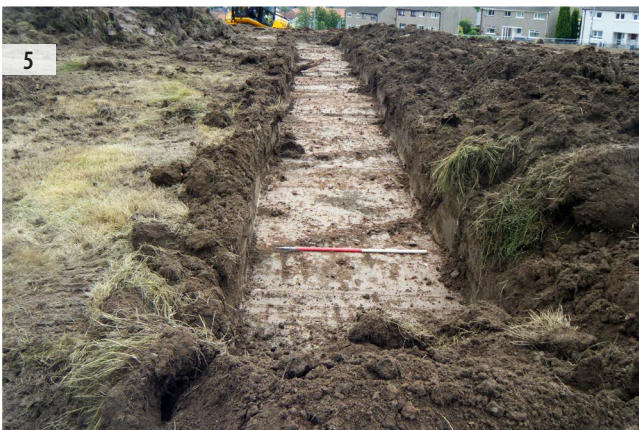
A number of modern plastic drains oriented north – south or north-east to south-west were observed in each trench (except trench one). No ceramic field drains were observed.
