# KINFAUNS OLD PARISH CHURCH

## ARCHAEOLOGICAL WORKS

commissioned by The Tay Landscape Partnership (TLP)

October 2015

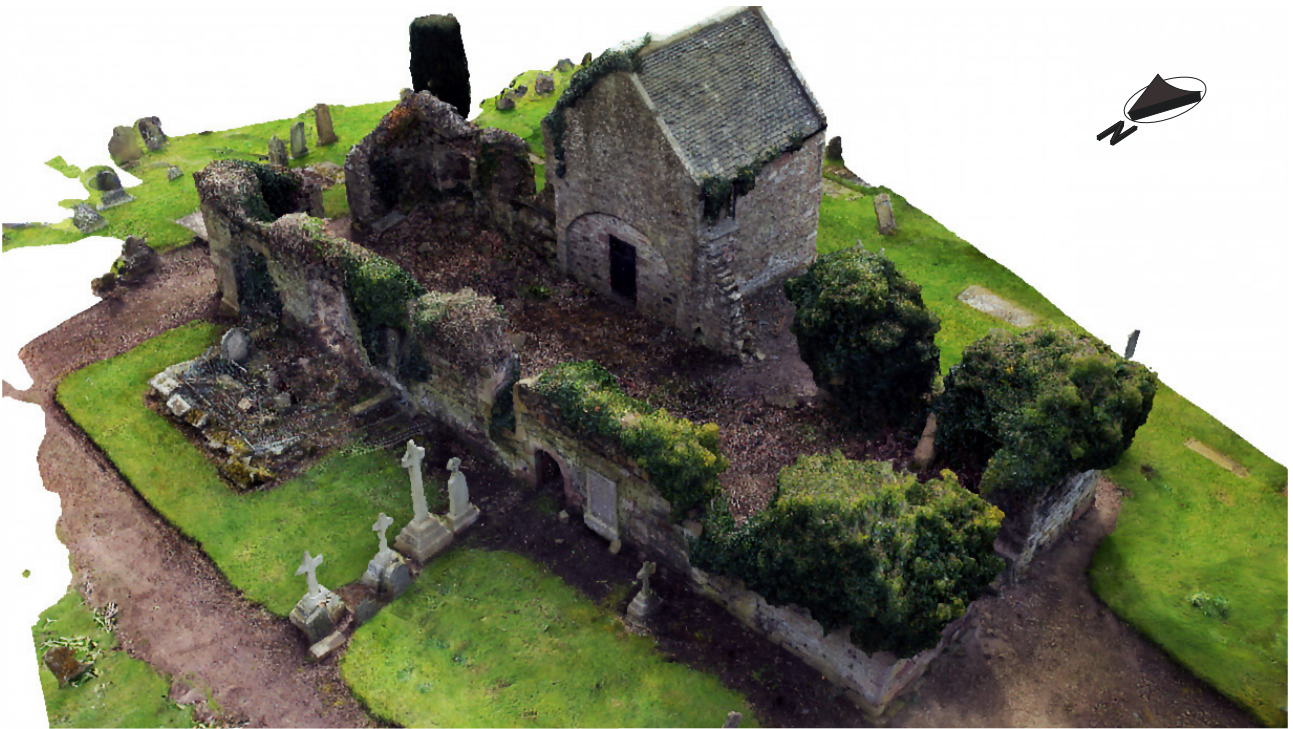
ILLUS 2

Aerial view of photogrammetric model

The photogrammetry completed during the Historic Building Recording allowed a 3D model of the monument with information

captions to be generated and linked to the Tay Landscape Partnership website. As a result, any member of the public can access the model and move around and within it to examine structural detail as they please.

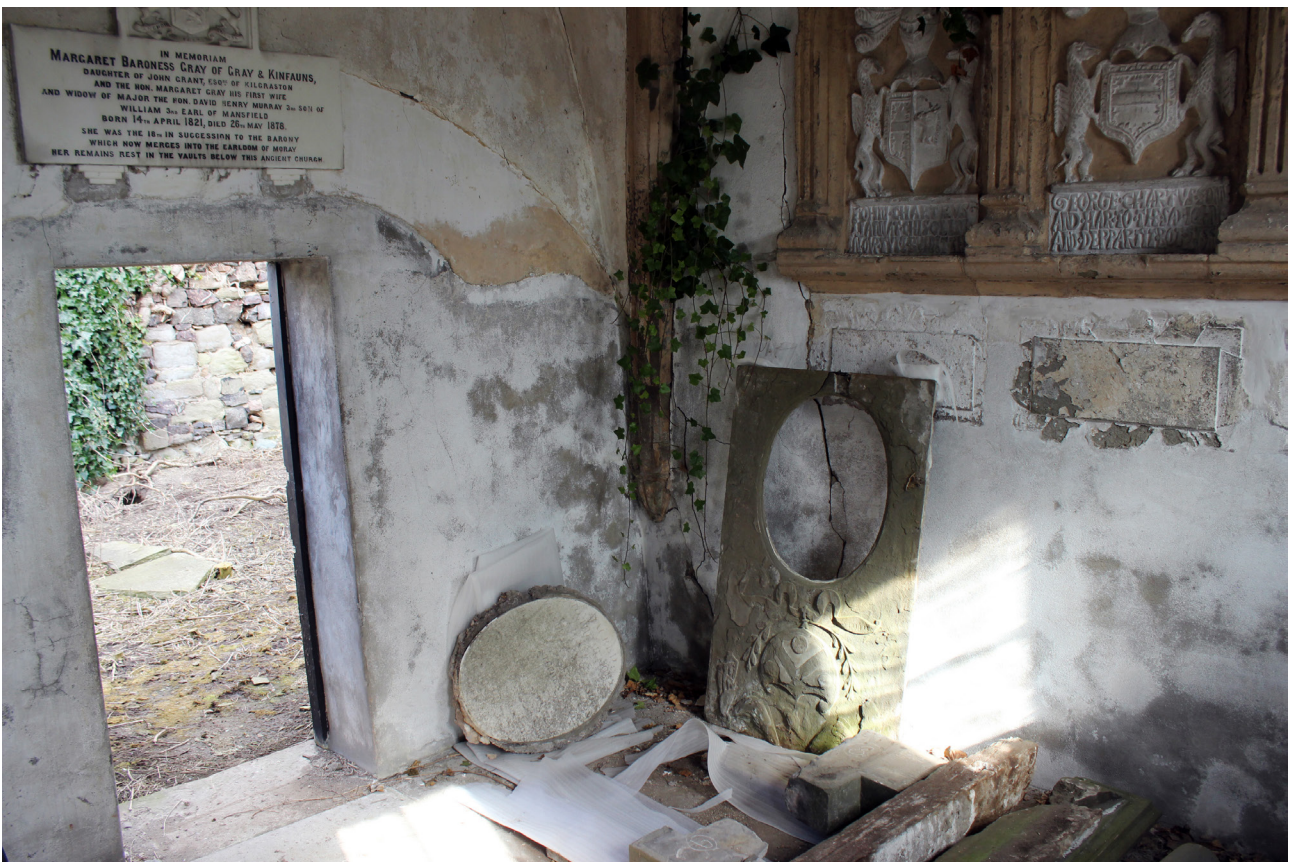
ILLUS 3

General view of interior of burial aisle, facing NE

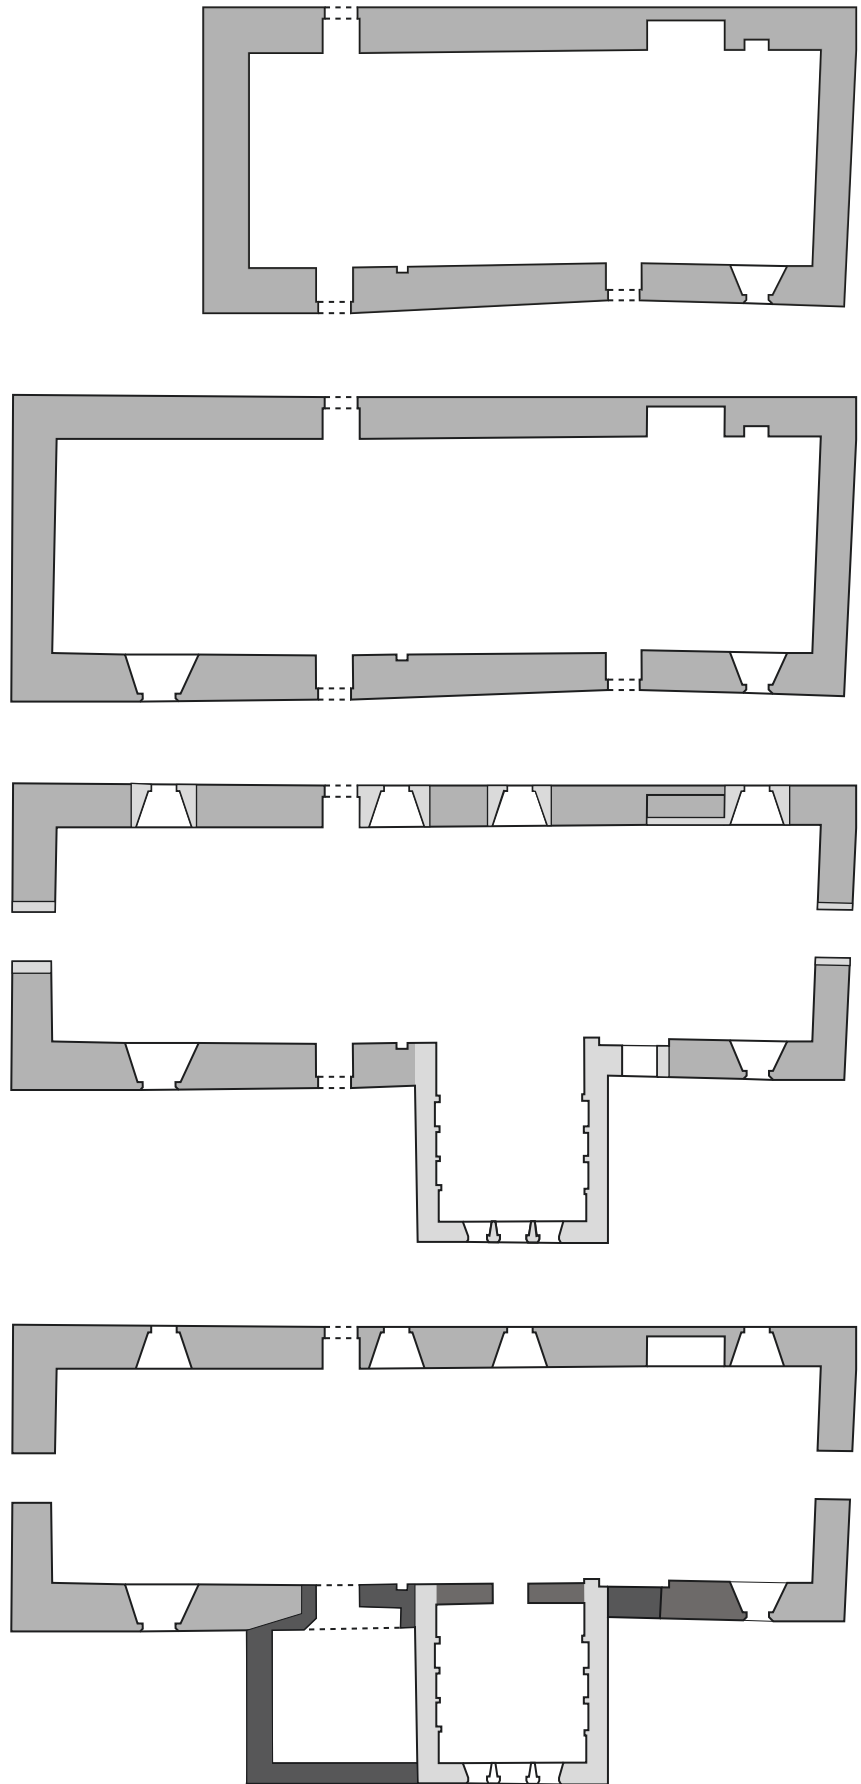
ILLUS 4

- phase 2
- phase 3
- phase 4

Suggested phasing for Kinfauns Old Parish Church

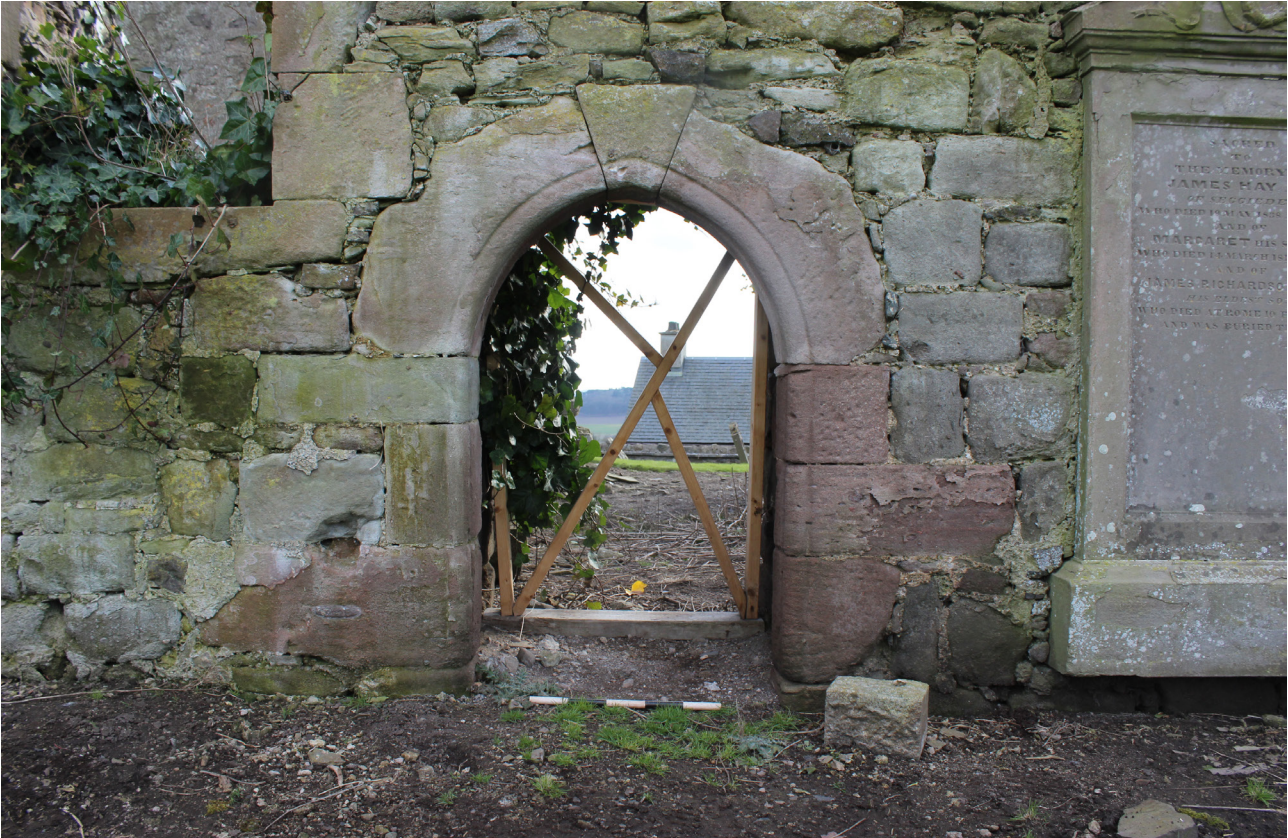
ILLUS 5

North door, facing S

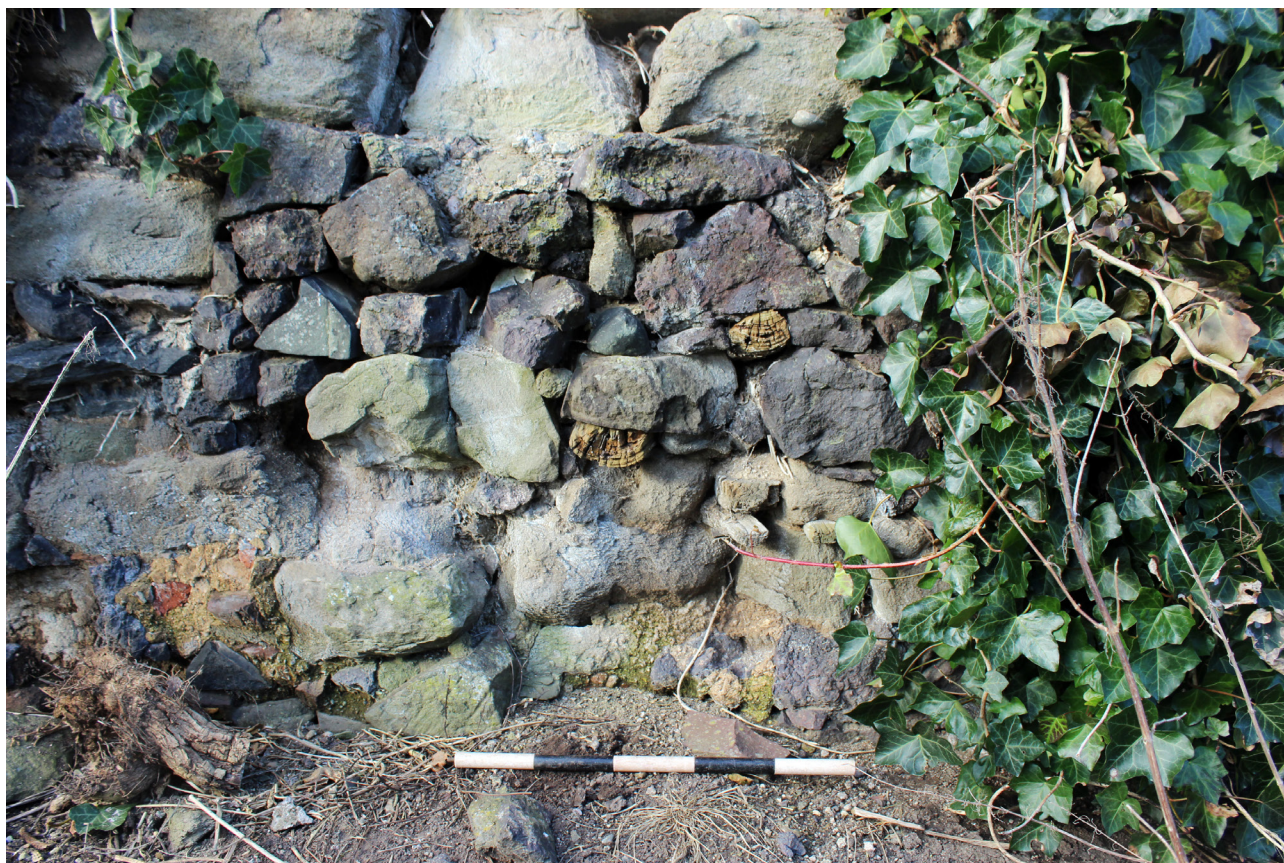
ILLUS 6

Timber dooks in north wall, facing N

The poor quality of the replacement masonry may suggest that the building was more fully rendered externally at this time. The timber dooks visible on the interior of the north wall may also date from this point, suggesting a new plastered interior that most likely covered any earlier painting. The chancel recess and water stoup would also have been covered, with any protruding elements initially chipped away.

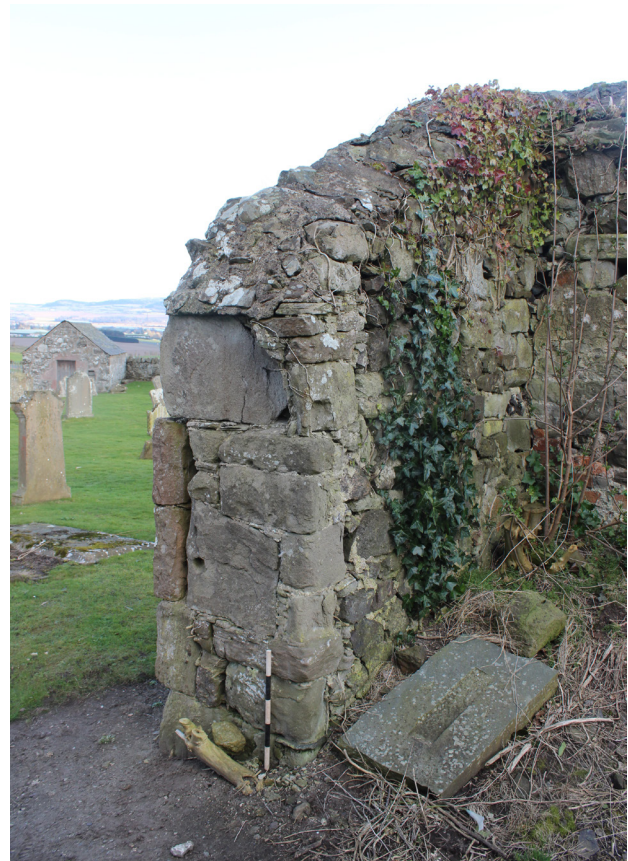
ILLUS 7

The only significant modification to this elevation appears to be the insertion of a central doorway. This was built using very thin grey or red sandstone facings with some horizontal tooling. They are pinned in places with slate. A stoop was just visible on the northern side of the doorway. There was no obvious sign of fittings for hinges, but the potential remains for a pivot in the stoop. A small possible bolt-hole was observed in the southern jamb (ILLUS 7).

Southern door jamb on east wall, facing south-east and showing possible bolt-hole

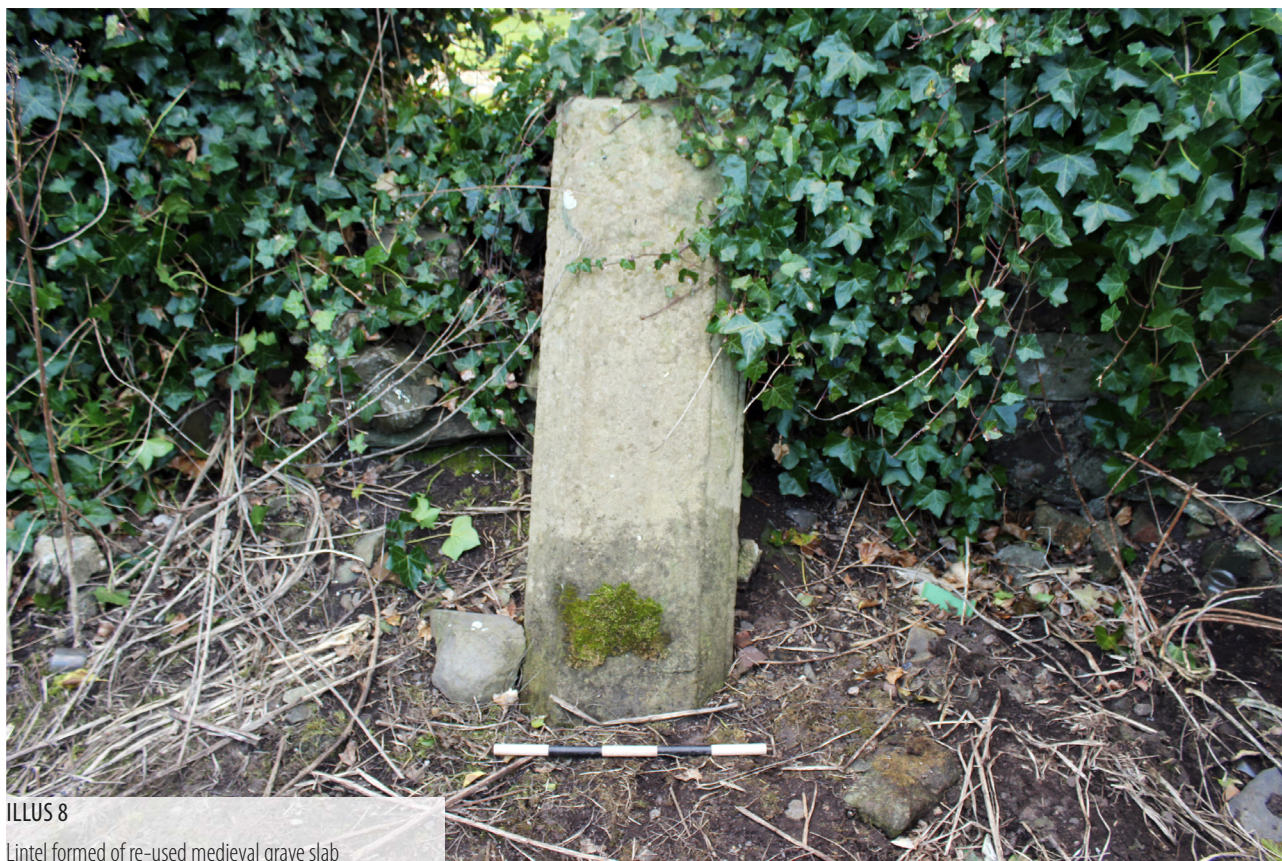
ILLUS 8

Lintel formed of re-used medieval grave slab

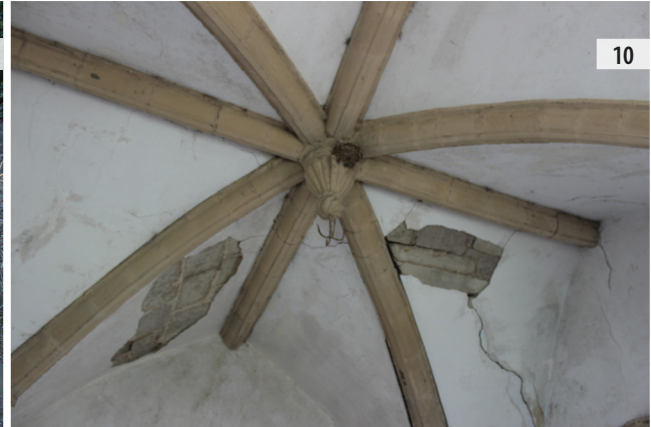
10

The interior of the burial aisle (ILLUS A1.7) is dominated architecturally by a plastered rib vault (ILLUS 10). The ribs are exposed sandstone with triple-filleted roll moulding, on shell-shaped springing. The ribs feature heraldic crests mid-length on the diagonal ribs. These depict either a unicorn or a scrolled design, with opposing crests matching. A twisted ribbed boss finishes the apex of the vault. Some ivy has penetrated through the render to the north-east corner. The floor is of stone flags with some concrete replacements. One of these, near the north door is loose and may have been used to access the burial vaults below.

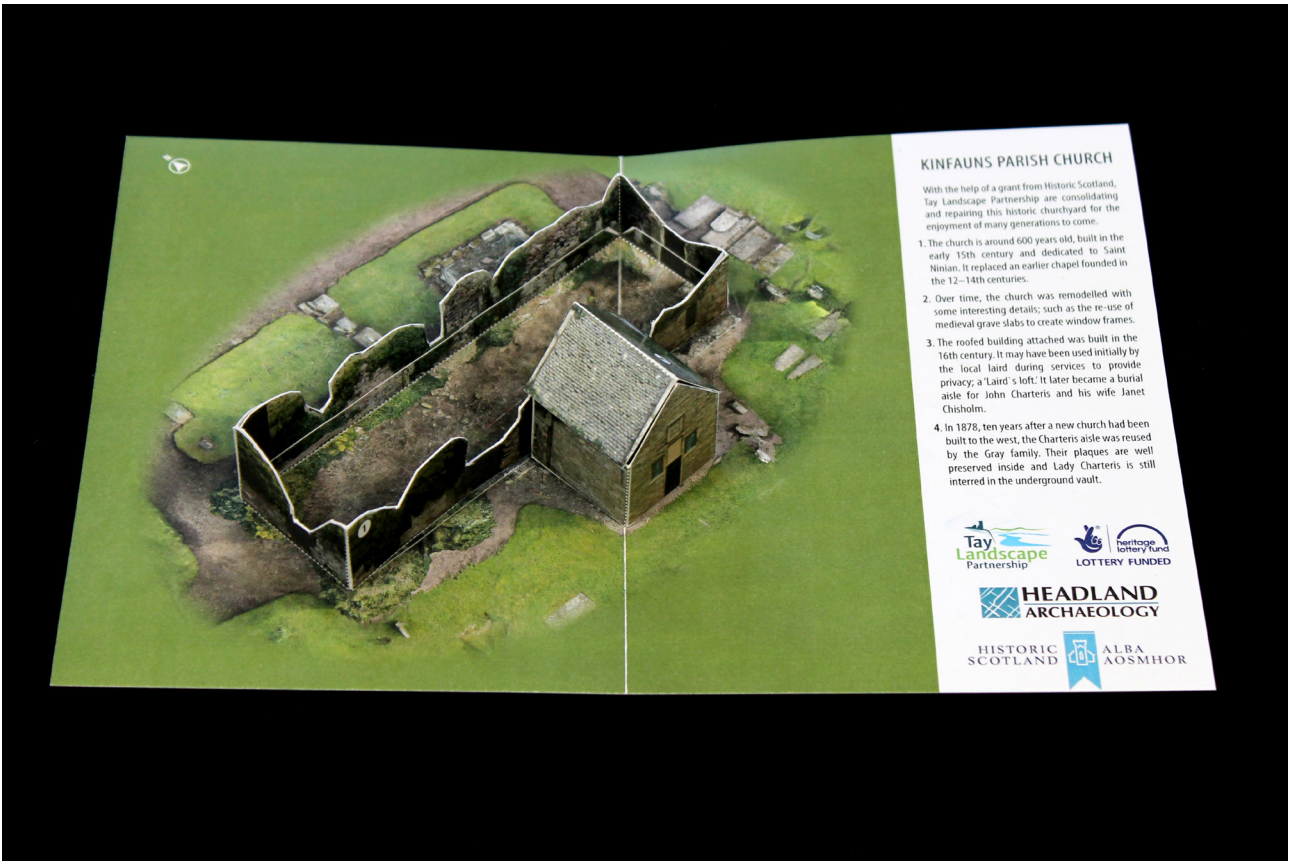
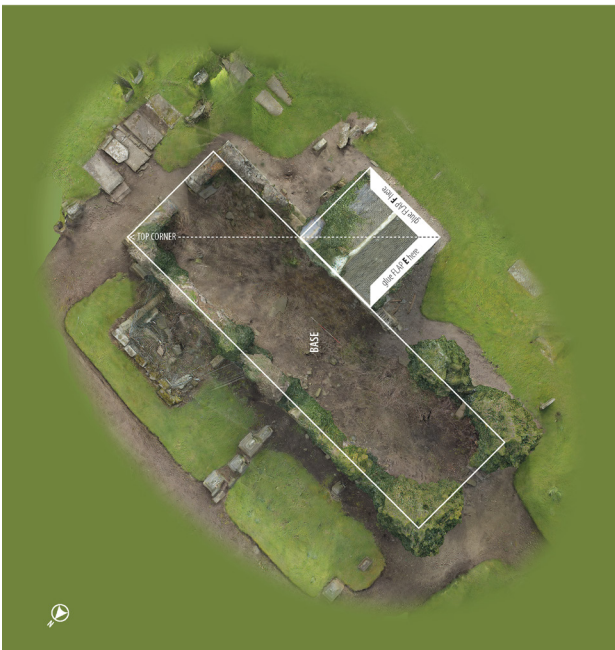
**KINFAUNS PARISH CHURCH**

With the help of a grant from Historic Scotland, Tay Landscape Partnership are consolidating and repairing this historic churchyard for the enjoyment of many generations to come.

1. The church is around 600 years old, built in the early 15th century and dedicated to Saint Ninian. It replaced an earlier chapel founded in the 12-14th centuries.
2. Over time, the church was remodelled with some interesting details, such as the re-use of medieval grave slabs to create window frames.
3. The roofed building attached was built in the 16th century. It may have been used initially by the local laird during services to provide privacy, a laird's loft. It later became a burial aisle for John Charteris and his wife Janet Chisholm.
4. In 1878, ten years after a new church had been built to the west, the Charteris aisle was reused by the Gray family. Their plaques are well preserved inside and Lady Charteris is still interred in the underground vault.

In addition, the material and instructions to make a pop-up card have been produced that will also be available to download, print out and make from the website (ILLUS 11).

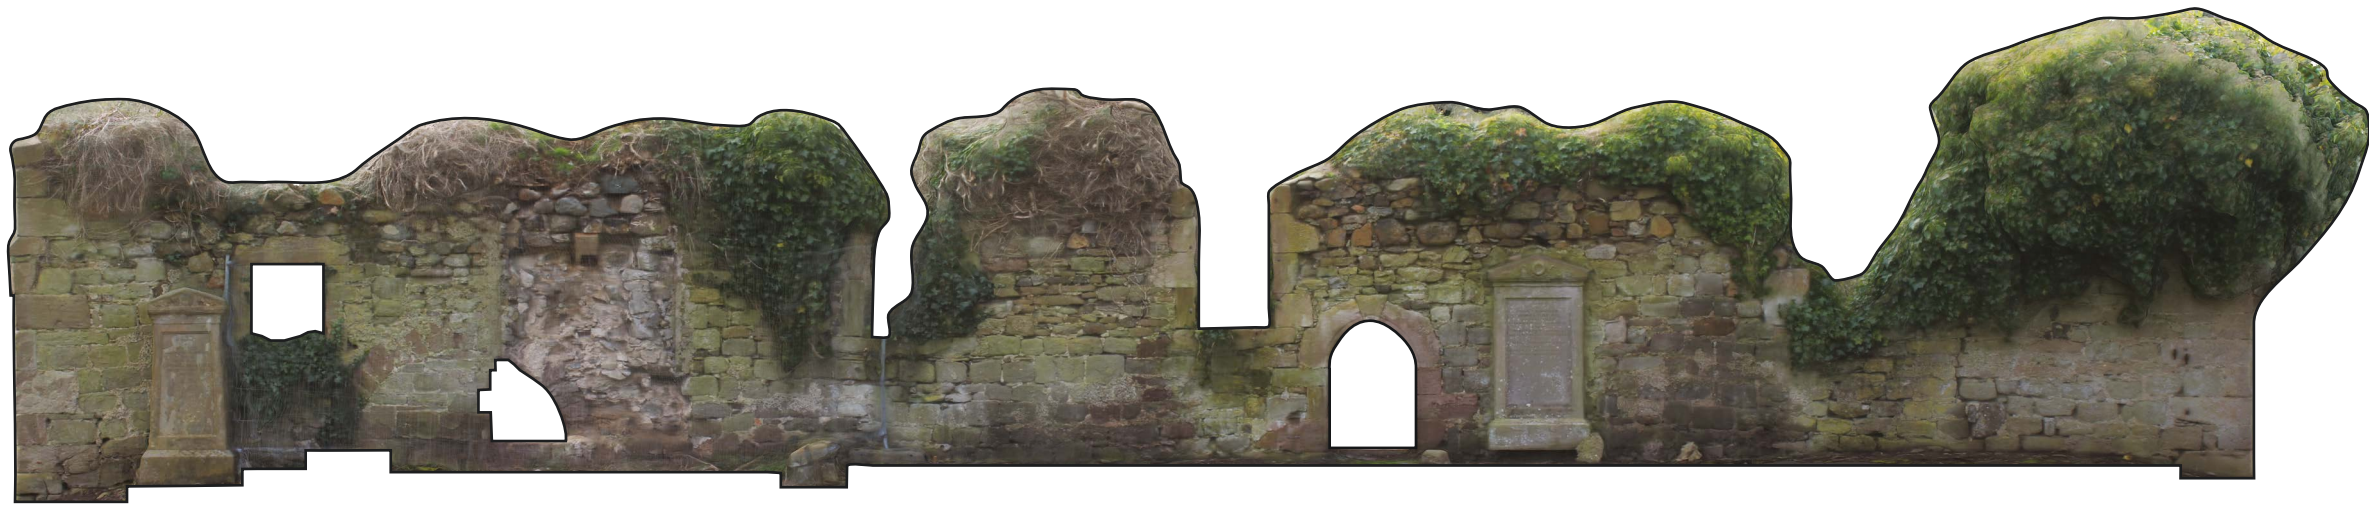
The north wall stood to around 12 courses (approximately 3.5-4m) with three different fabric types evident (ILLUS A1.1). The lower six to ten courses and most of the east and west ends were principally of a similar coursed grey/brown sandstone as the east elevation and may be presumed original. Two original features are evident; the first being the vaulting of the internal semi-circular chancel recess which can be seen externally and is built of red sandstone and infilled

The wall appears to have been heavily rebuilt to incorporate four substantial rectangular windows. The fabric surrounding these openings is of thinner and more variable stone that was only partially coursed, there does not seem to be a lot of re-use of original squared stone. The windows were of similar style with heavy red/grey sandstone surrounds with some horizontal tooling. Three of the windows were at the same height, and all missing their lintels. The easternmost window was built lower in the wall and survived intact, almost abutting the stone arch for the chancel recess. This may be an indication that a gallery had been constructed at this end that would have blocked a higher window. The stonework around the top of the windows is distinct in that it is completely uncoursed and comprises a mixture of roughly squared and unshaped, sub-rounded stones with many packing stones. This could relate to the insertion of the windows but may also be a later phase, possibly relating to a later replacement of the roof. The wall heads have been largely consolidated with modern cement although this is generally obscured by ivy, which has taken a strong hold in the fabric of this wall and poses a threat to its stability. Two memorials have been incorporated into the wall in the 19th century, one each at the east and west ends. The one at the east end has since collapsed and been removed to the burial aisle for safety. A large section of the core of

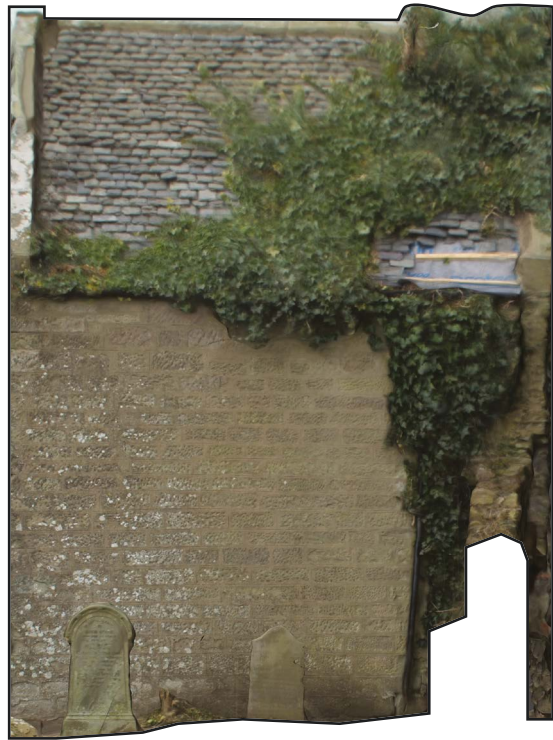
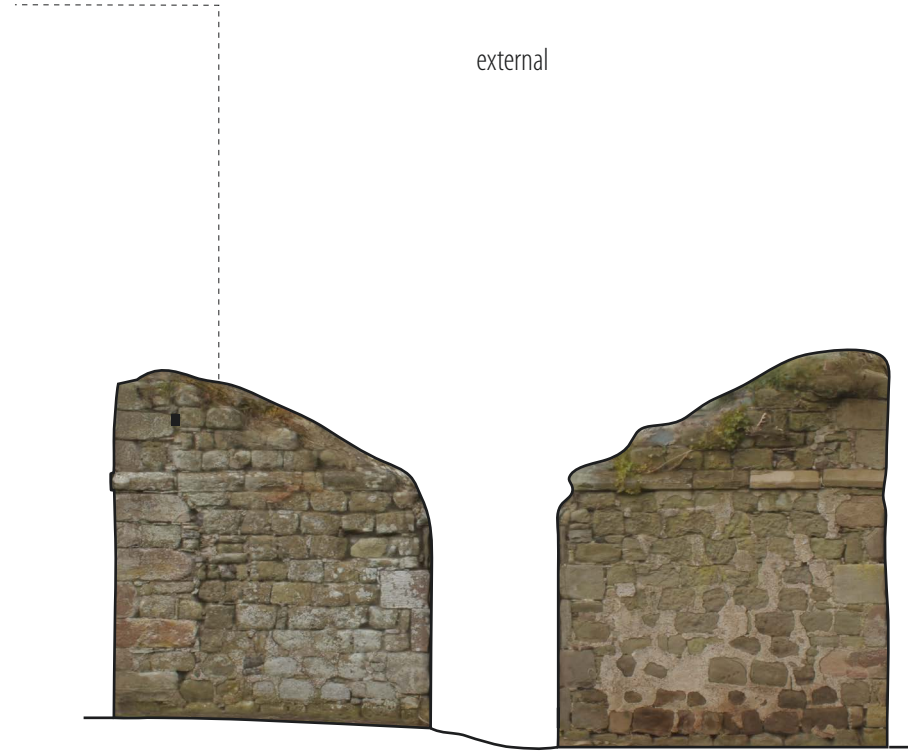
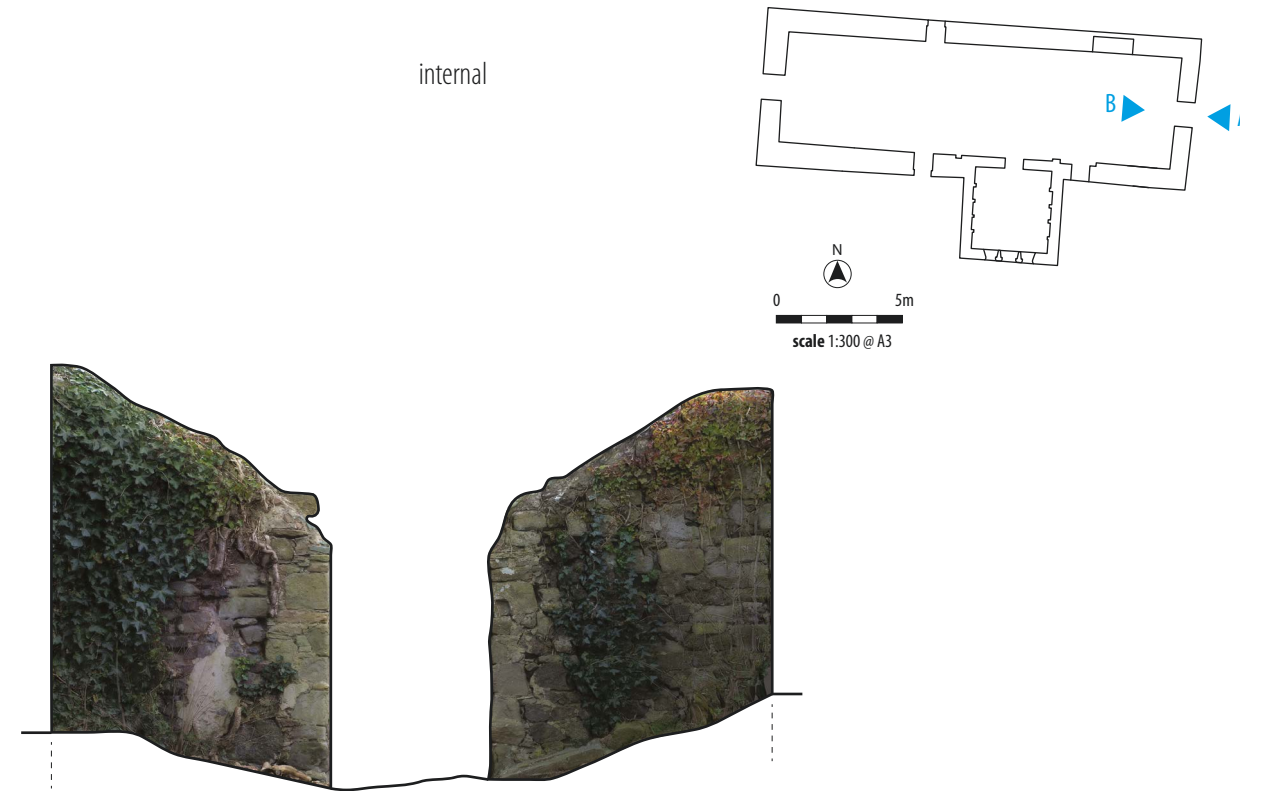
The fabric of the wall comprises regular courses of squared grey/brown sandstone blocks (ILLUS A1.3). The gaps between the blocks are large and irregular and are frequently pinned with small stones (snecked construction). The surface of some of the stones has been coarsely pecked. The mortar was a coarse grey lime mortar, which was also applied in places as a render on the northern part of the elevation and likely to be relatively recent. There are several small areas of repair, where a larger stone has been removed and replaced with several smaller ones, including some black whinstone fragments which are otherwise absent from fabric. An iron fitting was noted on the south side above head height and may have been a mounting for a bell. A possible foundation course of smaller, more rounded stone was visible on the northern part of the elevation, where the ground level was somewhat reduced. The wallhead is sealed with modern cement – most likely the result of stabilisation in the 19th- or 20th centuries. Although some ivy was growing from the top of the wall, this was one of the least affected parts of the building.

The quoins are of long, neatly squared red sandstone ashlar with fine pecked tooling. They are irregular in height and do not align well with the coursing of the main fabric. A possible crack (or at least a significant gap) is evident especially on the southern side of this elevation. The quoins on the north side of the elevation appear a little shorter than those on the south. A projecting chamfered string course of the same stone and finish as the quoins divides the wall at a height of 2.3m. Some of the stones appeared heavily weathered or otherwise damaged. Thin pinning stones are evident above and below this course, as well as between some of the quoins. The fabric above and below this course is not perceptibly different.

The internal stonework was of random grey, red and brown sandstone blocks (ILLUS A1.3). These have been built to a face and some are roughly squared, although there are many large gaps and packing stones. This would undoubtedly have been rendered – there was no obvious sign of dook-holes on this elevation although these would not necessarily be readily distinguished from gaps in the masonry. A patch of fine grey lime render survived to the northern side although this is unlikely to be original. The insertion of the doorway is especially clear internally. This elevation suffered from considerable ivy coverage and the build-up of debris against the stonework.

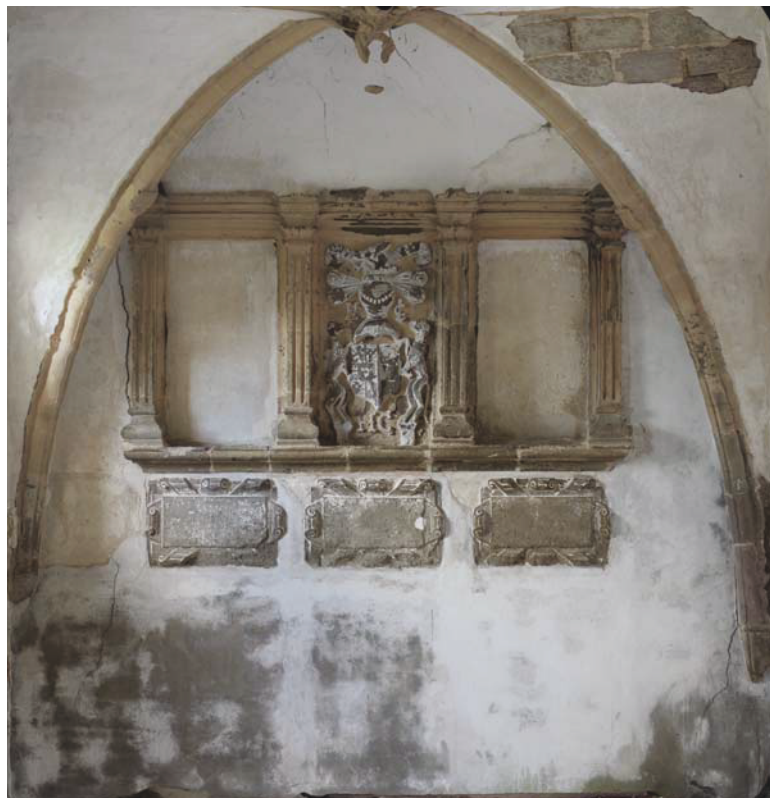
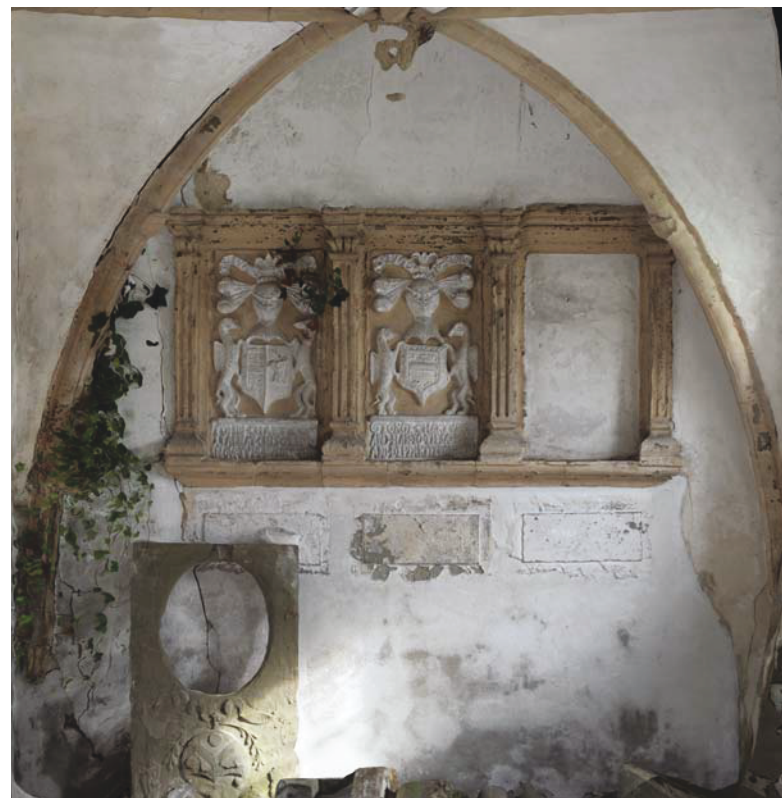
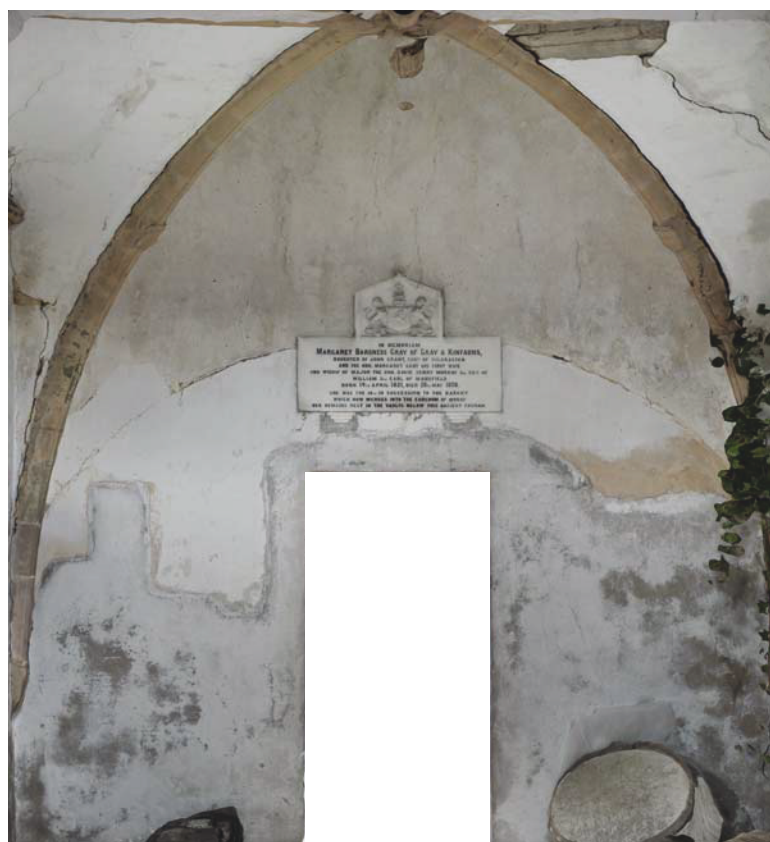
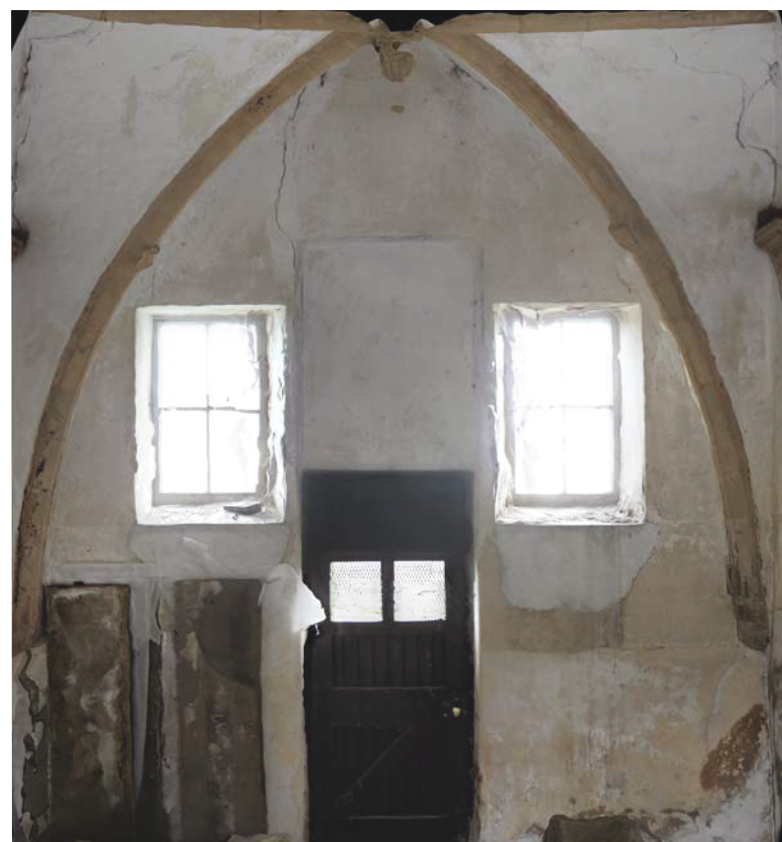
The internal render seems to be relatively modern, and particularly on the lower parts of the walls where it appears to be a white-painted concrete and masks some of the stone detailing. Some of the upper plaster/render may date to the late 19th century when the Gray family re-purposed the aisle as their family burial vault. This is especially evident on the north elevation where the low, wide archway to the nave of the church was infilled and replaced with a wooden door. Above the door, on the line of the former arch, is a marble memorial plaque in memory of Margaret Baroness Gray of Gray & Kinfauns, dated 1878, whose remains lie in the vaults beneath the floor. The south elevation features a similar wooden door in a tall recess flanked by the two high-level windows.

The east and west elevations feature mirrored triptychs containing Charteris family arms (albeit with several empty panels), which appear to be in good condition and may have been restored. The square, fluted pilasters bordering the panels have chamfered bases and are topped with acanthus leaves. Below each panel are stone scrolls, which have become somewhat swamped during the most recent re-rendering.

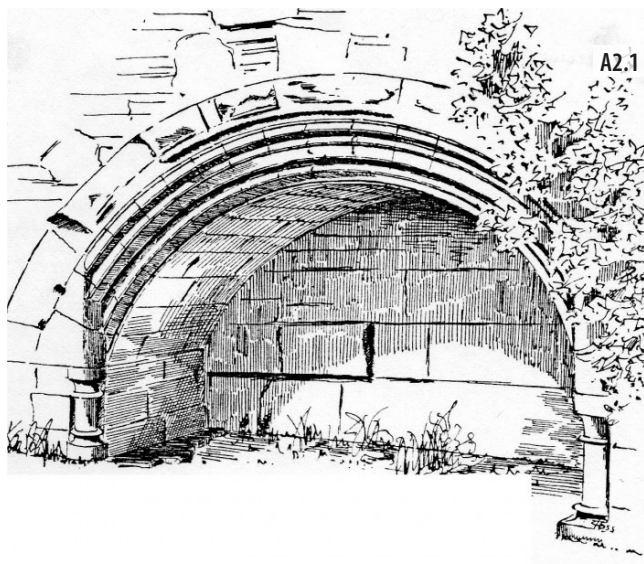
#### ILLUS A2.1

Comparison of a 1902 sketch of the recess (**ILLUS A2.1**) with a modern photograph (**ILLUS A2.2**) gives some indication as to the height of the floor level in the building. At least a full course of masonry from the back wall of the recess has been obscured, giving an indication that

The semi-circular-headed recess in the north wall of the chancel in 1902 (after MacGibbon and Ross 1902, Fig 1477)

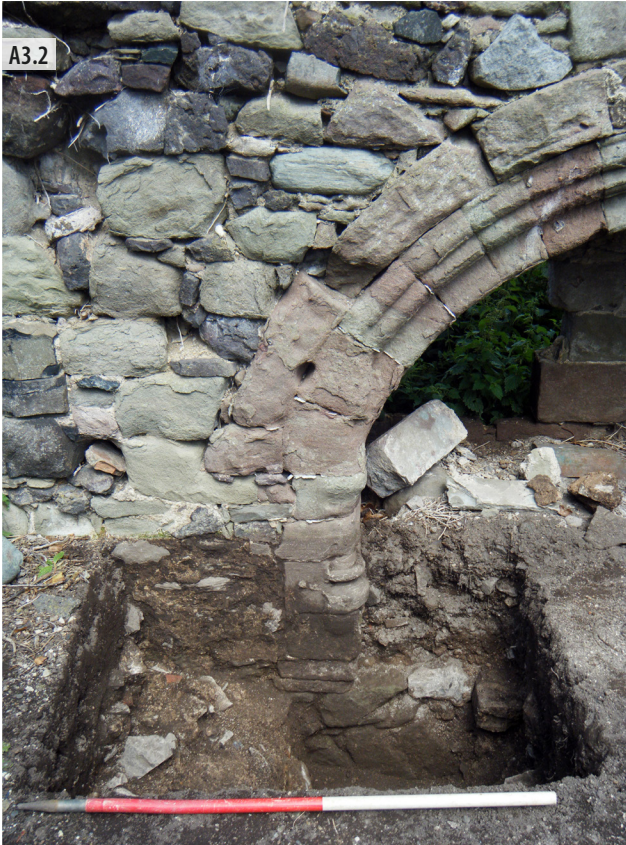
ILLUS A3.2

The wall foundations below the assumed floor level were laid in a way that formed a flushed face in line with the wall above, possibly indicating that the original floor was at a lower level. However, the floor level was indicated by plaster remnants still adhering to the wall to the west of the recess. The plaster only extended down to the proposed floor level and was not seen on the flushed wall face further down (Appendix 3, **ILLUS A3.2**).

Wall face and lower part of recess exposed in Test Pit 1.  
From S

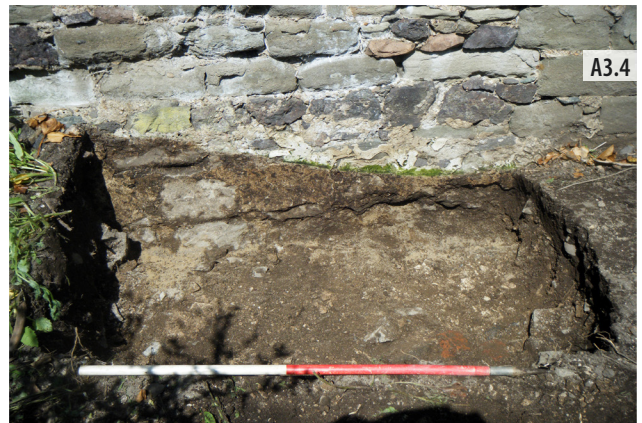
The pit was excavated to a level fully exposing the base of the north wall (Appendix 3, **ILLUS A3.4**). Remnants of wall plaster still adhering to the wall were recorded on the lower parts of the wall behind the upper dumped deposit (006). The remnants had probably been protected from weathering by the soil. The upper part of the foundations were exposed below the base of the wall comprising a couple of rounded boulder protruding beyond the wall face.

Base of wall with remains of wall plaster. From S

The base of the north wall was clearly identified in Test Pit 3, where a stone from the foundations was exposed protruding beyond the internal wall face. However the foundations exposed in Pit 1 were of different construction, built with a flush inner face in line with the wall face above and not displaying any clear transition from foundations to the overlying wall. Similar straight foundations were found in Pit 2 and may indicate that there had been a crypt under the chancel that was subsequently infilled. Due to the find of skeletal remains, the full depth of the foundations were not exposed and this hypothesis could not be further explored.

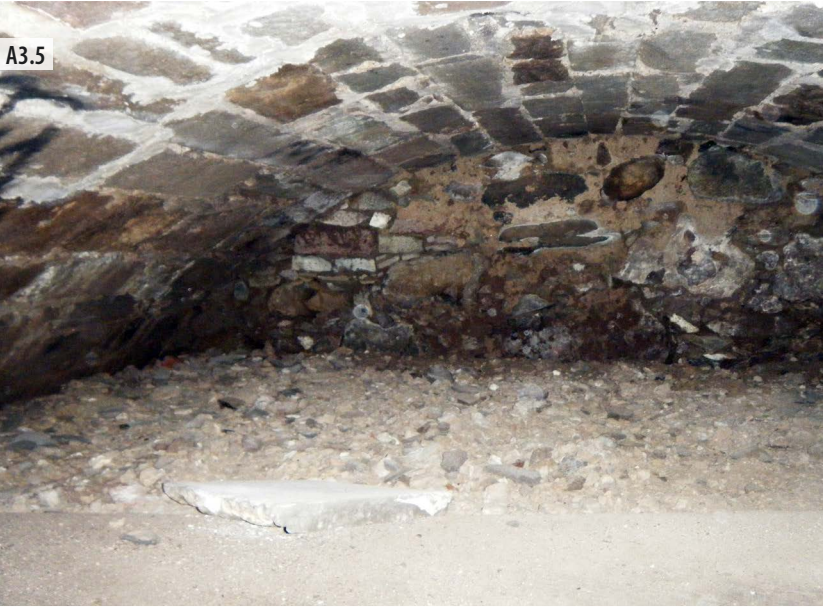
ILLUS A3.5

Barrel vault in burial crypt. From N

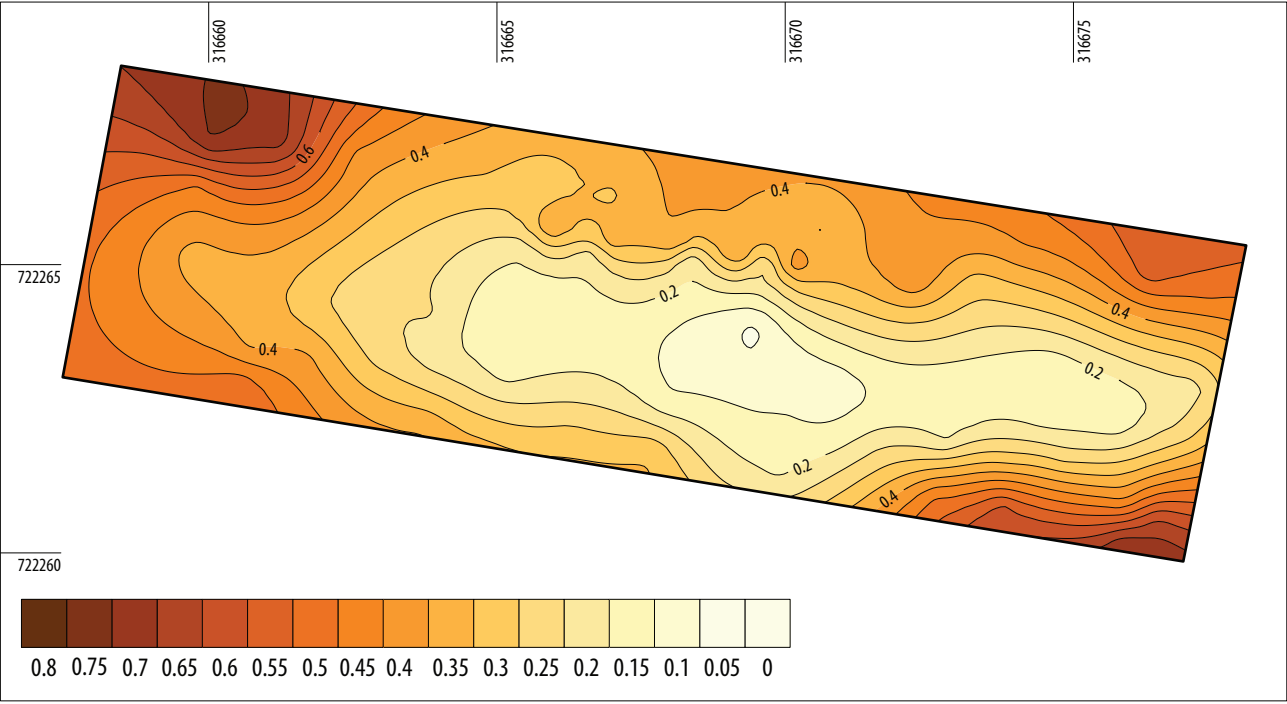
ILLUS A3.8

Contour plot showing depth of dumped deposits inside the church
