KOPC15/03

KINFAUNS OLD PARISH CHURCH

Report on Test Pit Evaluation

Client: Tay Landscape Partnership

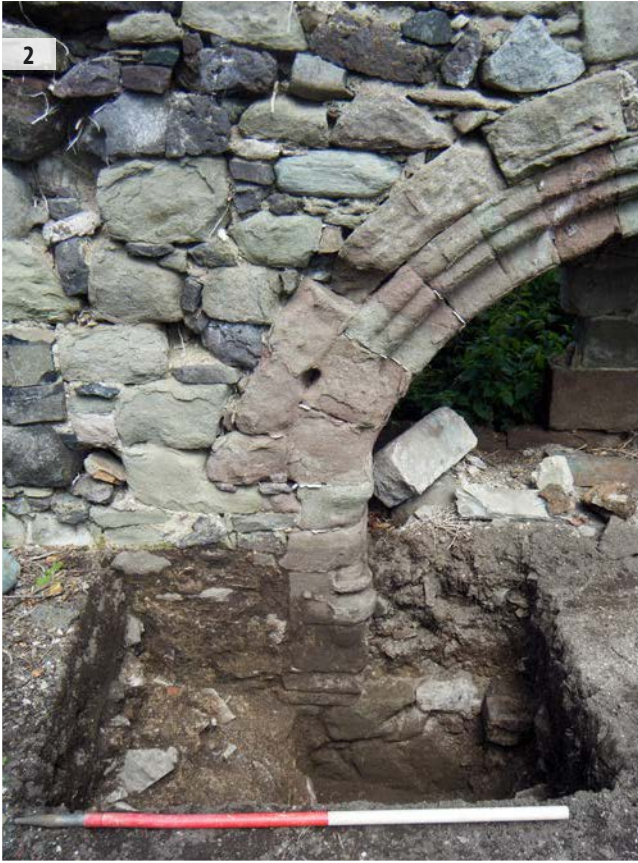
ILLUS 2
Wall face and lower part of recess exposed in Test Pit 1. From S

The wall foundations below the assumed floor level were laid in a way that formed a flushed face in line with the wall above, possibly indicating that the original floor was at a lower level. However, the floor level was indicated by plaster remnants still adhering to the wall to the west of the recess. The plaster only extended down to the proposed floor level and was not seen on the flushed wall face further down (Illus 2).

level of this deposit coincided with the base of the recess and appears to indicate the position of the floor level within the church.

The floor level was interpreted in Pit 1 as the base of the chancel recess and the corresponding base of wall plaster to the north. In Pit 3 some 8m to the west, the floor level was taken to be the base of the wall. Analysis of absolute heights indicates this interpretation to be correct as in both cases that level was almost identical; between 56.20-56.26m OD (003)/ (007).

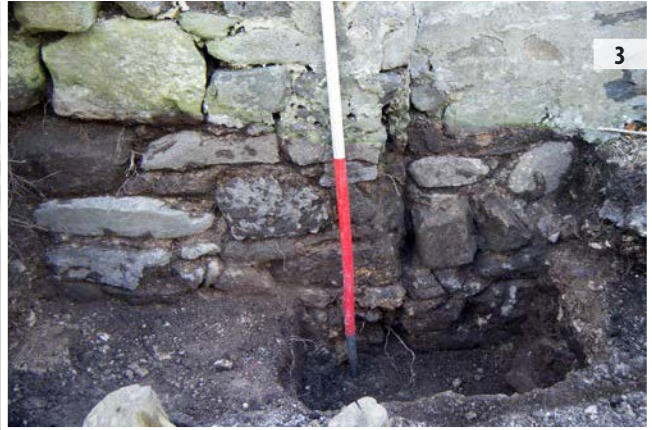
ILLUS 3
Wall face showing butt joint between nave and south aisle exposed in Test Pit 2. From N

The junction between the south wall of the nave and the north wall of the aisle was exposed within the pit. The junction was a butt joint and there was no evidence of the two walls being keyed into each other (Illus 3).

As seen in Test Pit 1 the wall foundations below the assumed floor level formed a flushed face in line with the wall above (Illus 3).

The evidence from Test Pit 2 shows that there is a butt joint between the nave wall and the southern aisle added in 1598. The masonry on either side of the joint is uneven and comprises small stones; possibly indicating that the wall had been entirely truncated when the aisle was added.

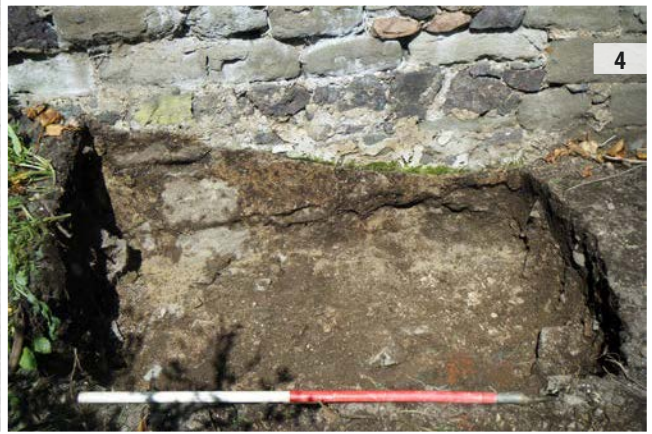
ILLUS 4
Base of wall with remains of wall plaster. From S

The pit was excavated to a level fully exposing the base of the north wall (Illus 4). Remnants of wall plaster still adhering to the wall were recorded on the lower parts of the wall behind the upper dumped deposit (006). The remnants had probably been protected from weathering by the soil. The upper part of the foundations were exposed below the base of the wall comprising a couple of rounded boulder protruding beyond the wall face (Illus 4).

No surviving remnants of the floor were seen at the base of the wall. However the rubble deposit (007) coincided with the original floor level as defined by the wall base.

The base of the north wall was clearly exposed in Test Pit 3, where a stone from the foundations was exposed protruding beyond the internal wall face. However the foundations exposed in Pit 1 were of different construction, built with a flush inner face in line with the wall face above and not displaying any clear transition from foundations to the overlying wall. Similar straight foundations were found in Pit 2. Due to the find of skeletal remains the full depth of the foundations were not exposed. It is therefore not clear if the straight face of the foundations below floor level would indicate that there had been a crypt under the chancel that later has been infilled.

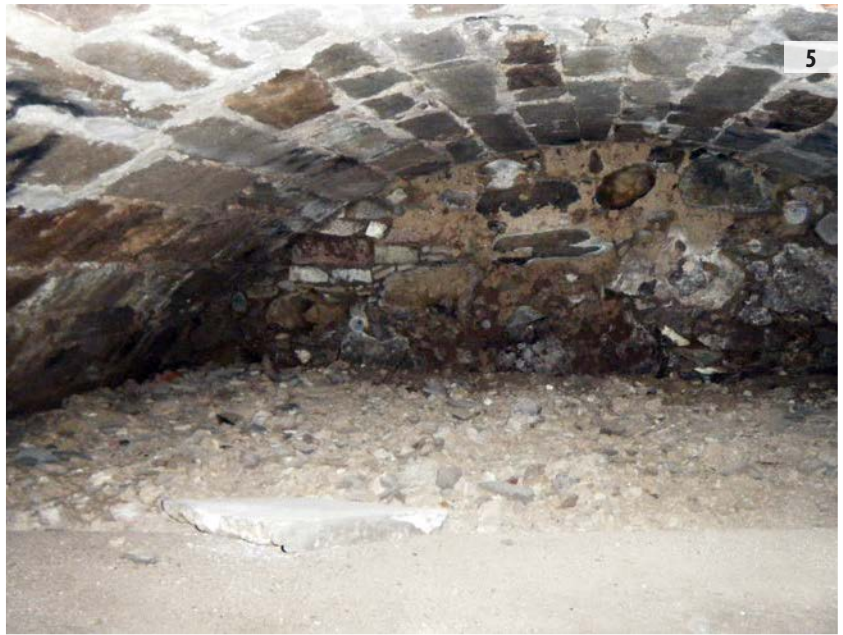
ILLUS 5

The floor of the crypt lay some 1m below the floor of the aisle. It was covered by a barrel vault springing from east to west (Illus 5). A sub-rectangular shaft aligned east to west and some 1m by 2.2m by about 1m deep was built into the floor of the crypt. It contained a lead coffin inside an outer wooden coffin. The lid of the wooden coffin had been displaced to the side, exposing the inner lead coffin with a collapsed lid (Illus 6). The shaft was covered by stone slabs bearing the name of Margaret Baroness Gray of Fray & Kinfauns who died in May 1878, according to a commemorative plaque set above the north door inside the burial aisle (Illus 7).

Barrel vault in burial crypt. From N

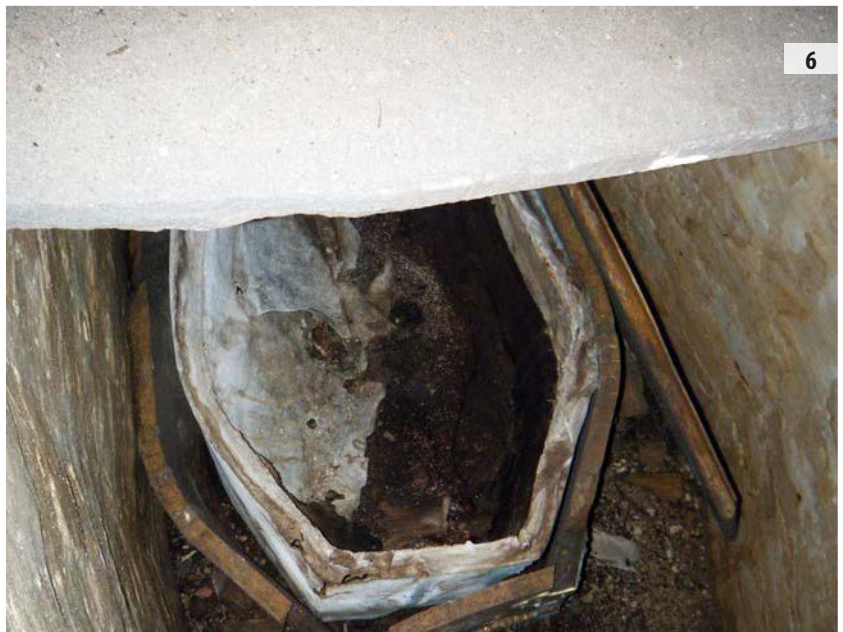
ILLUS 6

Lead coffin inside outer wooden coffin in burial crypt.
From W

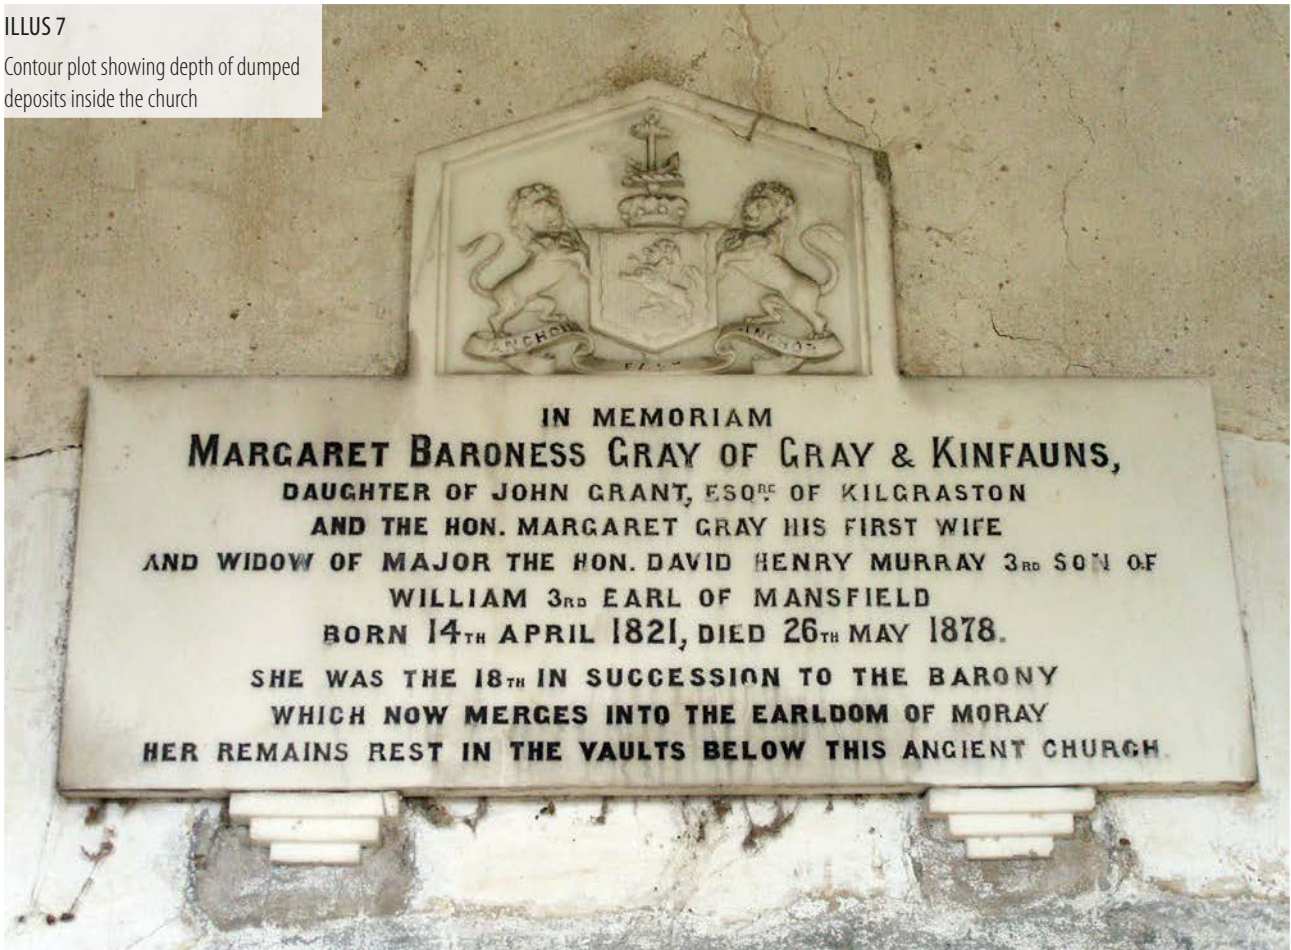
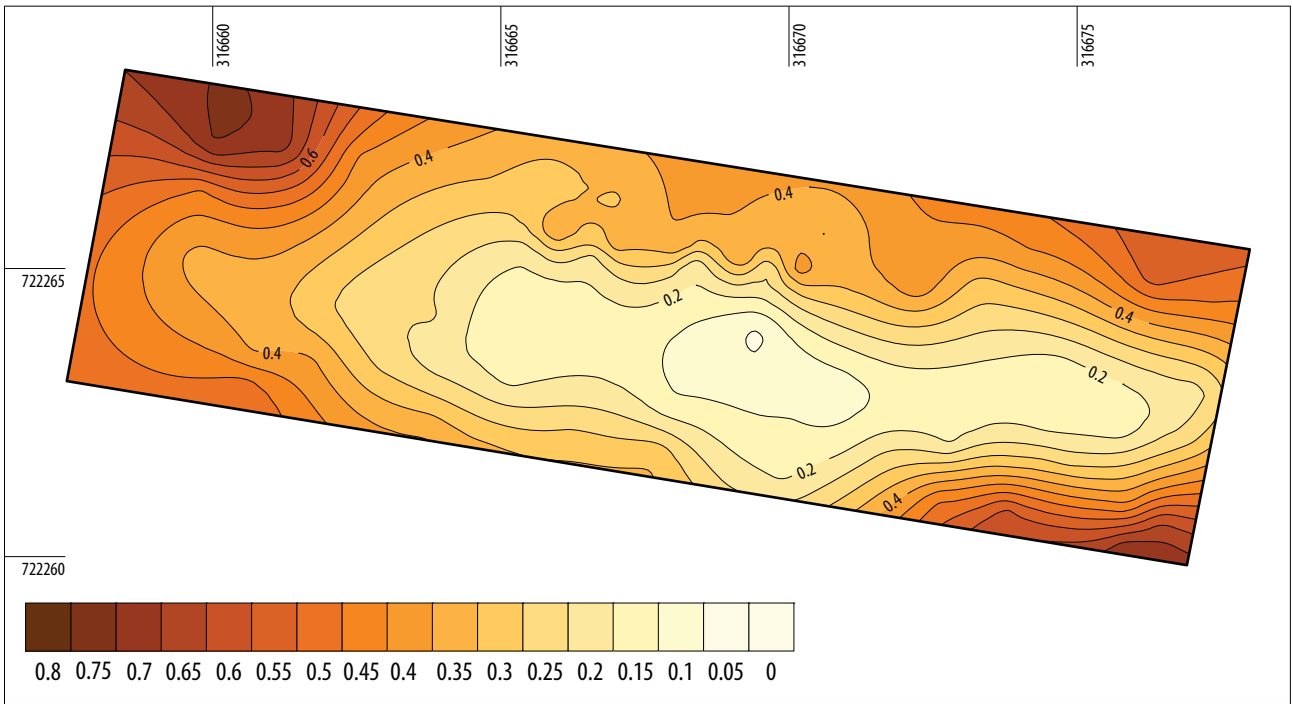
ILLUS 8
Contour plot showing thickness (m) of dumped deposits inside the church

The interior of the church is covered in mounds of soil heaped up against the interior walls up to 0.7m deep. It is not a deposit that has been gradually accumulating over time, but appears to represent episodic dumping. The deposits contains occasional fragments of human bone and is therefore likely to be surplus soil from the digging of new graves in the active churchyard to the north of the old church.

In order to assist the future clearance of these deposits, an approximate volume was established by recording in 3D a series of spot heights (Illus 8). Assuming that the floor level is at 56.25m OD across the interior of the church, the volume of dumped deposits inside the church amounts to some 35m³.
