SHAP ABBEY, PENRITH, CUMBRIA

HISTORIC BUILDING RECORDING

commissioned by English Heritage

March 2016

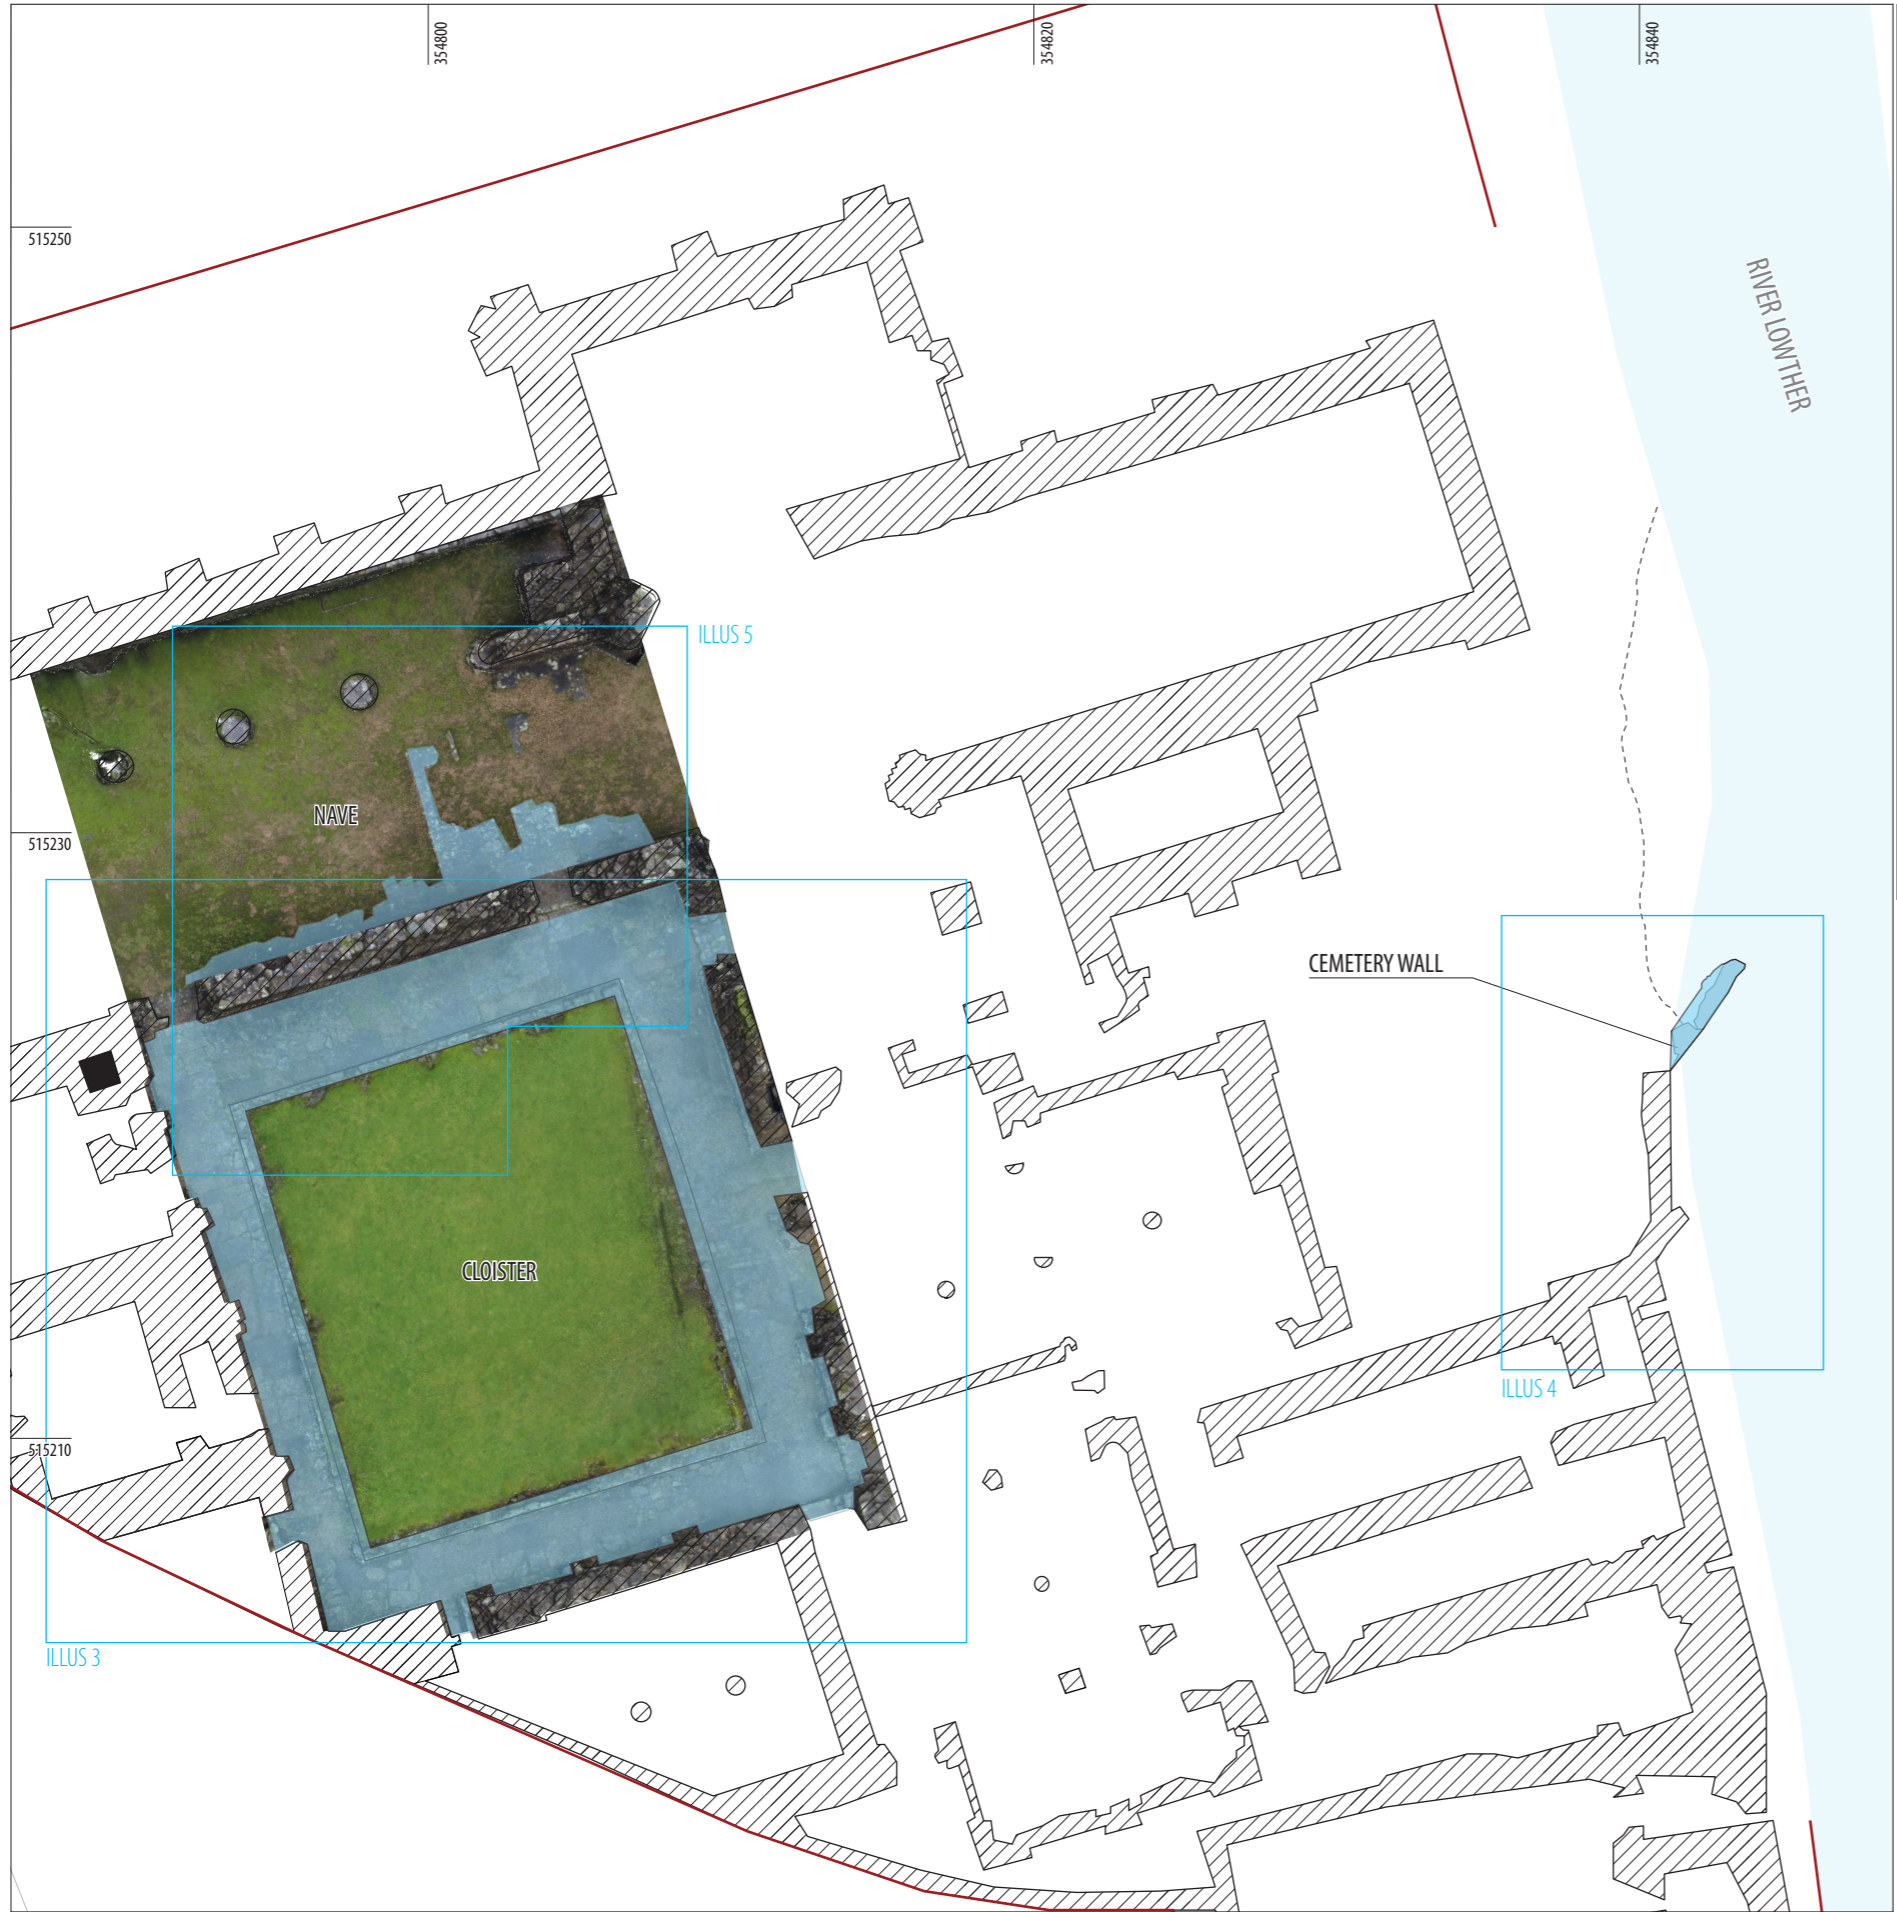
PHOTOGRAMMETRY/ CLOISTER & NAVE

Concrete located between the stone paving along the cloister walks is deteriorated. The walk was recorded with dGPS and a photogrammetrical record produced (ILLUS 3 & 7)
