A96 PARK AND CHOOSE SCHEME

ARCHAEOLOGICAL WATCHING BRIEF AND EXCAVATION

commissioned by Aberdeen City Council

March 2016

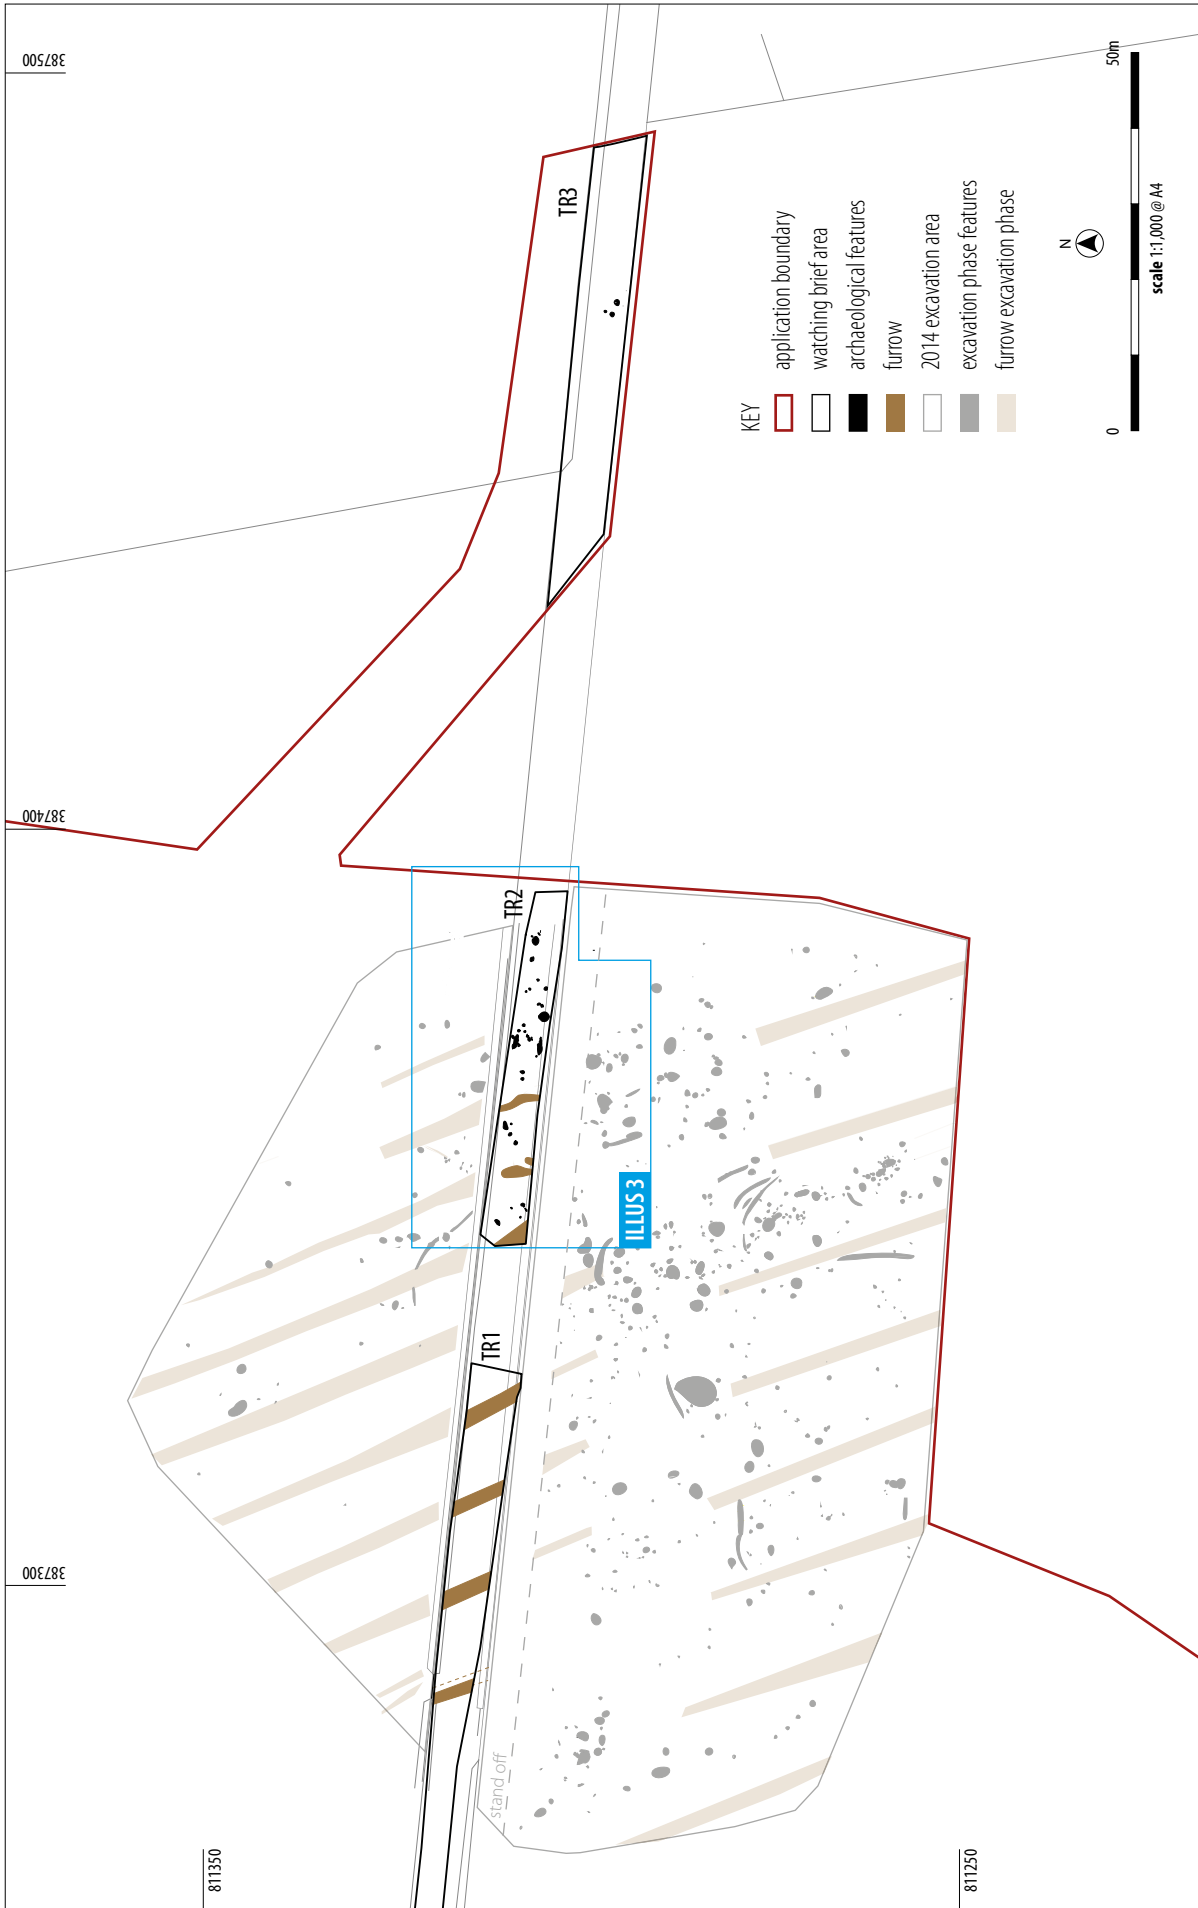
ILLUS 2 Site plan

Initially the watching brief had been timetabled to begin at the start of the project ground works, however for logistical reasons the contractor moved it to the end of their programme. A result of this was the previously unexcavated strip below the overhead cable was excavated by the contractor prior to the watching brief, along with a small section of the road (ILLUS 2).

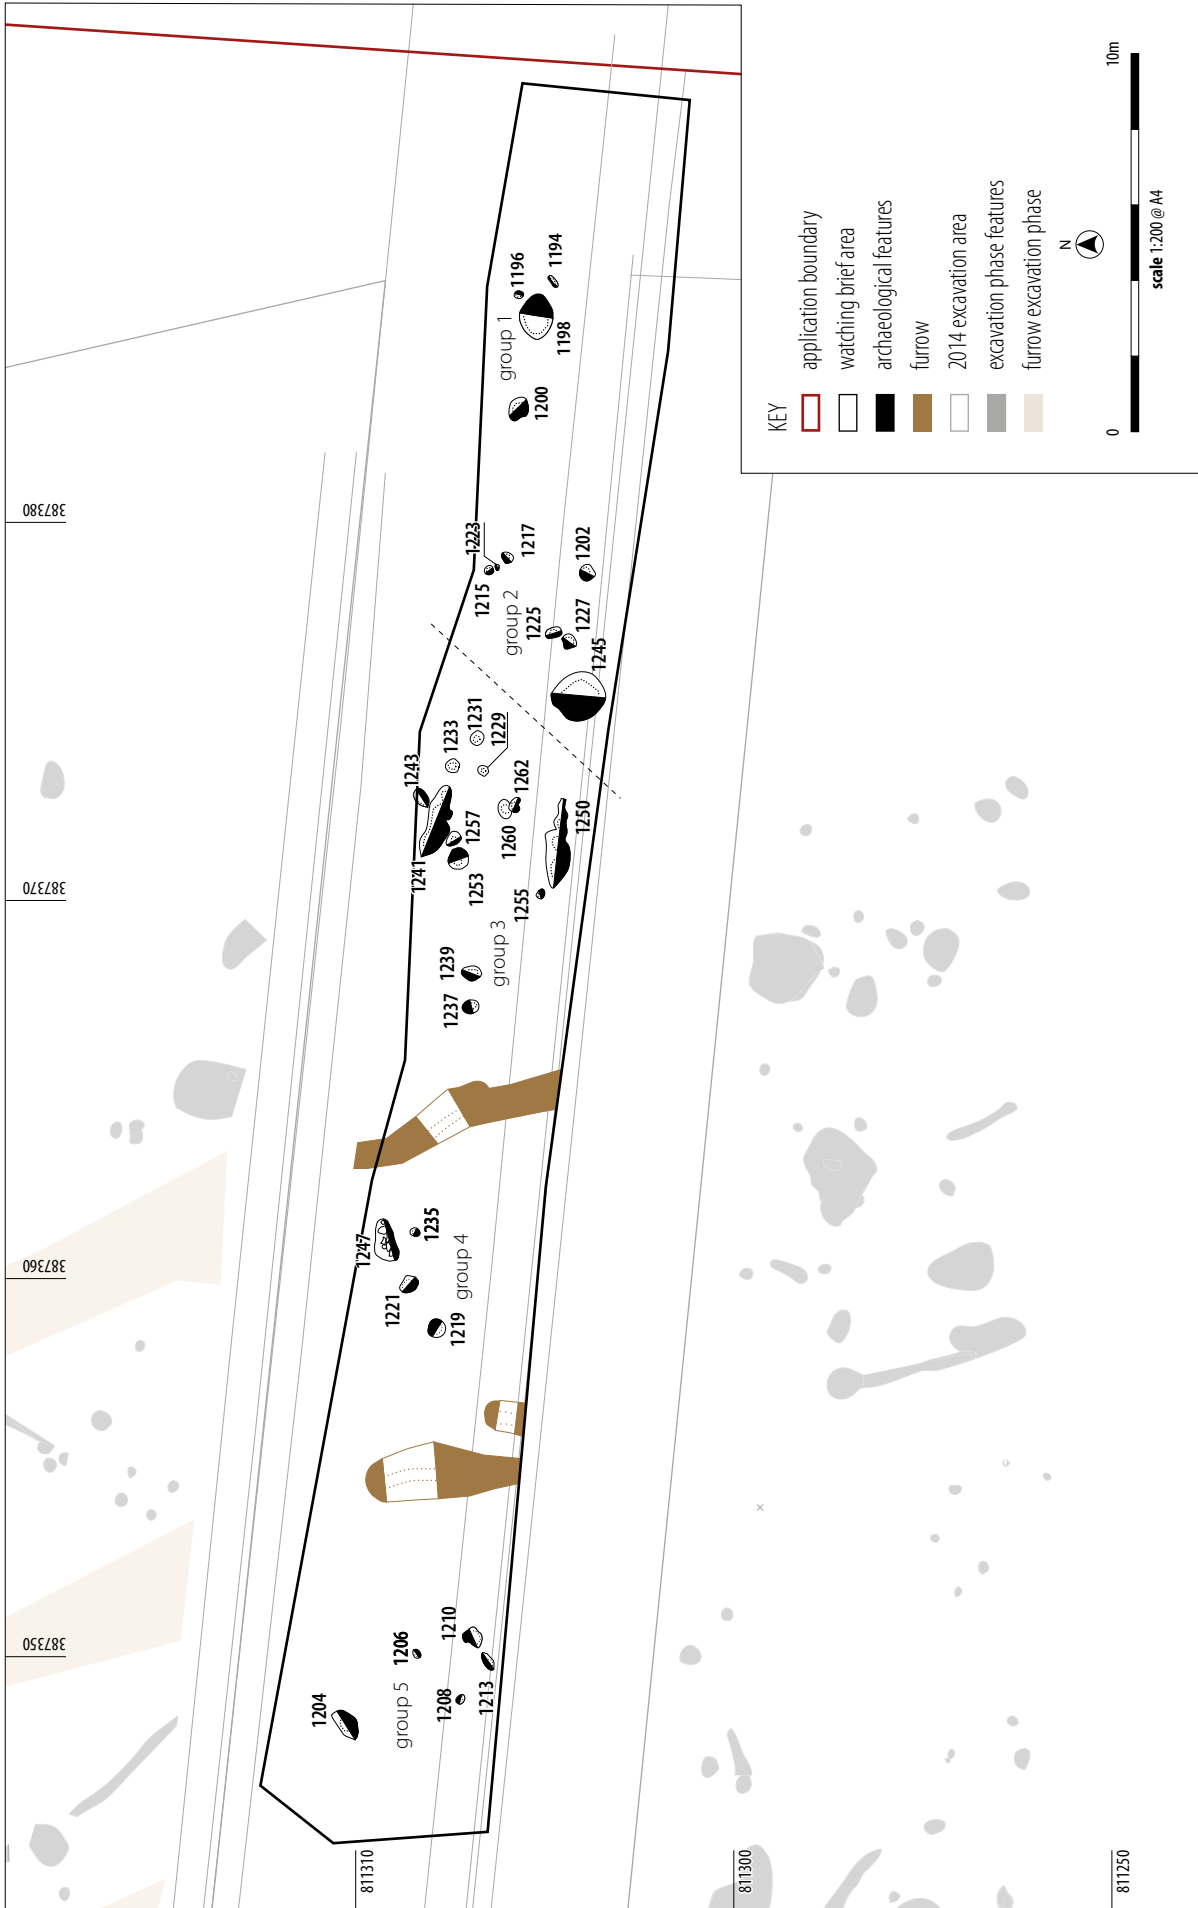
ILLUS 3 Detail plan of Trench 2

Trench 2 was excavated in the central area of Walton Road and measured 47.25 x 6.35m. A number of archaeological features were recorded in this trench. In order to aid discussion, these features have been assigned to arbitrary Groups, based on proximity, within Trench 2.

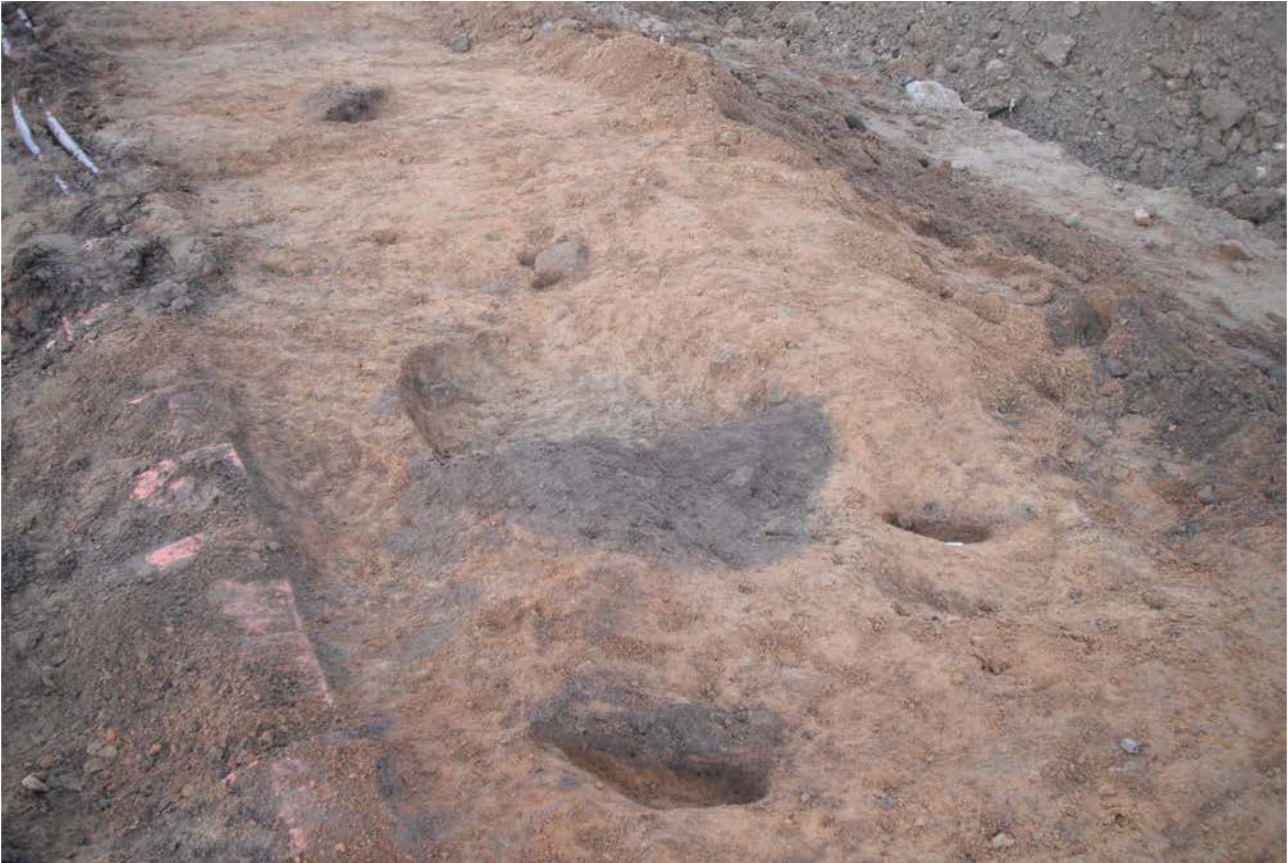
ILLUS 4 View of post-holes [1194], [1196] and [1198] looking SW

Central to the group was an ovoid shaped cut [1198] measuring 1.21 x 0.84m and 0.20m deep that was interpreted as a pit. The pit was backfilled with a deposit (1199) which contained a mottled, heat affected sandy silt and charcoal flecks. The natural geological sands at the base of the pit were compact and pale further suggesting burning in situ. This feature may have been a hearth or fire pit (ILLUS 4).

Features [1194] and [1196] were situated 0.30m east and 0.30m north east of feature [1198] and were interpreted as post-holes, possibly for a windbreak or other protective structure associated with feature [1198]. Both post-holes were truncated and ranged in size from 0.40m to 0.24m with a maximum depth of 0.09m, both filled with a greyish brown sandy silt.

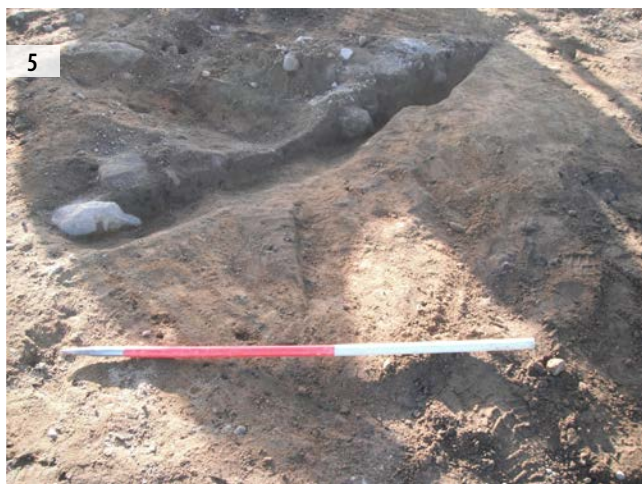
Central to the group was an irregular shaped feature [1241] with an uneven base measuring 2.04m x 0.98m and 0.16m deep. It was filled with a loose greyish brown sandy soil (1242) containing occasional medium pieces of granite and sub angular stones. This has been interpreted as a reused tree throw, due to the irregularity of the cut, which was deliberately backfilled to create an even surface – possibly a working floor or platform (**ILLUS 5**).

ILLUS 5 View of hollow [1241] looking W **ILLUS 6** Post-ex of hollow [1241] and associated post-holes looking E

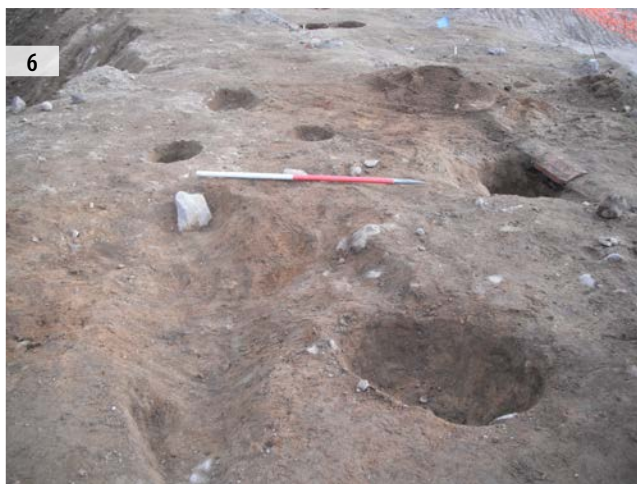
Associated with feature [1241] were five post-holes ([1229], [1231], [1233], [1243] and [1253]) and a stake-hole [1257] which appeared to form an arc around the eastern extent of [1241]. The post-holes were variably truncated and ranged in size from 0.25 to 0.45m diameter. These post-holes all had similar sandy silt deposits within and may have formed an exterior protective structure around [1241]. Post-hole [1253] measured 0.45 x 0.25m and 0.25m deep and was the largest post-hole in this arrangement. It appeared to be braced by stake-hole [1257] and was likely a load bearing post for the structure around [1241] (**ILLUS 6**).

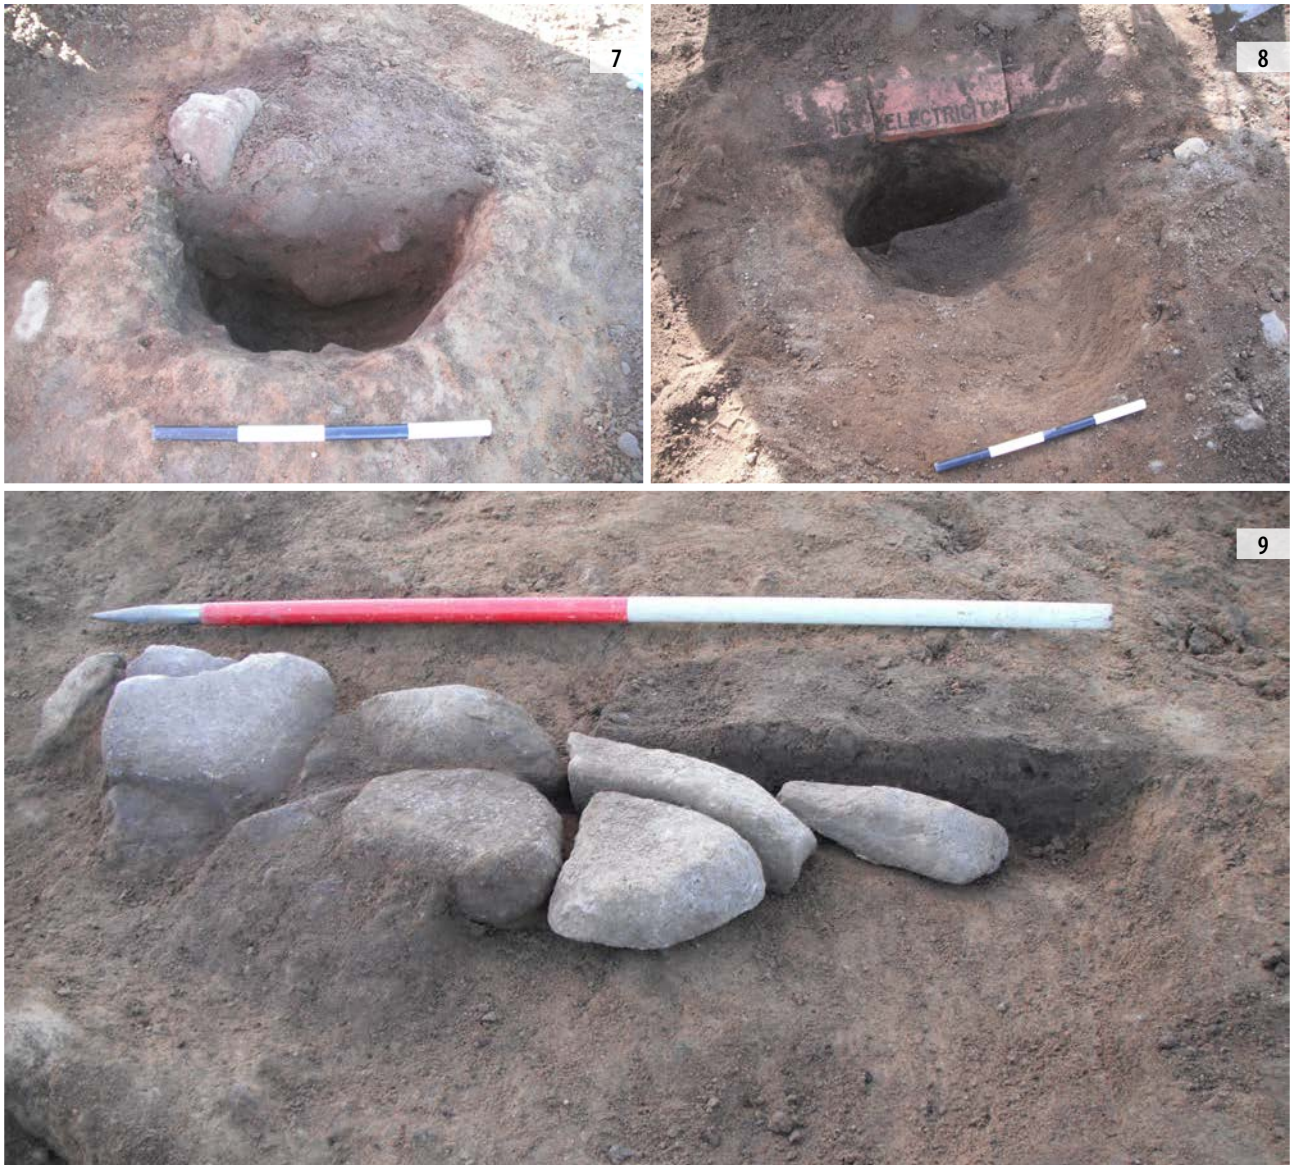
Feature [1202] (**ILLUS 7**) was a circular cut which measured 0.50m in diameter and 0.53m deep. Feature [1202] has been interpreted as

a post-hole, with packing stones and a prehistoric lithic recorded within its deposit (1203). No other features can be definitely associated with the feature - its function and associations are unclear.

Feature [1260] was recorded 1.30m to the south of [1241], measuring 0.38 x 0.56m and 0.14m deep. It was truncated by feature [1262] which measured 0.50m in diameter and was 0.27m deep. Both features were sub circular with flat compact bases. It was initially thought that these features were also associated with the post-holes forming a structure around feature [1241]. The fills of both features (1261 and 1263), differed from the fills of those associated with feature [1241], comprising a dark greyish brown sandy loam. Both contained topsoil-like fills and their cuts respected a modern electrical service running east-west across the trench (**ILLUS 8**).

Feature [1247] was located at the north-eastern extent of Group 4. Teardrop-shaped in plan, the feature measured 1.20 x 0.58 m and was 0.10m deep. It consisted of granite fieldstones (1248) of a uniform size (0.25 x 0.25 x 0.05m) placed into a natural depression in order to form a level surface. The fieldstones were mostly flat on top with a smooth, worn surface indicating it was used as a surface (**ILLUS 9**).

ILLUS 7 Section of post-hole [1202] looking W **ILLUS 8** View of post-holes [1260] and [1262] looking S **ILLUS 9** Section of [1247] looking S

A distal fragment from a flint flake or blade was retrieved from fill (1203) of post-hole [1202]. Small flakes removed from around the distal end appear to be nibbled retouch while some flakes along the lateral are likely to be edge damage or use wear. Whilst prehistoric in date, closer dating is not possible due to its fragmentary state
