GLASGOW MEAT MARKET

*Archaeological Watching Brief
for Glasgow City Council*

July 2016

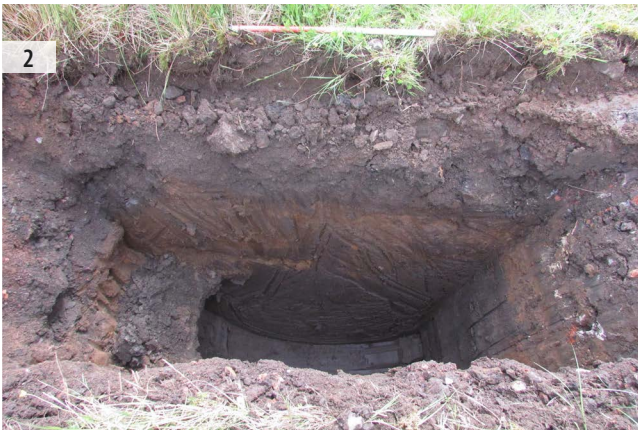
ILLUS 2 W facing section of Trial Pit 2

Trial pit Two (Illus 2) was located in the southern part of the site and revealed at its base a dark purplish-grey clay (204) overlain by a mid-yellowish-brown silty sand (203) – both were natural subsoils. These were overlain by a dark grey sand (202) which was 0.75m thick with very frequent brick, stone and concrete fragments interpreted as a layer of demolition rubble. This layer was overlain by a 0.25m thick layer of topsoil (201) - a stony dark greyish-brown sandy loam. No archaeological features were observed.

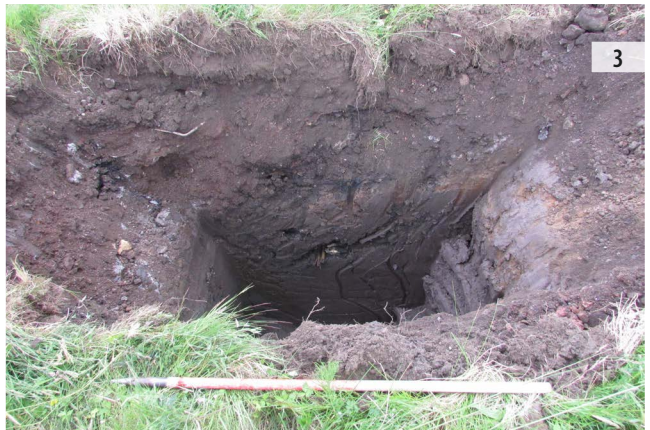
ILLUS 3 SW facing section of Trial Pit 6

Trial pit Six (Illus 3) was located in the north-east corner of the site and revealed at its base a dark

purplish-grey clay (605) natural subsoil. This was overlain by a similar deposit (604) 0.6m thick containing wooden planks and other concrete fragments which is interpreted as a layer of redeposited natural containing demolition rubble. Deposit (603) a mid-yellowish-brown sand 0.4m thick overlay this and is interpreted as a layer of redeposited natural. Above this was a dark grey sand (602) 0.7m thick with frequent brick and concrete fragments - a layer of demolition rubble. This was overlain by a 0.3m thick layer of topsoil (601). No archaeological features were observed.

The sub-surface remains revealed in the trial pits 3, 4, 8, 10, 11 and 14 are most likely associated with the Glasgow Meat Market buildings. However it should be noted that Trial Pit Six revealed a deposit containing wooden planks and demolition rubble which was overlain by a layer of redeposited natural and the earlier layer could represent a period of industrial activity which predates the meat market.

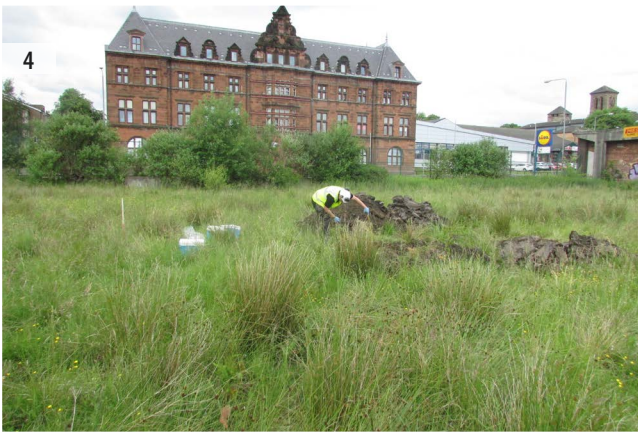
ILLUS 4 N facing view showing location of Trial Pit 7

Trial pit Seven (Illus 4) was located to the west of trial pit Six and revealed a mid-orangy yellow sand layer (705) with clay lenses at its base – the natural subsoil. The cut of a pit [704] with steeply sloping sides was observed in the western part of the trial pit. It was oriented north-east to south-west and filled with a very dark grey sand (703) 0.6m thick containing frequent cinders and brick fragments, and rare fragments of slag. It is possible that the pit was cut to contain demolition rubble. Fill (703) was overlain by a dark grey sand (702) 0.7m thick with frequent concrete and red and yellow brick fragments – a layer of demolition rubble. This was overlain by a 0.25m thick layer of topsoil (701).

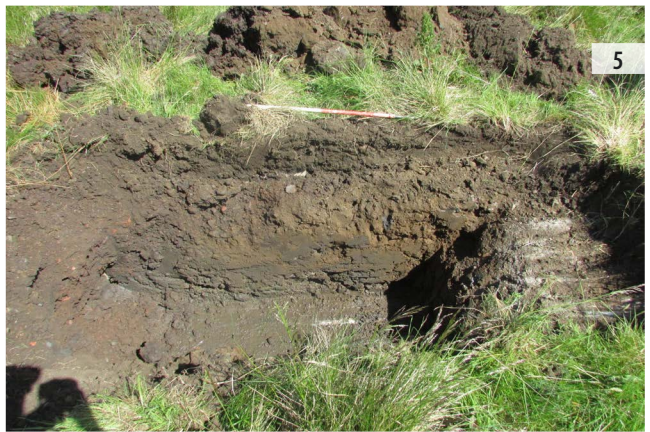
ILLUS 5 S facing section of Trial Pit 8

Trial pit Eight (Illus 5) was located towards the centre of the site and revealed a concrete floor surface (805) 1.45m below ground level which extended beyond the limits of the trial pit. Excavation did not proceed beyond this surface. It was overlain by a dark grey clay deposit (804) 0.45m thick with frequent brick and stone fragments, which was overlain by a layer of mid-brown sand (803) 0.75m thick with frequent fragments of concrete and paving slabs – a layer of demolition rubble. Within this deposit a concrete slab (802) 0.3m thick was located approximately 0.4m below the present ground level at the eastern end of the trial pit extending beyond the limit of excavation. Overlying deposit (802) was a 0.3m thick layer of topsoil.

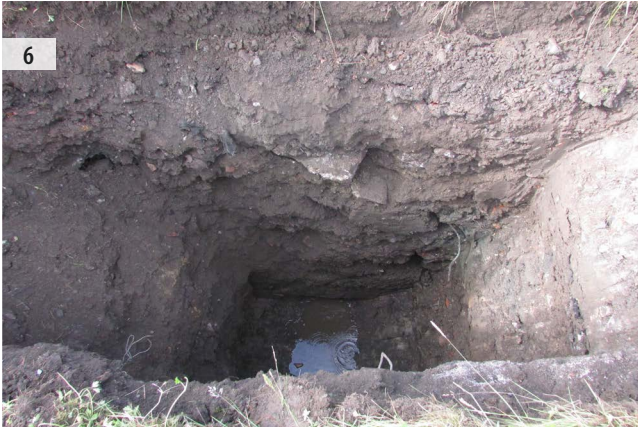
Trial pit Nine (Illus 6) was located in the north-west part of the site and revealed a 3.7m thick layer of dark grey sand (902) with very frequent brick and concrete fragments. It also contained large rounded stones, fragments of brick wall (bricks mortared together and plastered on one side) and large concrete fragments with rebar. Excavation stopped at 4m below present ground level as arm of the machine could not reach any further. It is likely this deposit was the fill of a large pit whose edges lie beyond the limits of excavation. No archaeological features were observed.

ILLUS 6 N facing section of Trial Pit 9 **ILLUS 7** NW facing section of Trial Pit 12 **ILLUS 8** SE facing view showing location of Trial Pit 14

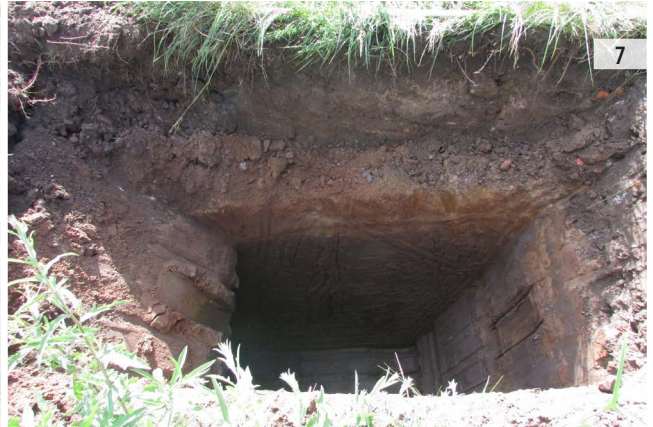
Trial pit 12 (Illus 7) was located north of trial pit 10 and revealed three layers of natural subsoil. Layer (1205) was a dark purplish-grey clay which was overlain by a layer (1204) 0.6m thick of mid-purplish-grey clay with yellow clay lenses, which was itself overlain by a layer (1203) 0.7m thick of mid-yellow sand. Layer (1203) was overlain by deposit (1202) comprising mid-brown sand 0.25m thick with frequent brick fragments and interpreted as a layer of demolition rubble. This was overlain by a 0.25m thick layer of topsoil (1201). No archaeological features were observed.

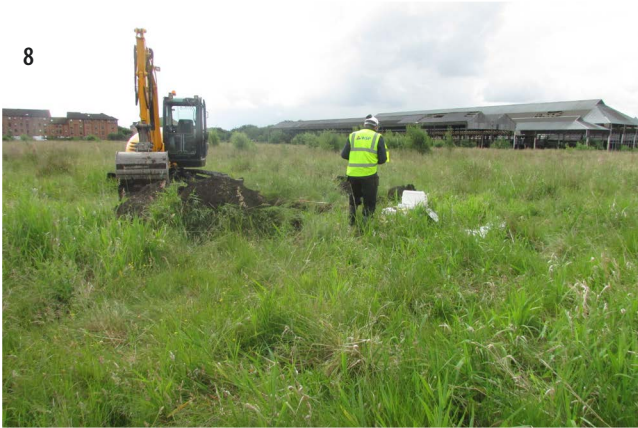
Trial pit 14 (Illus 8) was located in the western part of the site and revealed a concrete floor surface (1403) 0.85m below ground level which extended beyond the limits of the trial pit. Excavation did not proceed beyond this point. The floor surface was overlain by a layer of dark grey sand (1402) 0.5m thick with frequent concrete and red and yellow brick fragments – a layer of demolition rubble. This was overlain by a 0.35m thick layer of topsoil (1401).
